NATIONAL TRANSPORTATION SAFETY BOARD

Group Chairman's Factual Report

OPERATIONAL FACTORS

DCA14IA037

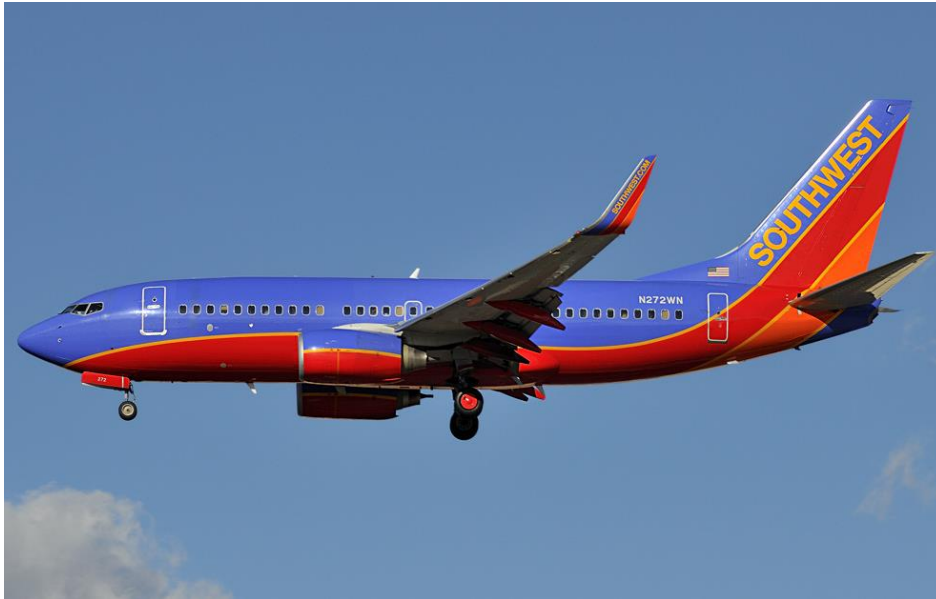
Photo 1: Incident Airplane (N272WN registration)

The incident airplane was a Boeing 737-7H4 (Registration N272WN), Serial number 32527, and was manufactured on March 29, 2007. The airplane had a max weight of 154,000 pounds and seated 151 passengers. At the time of the incident, it had a total of 24,561 airframe hours, and the last recorded inspection occurred on December 3, 2013. The registered owner of N272WN was Southwest Airlines. It held a transport category airworthiness certificate dated March 29, 2007. At the time of the incident, the airplane carried two MEL (minimum equipment list) deferrals. The #2 aft fuel boost pump and the right hand retractable landing light were both placarded inoperative.²⁶
