NATIONAL TRANSPORTATION SAFETY BOARD

**OPERATIONAL FACTORS/HUMAN PERFORMANCE
SPECIALIST REPORT TO THE U.S. ACCREDITED
REPRESENTATIVE**

DCA10RA092

Operator: United Parcel Service (UPS) Flight 6
Location: Dubai, United Arab Emirates
Date: September 3, 2010
Airplane: Boeing 747-400

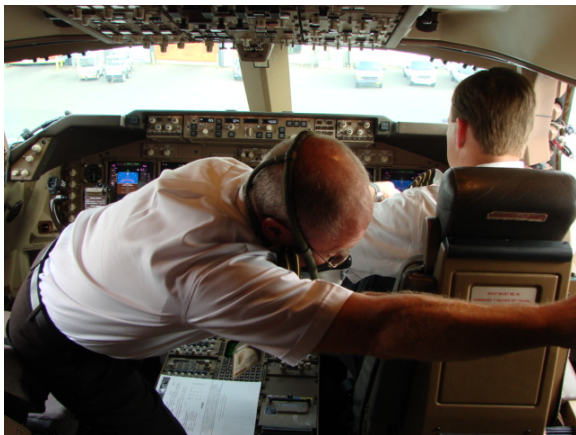
Figure 3: O2 mask with hose fully extended

On December 1, 2010, the Group traveled to Seattle, Washington, to document crew procedures and the aural and visual alerts/messages that occur during pack failure and main deck fire events in a Boeing 747-400 simulator. The Group also documented how crew performance was affected by modifying the font size of crew checklists and various lighting configurations by removing outside visual references, and during single pilot operations. Investigators tested the range of the crew oxygen mask hose lines. A pilot exiting his/her flight deck seat while donning the crew oxygen mask cannot reach the emergency portable oxygen bottle (full-face mask and oxygen bottle located behind the left cockpit jumpseat) without removing their crew oxygen mask (see figure 3).

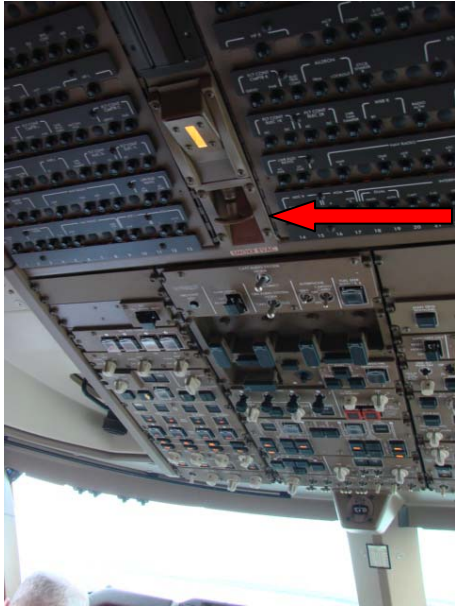
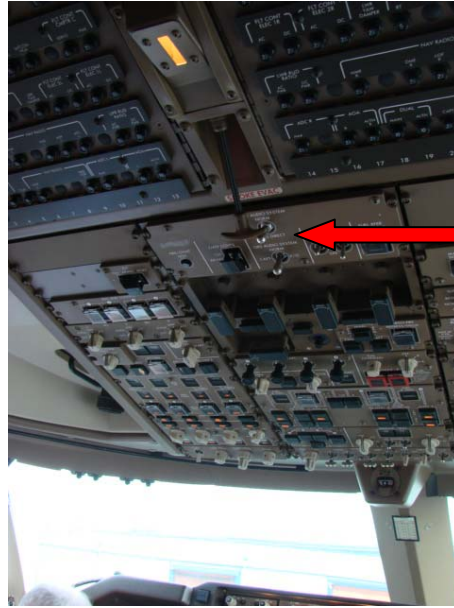
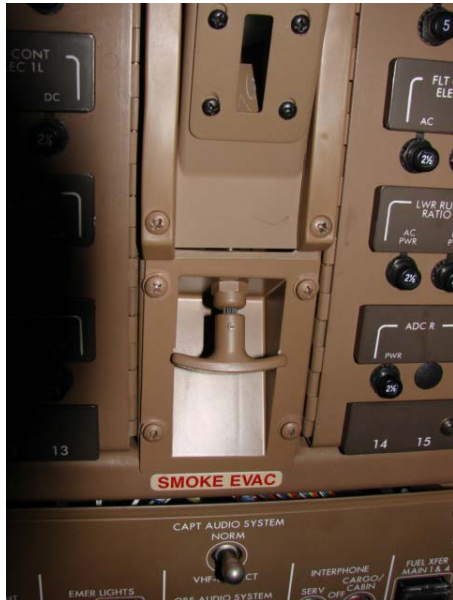
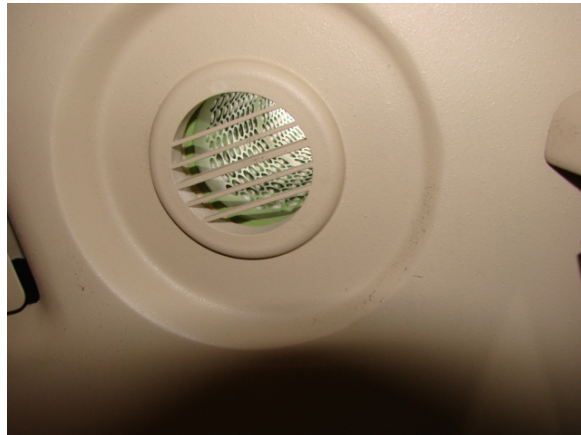
displays and covering the backup display. The captain pulled the smoke handle (see figures 5 through 8); however, no checklist was used to make this decision.

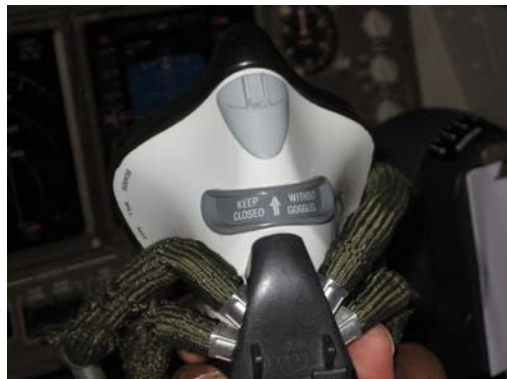
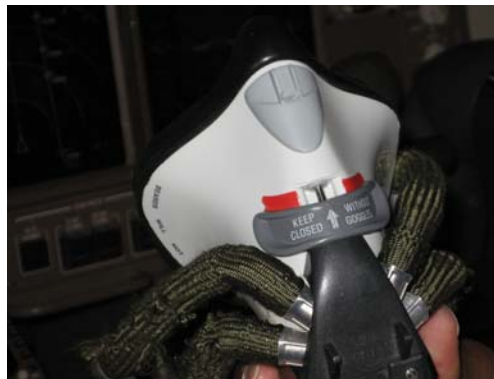
Figure 9: Smoke vent valve selector (closed) Figure 10: Smoke vent valve selector (open)

The pilots involved in the exercise indicated that with the smoke goggles donned, it was difficult to find the switch to clear the goggles of smoke (see figures 9 and 10) and one stated “it was “awkward”.

The pilots did not believe they would have thought to clear the goggles if they had not practiced it before the scenario. Pilot #1 stated that it was a misconception that the goggles should fit snugly. He said they were designed to be loose so that the goggles could be cleared of smoke. The instructor informed the crew that they should have completed the smoke fire and fumes checklist prior to completing the smoke removal checklist. Asked who would be in charge of communicating with ATC, both pilots indicated that the PM would do this.

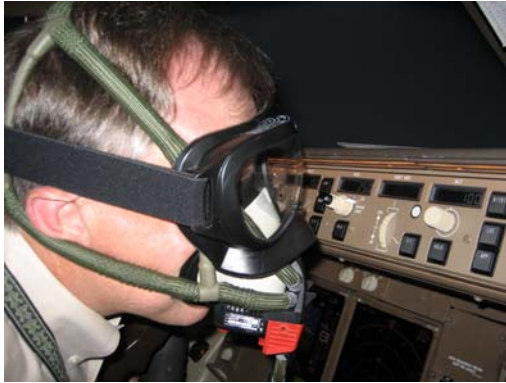
Figure 11: Closest position to the MCP

Pilot #2 indicated that with the smoke goggles donned, he could not see the standby compass. He said the image was distorted and he would have gotten his flashlight to improve visibility of the compass. Figures 11 and 12 show how close a pilot could get to the instrument panel with the oxygen mask and goggles donned.

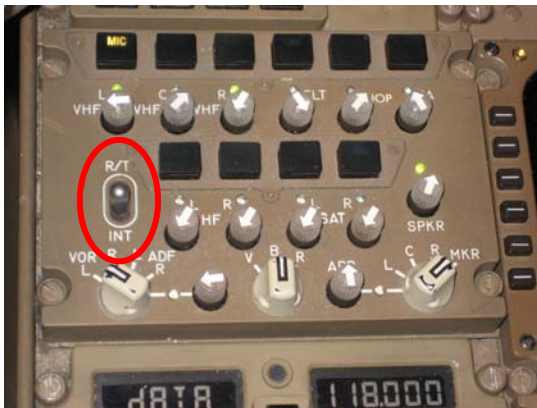
Figure 13: “Push to Talk” switch

Pilot #1 stated that not having a live mic could be an issue. He said if he did not hit the lower rocker (the “push to talk” switch on the audio panel; see figure 13), pilot #2 could not hear him. It was difficult to do this when holding the checklist.

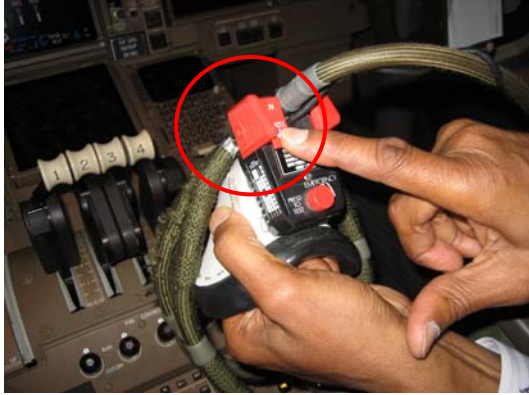
Figure 14: 100% Selector Switch on Oxygen Mask

The pilots in the exercise did not know about preflight maintenance of O2. Regarding the different oxygen levels of the oxygen mask (see figure 10), “Normal” was a mix of ambient air and oxygen and the higher you get, the more O2 that was introduced, “100%” was 100% oxygen and “emergency” was positive pressure and 100% oxygen.

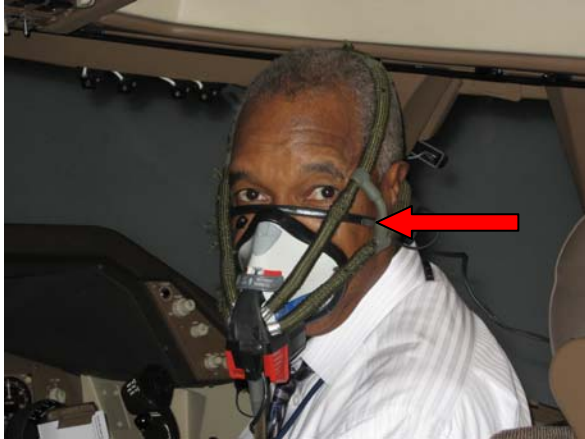
Figure 15: Headset location after donning mask

It took approximately 28 seconds for the crew to don both the oxygen mask and smoke goggles. It took an additional 6 seconds for the crew to establish crew communications. The scenario was run two times and both times the headset was knocked off when donning the oxygen mask (see figure 15).

Pilot #2 also indicated that to don the oxygen mask with the headset on, the pilot would have to move the boom of the headset to get the right seal on the mask. With the mask on, the crew could communicate using the rocker switch on the audio panel or on the control yoke.
