NATIONAL TRANSPORTATION SAFETY BOARD

OPERATIONS GROUP FACTUAL REPORT

DCA 08 MM 004

Vessel:	<i>Cosco Busan</i>
Date:	November 7, 2007
Time:	0830 PST (UTC -8)
Location:	40° 27.0' N, 073° 48.0' W
Owner:	Regal Stone Limited, Hong Kong
Managing Operator:	Fleet Management Limited, Hong Kong
Charterer:	Hanjin Shipping Company Limited, Seoul, Korea
Complement:	24 crew members

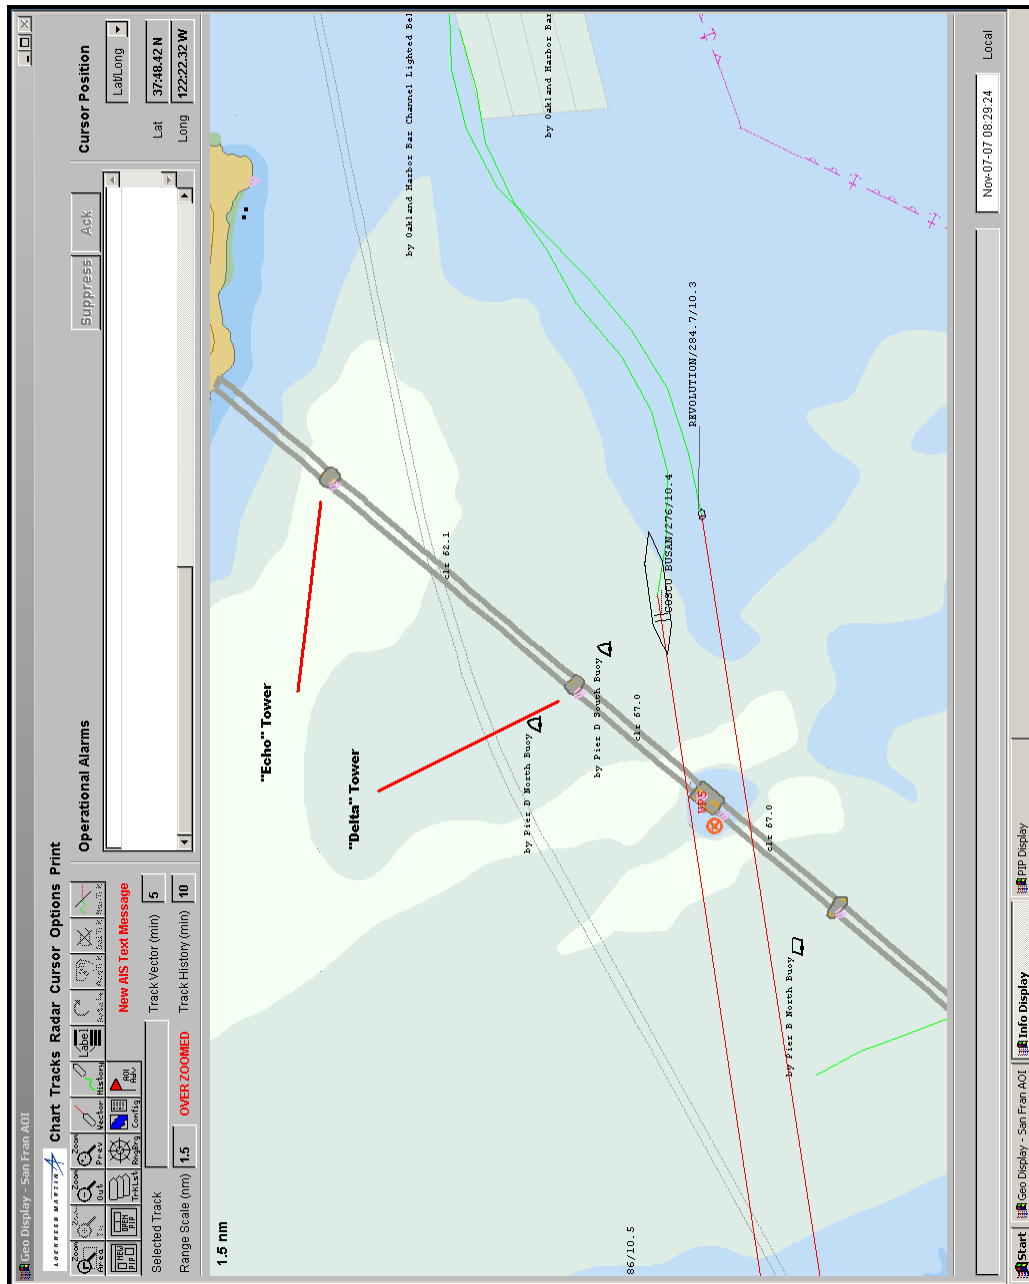
Figure 2. Time of VHF radio call from VTS controller to pilot on board the *Cocso Busan* regarding the pilot's intention.

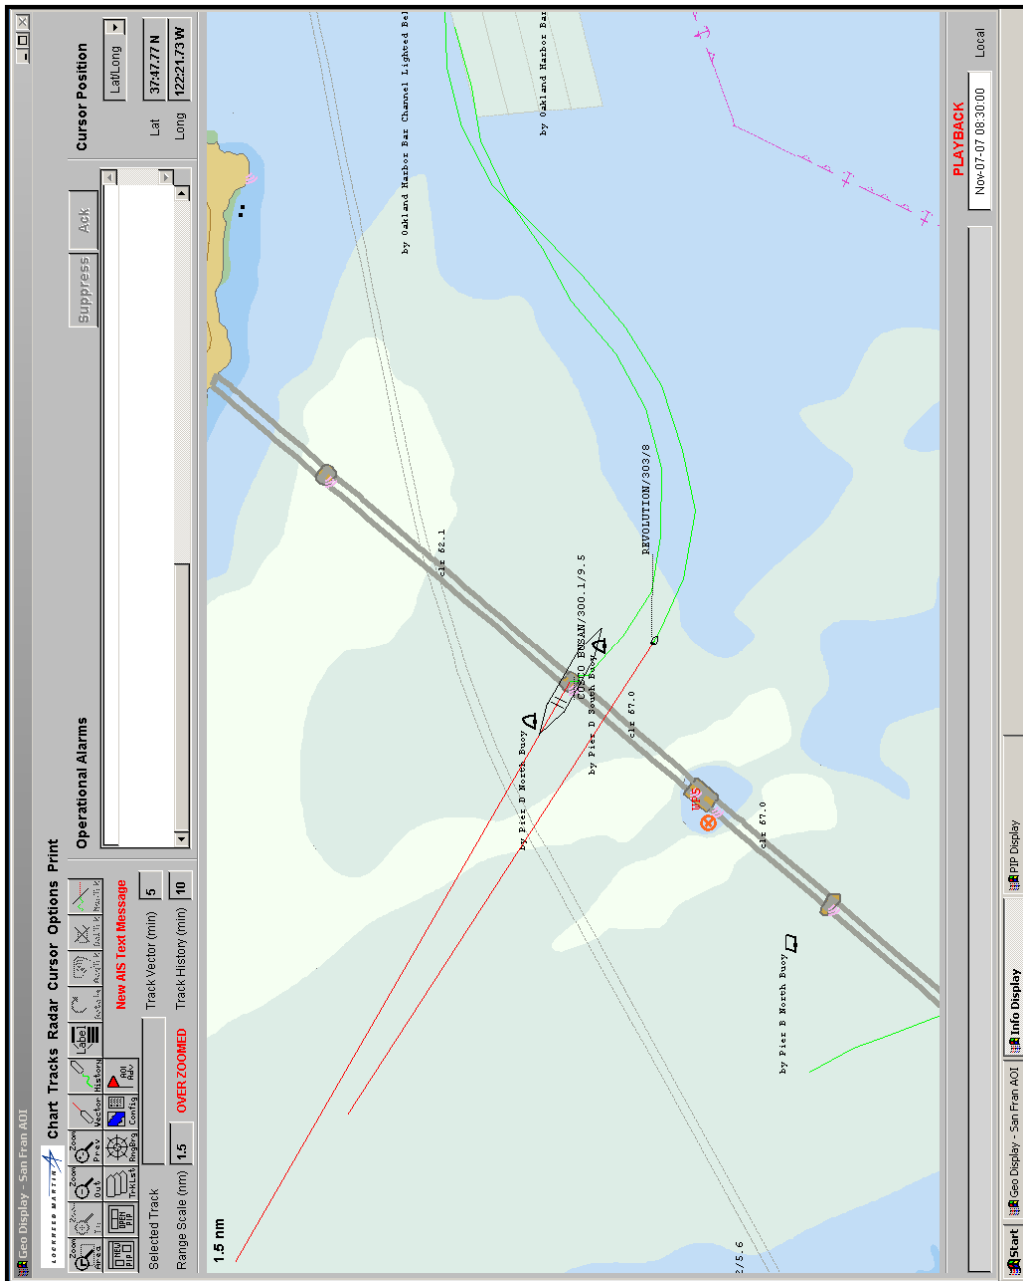
Figure 3. Time of vessel's allision with fender system of Delta support tower.

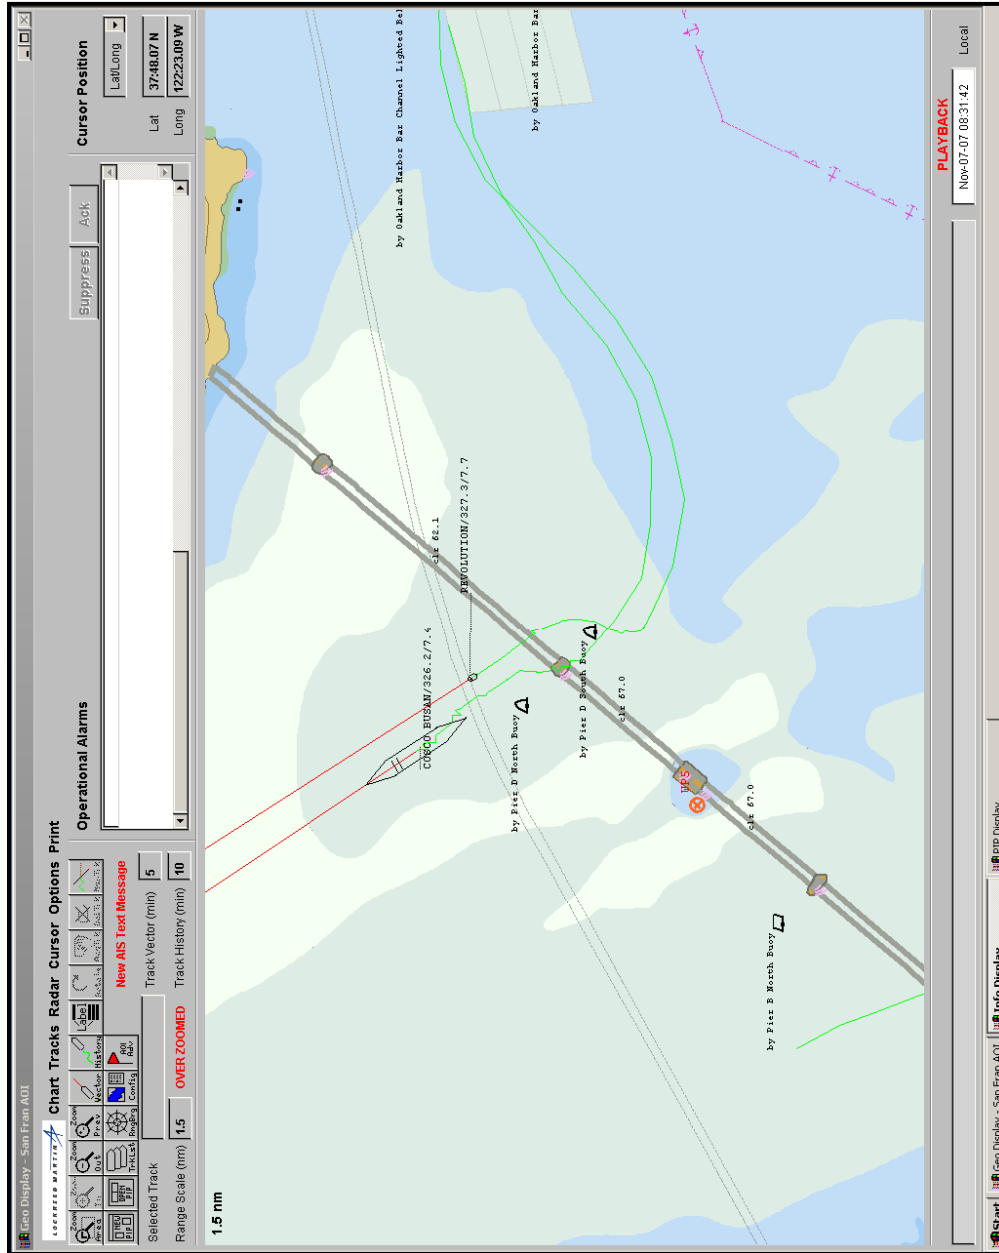
Figure 4. Time of VHF call from pilot on board Cosco Busan to VTS San Francisco reporting allision

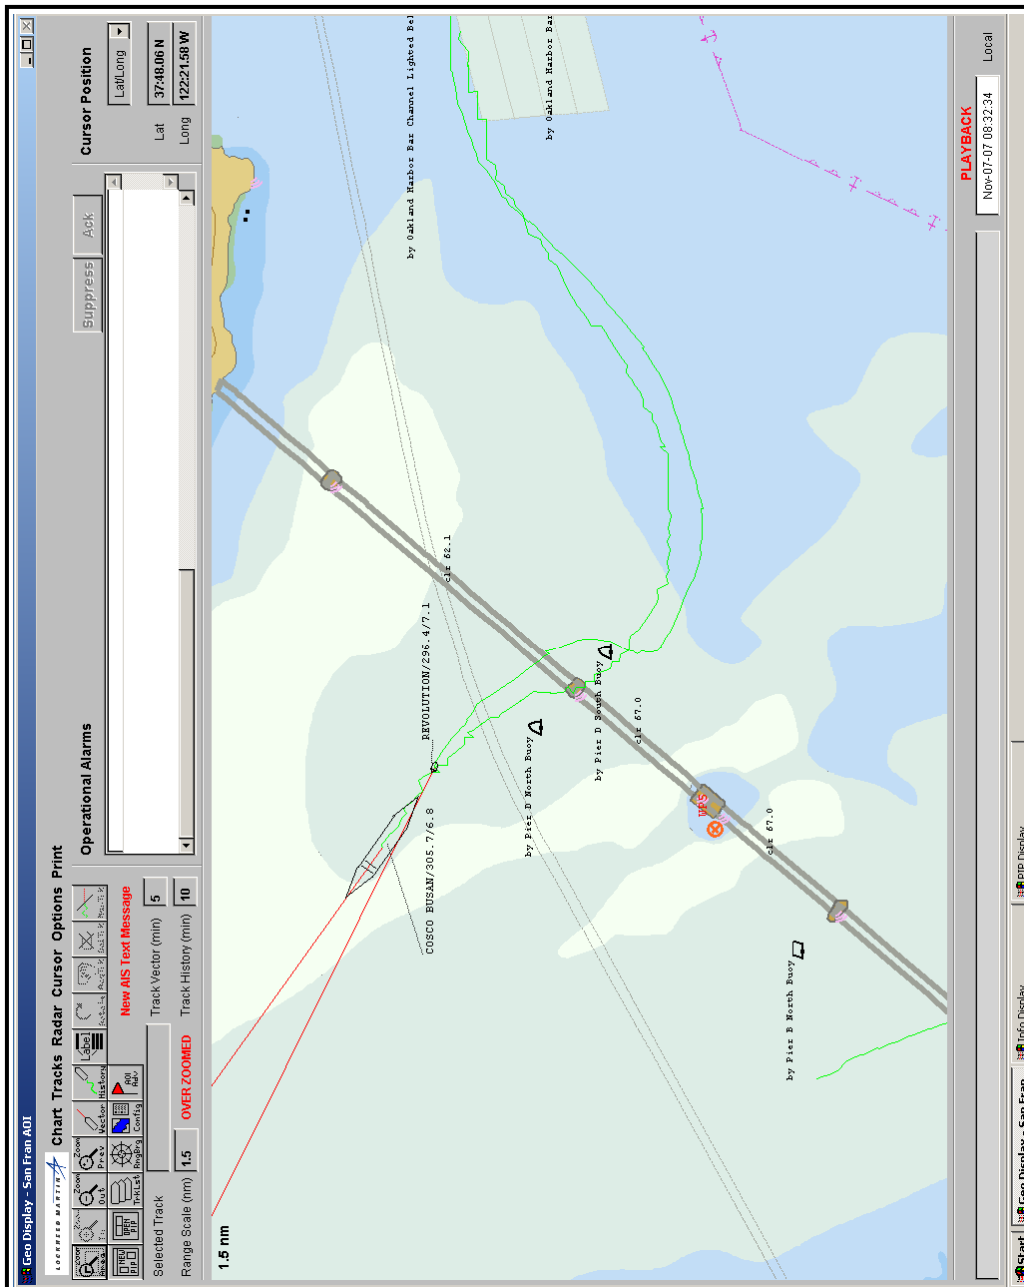
Figure 5. Record track lines of the *Cosco Busan* and the *Revolution*.
