Addendum 1
To Operations/Human Performance Group Factual Report
Attachment 6

DCA11IA040

Meeting Notes – Airbus

**Meeting summary for United Airlines flight 497 Incident, A320 Runway Excursion,
April 4, 2011 (NTSB # DCA11IA040)**

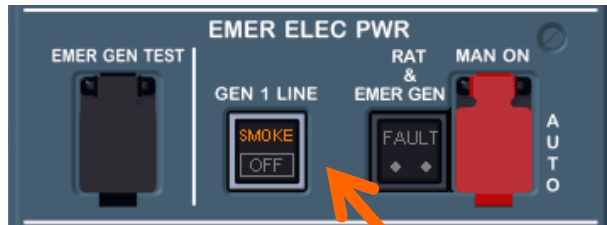
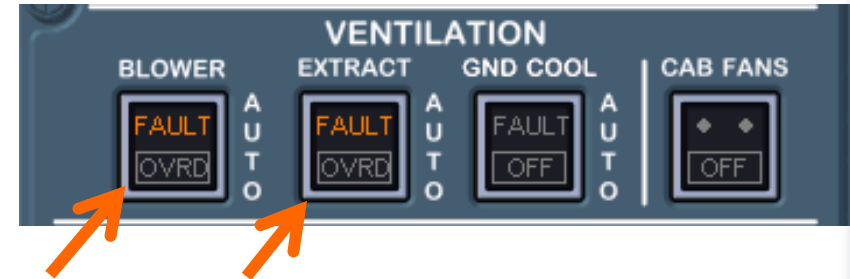
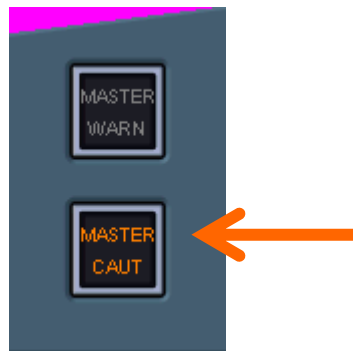
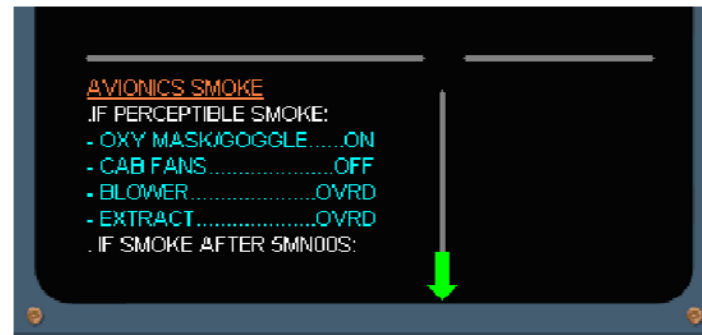
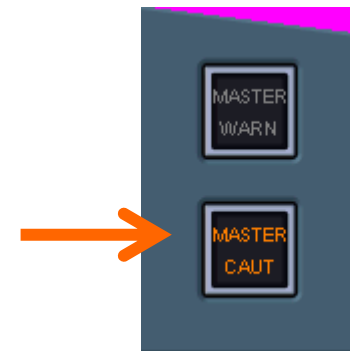
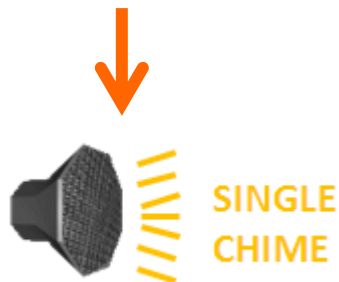
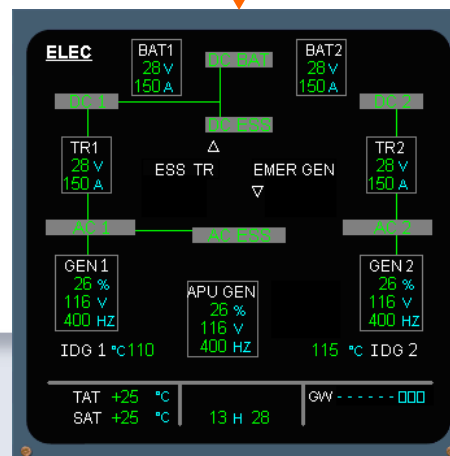
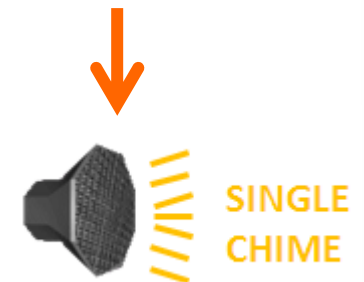
ON GROUND – CKPT effects

- If a latched avionics smoke procedure is cleared from the ECAM and the master caution is pushed before the crew arrives at the airplane, the GEN 1 line smoke amber light and the Blower and Extract amber fault lights should still be illuminated on the overhead panel. In addition, the amber vent blower and vent extract messages should have been displayed on the lower ECAM when recall was pressed. Pushing recall is part of the preliminary cockpit prep flow.

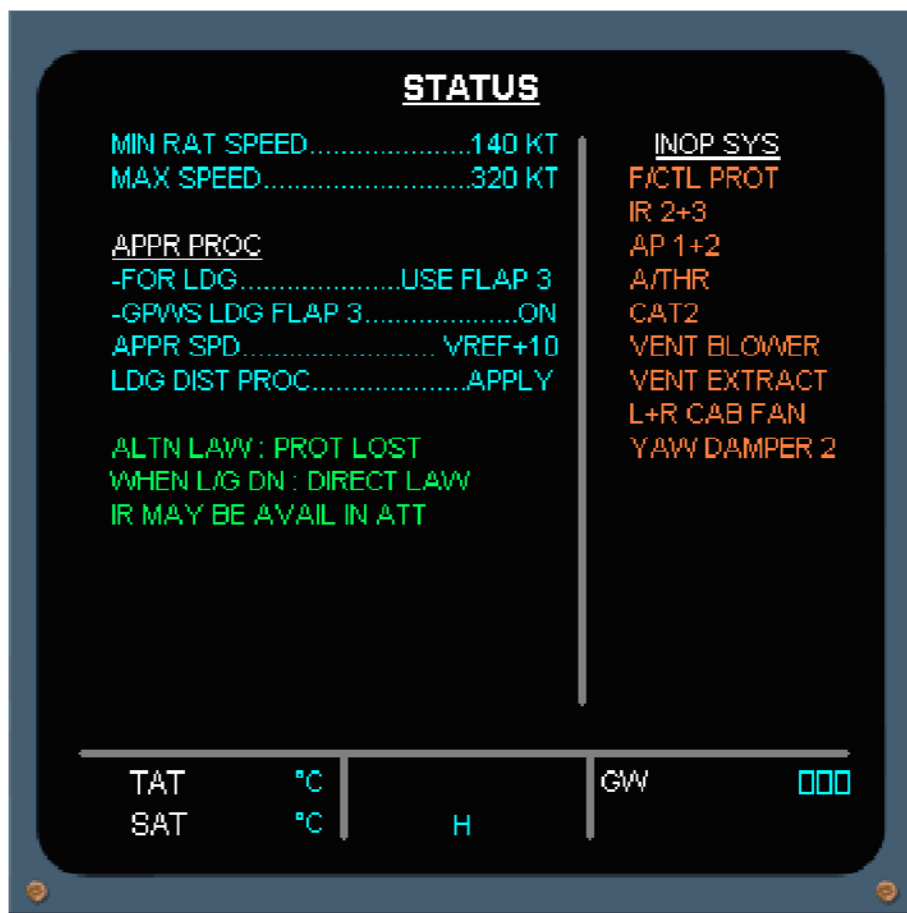
After recovery of Normal Elec. Config.

Recovery of normal braking
and all reversers

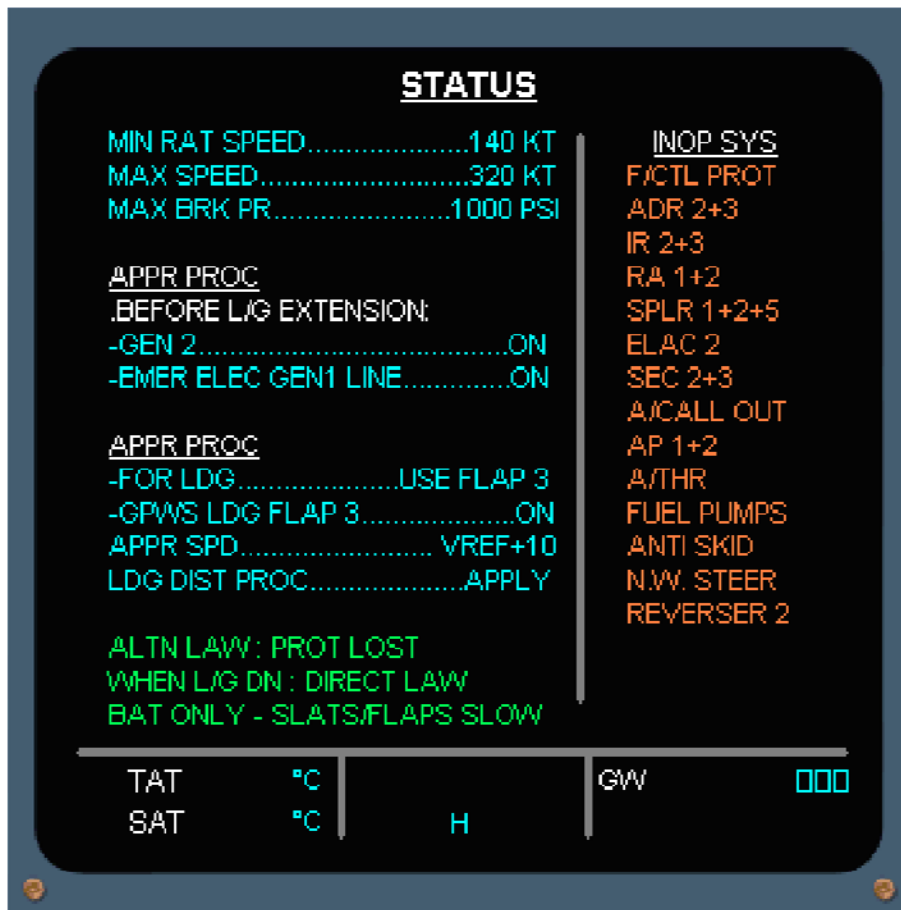
If Normal Elec. Config. Not recovered

Anti skid, nose wheel steering
and reverser 2 not recovered
