RECORD OF CONVERSATION

Subject: LAX08PA259, N612AZ
Witness: Fred J. Schoeffler
Concern: First flight out of H44, N612AZ

IRON COMPLEX – BUCKHORN FIRE – DIVISION E

HELISPOT 44 INCIDENT

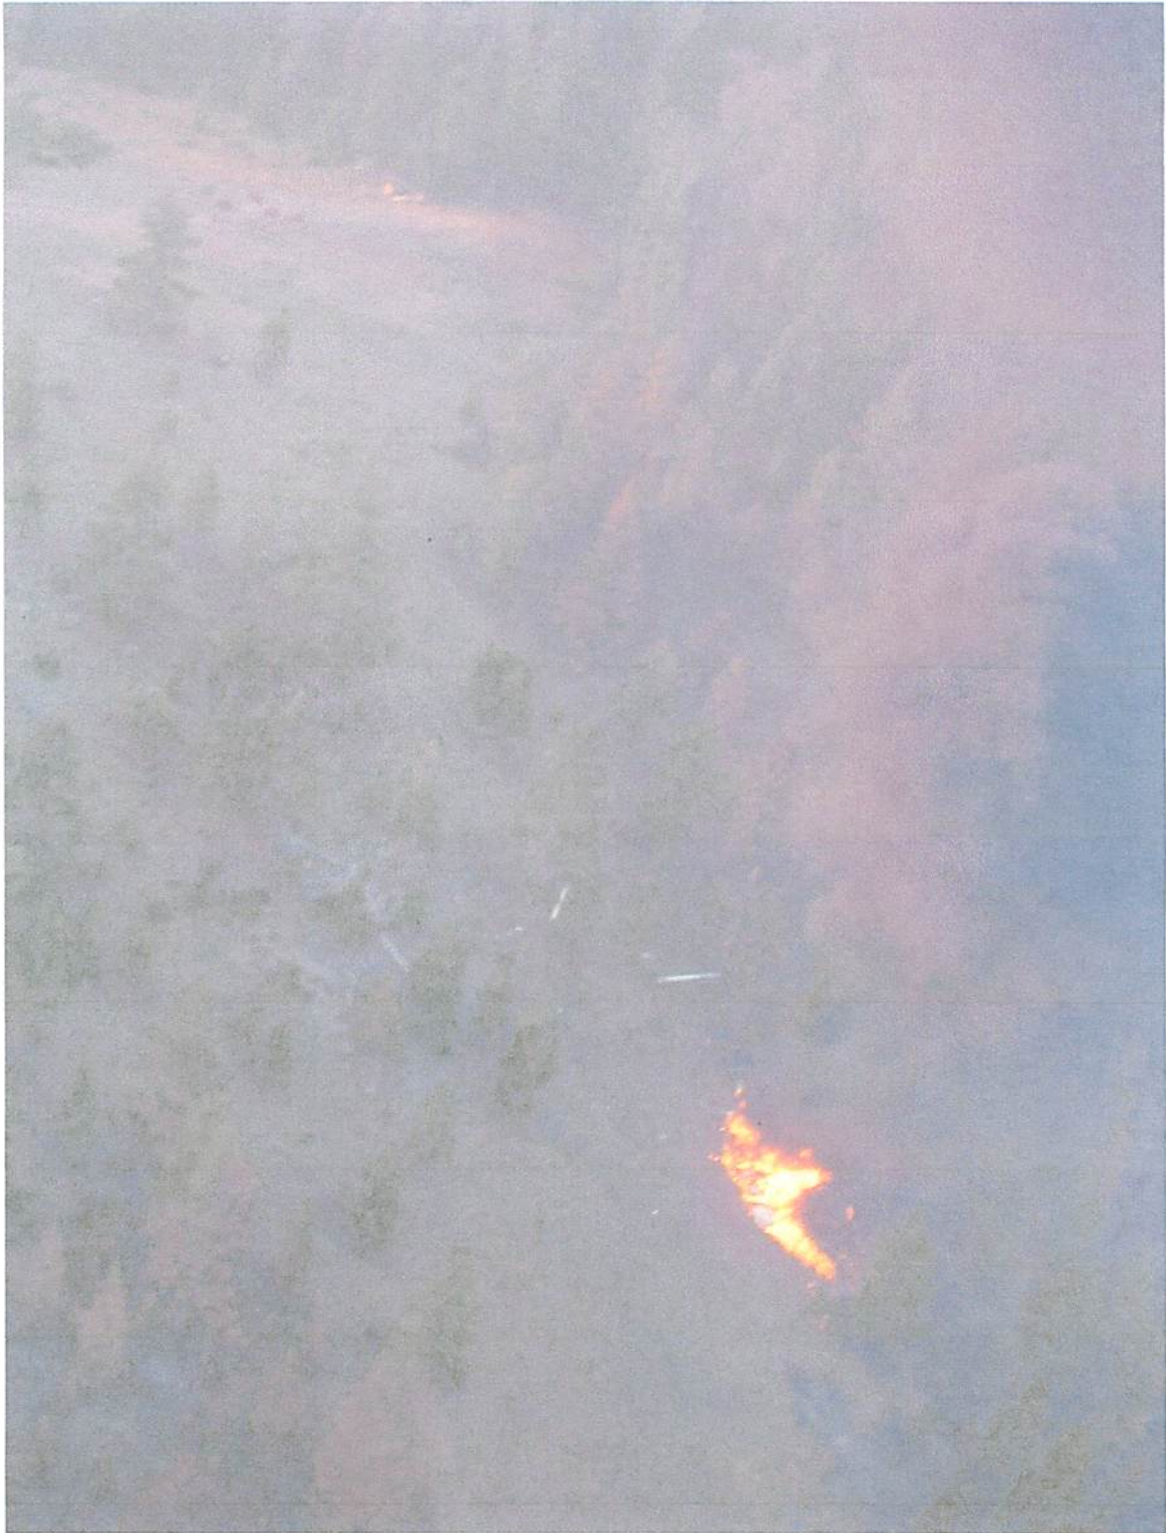
This Zion Helitack blog photo indicates the route that the first load flew out exiting to the left and southeast. As we flew, we were five to eight feet below the treetops for awhile.

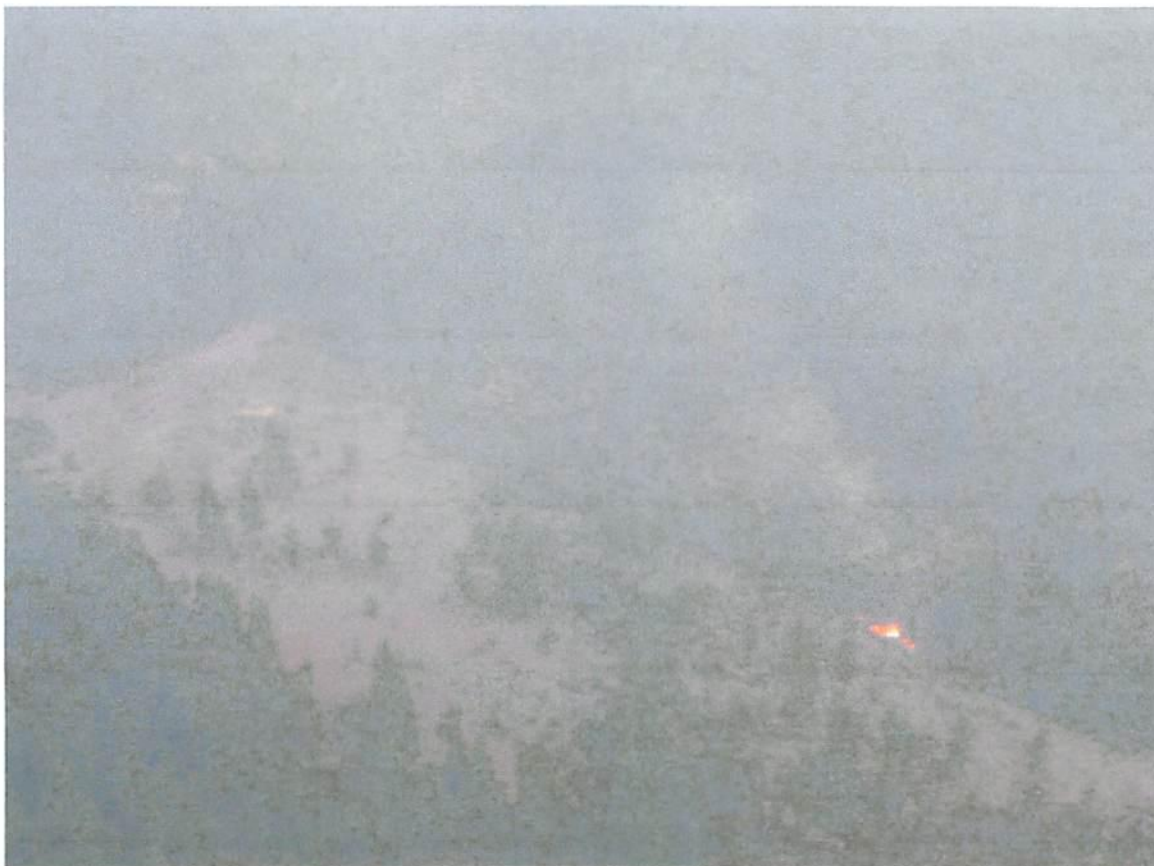
This second photo below indicates where the S-61 took off from with the first load. We followed that same flight path to the left and southeast. As we departed, we had very little actual translational lift, maintaining a long, circuitous flight off to the left. We flew out and above a large bowl, below the ridgeline. We felt heavy, slow, and sluggish.
