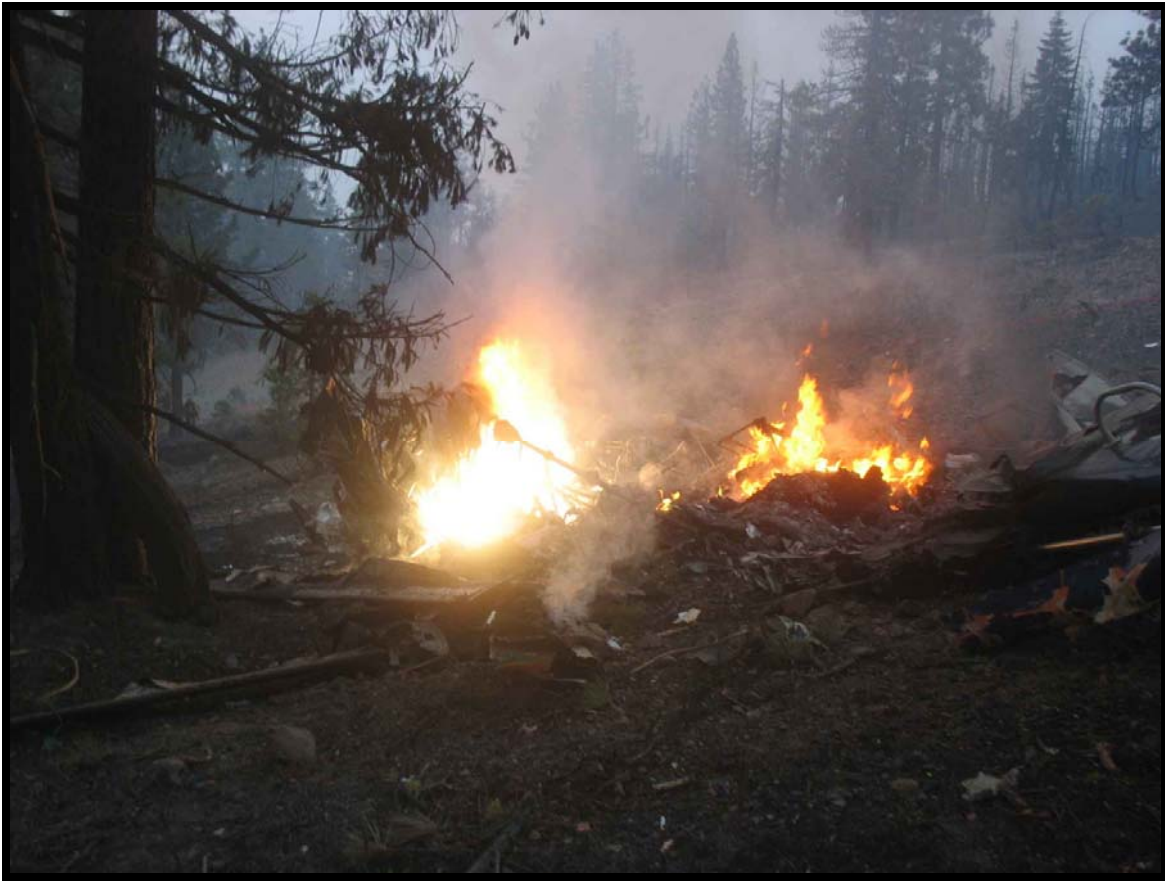
*Figure 01: Wreckage 20-30 minutes after accident*

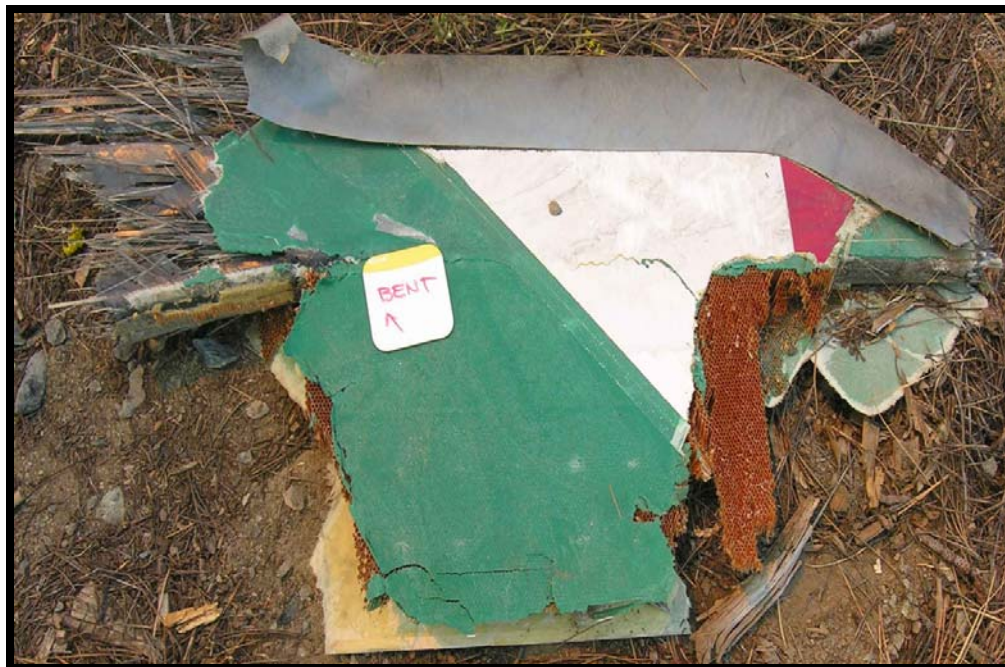
Figure 06: Outboard section of rotor blade (see figure 05 for location found)

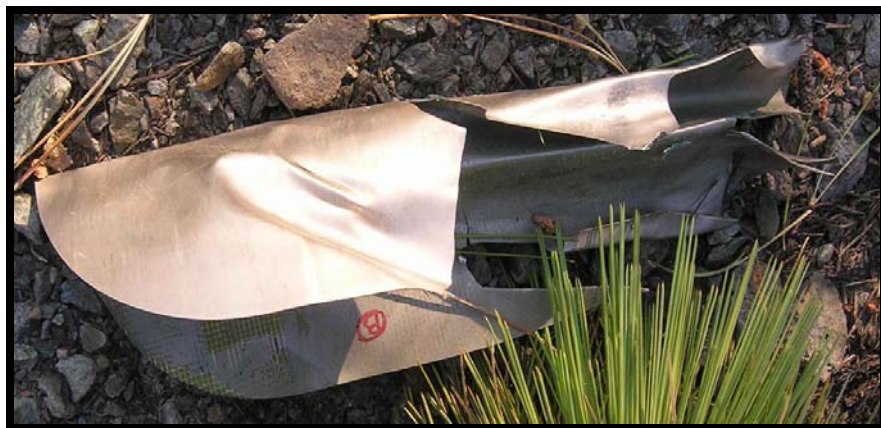
*Figure 10: Main rotor blade tip found below first tree cut*

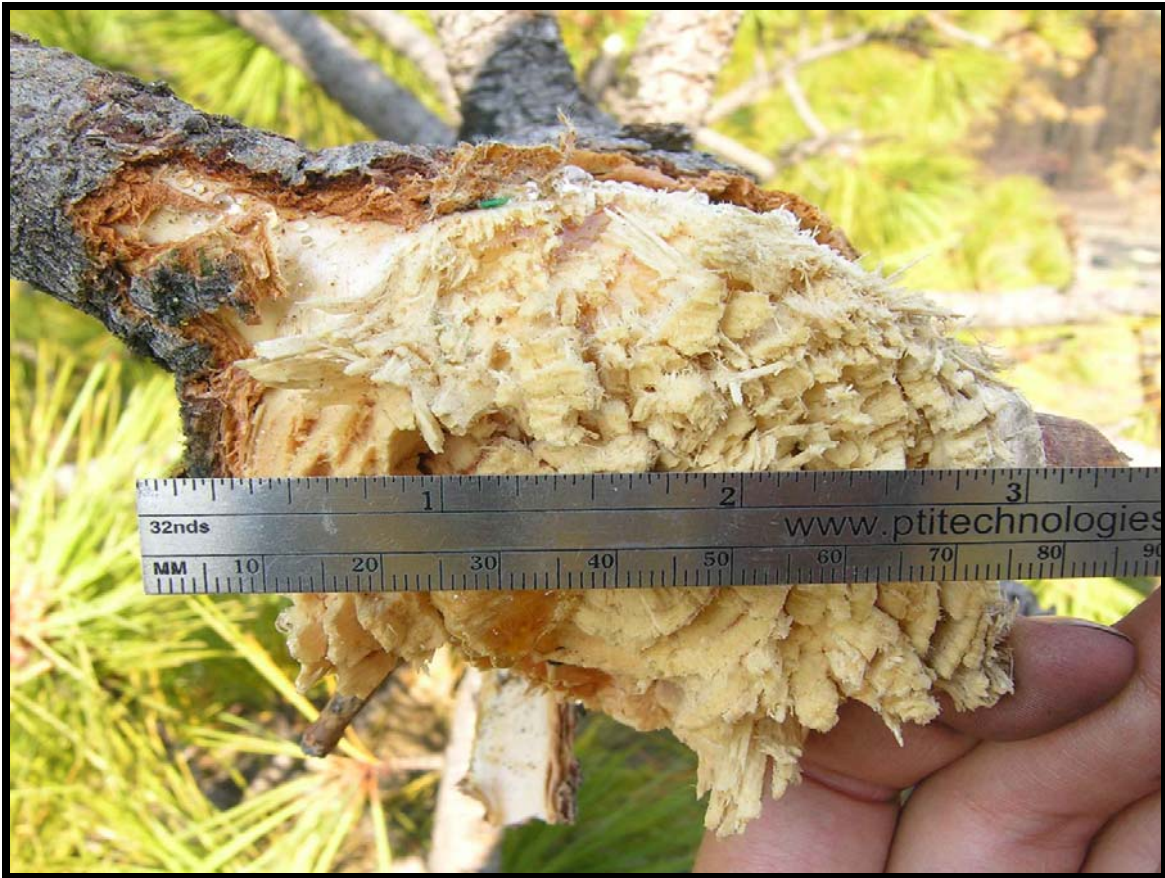
*Figure 11: First tree cut*

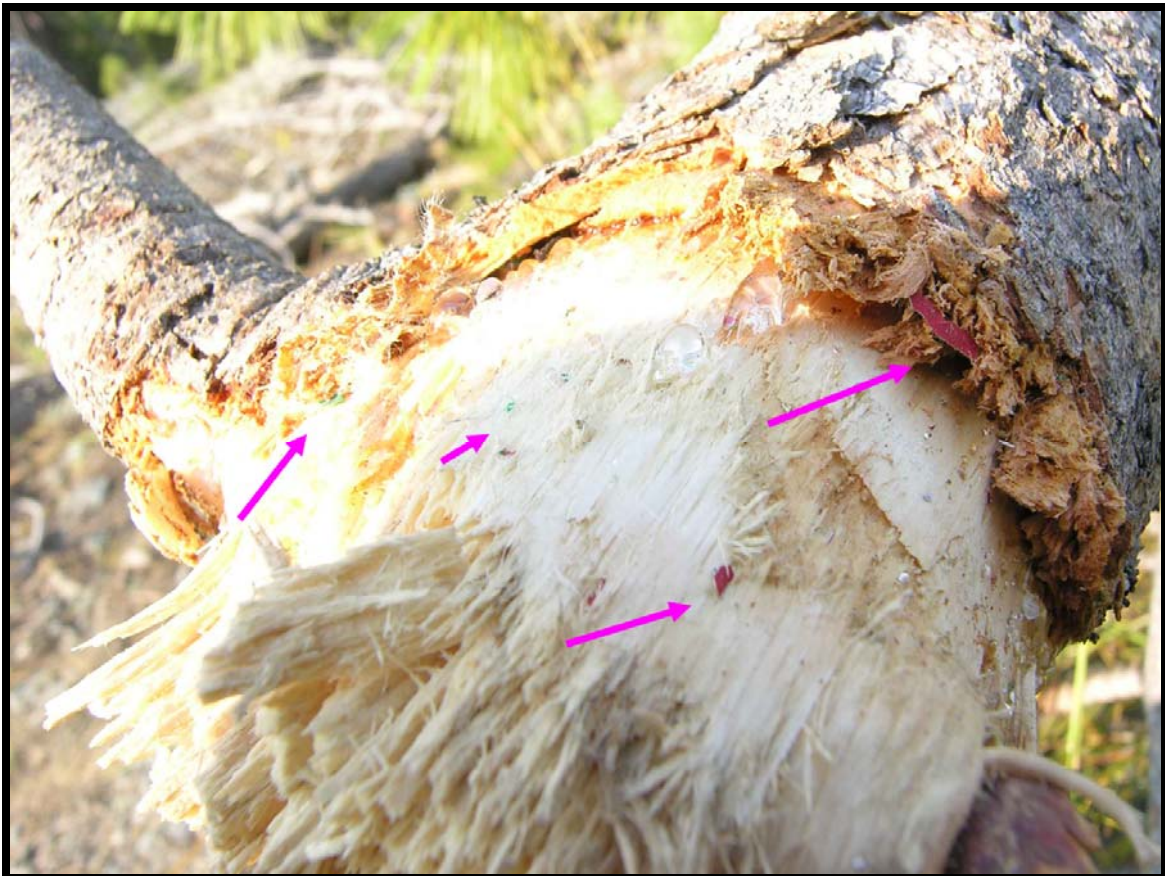
*Figure 12: First tree cut (referencing paint chips, which were similar in color to that of the main rotor blades, embedded in fibers)*

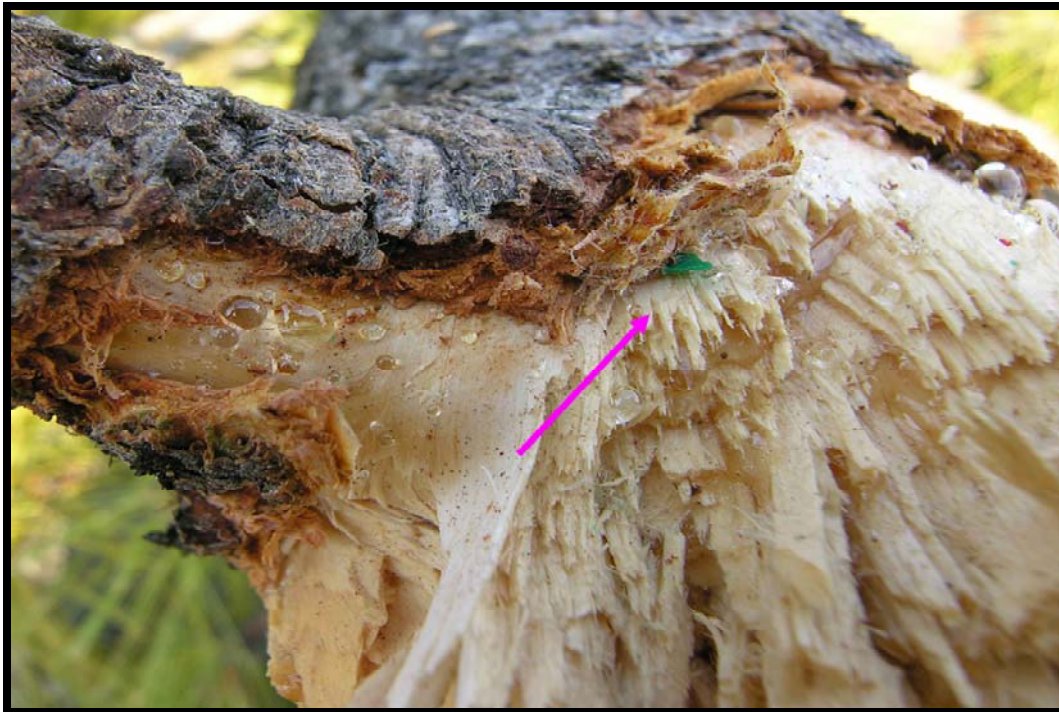
*Figure 13: First tree cut (referencing paint chips, which were similar in color to that of the main rotor blades, embedded in fibers)*

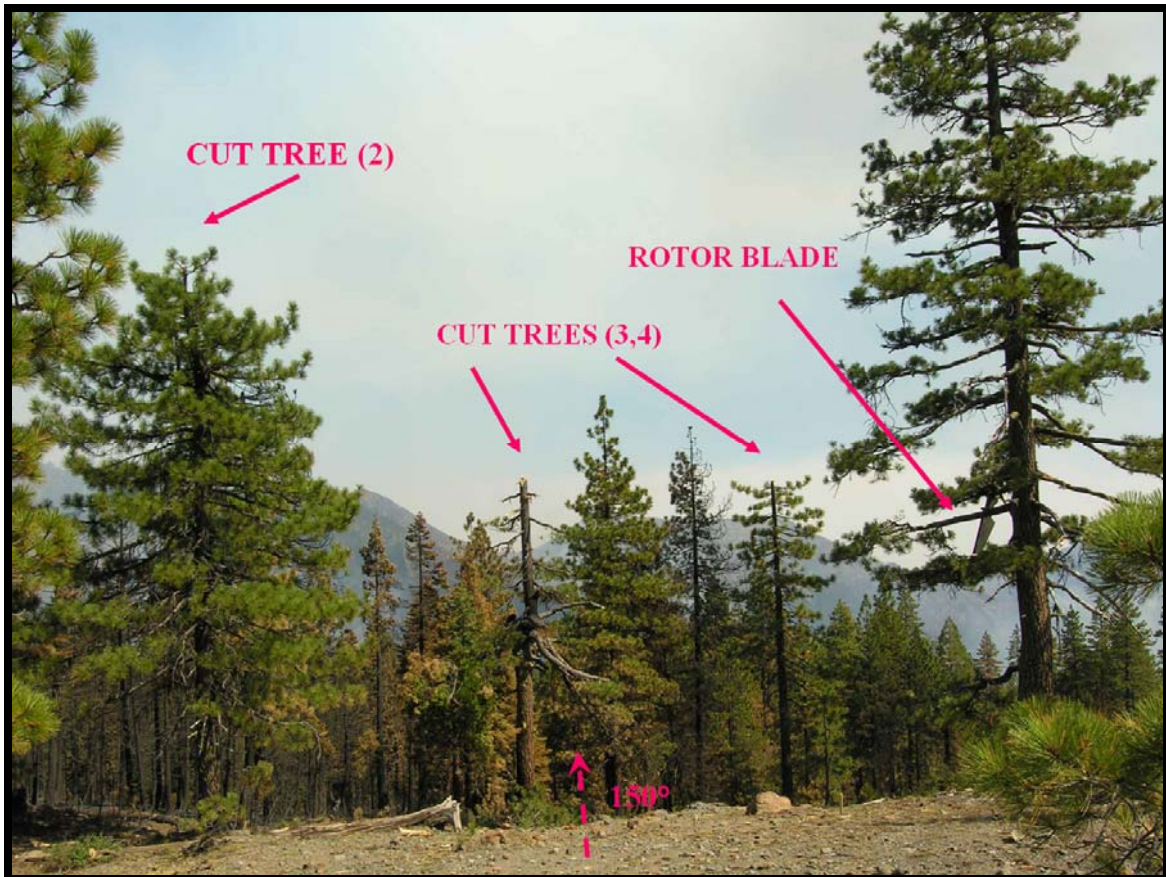
*Figure 14: Tree cuts in the presumed flight path (leading to the main wreckage)*

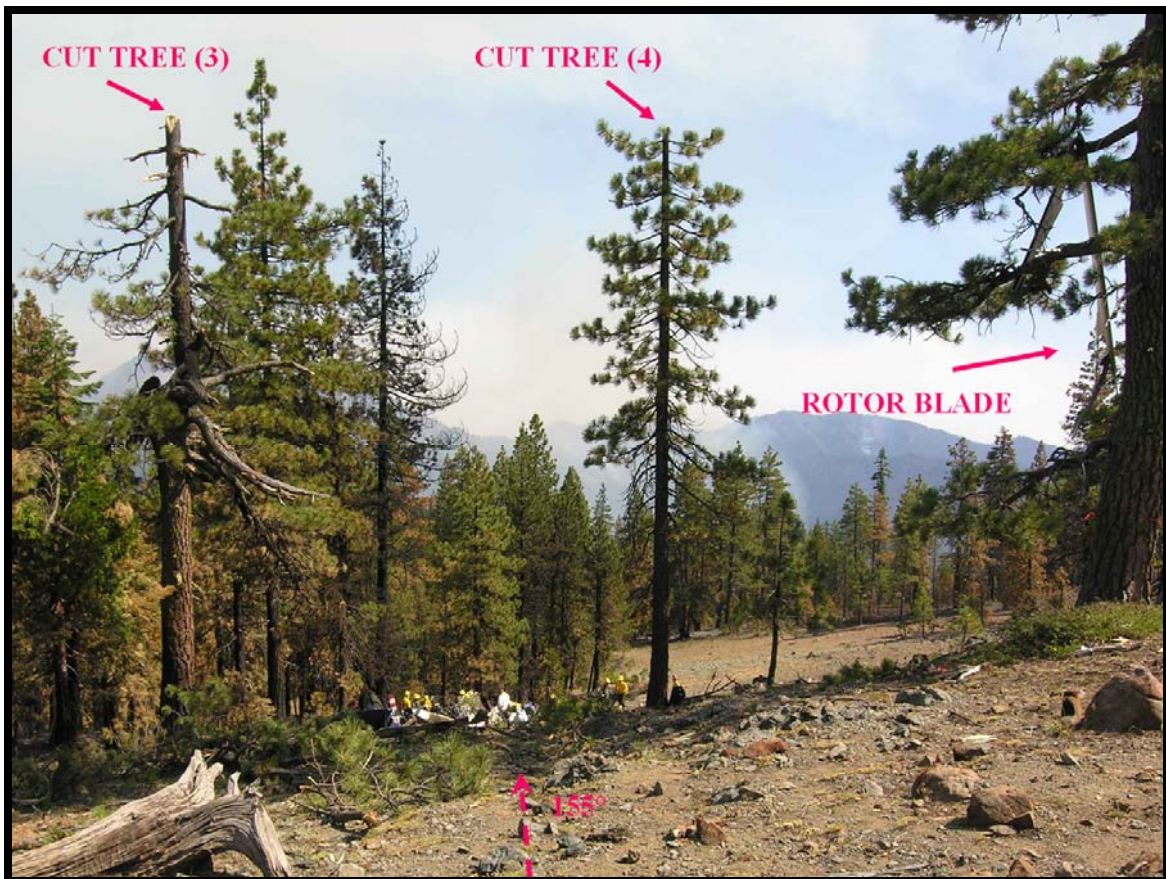
Figure 15: Tree cuts in the presumed flight path (leading to the main wreckage)

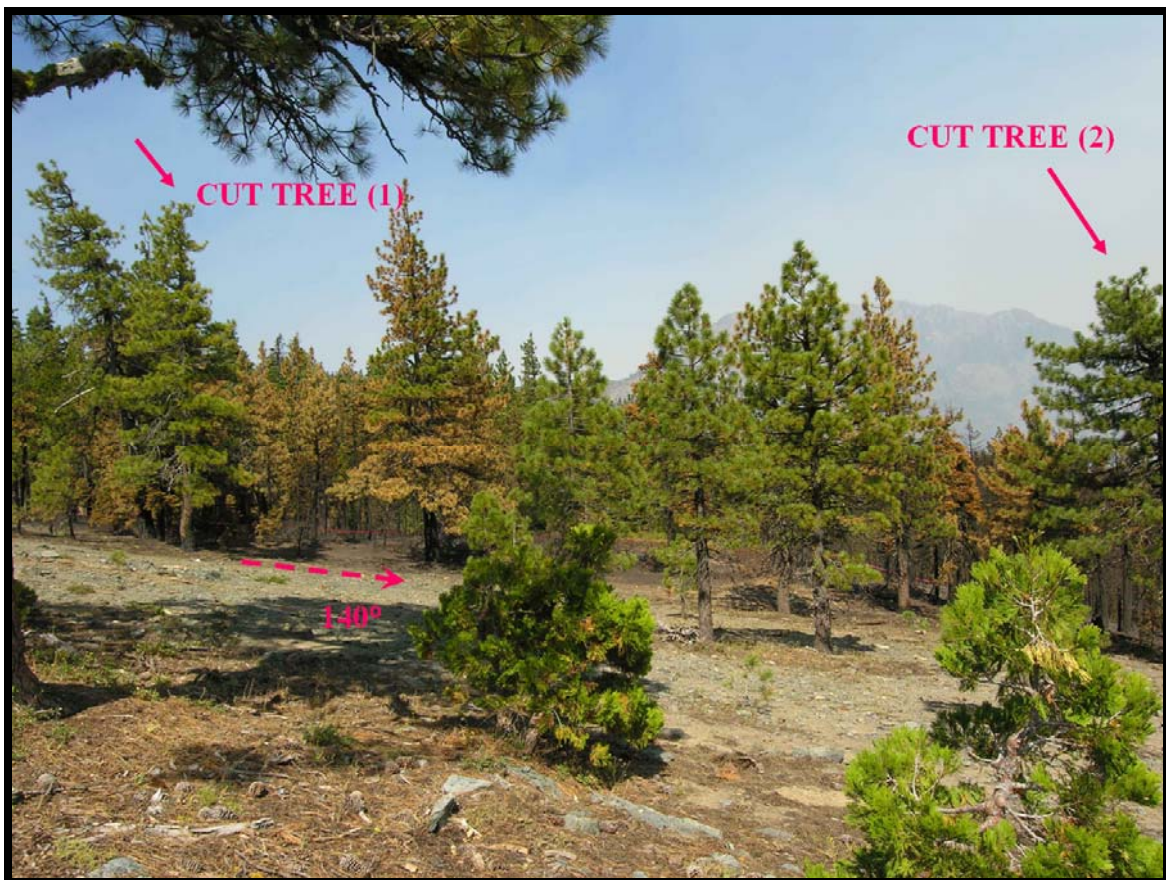
Figure 16: Profile view of tree cuts in the presumed flight path

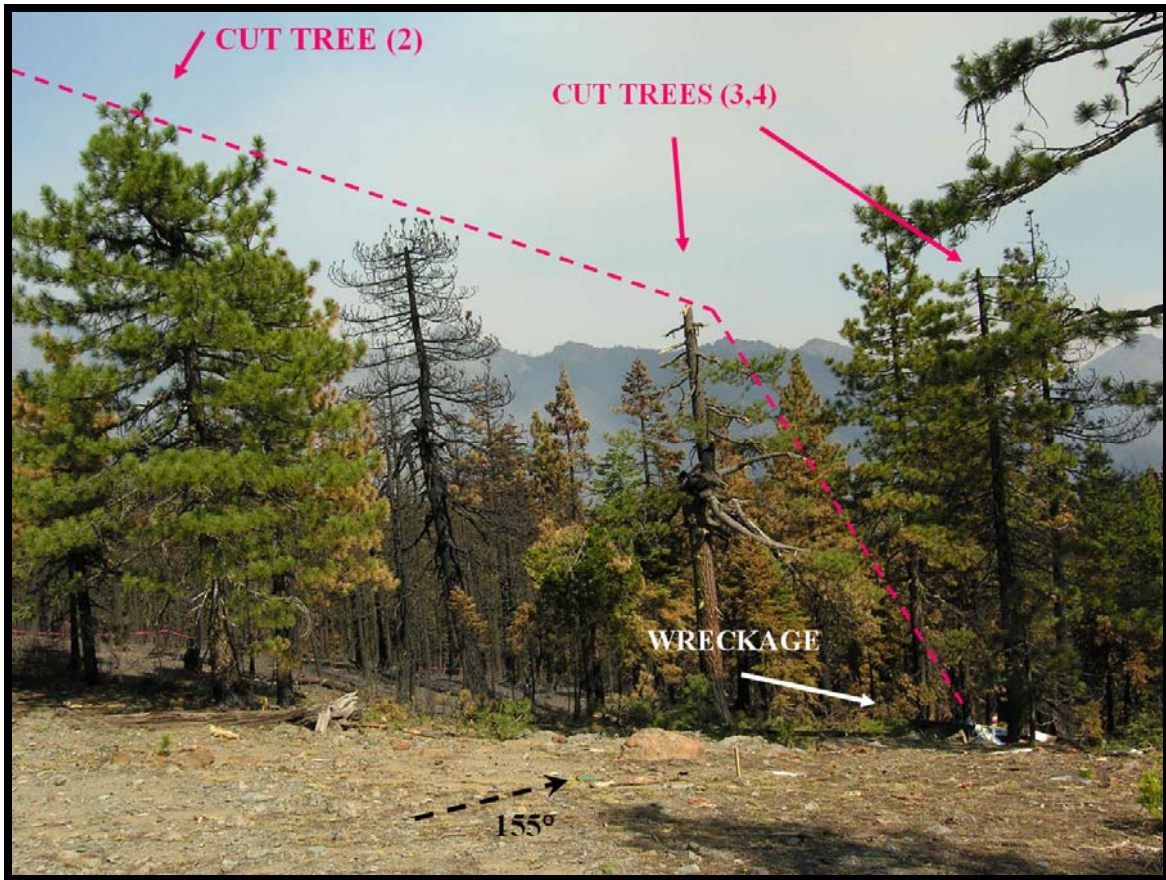
Figure 17: Profile view of tree cuts in the presumed flight path (dotted line showing angle)

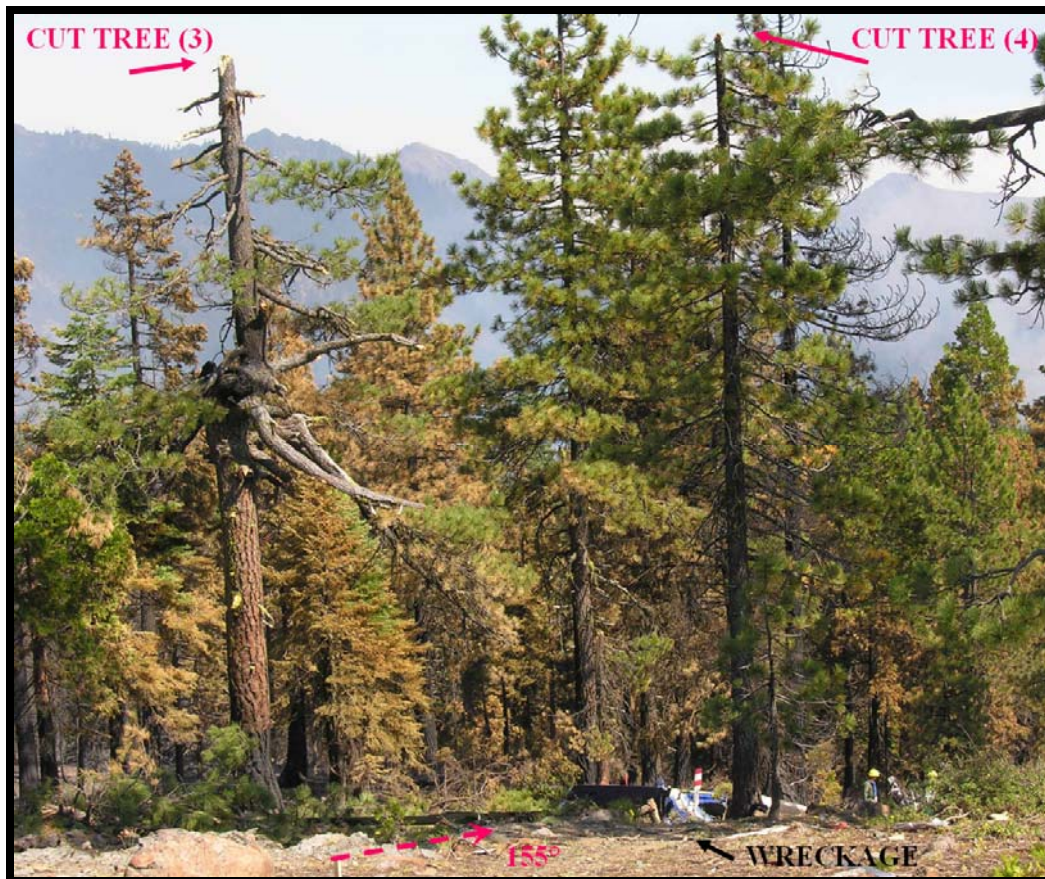
Figure 18: Tree cuts in relation to main wreckage

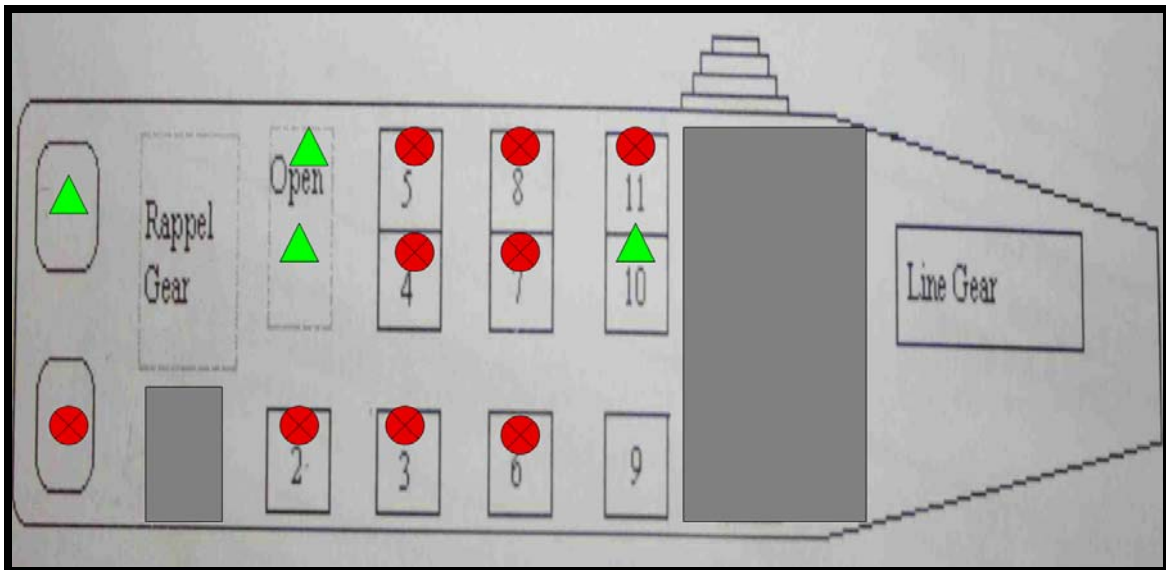
*Figure 19: Seating configuration displaying fatality's position in red and survivors' in green (far right seats represent the pilot and co-pilot)*

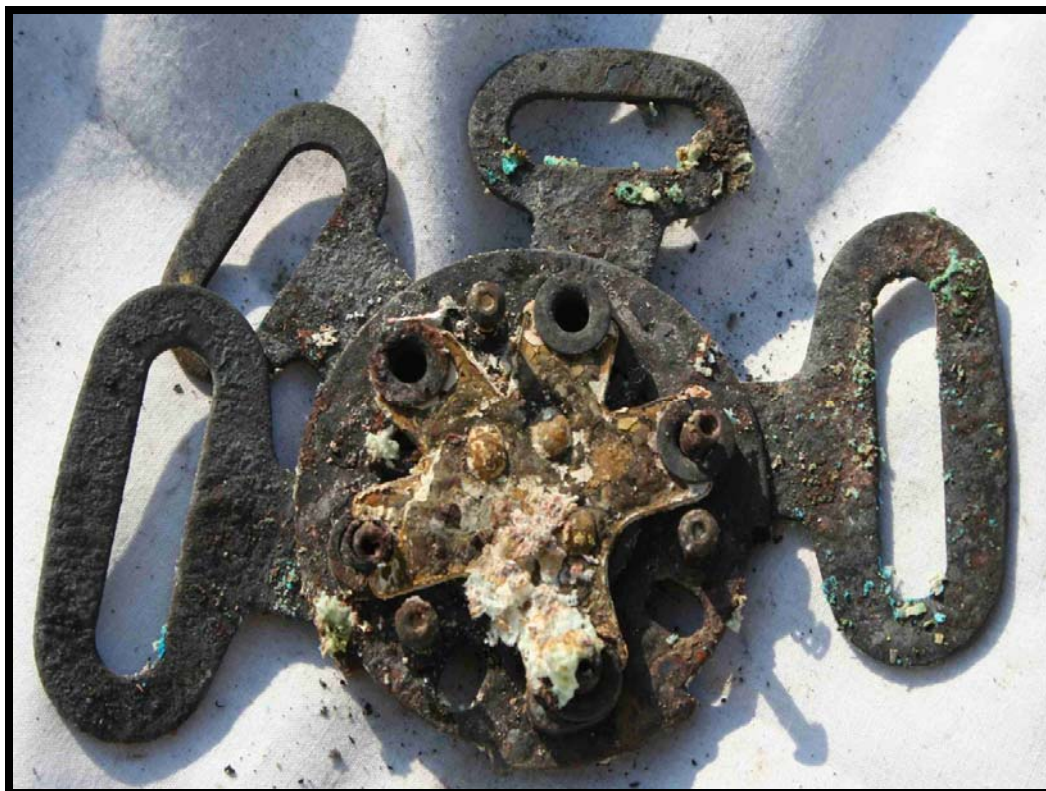
*Figure 22: Engaged seatbelt buckle (all found were engaged)*
