# Attachment 8

DCA12IA096

Airbus Safety First article “A320 Dual  
Hydraulic Failure”

# A320 - Dual hydraulic loss

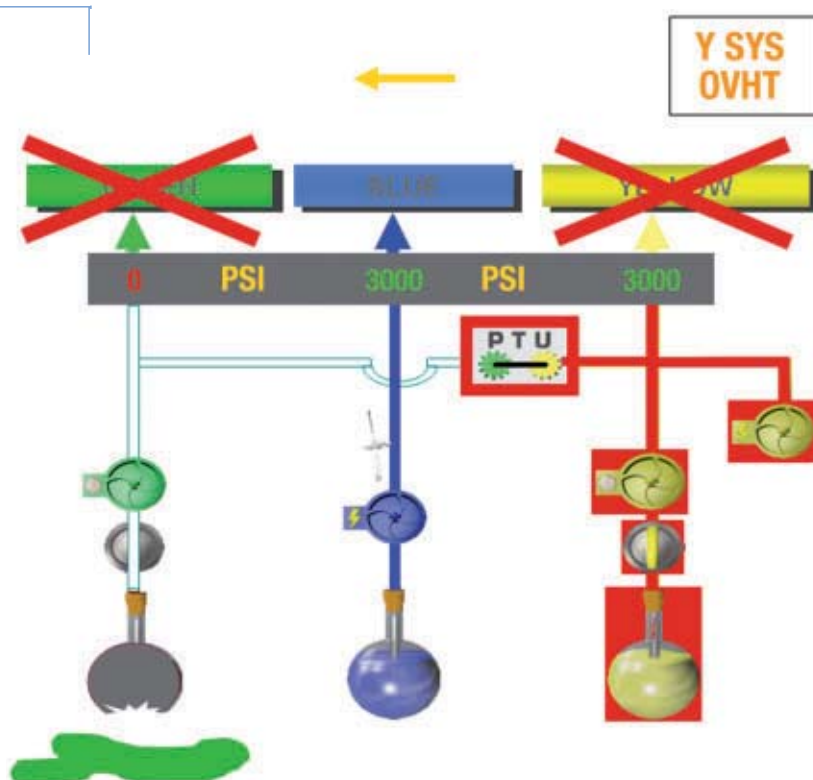
- 7) Within less than two minutes, the PTU overheats the yellow hydraulic system and causes its loss.

- In case of green low level, if PTU is not switched off this will lead to
- A Yellow overheat (around 2 minutes later)
- Then to a double G+Y hydraulic failure

Below 1,500 feet the PTU is automatically switched to OFF.

A design change has been developed, which consists in the automatic switching of the PTU to OFF below 1,500 feet.

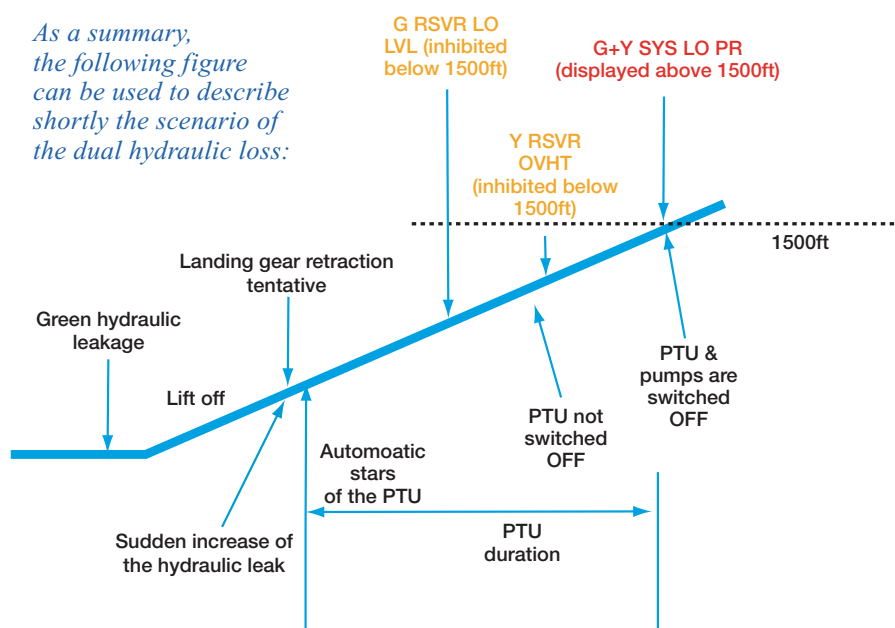
- 1) During takeoff, a leak in the gear retraction circuit leads to the loss of the green hydraulic system. This loss stops the retraction of the landing gear.

- 2) The 500 PSI pressure differential between the green and yellow hydraulic pressure is reached and the PTU automatically switches ON.
- 3) The loss of the green system normally triggers the corresponding ECAM caution, which requests the crew to switch off the PTU.

- 4) However, below 1,500 feet, the ECAM caution is inhibited.
- 5) The PTU therefore remains ON, and operates at its maximum speed.
- 6) As a consequence of the non retraction of the landing gear, the crew may be busy communicating with ATC and managing the situation, leaving the aircraft flying below 1,500 feet longer than usual, and thus keeping the ECAM caution inhibited.

*As a summary, the following figure can be used to describe shortly the scenario of the dual hydraulic loss:*
