NATIONAL TRANSPORTATION SAFETY BOARD

OPERATIONS / HUMAN PERFORMANCE

Factual Report (with 8 embedded images)

ANC13GA036

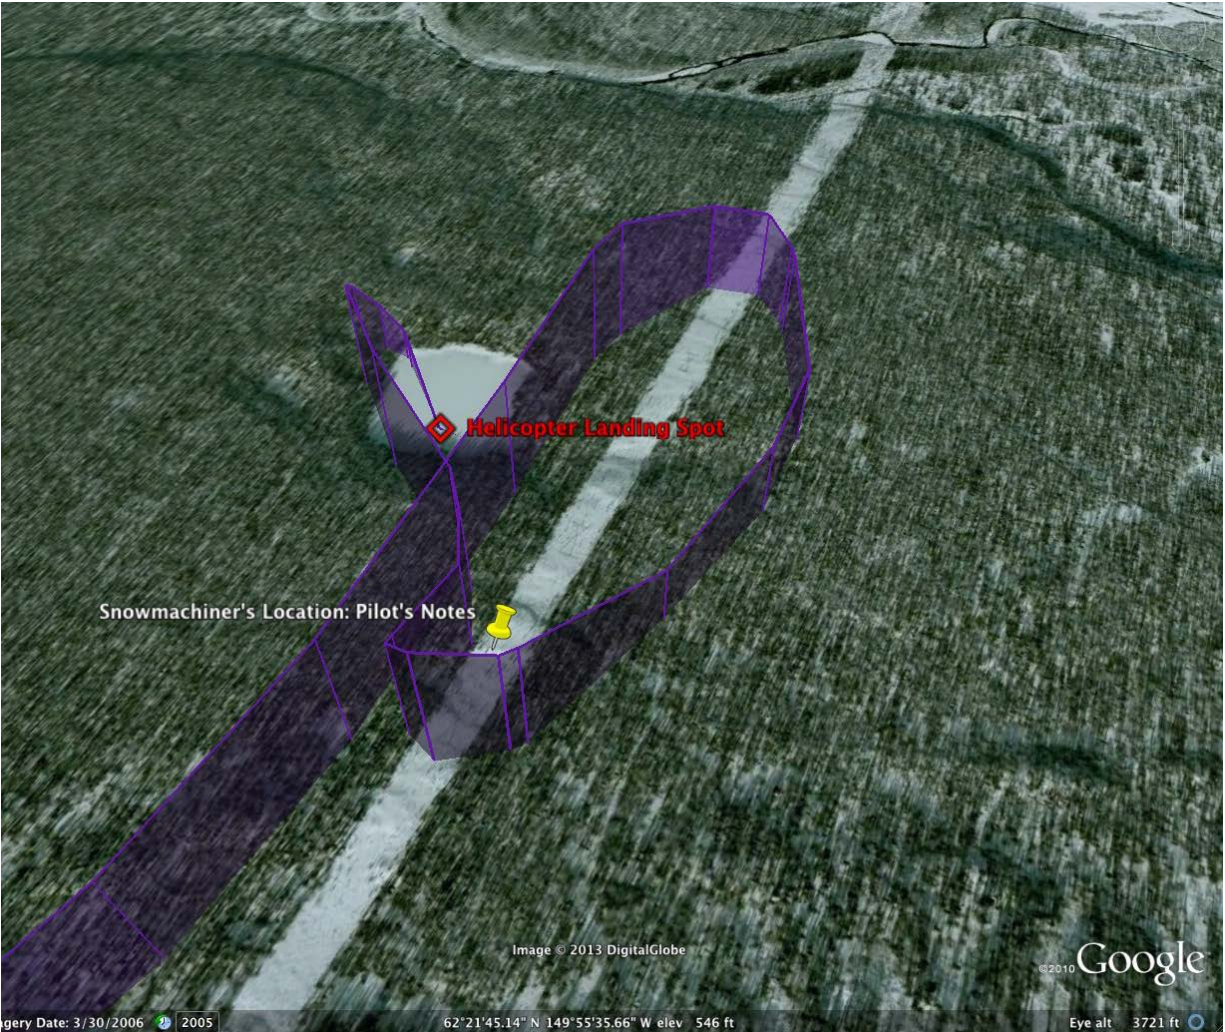
Figure 2. End of Garmin flight track from Sunshine to landing spot. Flight track is shown in purple.

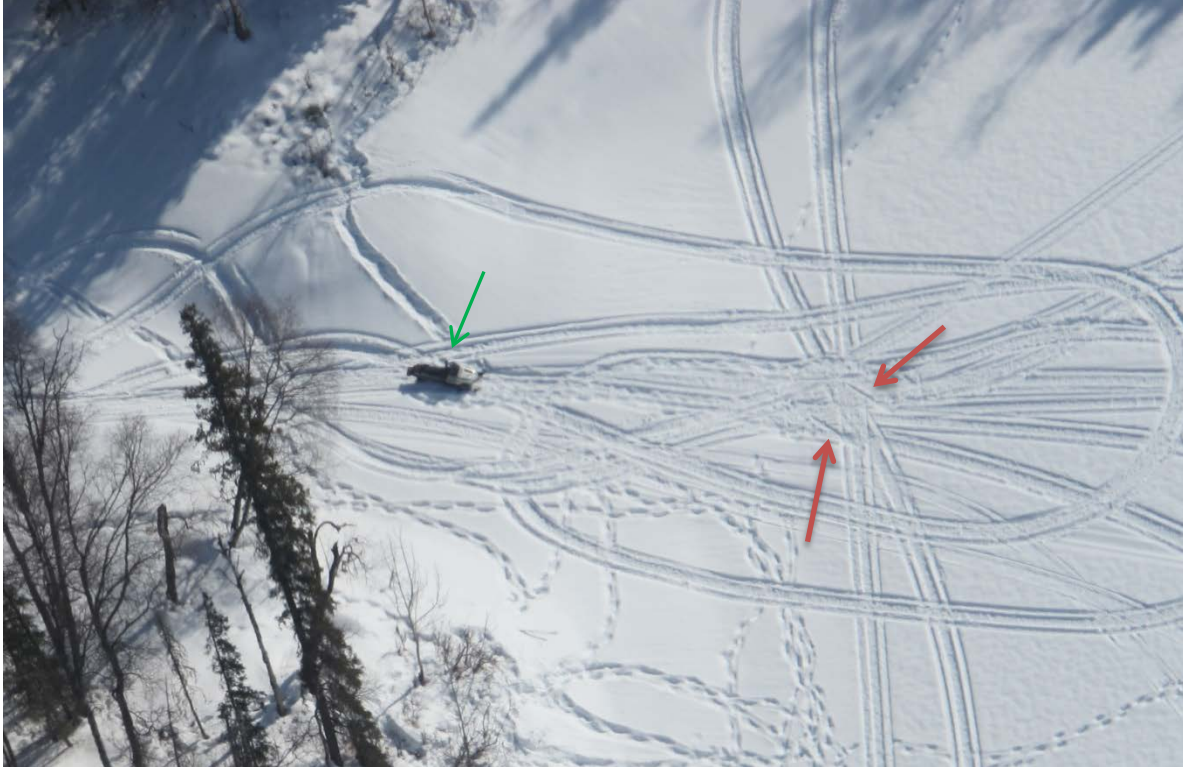
The snowmobiler's snow machine was found parked on the frozen surface of the pond near two parallel linear marks in the snow with dimensions that corresponded to the helicopter's landing skids. (See Figure 3.) This strongly suggests that the pilot and trooper dug out the snow machine and used it for transportation back to the helicopter.

Figure 3. Aerial photograph of helicopter landing spot. Red arrows point to marks made by helicopter's landing skids. Green arrow points to snow machine.

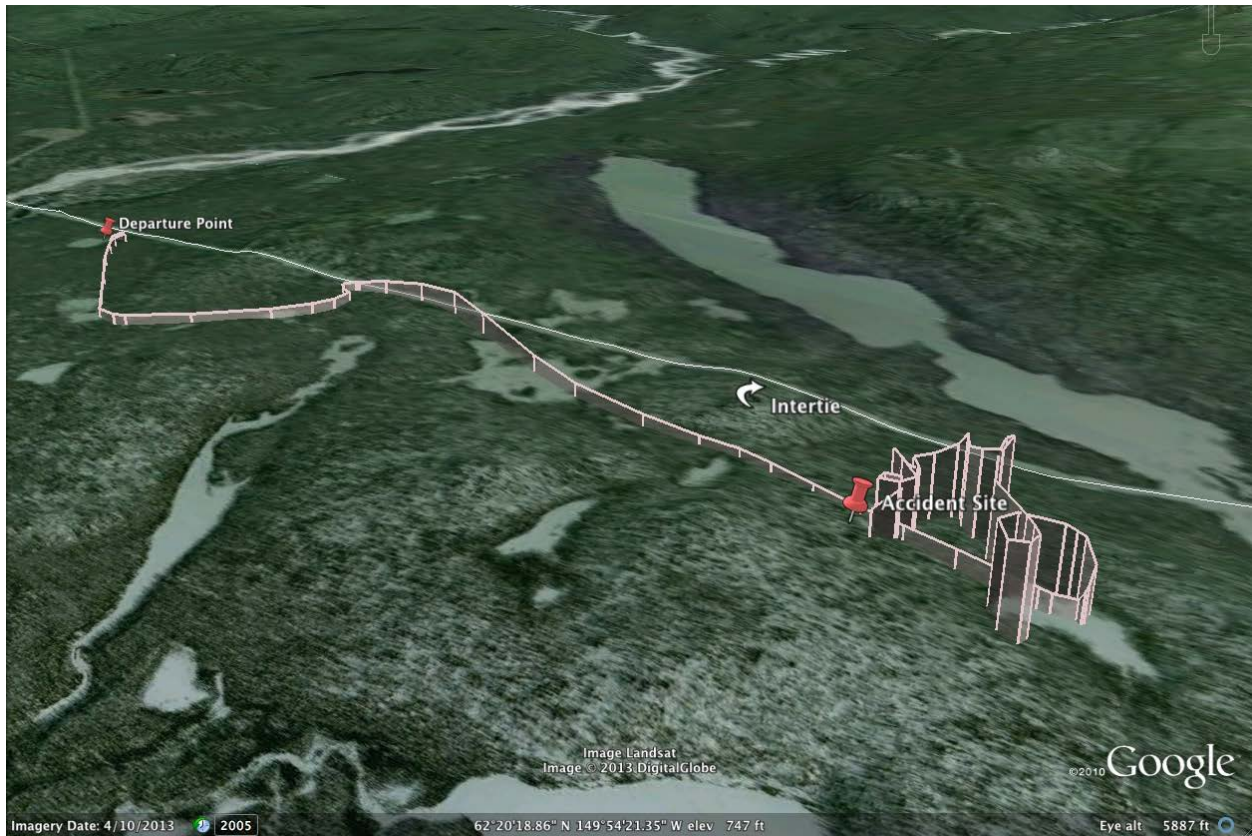
As shown in Figure 4, the Garmin GPS data for the accident flight indicated that the helicopter took off about 2313, intercepted and began to follow a true course of about 209° (close to the direct course back to Sunshine of about 193°). About 2314, the helicopter turned left to a heading of about 139° and continued on this heading until it reached the Intertie. About 2315, the helicopter turned right and flew south along the Intertie for about 30 seconds. The helicopter then turned right to a heading of about 190° and continued on this heading for about 2 minutes. At 2317:49, the helicopter was at an altitude of 1,060 msl (about 200 feet agl) with a groundspeed of 16 knots. The helicopter then entered a climbing left turn which continued through 360 degrees; this was followed by a series of erratic turns, climbs, and descents. The Garmin data for the accident flight ended at 2320:17; the duration of the flight was about 7 minutes; and the last position recorded placed the helicopter about 3 miles south of the takeoff point and 13 miles north of Sunshine.¹⁸

Figure 4. Garmin flight track of accident flight. Flight track is shown in pink.

When the helicopter did not arrive at Sunshine, a search was initiated,¹⁹ and the wreckage was located about 0930 on March 31, 2013. The accident site was about 200 feet north of the last recorded GPS position.

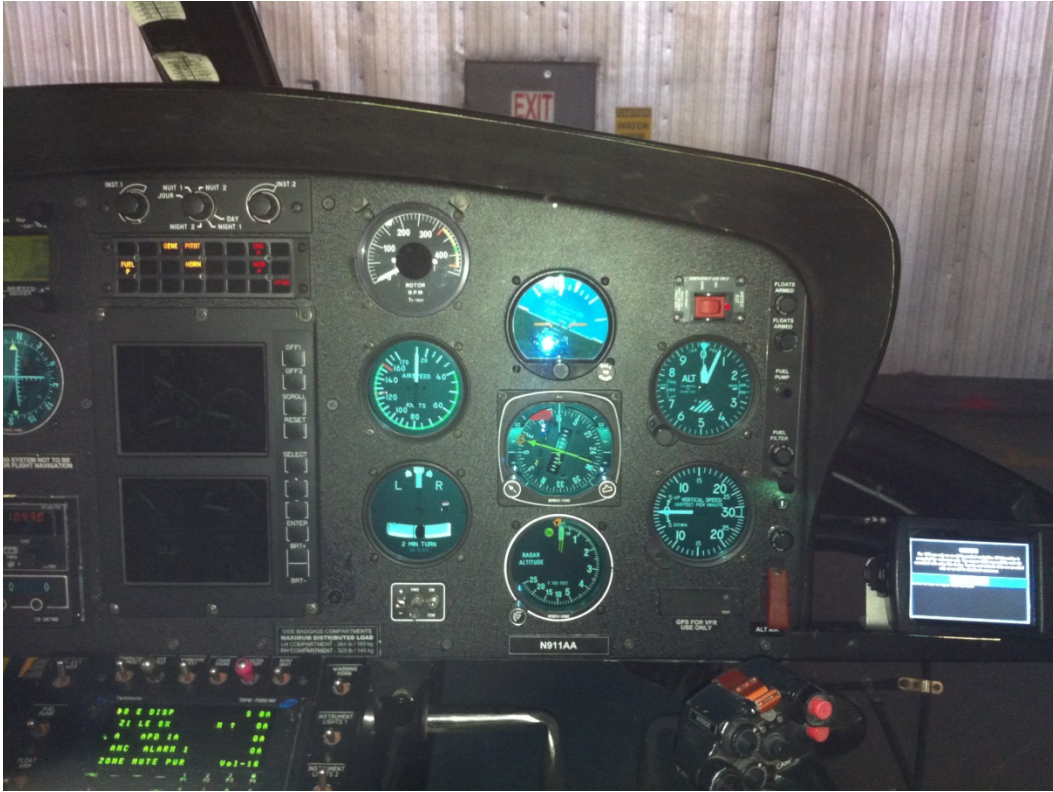
Figure 6. Photograph of the right side of the helicopter’s instrument panel taken on June 18, 2012. The small screen on the lower right side of the photograph is the Garmin 296 GPS unit.

The Garmin GPSMAP 296, which was mounted to the right of the helicopter's instrument panel (shown in Figure 6), was a portable GPS unit with a color-display measuring about 3 inches wide by 2 inches tall. As previously mentioned, data was retrieved from this unit after the

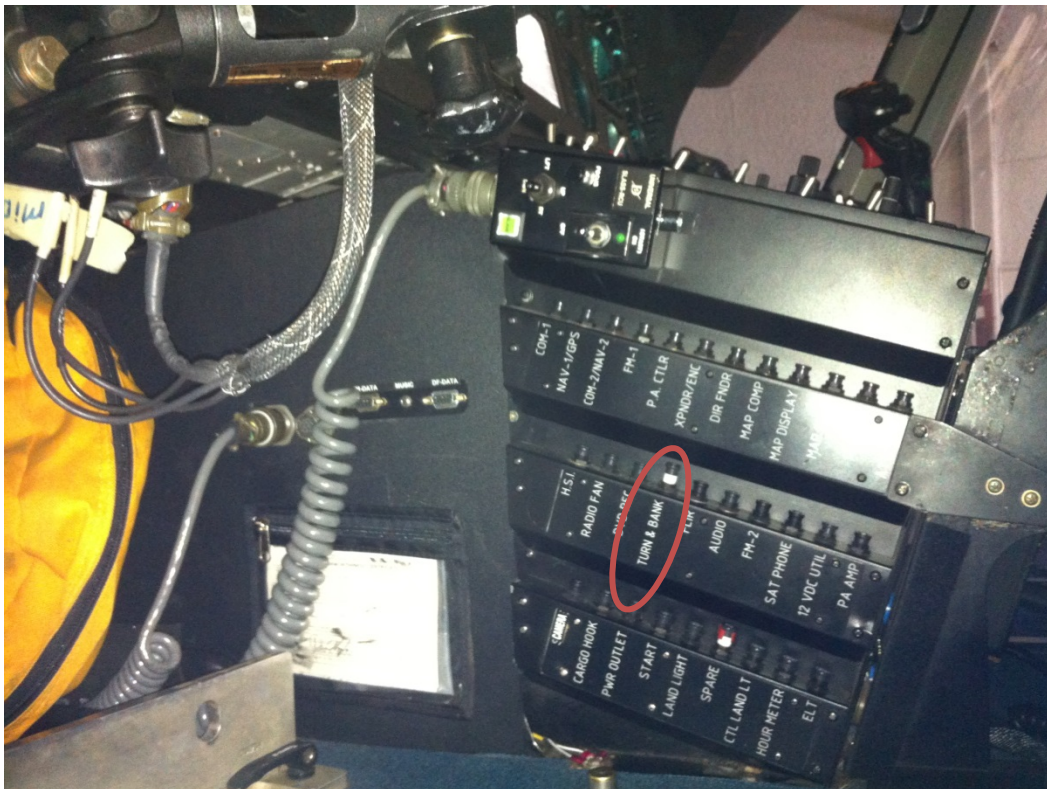
The AMRG observer who often flew with the pilot said that the turn and bank indicator worked but that there was “a problem with it” and that most of the time the circuit breaker was intentionally pulled out to turn the unit off. The AMRG observer did not know the nature of the problem. He said that sometimes the pilot would ask him to push the circuit breaker in so that the unit would operate. This typically happened when they were maneuvering at low altitude. A photo of the circuit breaker panel retrieved from the pilot’s smartphone (Figure 7) shows the circuit breaker in the off position.

The only maintenance discrepancy noted in the helicopter’s records that concerned the turn and bank indicator was on an Avionics Specialists of Alaska work order dated September 9, 2004. (Attachment 29) The sixth item listed on the work order stated “T&B [Turn and Bank] makes noise in Headset. Removed T&B to facilitate testing not able to reproduce problem. Note: T&B is powered from Avionics Buss.”

Figure 7. Photograph of the helicopter’s circuit breaker panel taken on June 18, 2012. The circuit breaker for the turn and bank indicator is in the off position (pulled out).

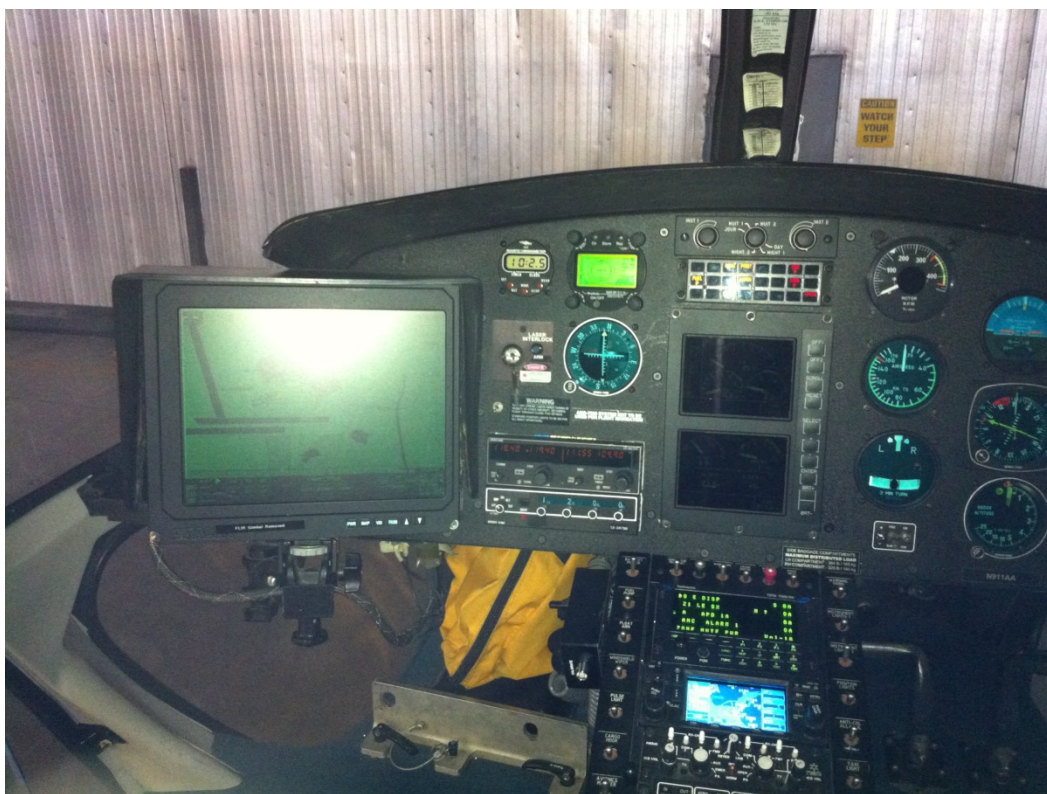
The Garmin GNS-430, which was mounted in the helicopter's center console (shown in Figure 8), was a combined communications radio, VOR/ILS navigation radio, and GPS receiver. It was coupled to the KI-525A HSI, and the input to the HSI could be switched from VOR/ILS to GPS by pushing the button labeled "CDI" on the GNS-430. The GNS-430 did not have the capability to store flight data.

Figure 8. Photograph of the left side of the helicopter's instrument panel taken on June 18, 2012. The large screen on the left side of the photograph is the Avalex mapping system display screen. The lighted screen in the lower center of the photograph is the Garmin GNS-430.
