NATIONAL TRANSPORTATION SAFETY BOARD

OPERATIONS GROUP FACTUAL REPORT

Location: Aleknagik, Alaska
Date: August 9, 2010
Time: 1442 Alaska daylight time (ADT)¹
Aircraft: de Havilland Canada DHC-3T, N455A
NTSB Number: ANC10MA068

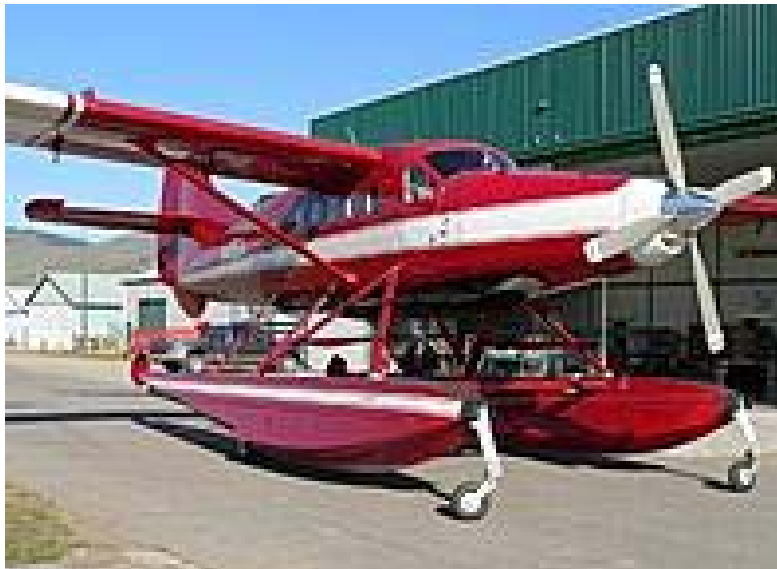
N455A: de Havilland DHC-3T
