NATIONAL TRANSPORTATION SAFETY BOARD
Office of Aviation Safety
Washington, D.C. 20594

Group Chairman's Factual Report
OPERATIONAL FACTORS

DCA11FA045A/B

On April 11, about 2006 EDT, an Airbus A380, F-HPJD, collided with a Bombardier CRJ 701, N641CA, while taxiing for takeoff from John F. Kennedy International Airport (JFK), Jamaica, New York. At the time of the accident, the CRJ was stationary with part of the airplane on the Comair parking ramp and its tail extended onto taxiway “Mike”. The CRJ was waiting for ramp clearance to its parking spot. The A380 was carrying 485 passengers and 25 crewmembers, and none were injured. The CRJ was carrying 62 passengers and 4 crewmembers, and none were

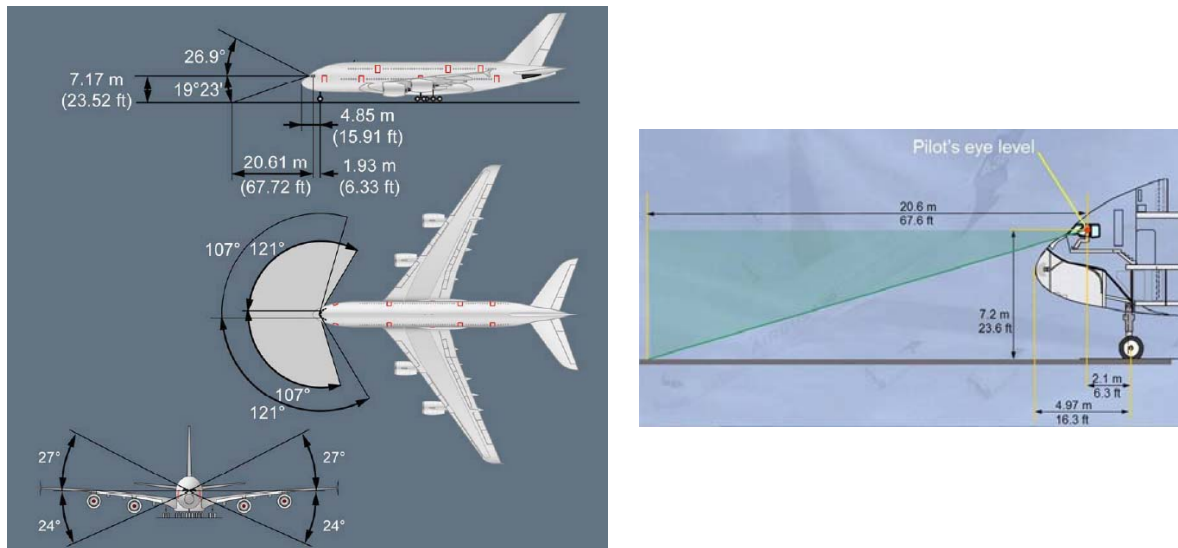
4.2 Visibility from cockpit²¹

Information supplied by Airbus and Air France indicated that when seated in the correct position [about 7.2 meters above ground] the pilot could see the ground from about 20.28 meters in front of the airplane. Anything less than 20.28 meters in front of the airplane would be blocked by the airplane nose. When looking sideways, the pilot could see the ground from about 4.97 meters [16.3 feet] from the airplane and ground closer than 4.97 meters would not be visible. The view looking sideways to the left was limited to about 121 degrees which did not allow the pilot to see the wingtip.

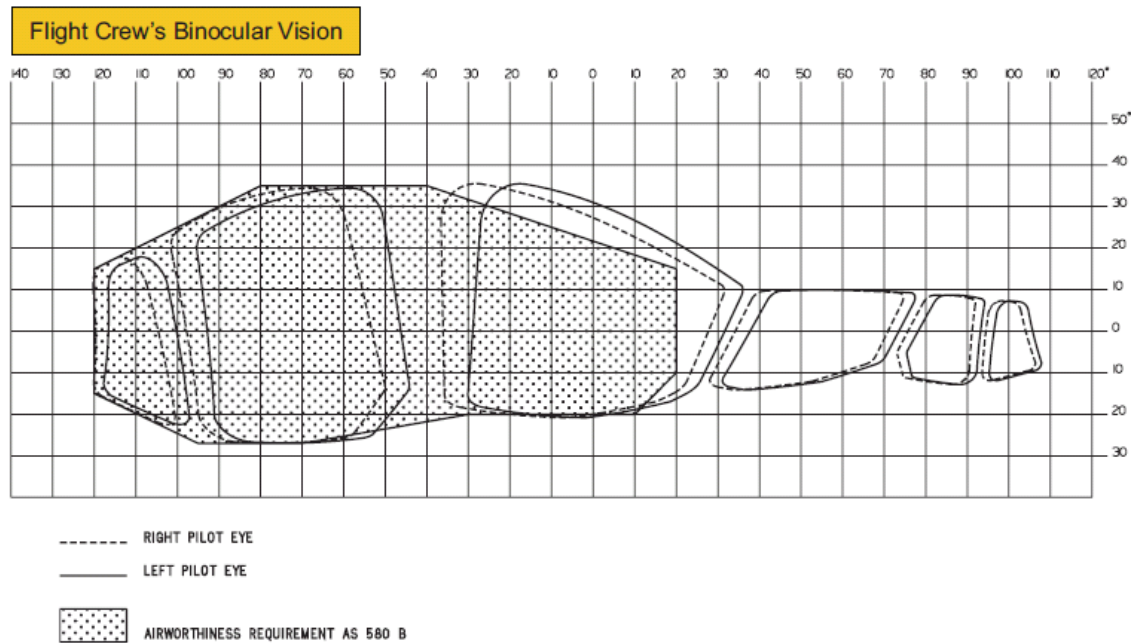
The A-380 Flight Crew binocular vision chart²² below indicates that as the Air France A-380 airplane was making the turn onto Taxiway Alpha, a 10 degree cone of vision may have blocked

the left seat pilot's vision of the Comair airplane momentarily. However, once the Air France A-380 was established on taxiway Alpha, the view of the Comair airplane and should have been in the binocular vision of both the Air France left seat and right seat pilots.

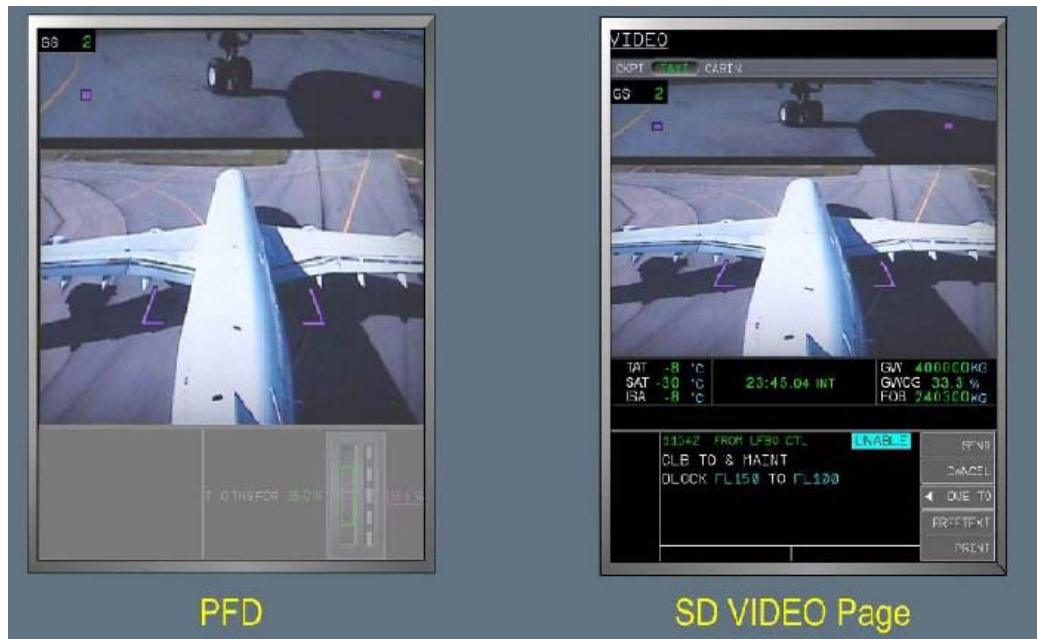
The top of the displays, shown below, provides the video from the BTAC. The ground speed is indicated on the top left corner. Two magenta brackets, one on each side of the Nose Landing Gear (NLG), indicate a lateral 5-meter distance from the NLG. The bottom of the display provides the video from the FTAC. A position indicator on each side of the Main Landing Gear (MLG) indicates the outer edge of the MLG and helps the flight crew to determine the landing gear position in relation to the runway or taxiway centerline. The wingtips do not appear on the camera views. There is no wingtip position indicator on the ETACS.

There was no camera display of the wingtips or the wingtip paths.
