**NATIONAL TRANSPORTATION SAFETY BOARD
Office of Aviation Safety
Gardena, CA 90248**

GROUP CHAIRMAN'S FACTUAL REPORT

OPERATIONS GROUP

WPR10FA371

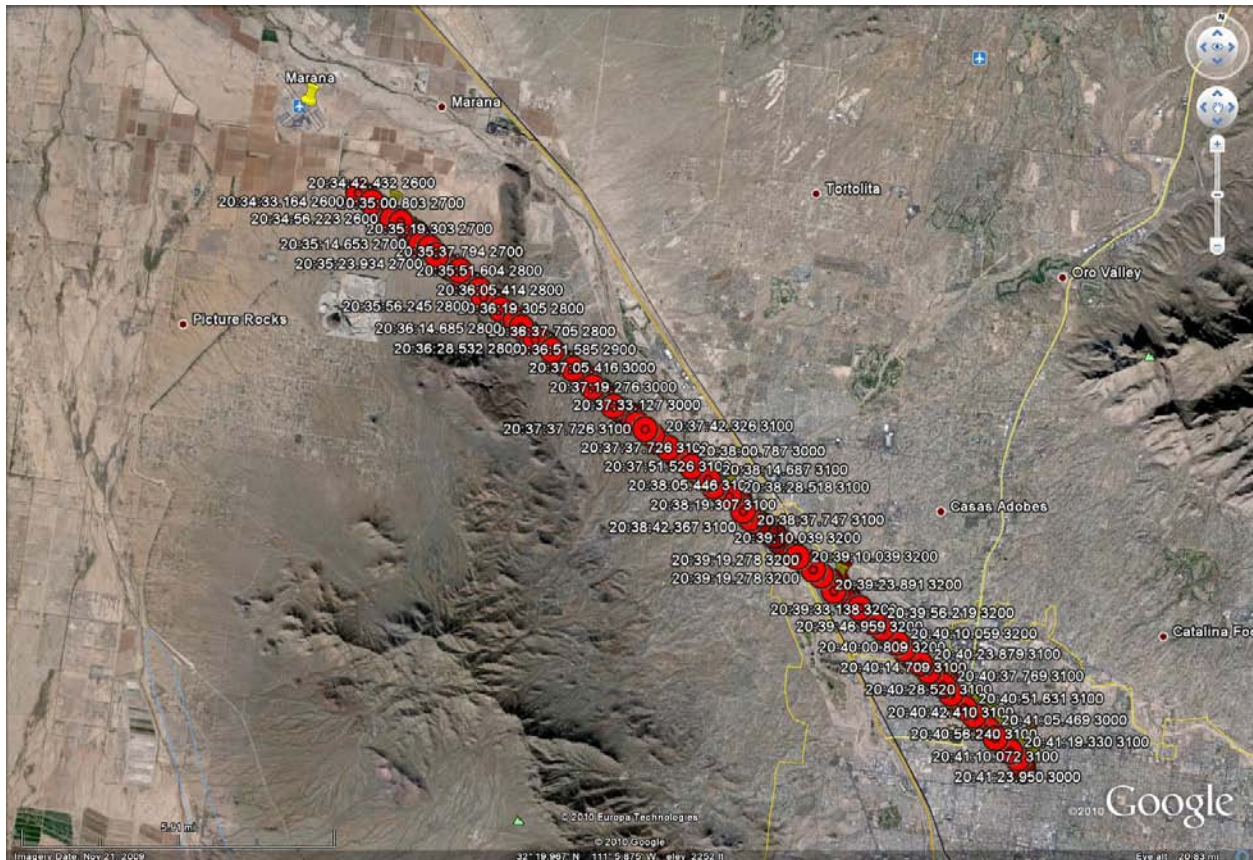
Fig 4 – Radar track of LifeNet 12 departing Marana and traveling southeast to the accident location.

No other communications with LifeNet 12 were recorded. At 1341:38, the Tucson TRACON controller noticed that LifeNet 12 had dropped off the radar display and attempted to contact LifeNet 12 unsuccessfully numerous times.

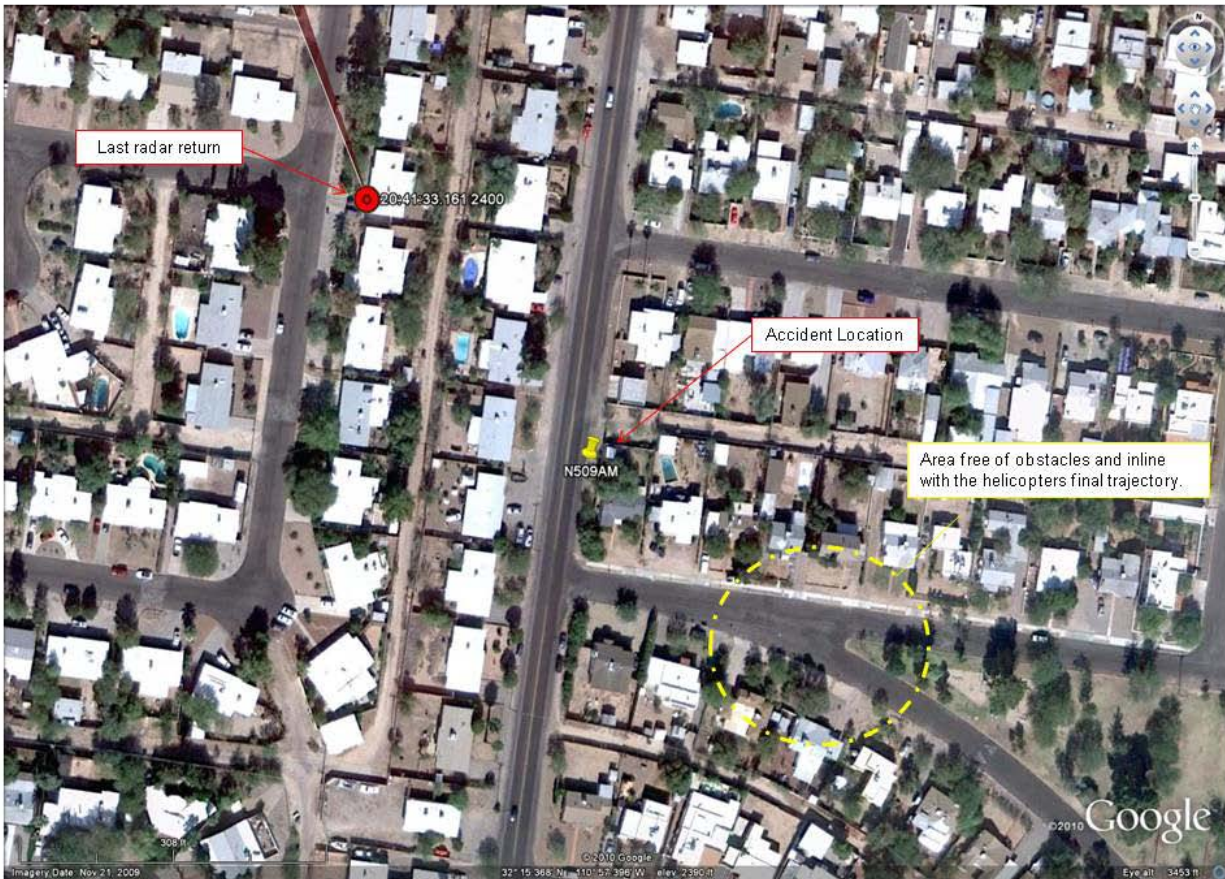
Fig 5 – Area surrounding the accident location

In the vicinity of the accident location, there was an open area that was free of obstacles. This open area was about 570 feet from the final radar return, and about 300 feet from the point of terrain impact, in line with the final flight path trajectory of the helicopter. See figure 5.

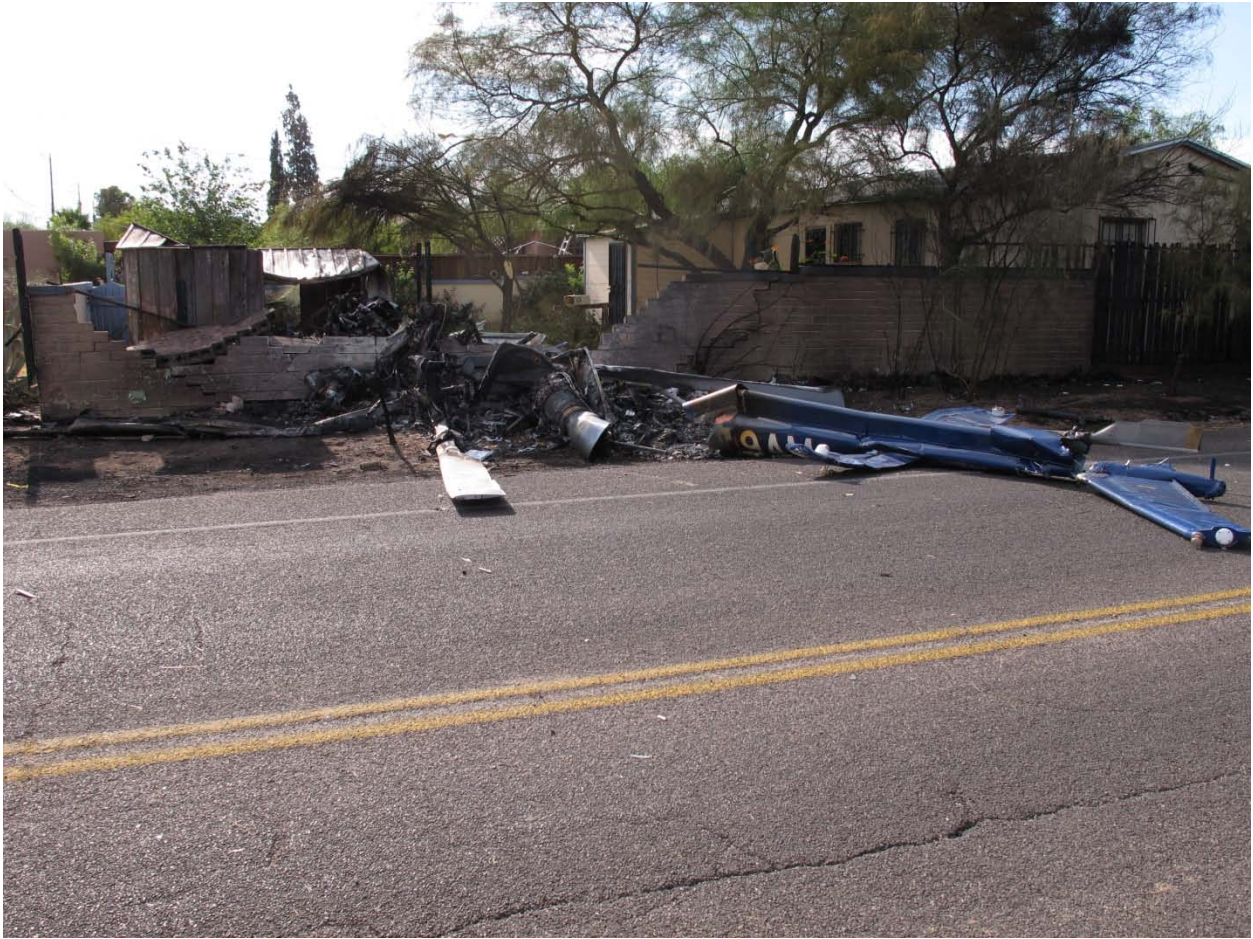
Fig 6 – Main helicopter wreckage.

External examination of the engine at the accident site revealed that the fuel inlet union, had become detached from the boss on the compressor case. The fuel supply line remained attached to the union and the hydro-mechanical unit (HMU). The intermediate gasket was located in the fuselage debris, directly below the union.

The wreckage was located on the east side of a north-south running residential road. Running along the length of the west side of the road were residential power and telephone lines suspended from wood telephone poles. On scene examination of the helicopter wreckage revealed that the helicopter descended nearly vertically and impacted the top of a six foot brick wall at the lateral centerline of the fuselage with a very slight left drift. Control continuity was established from the cockpit to the rotor head and tail rotor. All three main rotor blades remained attached to the main rotor hub. One blade was completely burned, another was partially burned, and the third was lightly burned. All three blades exhibited very little rotational movement signatures, very little leading edge damage, and some evidence of blade flapping. The tail rotor was in place on the tail boom and intact; no evidence of leading edge damage, or rotational scoring/damage, and a small amount of flapping was noted at the tail rotor head.
