NATIONAL TRANSPORTATION SAFETY BOARD

Operations Group Chairman's Factual Report

Aircraft: Eurocopter AS350-B2, N37SH

NTSB Accident Number: DCA12MA020

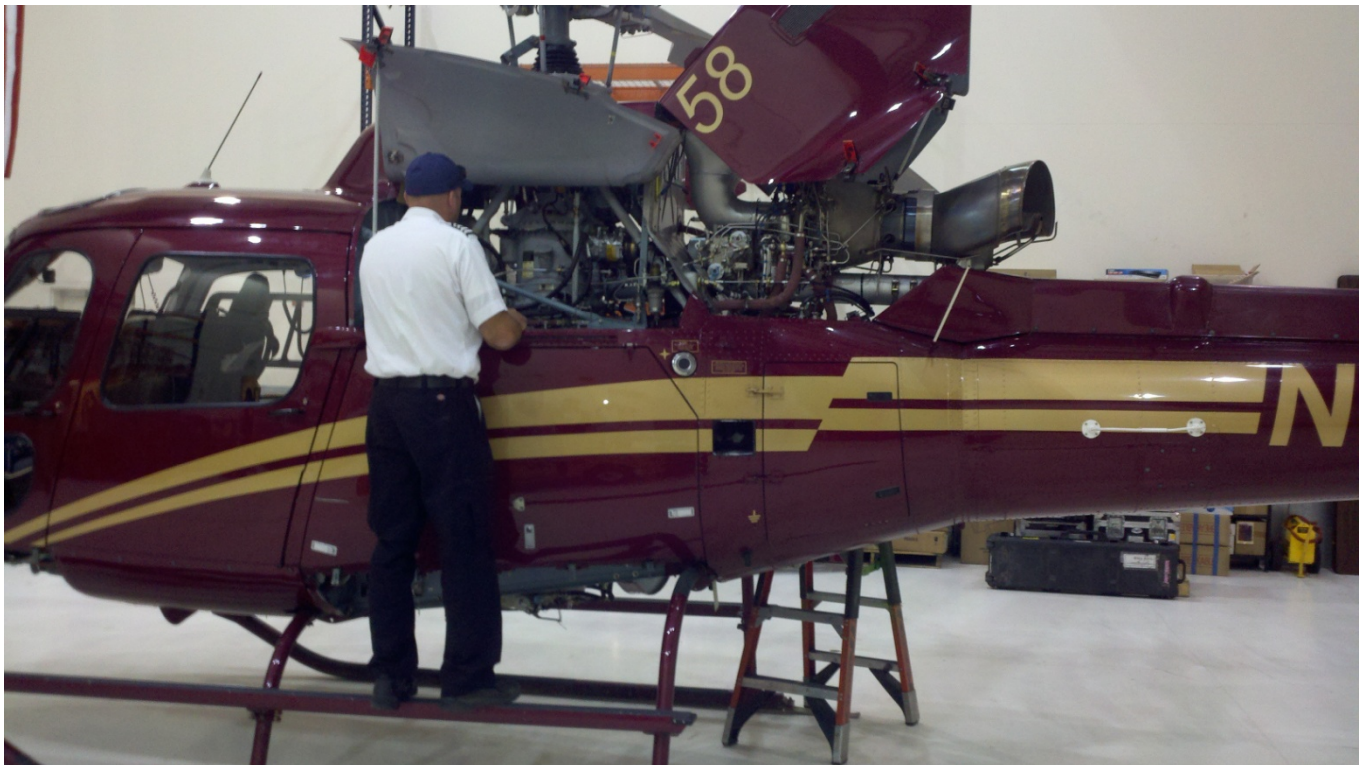
Pilot conducting a preflight inspection of the left MGB area

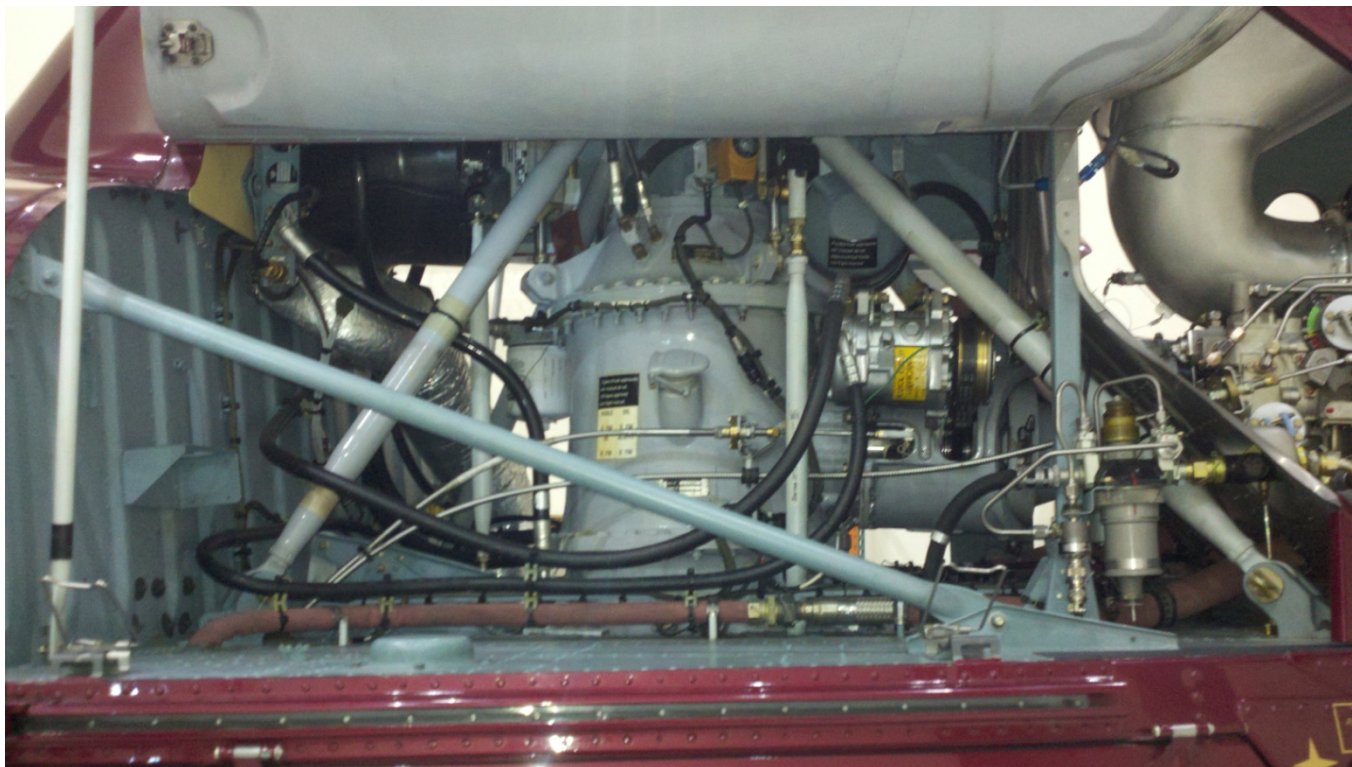
Left MGB inspection area

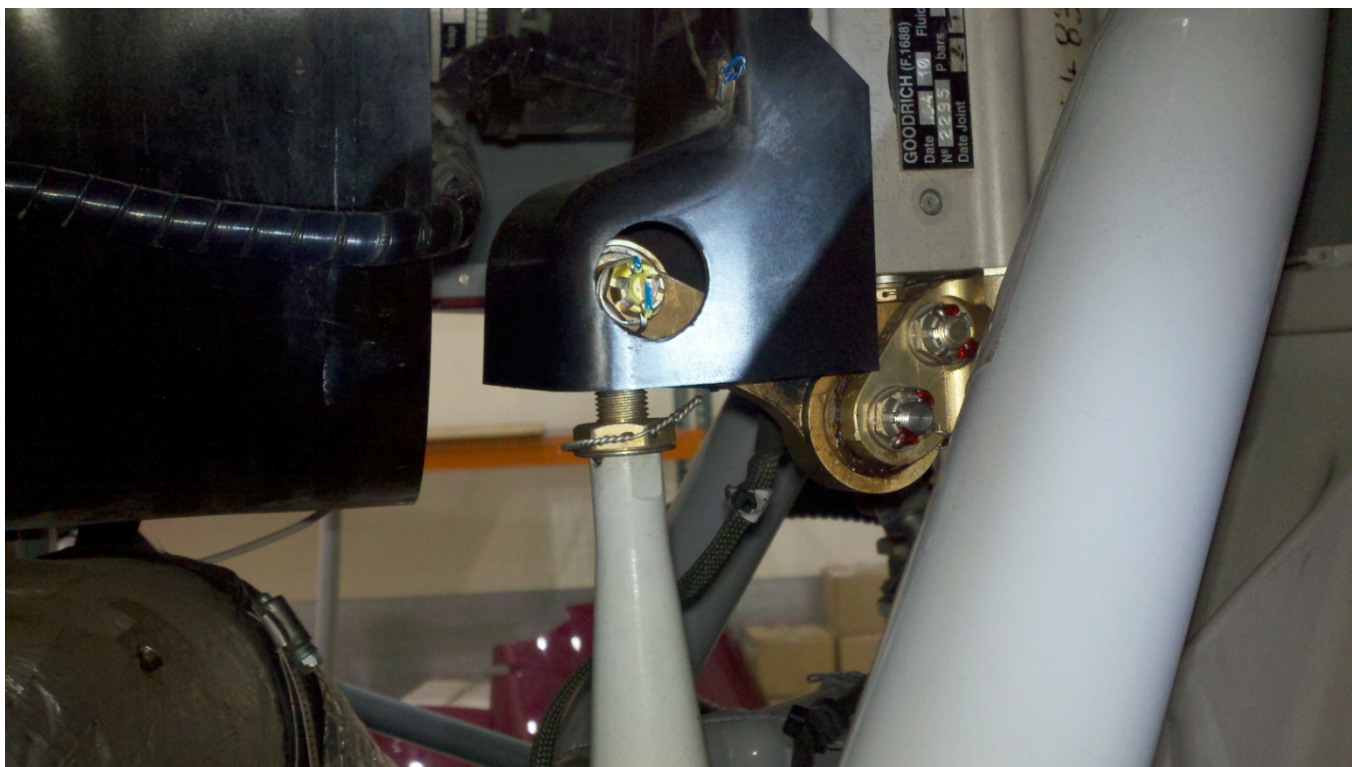
Note: During the course of the field phase of the investigation, at the accident site, the airworthiness group discovered that the cyclic servo connection hardware (bolt, nut, cotter key) were missing. This servo connection should be clearly visible during a preflight inspection, specifically when the pilot opens the left main gear box (MGB) cowl for access. On the day of the accident, the left MGB cowl was opened twice to perform a **BFF** inspection by the MOC pilot, before and after the MOC flight. The left MGB cowl was not opened, nor was it required to be opened during routine **TA** preflights for the remainder of the day. An excerpt from Sundance guidelines (Expanded External Checks Checklist, dated February 9, 2011) for inspection of the left MGB area is listed below.

Fore-aft servo connecting hardware visible through the cutout of the ice boot (about eye-level for a pilot inspecting the left MGB area)
