**NATIONAL TRANSPORTATION SAFETY BOARD  
Office of Aviation Safety  
West Chicago, IL 60103**

**OPERATIONS FACTUAL REPORT**

**CEN11FA599**

Accident Number: CEN11FA599  
 Operator: Air Methods Corporation DBA LifeNet  
 Location: Mosby, Missouri  
 Date: August 26, 2011  
 Time: 1841 cdt  
 Airplane: Eurocopter AS350 B2, N352LN

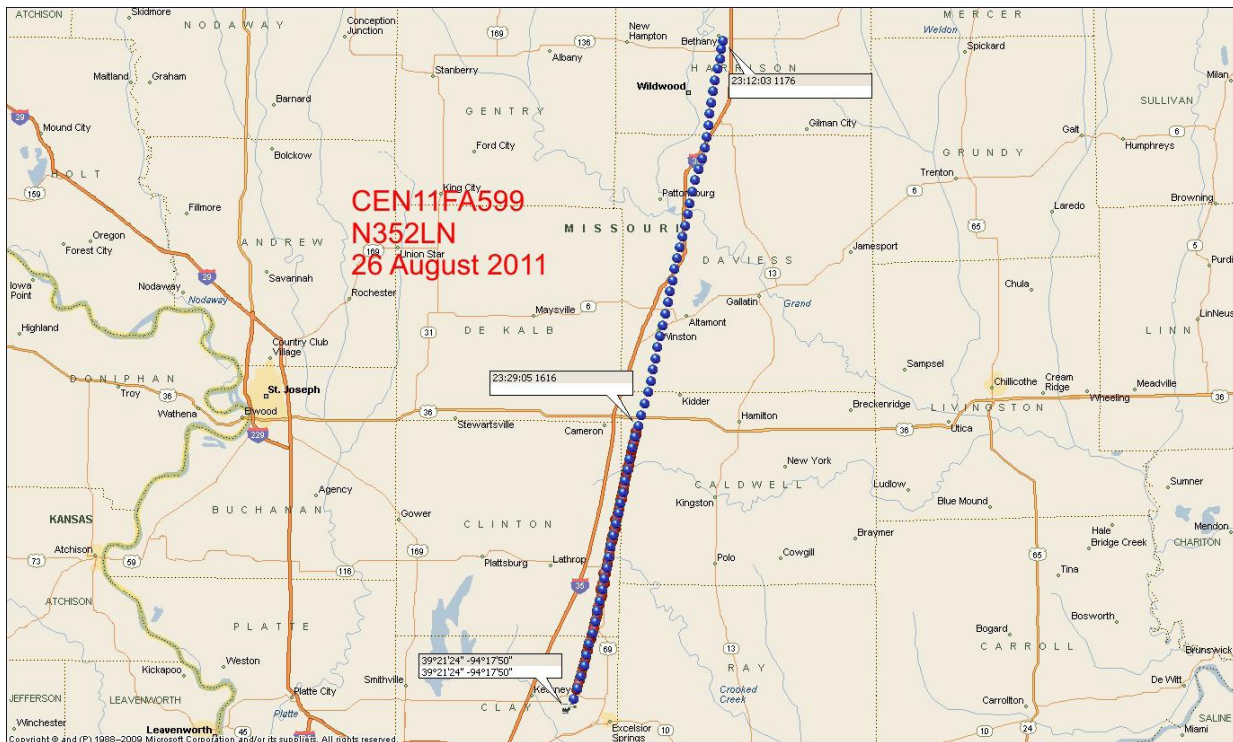
Fig 1 - Overview of flight showing MCI radar data (red dots) and Air Methods tracking data (blue dots.)

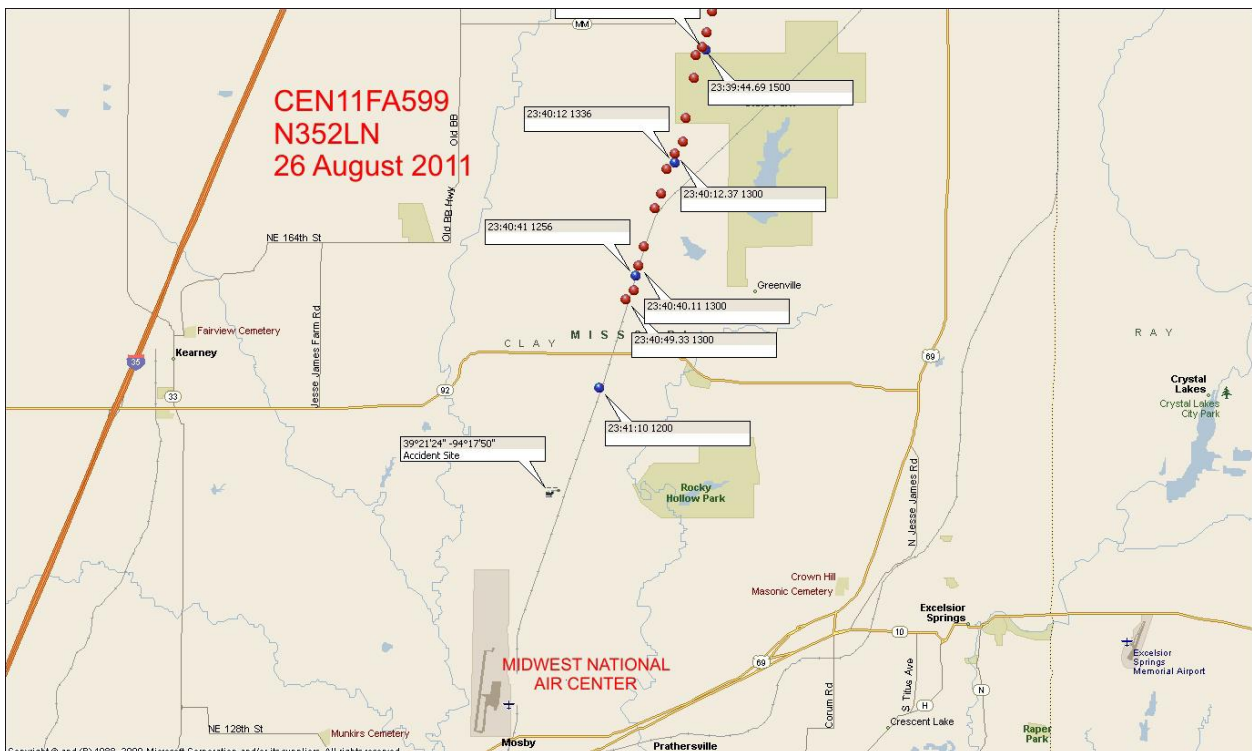
Fig 2 - Last radar targets and GPS position reports along with the location of the destination airport

The combined radar and GPS track data indicated that the helicopter's altitude and airspeed from STJ to the hospital pad at Bethany, Missouri, averaged between 800 to 1,000 feet above ground level (agl) with an average ground speed of about 115 to 120 knots on a 050° heading. After the helicopter departed from the hospital pad en route to GPH, the track data indicated that the helicopter's altitude averaged between 400 to 600 feet agl with an average ground speed of 111 to 116 knots on a 190° heading. At 1841, the last GPS position recorded was about 0.9 nm from the accident site, and it showed the helicopter was about 373 feet agl<sup>9</sup> with a 116 knot ground speed.

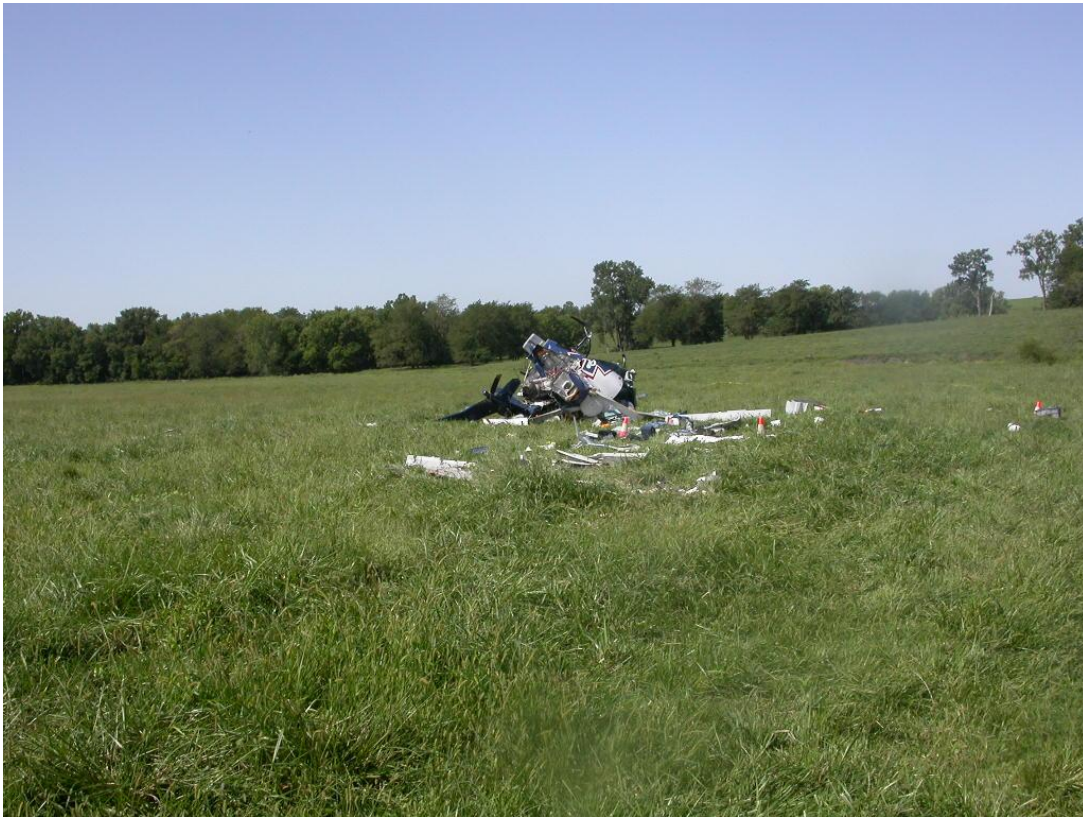
The aircraft wreckage was located in a farm field on a direct course line between the Harrison County Community Hospital helipad and GPH. The initial impact point was located about 1 nm from the approach end of runway 18 at GPH (See Wreckage Diagram for additional details).

Photo 1 - Impact in an open field

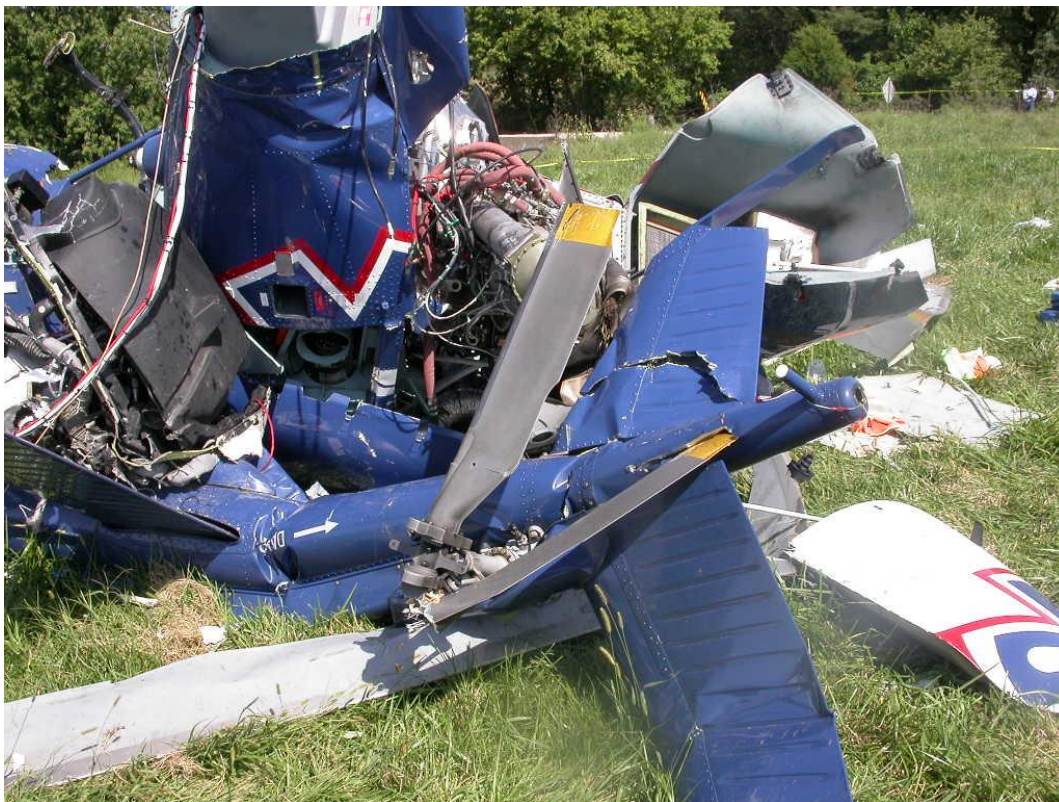
The aircraft structure was heavily fragmented and scattered along the 100-foot-long debris path, which was oriented on a heading of about 242°. All the impact signatures were consistent with a low rotor RPM and a high rate of descent. The impact signatures to the components of the airframe structure were consistent with the initial impact occurring in a 40° nose-low and slight left-bank attitude, on a heading of about 030°

Three separate main rotor blade strike ground scars were found at the beginning of the wreckage path, to the right of center. The main rotor blades remained attached to the rotor head and mast. Due to the post impact vaulting of the wreckage along the energy path, one blade (blue) came to rest bent down and inward more than 90° at the root, and the other two blades were relatively straight. Similarly, the two tail rotor blades exhibited little impact damage and were relatively straight, although one blade was partially separated at the blade root.

Photo 2 - Main helicopter wreckage

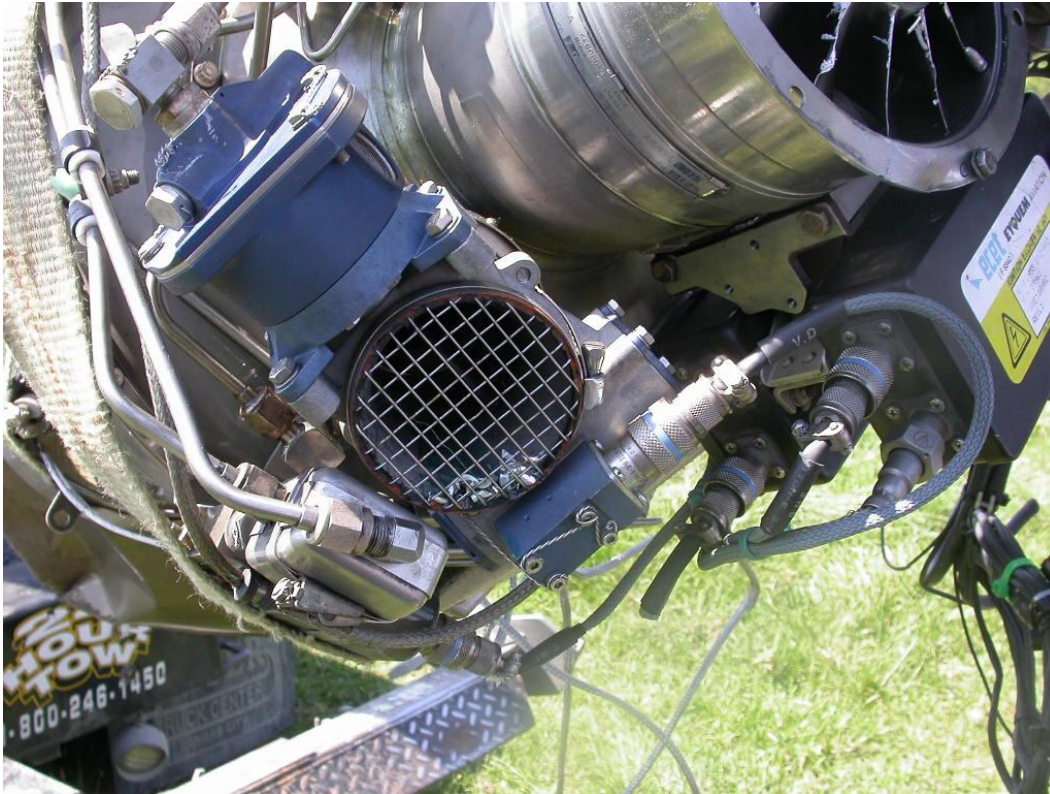
The on-site examination of the engine revealed that the axial compressor blades exhibited blade rub opposite the direction of travel. Metal shavings were found in the engine bleed air valve. The Module 5 input pinion nut slippage mark was found intact and not misaligned, which was consistent with an engine rotating but not making power at impact.

Photo 3 - Metal Shavings in Bleed Air Valve

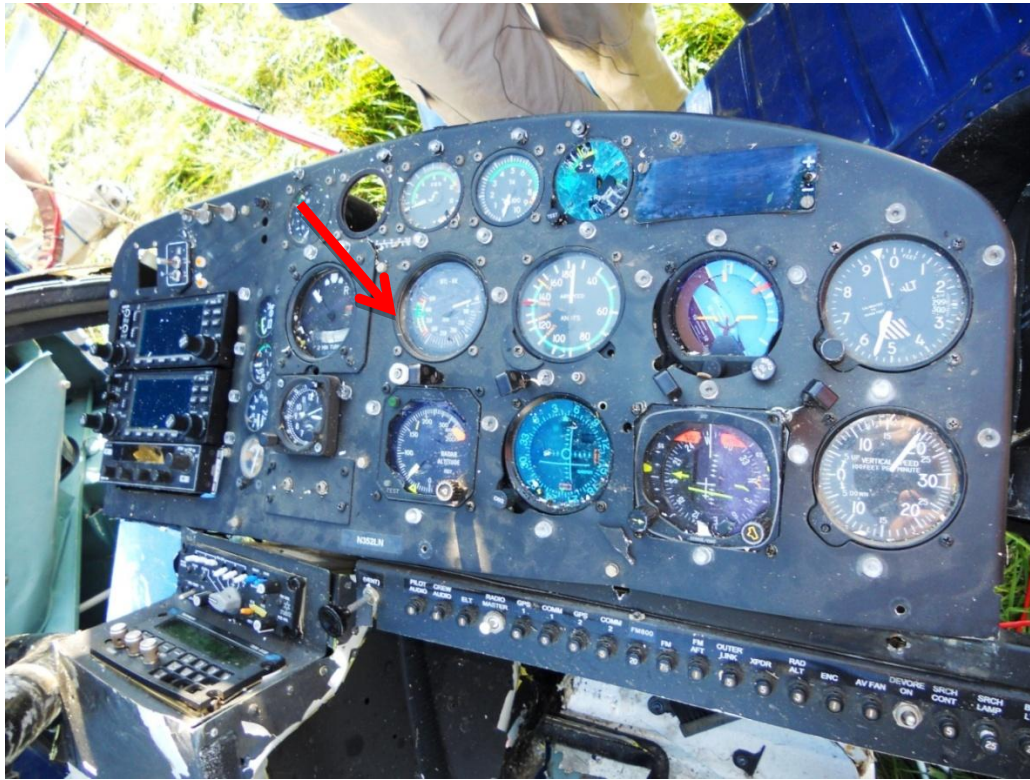
The instrument panel was relatively intact and separated from the airframe; however, most of the instruments could be easily read and observed. Many displayed settings towards the low side of measurements; however, the overall impact damage precluded the ability to rely conclusively on their readings. The instrument panel was configured with NVG lighting and filters. The brightness switch on the caution-warning annunciator panel was found on the low (dim) setting, which would be the correct position for night operations.

Photo 5 – Instrument panel. The red arrow points to the NR gauge.
