NATIONAL TRANSPORTATION SAFETY BOARD
Office of Marine Safety
Washington, D.C. 20594

Operations Group Factual Report

Seastreak Wall Street allision with Pier 11, New York, NY

DCA 13 MM 005

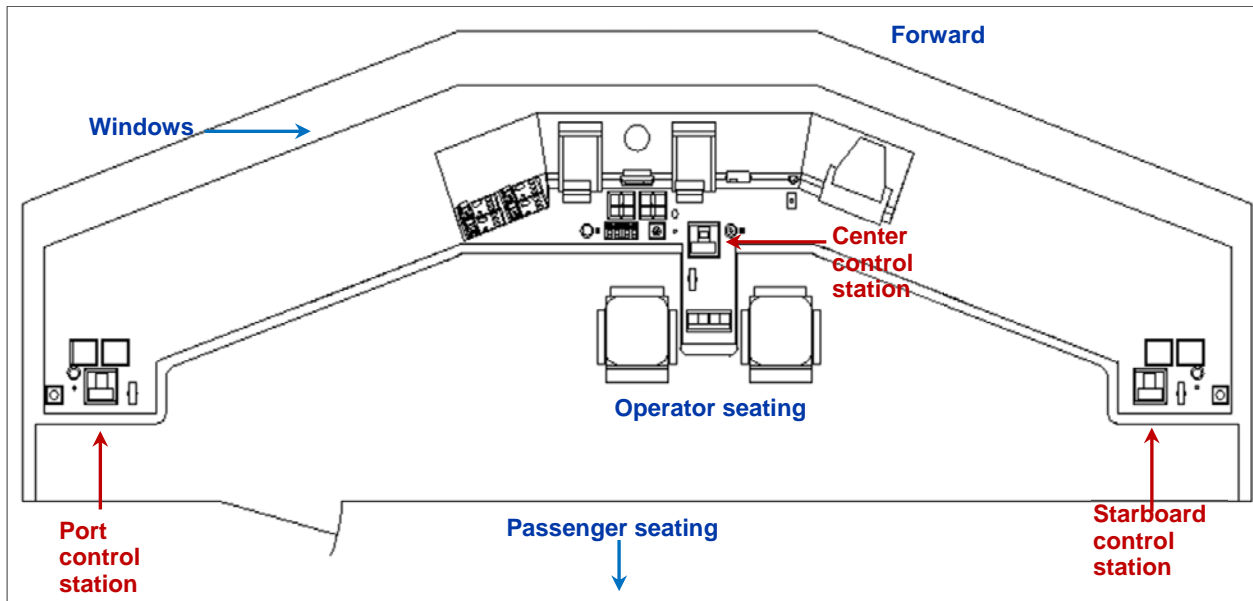
Figure 1: Seastreak Wall Street Bridge Diagram of Ship's Control Systems

The pilot house of the *Seastreak Wall Street* showing the arrangement of the 3 Scana throttle control panels, the 4 full follow up steering stations, and seating for the Master and the Mate.
