NATIONAL TRANSPORTATION SAFETY BOARD

Group Chairman's Factual Report

OPERATIONAL FACTORS

ERA13MA139

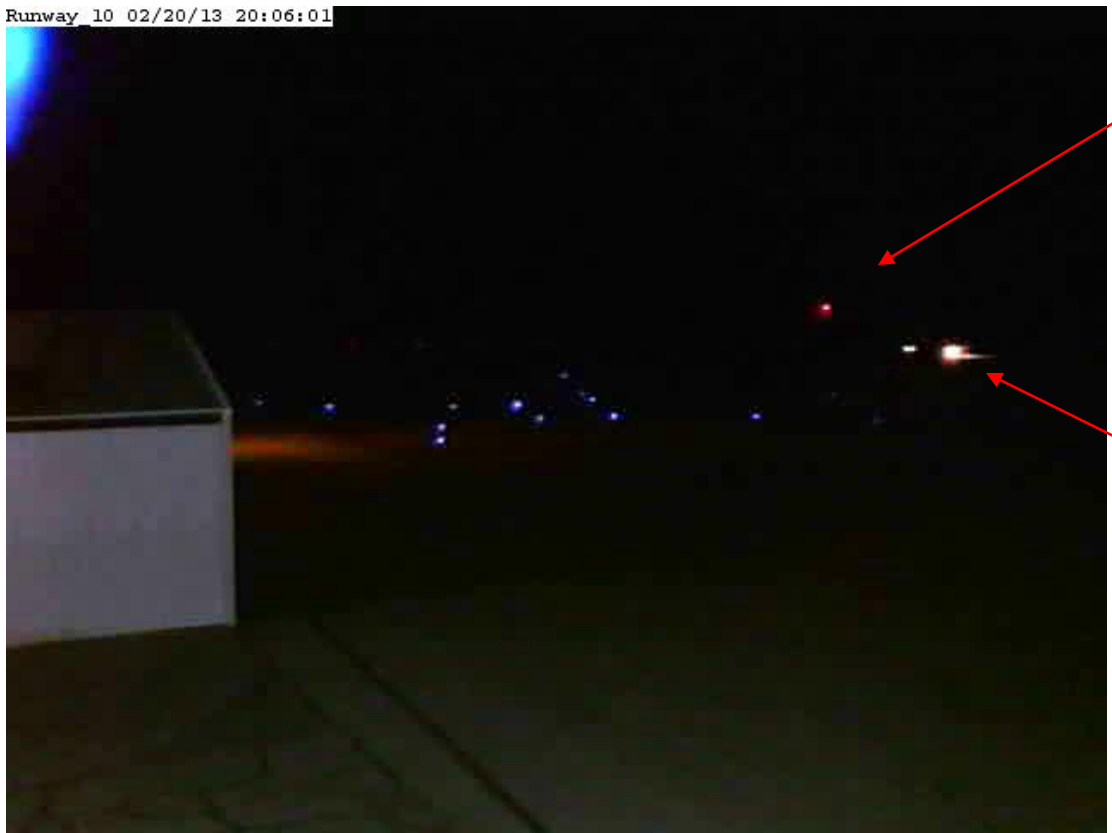
Photo 8: Screen shot of security camera video of accident airplane (2/20/2013 at 20:06:01 EST)

Runway 10 02/20/13 20:06:01

Glideslope
antenna light

N777VG over
runway 10

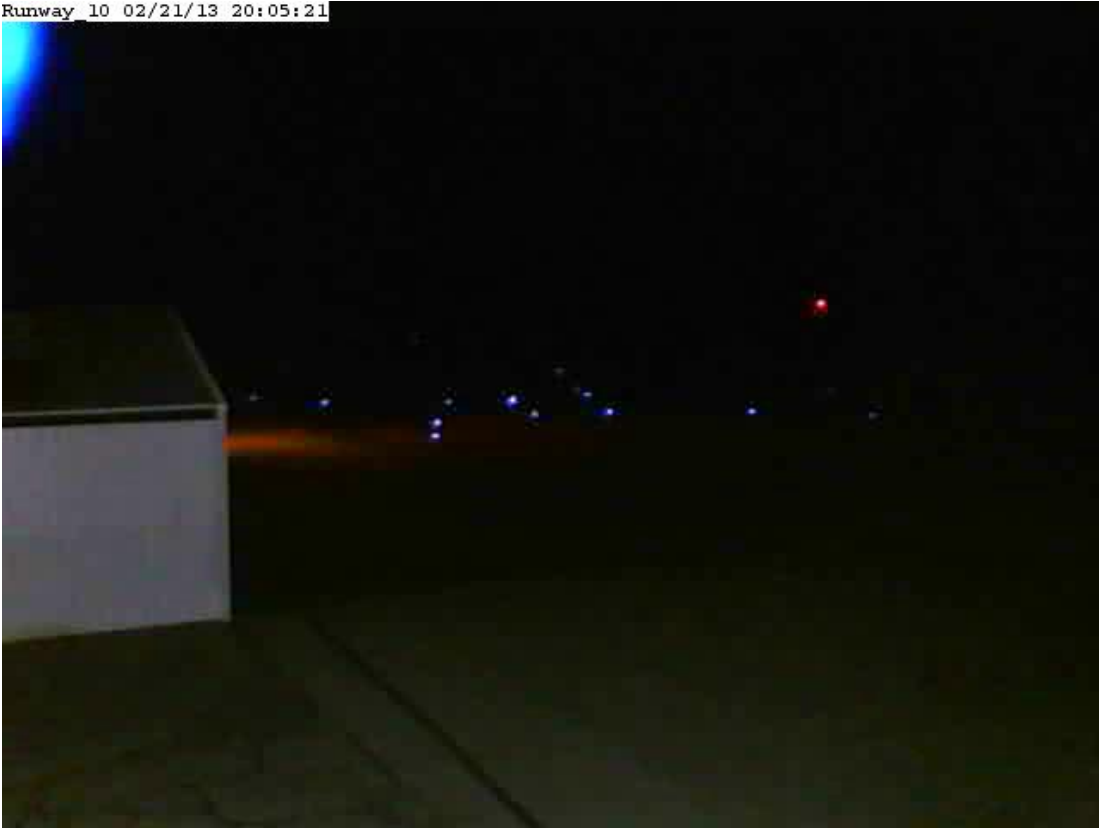
Photo 9: Screen shot video the following night (2/21/2013), runway lights on low intensity.

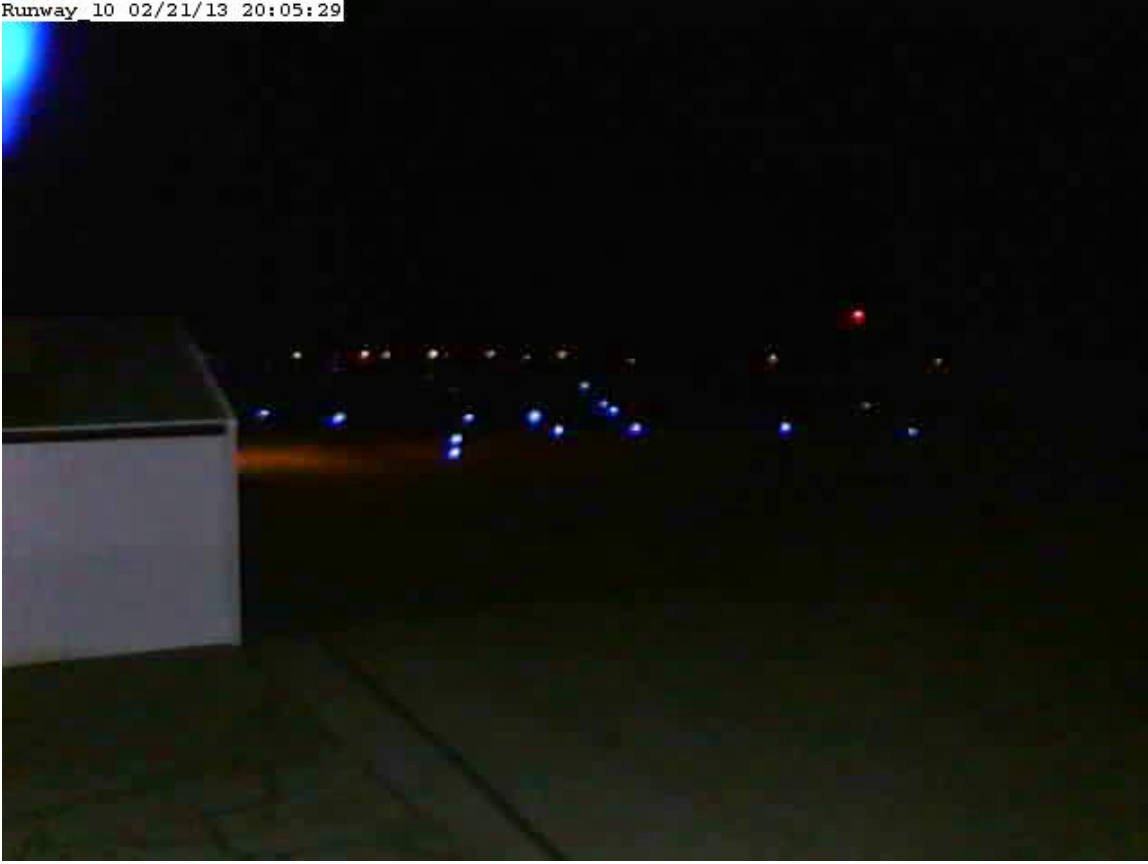
Photo 10: Screen shot video the following night (2/21/2013), runway lights on medium intensity.

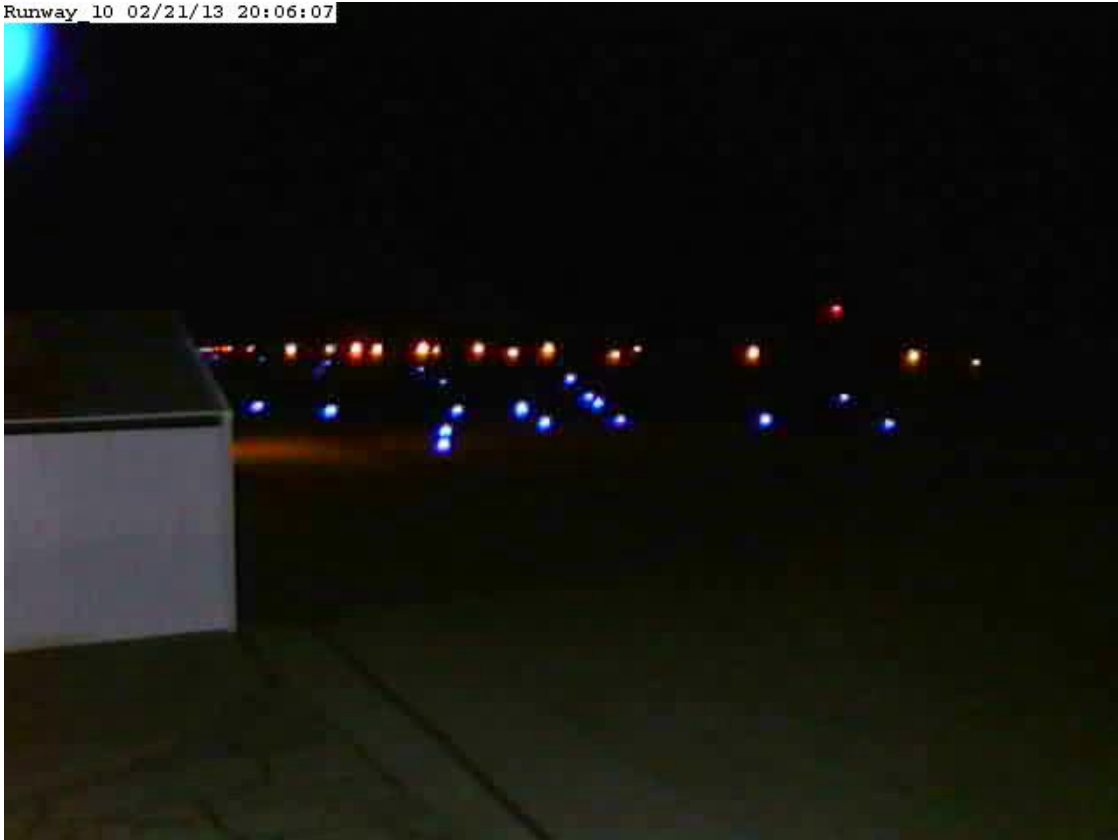
Photo 11: Screen shot video the following night (2/21/2013), runway lights on high intensity.

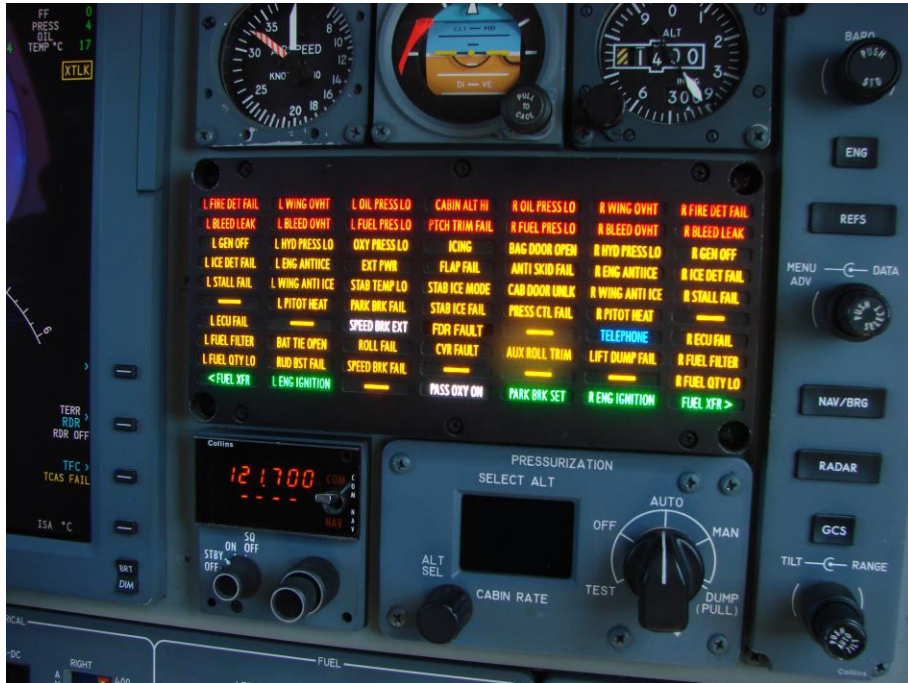
Photo 12: Premier 390 annunciator panel⁹⁵

According to recorded data, on the final approach to HQU the ANTI SKID FAIL annunciator and master caution illuminated in the cockpit on the accident flight when the landing gear was lowered. The master warning/caution system was provided to monitor the operating status of various airplane systems.⁹² The ANTI SKID FAIL annunciator would illuminate if a
