## **NATIONAL TRANSPORTATION SAFETY BOARD**

### **Group Chairman's Factual Report**

# **OPERATIONAL FACTORS**

**DCA13FA082AB**

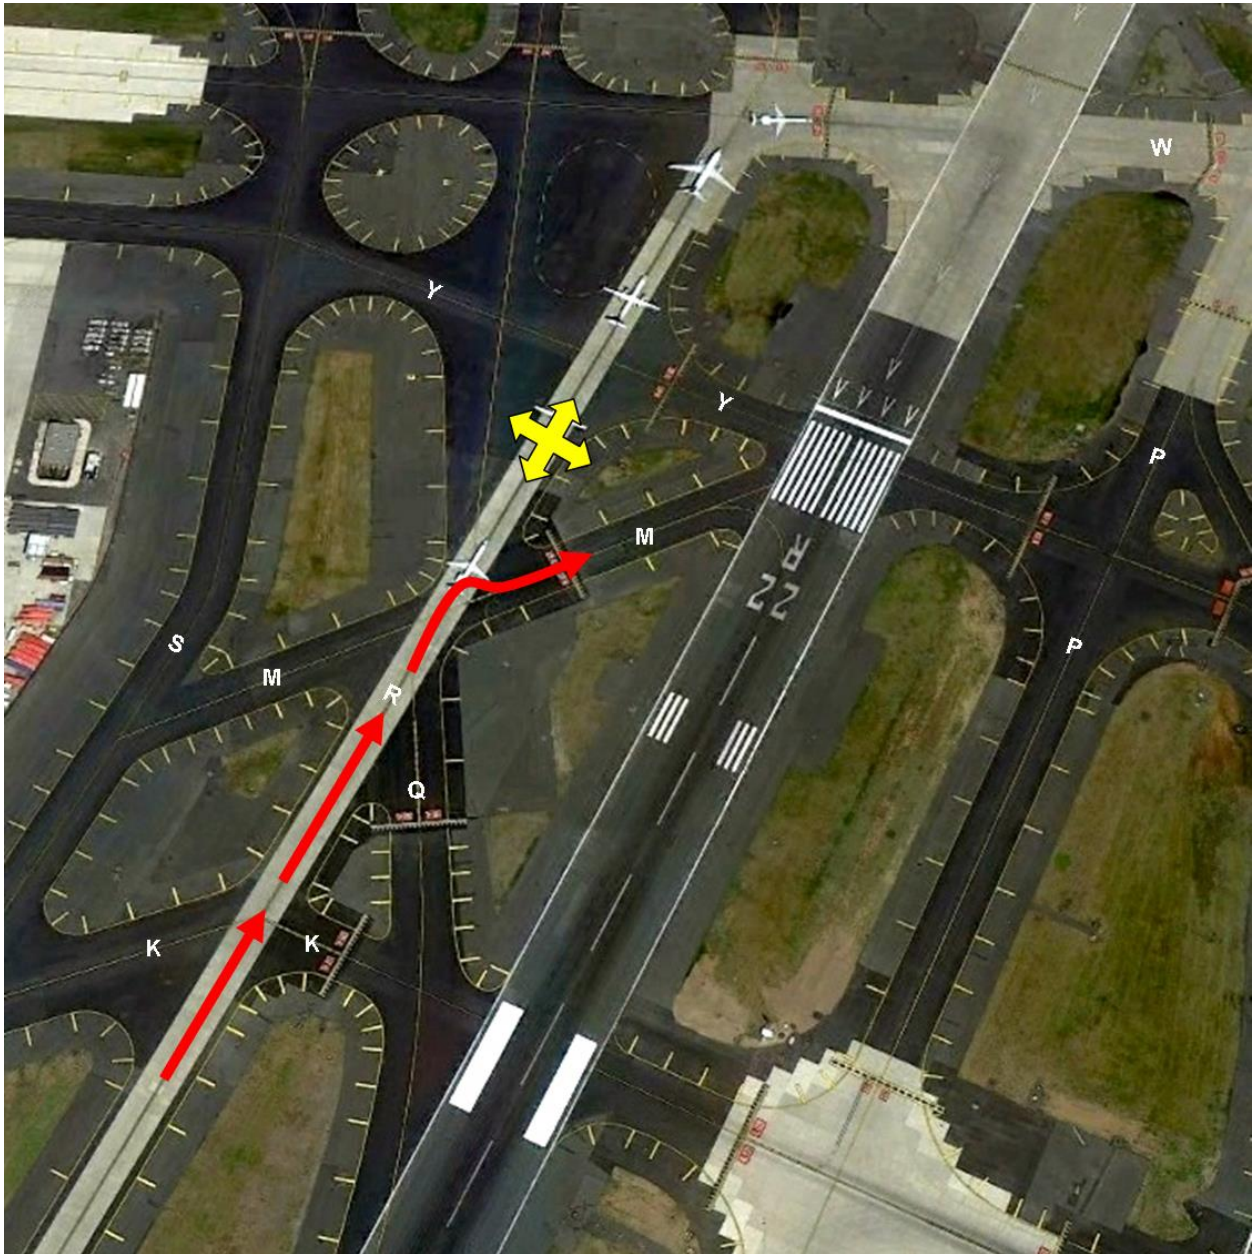
**Google Earth Photo of Area Where Ground Collision Occurred**

**The Red Arrows Describe the Taxi Route of SAS 908 and the Yellow Cross Indicates the Approximate Area of the Parked Expressjet 4226.**

**(Note: It could not be determined the exact position of the ExpressJet ERJ-145 on taxiway R at the time of the impact.)**
