**NATIONAL TRANSPORTATION SAFETY BOARD  
OFFICE OF AVIATION SAFETY**

Operations Factual Report

LAX08PA259

Operator: United States Forest Service  
Location: Weaverville, California  
Date: August 05, 2008  
Time: 1941 Pacific daylight time  
Aircraft: Sikorsky S-61N, N612AZ

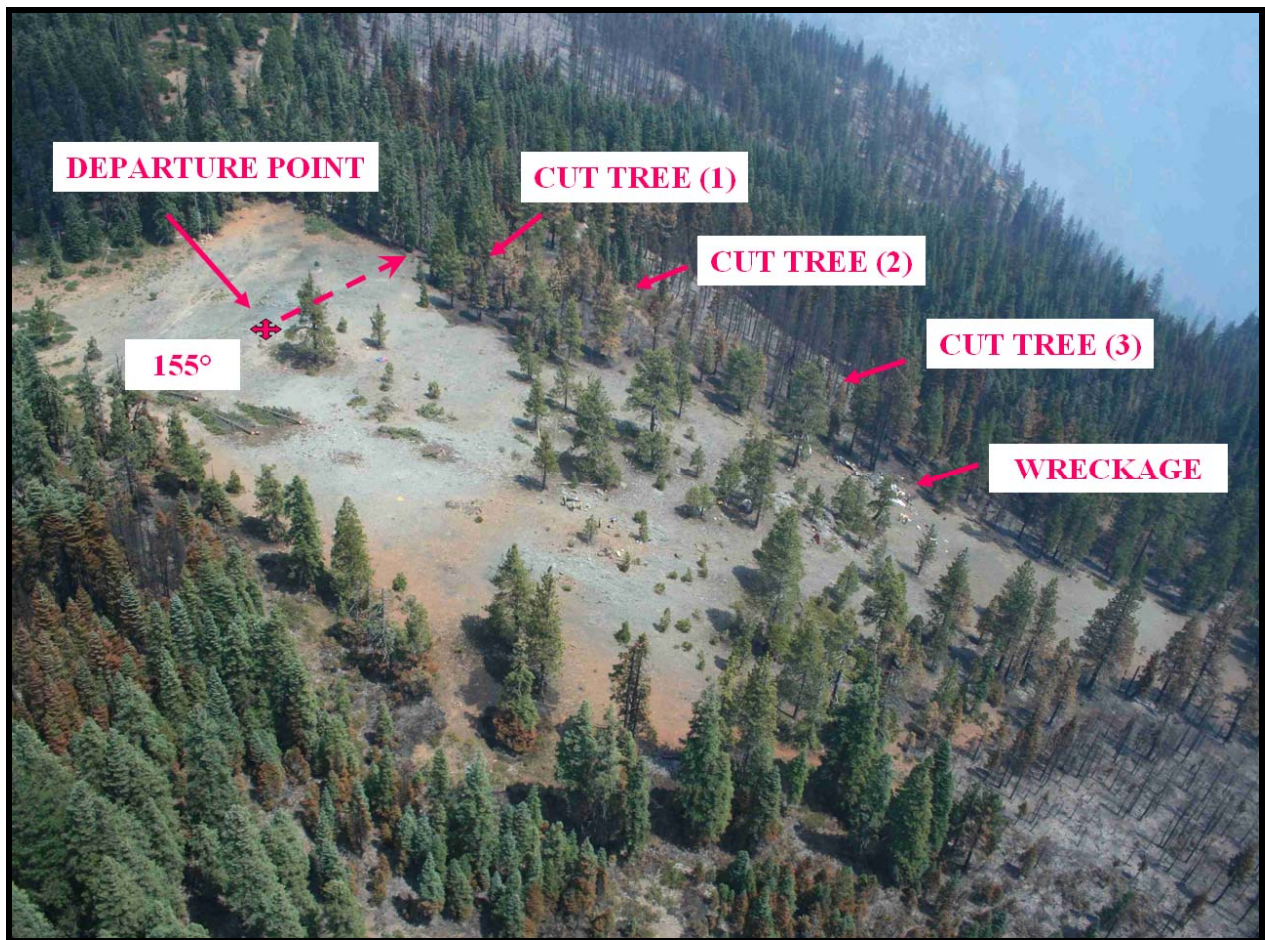
*Figure 03: H-44 Wreckage in Relation to Approximate Departure Point*

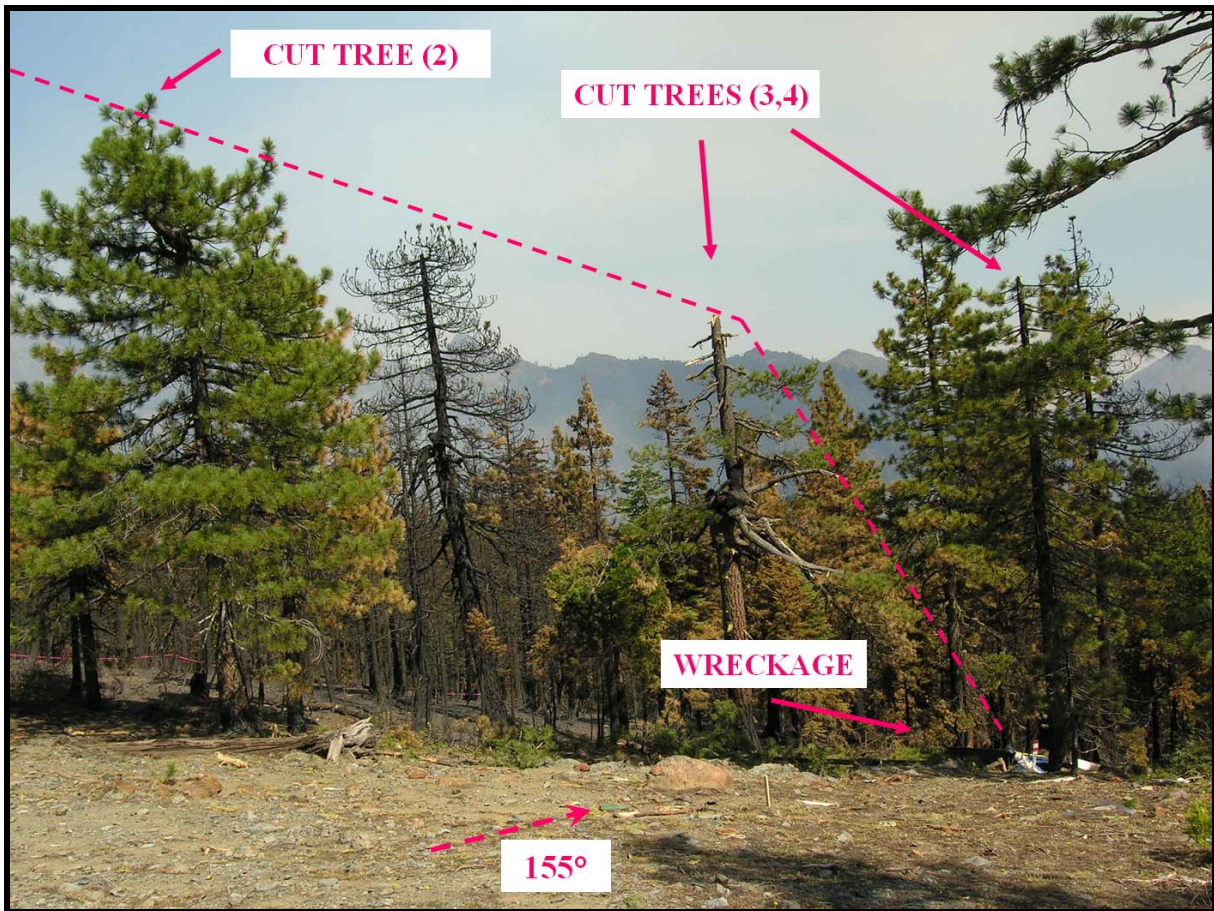
Witnesses<sup>32</sup> stated that as the helicopter began to lift off, the vertical ascent appeared very slow and the helicopter moved as though it was labored. The helicopter began to move forward in a nose-low configuration, and was drifting right with the nose still pointing in the same direction. The flight path of the helicopter continued forward and then began losing altitude as it continued down slope. The helicopter collided with the trees and subsequently impacted the down sloping terrain, coming to rest on its left side.

Figure 04: Main Wreckage

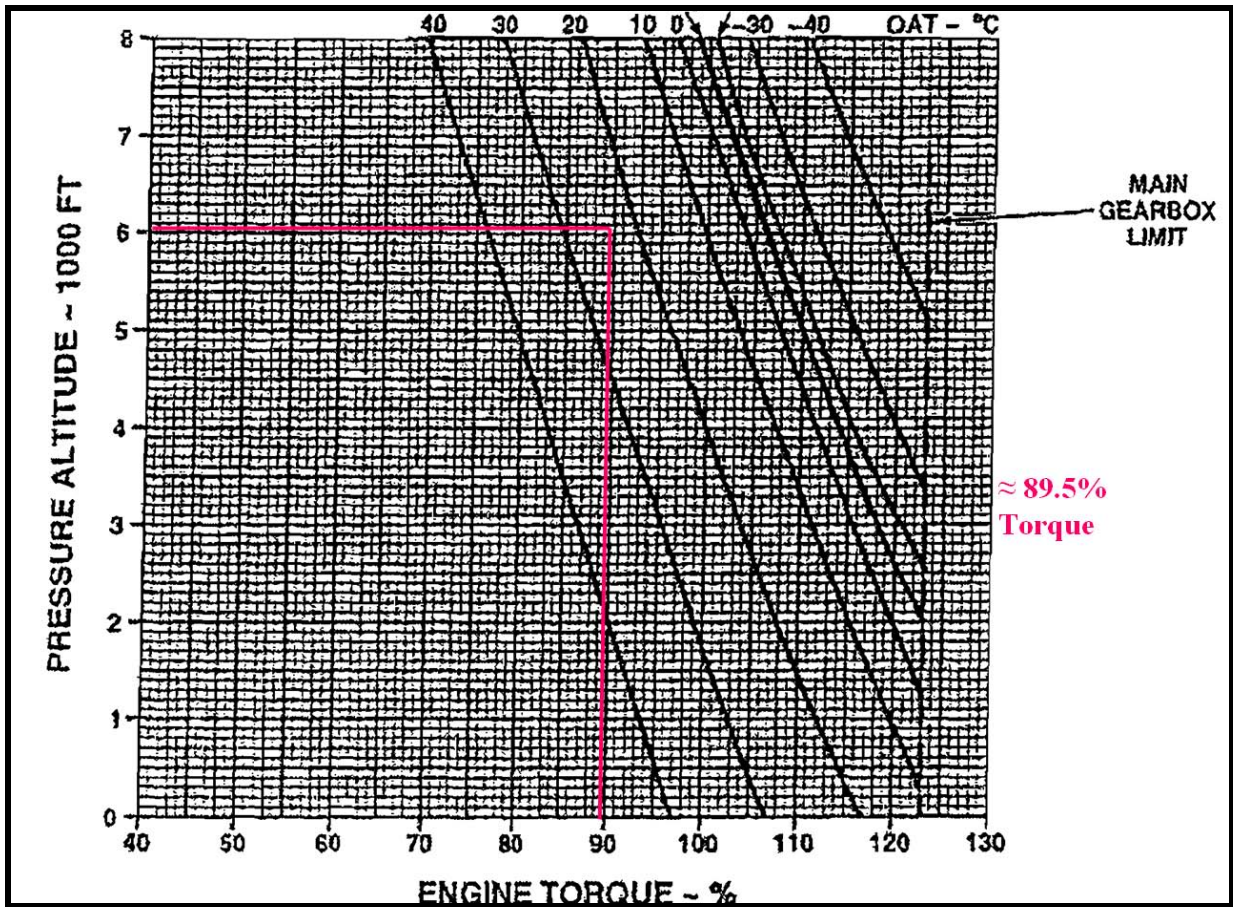
In using the accident conditions, the chart gives an engine torque of 89.5 percent, which is the same value from using the Figure 1 charts. The pictorial section of the charts did not reference both a twin engine and OEI limit, as it should. Additionally the charts are slightly askew on the page and have less crisp, distinct lines than the other charts in RFMS 8. The pictorial section of the chart was compared to the pictorial section of Figure 1, and they appeared to be identical.<sup>100</sup>

Figure 21: CHSI Provided RFMS 8, Figure 4; Power Available Takeoff Power; 5 minute twin and 30 minute OEI (103-percent  $N_R$ ) for actual accident conditions

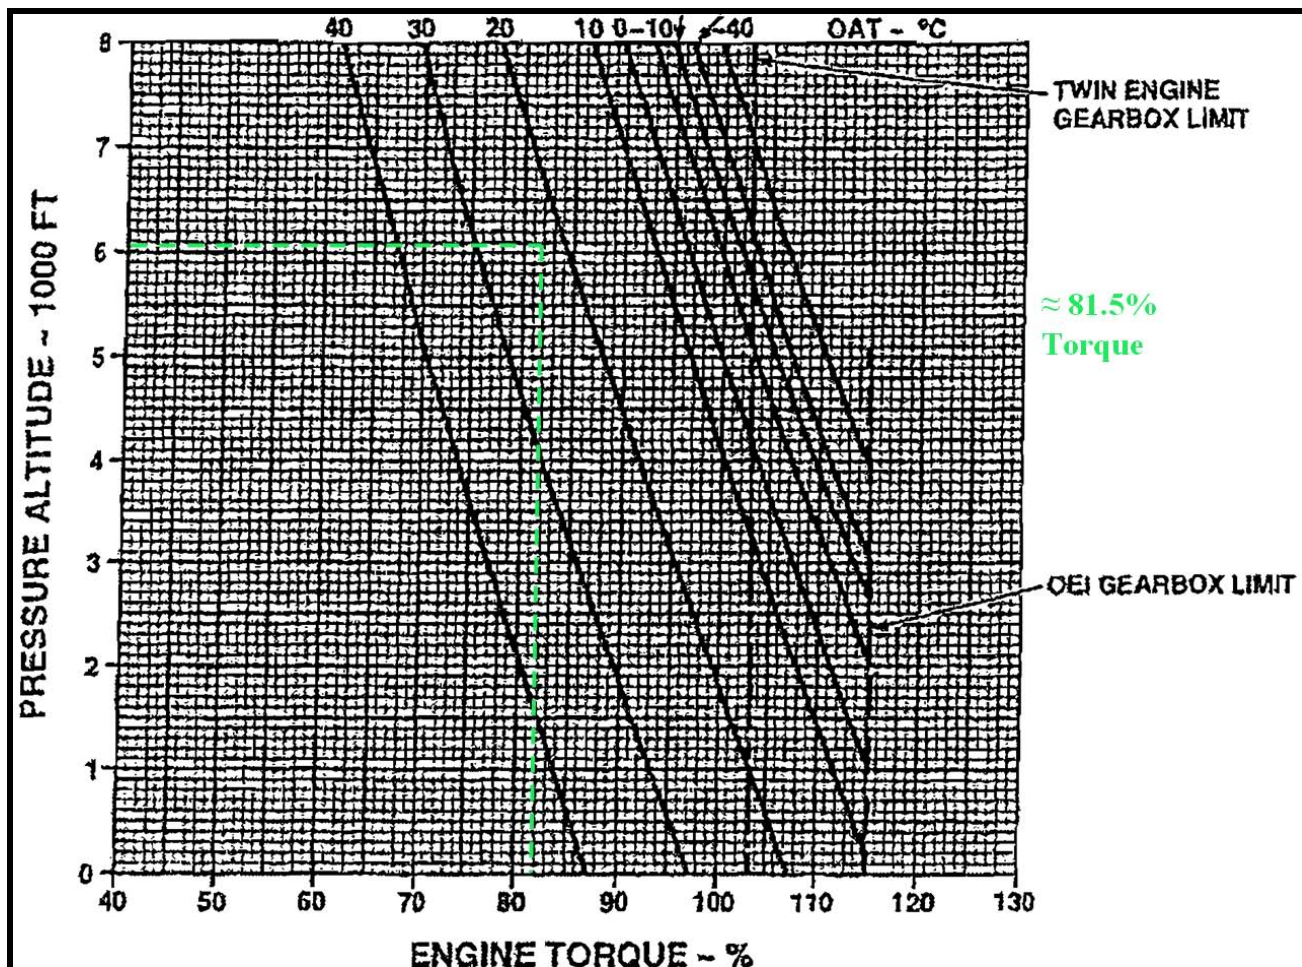
The Figure 4 chart was requested directly from the FAA after the aforementioned anomalies were found with the CHSI provided charts. The FAA provided Figure 4 looked identical in format to the CHSI provided chart with the page header and footer the exact same; both charts were dated as FAA approved on February 07, 2008. The notable difference was the pictorial charts were not the same. The pictorial section of the FAA provided chart did have twin engine and OEI limits as it should. In using the accident conditions, the chart gives an engine torque of 81.5 percent, which is a difference of 8 percent from the CHSI provided chart. When

asked to explain the discrepancy between the two charts, CHSI personnel stated that origin of the "mislabeled" charts is unknown.<sup>101</sup>

Figure 22: FAA Provided RFMS 8, Figure 4; Power Available Takeoff Power; 5 minute twin and 30 minute OEI (103-percent  $N_R$ ) for actual accident conditions

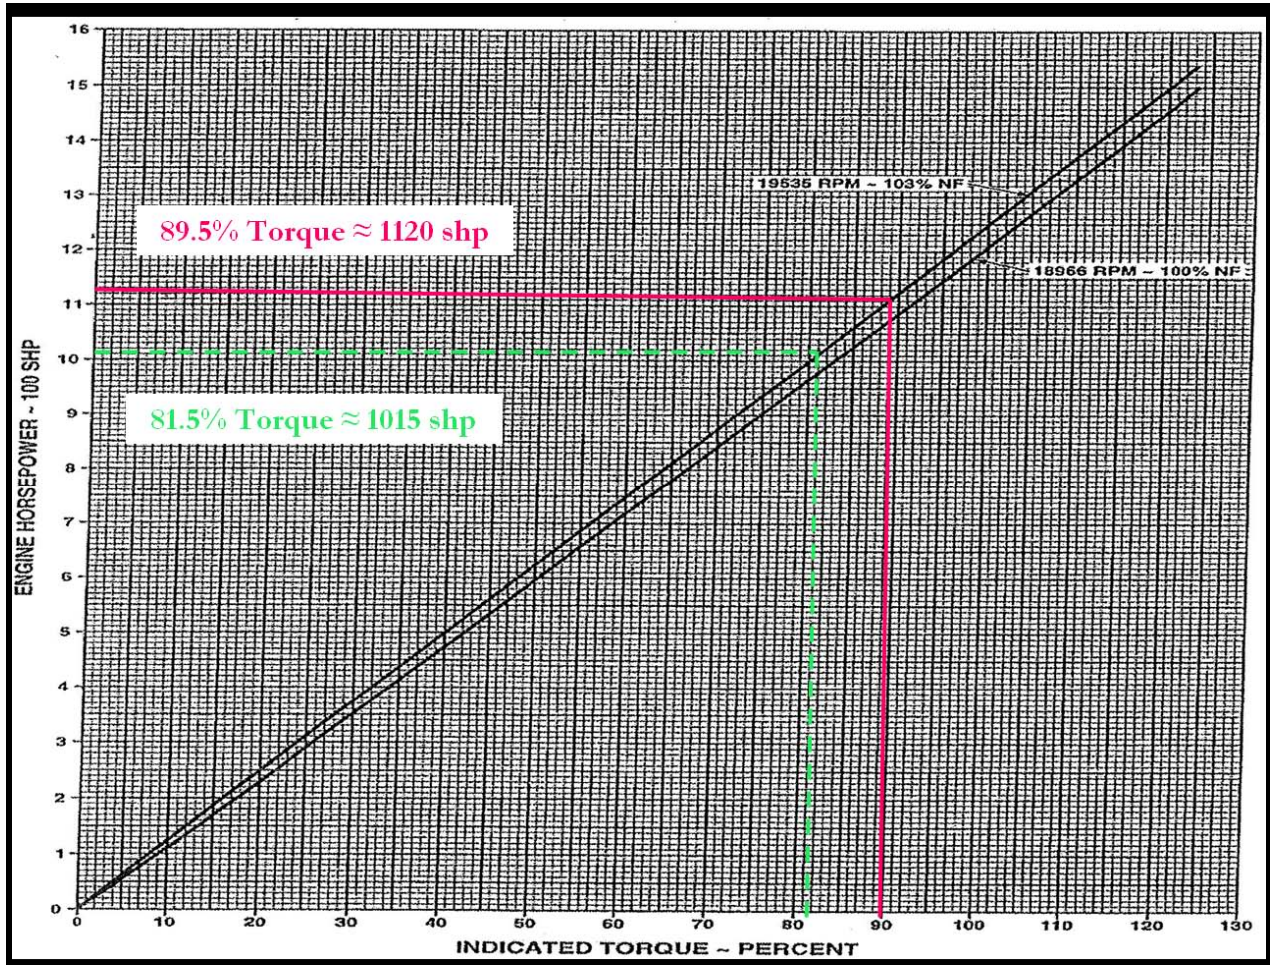
RFMS 8, Figure 5, Indicated Torque vs. Engine Shaft Horsepower, is the chart that converts the indicated torque derived in Figure 4 to horsepower using either 100 or 103 percent. In using Figure 4 from the CHSI and FAA provided charts, the engine horsepower at 103 percent equates to 1,120 shp and 1,015 shp, respectively.

Figure 23: RFMS 8, Figure 5; Indicated Torque vs. Engine Shaft Horsepower, Using Percent Torque Obtained by CHSI (pink) and FAA (green) Provided Figure 4 Charts for actual accident conditions

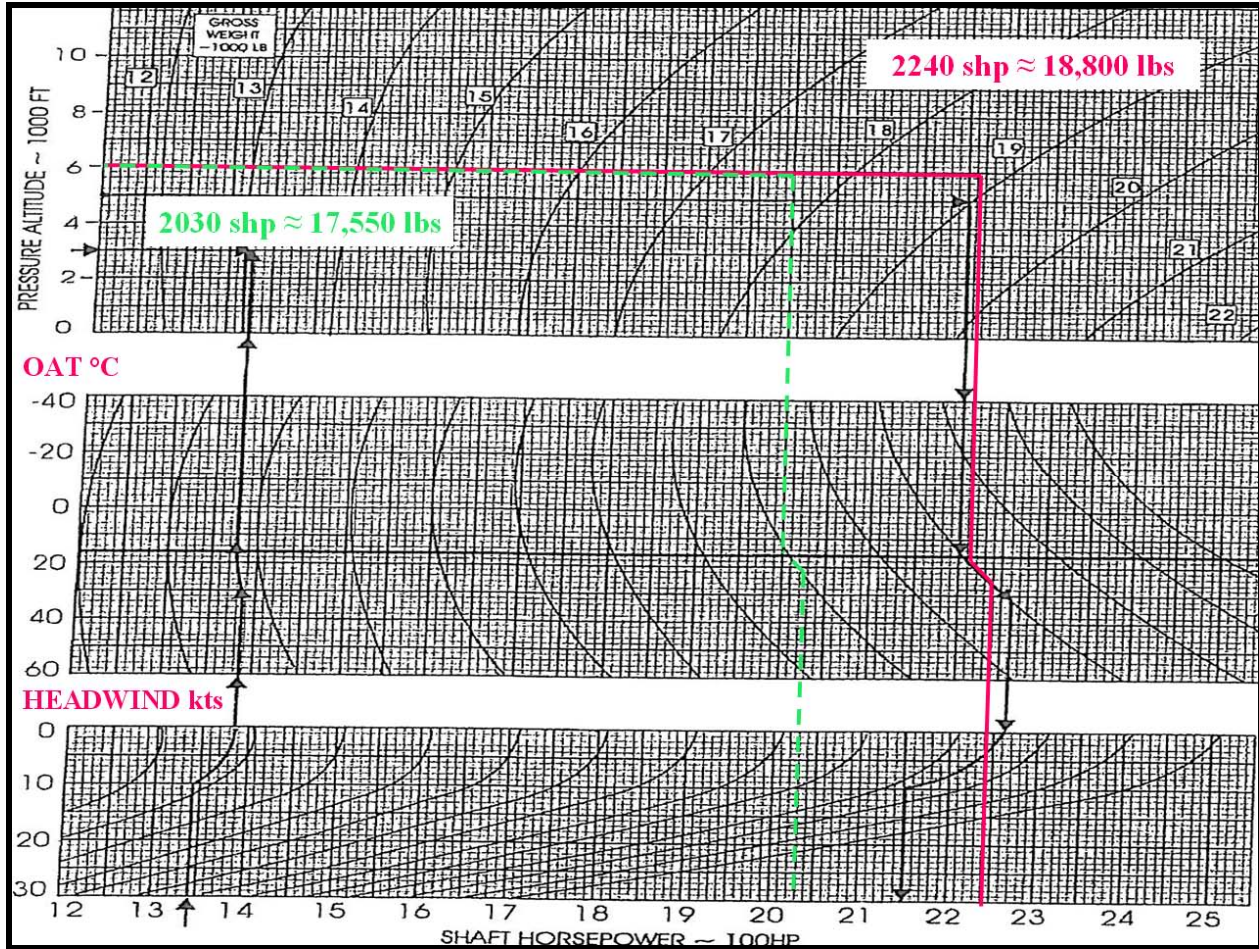
RFMS 8, Figure 7, Power Required to Hover Out of Ground Effect (103 percent  $N_R$ ), is used to determine the weight at which the helicopter can hover OGE. The shaft horse power obtained from Figure 5 is multiplied by 2 to account for both engines and input in the chart. Accounting for winds, temperature, and pressure altitude, the chart derives the HOGE weight. In using Figure 5 from the CHSI and FAA provided chart numbers, the HOGE weight is 18,800 lbs and 17,550 lbs, respectively (a difference of 1,250 lbs).

Figure 24: RFMS 8, Figure 7; Power Required to Hover Out of Ground Effect (103 percent  $N_R$ ), Using Shaft Horsepower by CHSI (pink) and FAA (green) Provided Figure 4 Charts for actual accident conditions

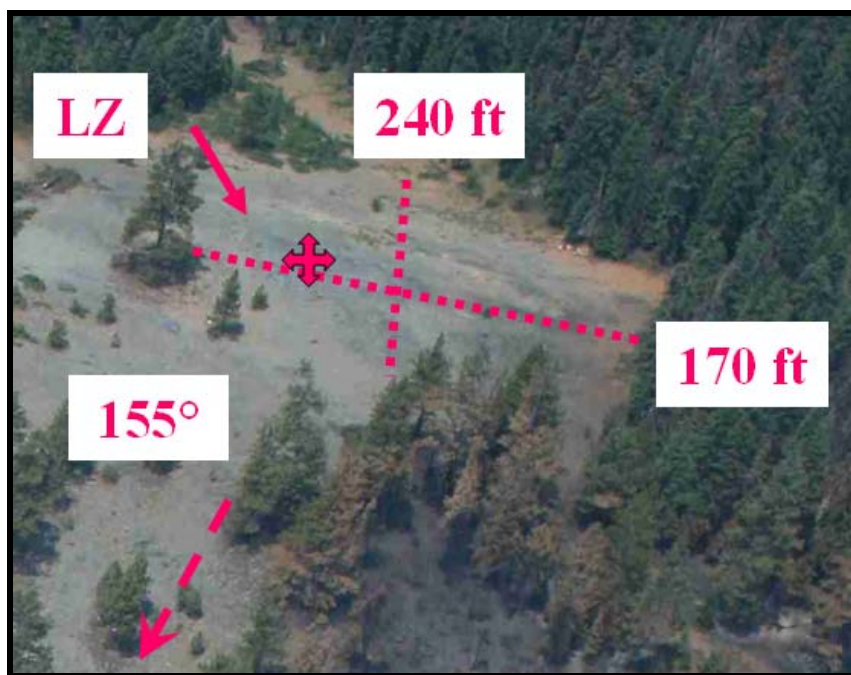
Helispot H-44 clearing measured approximately 240 feet by 140 feet, with surrounding trees around 50 feet in height. According to the USFS IHOG, Type 1 requirements for a helispot safety circle must be at least 110 feet in diameter with a touchdown pad at least 30 feet by 30 feet. It adds that a path should be cleared of all obstacles higher than touchdown pad for distance of 300 feet along approach and departure path. A note states that pilots should "Avoid helispots that require vertical take-offs," and that "Almost-vertical approaches and departures are not inherently unsafe, but should be avoided if possible, especially on an extended-use basis."

*Figure 25: Approximate Helispot H-44 Orientation and Dimensions*
