NATIONAL TRANSPORTATION SAFETY BOARD

Group Chairman's Factual Report

OPERATIONAL FACTORS

DCA13MA133

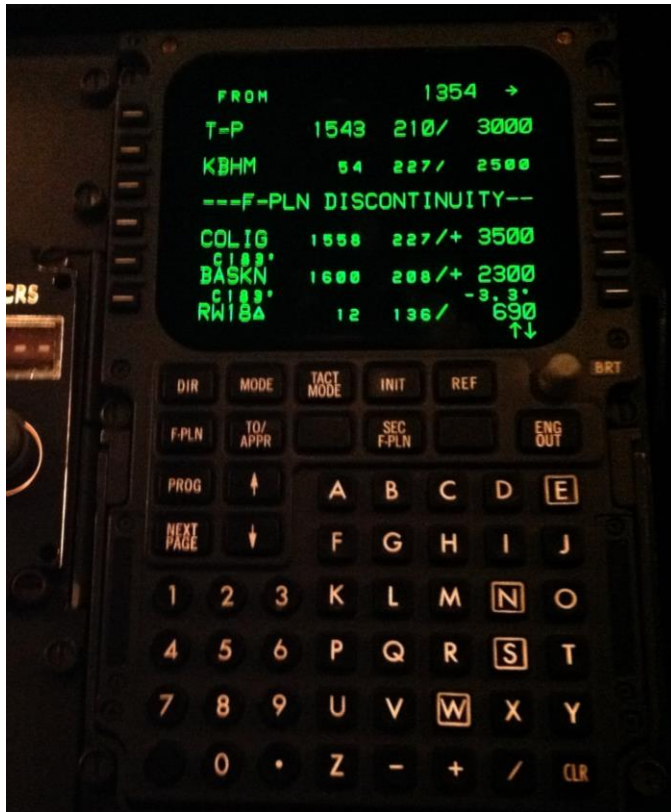
Photo 4: CDU F-PLN page showing flight plan discontinuity.¹²⁷

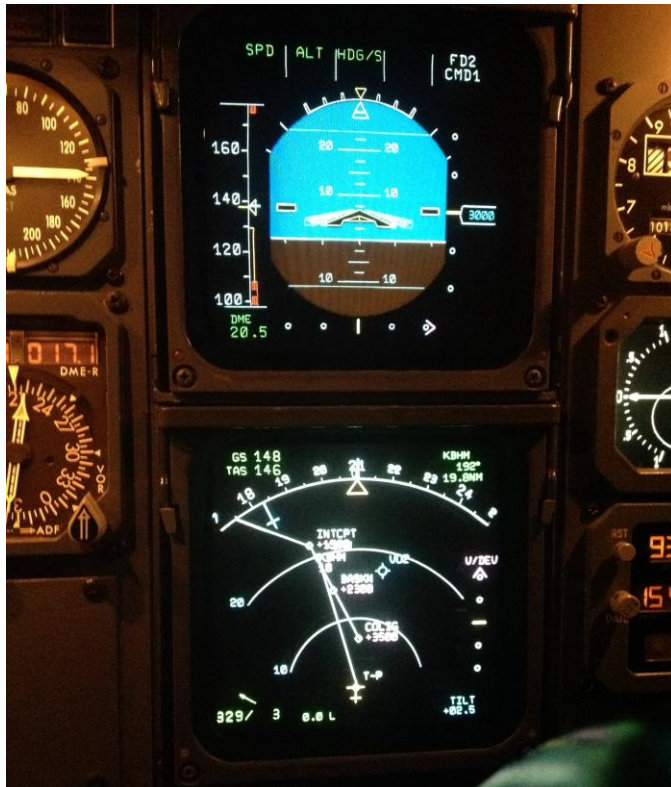
The Navigational Display also showed the active routing (direct to KBHM) and the approach routing as entered in the FMC, with the F-PLN DISCONTINUITY still in the active flight plan (see photo 5).

Photo 5: PFD and ND with flight plan route discontinuity in the active flight plan.¹²⁸

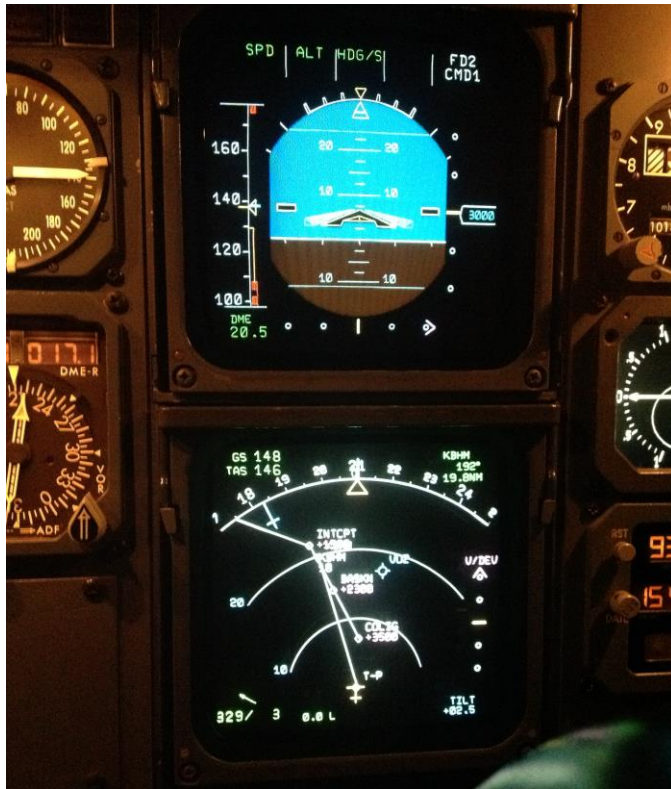
According to downloaded FMC data from the accident airplane, the flight plan for UPS1354 was not re-sequenced prior to executing the KBHM LOC18 approach, and the flight plan discontinuity remained in the flight plan (see photos 10 through 12, taken during the December 4, 2013 simulator testing in KSDF of the PFD/ND and CDU when the KBHM LOC18 approach was not sequenced).¹³⁹

Photo 10: PFD/ND with approach not sequenced.¹⁴⁰

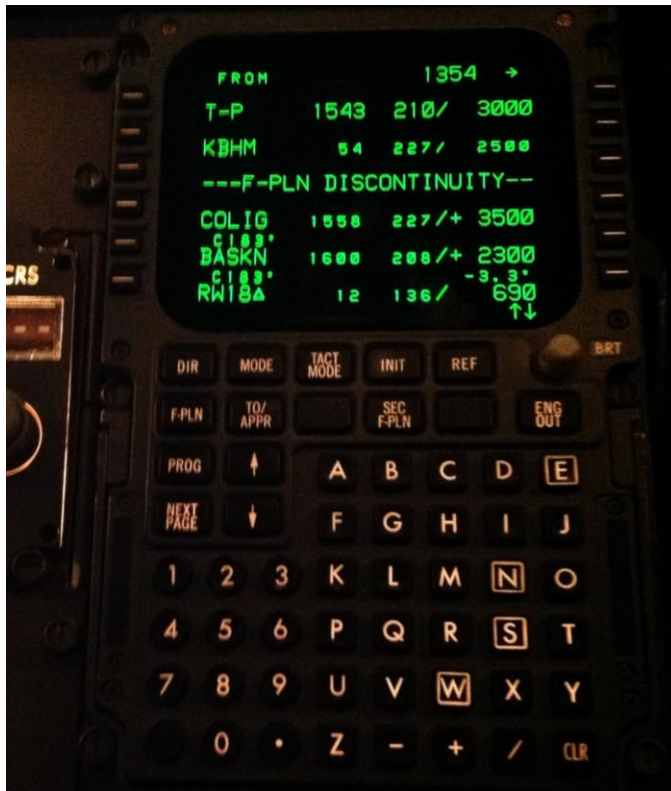
Photo 11: CDU F-PLN page with approach not sequenced.¹⁴¹

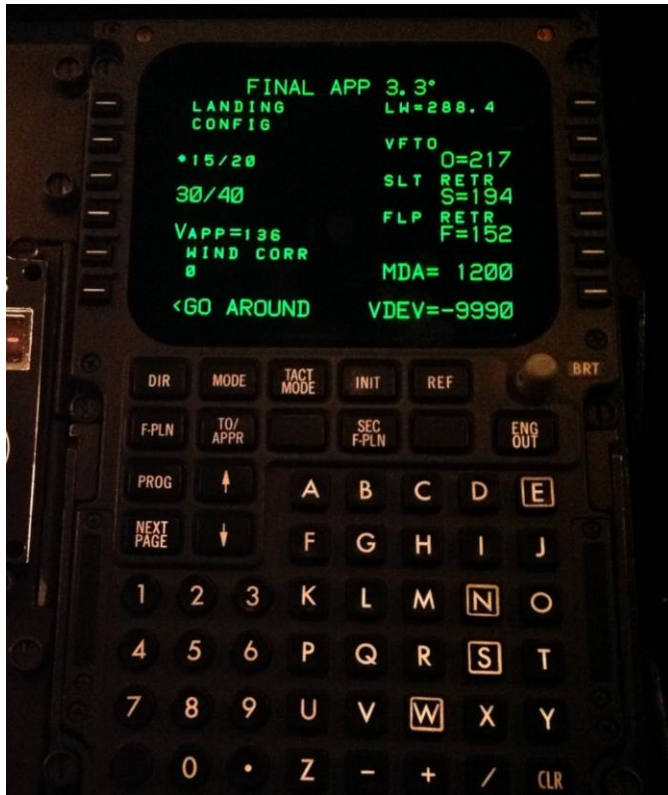
Photo 12: CDU FINAL APP page with the approach not re-sequenced.¹⁴²
