Factual Report – Attachment 15

FAA Photos

OPERATIONAL FACTORS

ERA18MA099

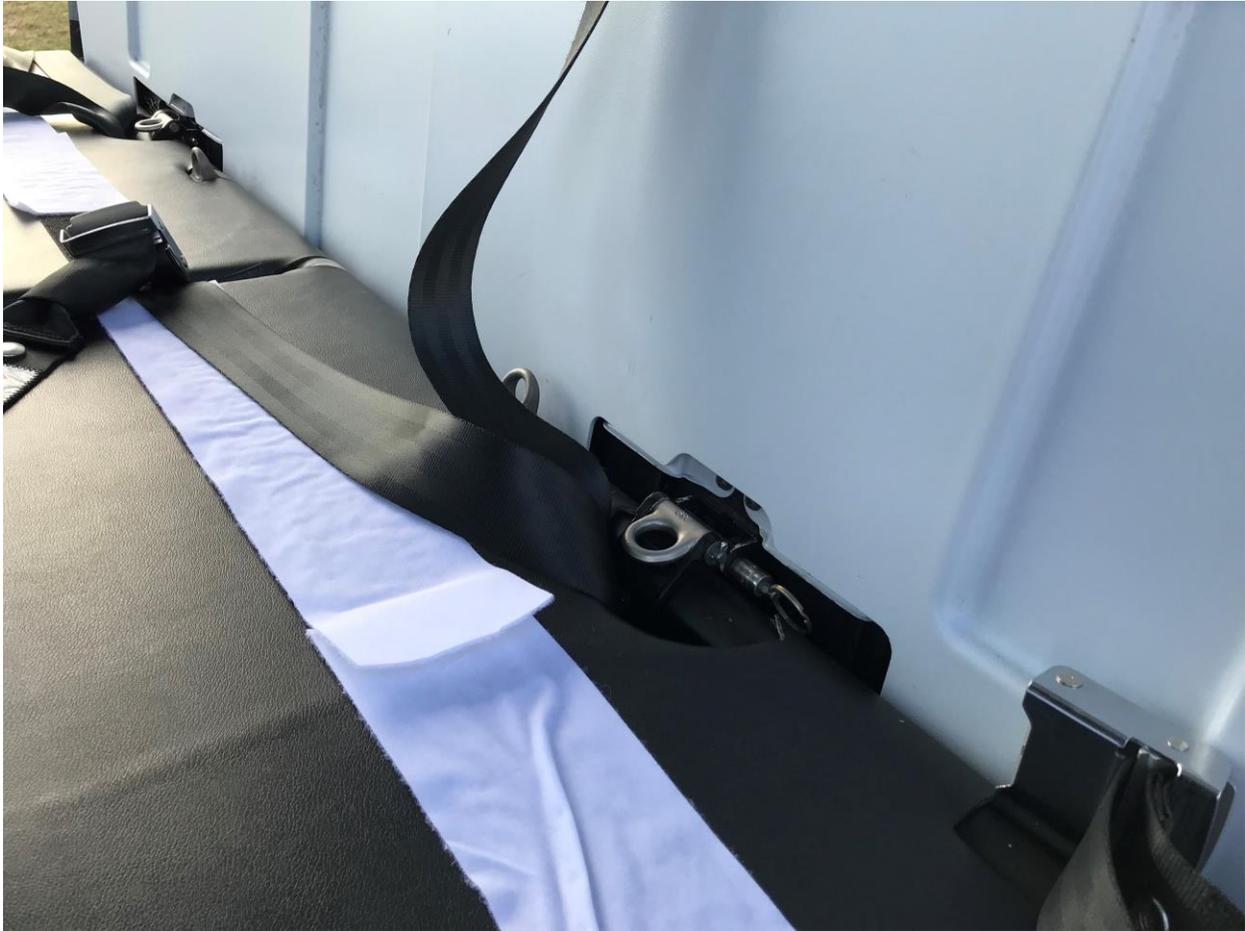
Photo 1: FAA photo of interior bench seat.¹

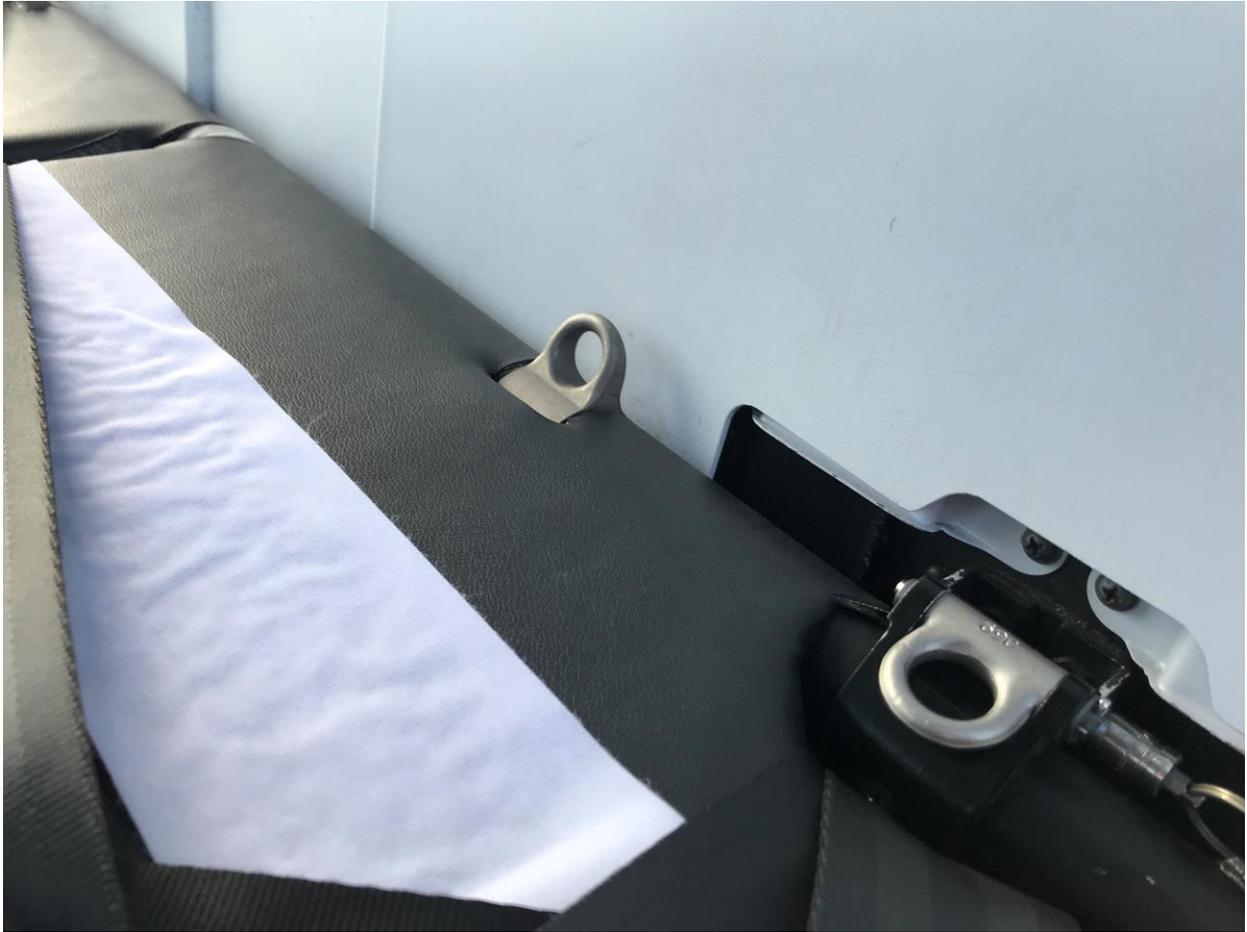
Photo 2: FAA photo of attach point.

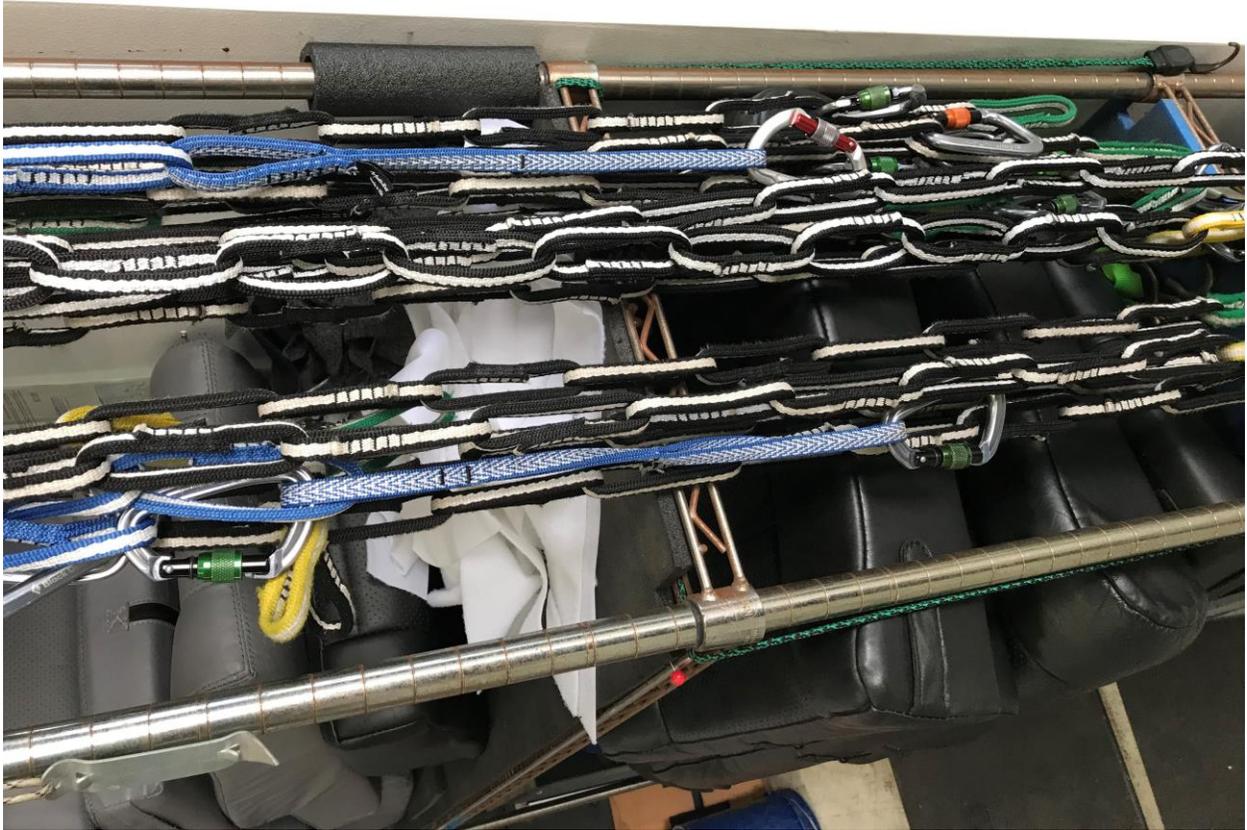
Photo 3: FAA photo of lanyards.

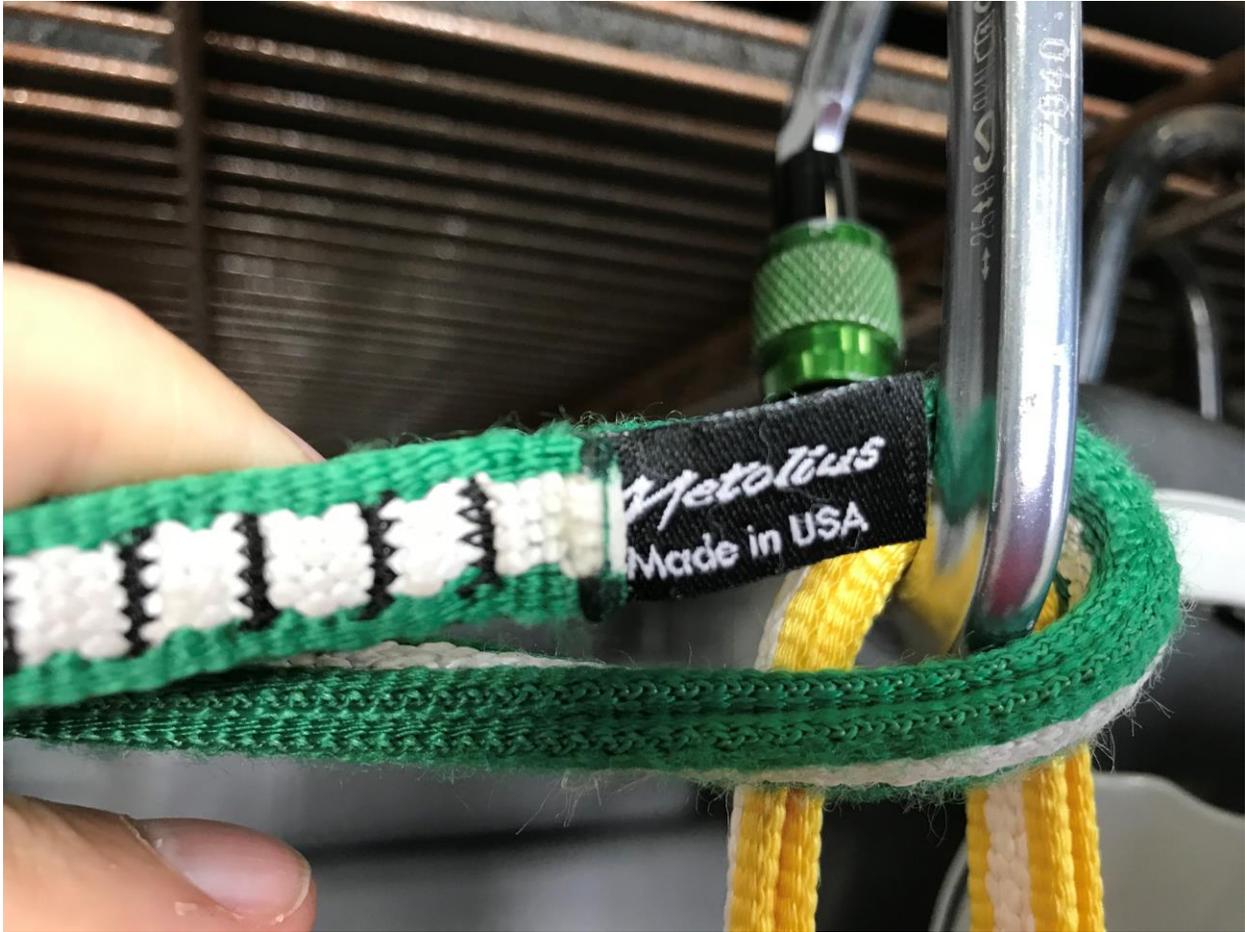
Photo 4: FAA photo of carabiner and tether.

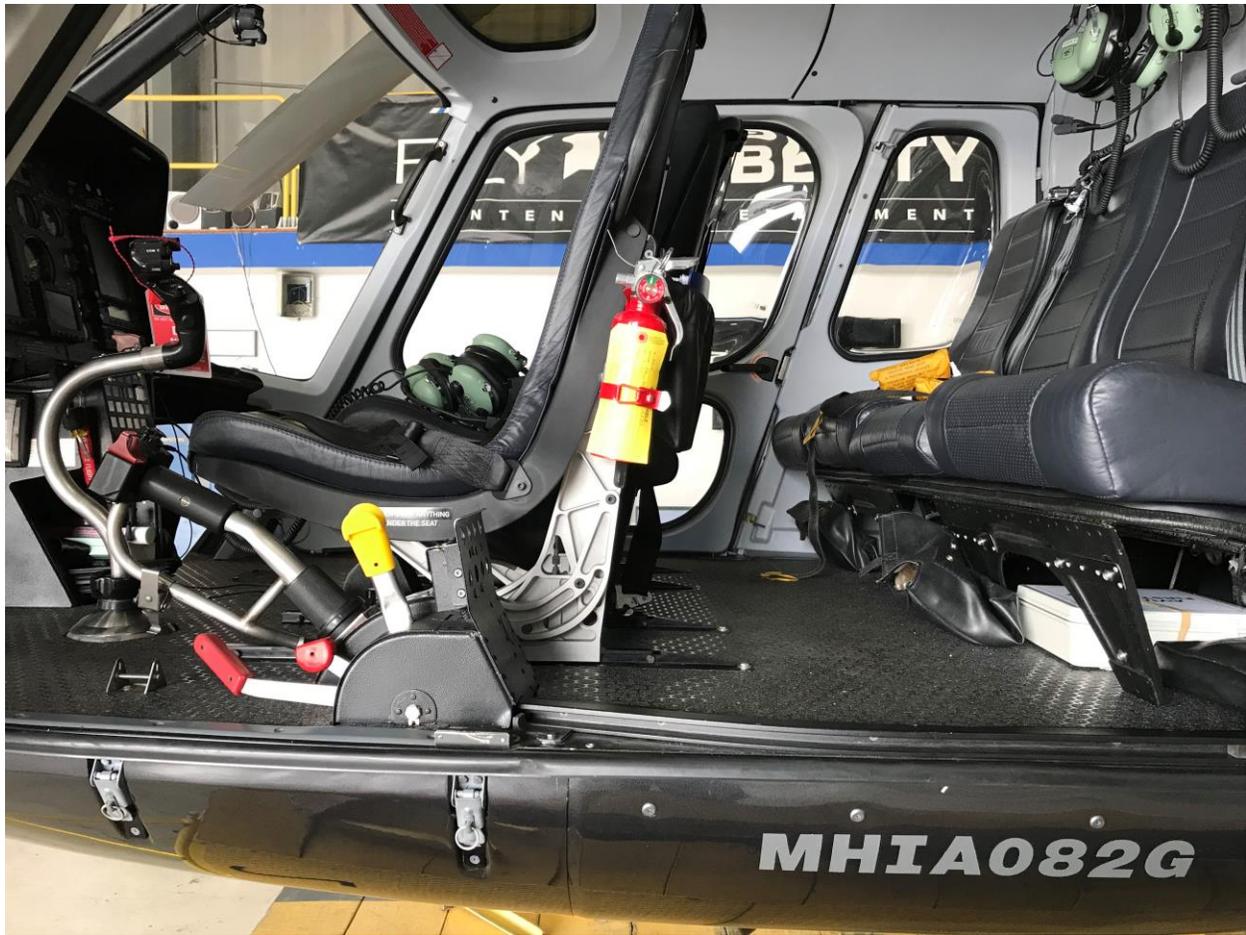
Photo 5: FAA photo of helicopter interior.
