Factual Report – Attachment 18 CEN17MA183 - TEB Simulator Observation

OPERATIONAL FACTORS

CEN17MA183

TEB SIMULATOR WORK 4 CEN17FA183

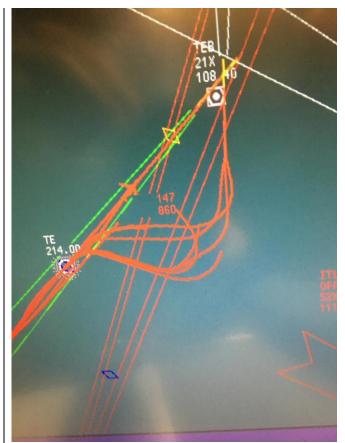
Time	Notes
	31. Cockpit documentation: same
	32. Observe SOP procedures: same
	33. Observe configuration changes: same
	34. Observe callouts: same
	35. Note position of the airplane to runway 01
	- At 2.15 dme TEB, froze simulator to view position to runway 06 prior to turn

Photo 1: Simulator Instructor Panel display snapshot at 2.15 dme TEB prior to right turn.

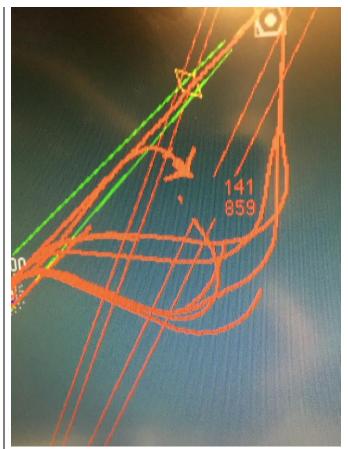
- Visibility brought up to 25-mile visibility
- Initiated a 45-degree banked turn to a heading of 150 degrees (90 degree turn from runway 06 course)
- No aural bank angle alert was noted during the turn
- On rollout to 150-degree heading, froze simulator

Photo 2: Simulator Instructor Panel display snapshot after rollout to 150 heading.

- Position was 1.62 dme TEB at 860 feet, Vref+20
- Released simulator and stayed on 150 heading until centerline to runway 01.
- Froze simulator. Position was 2.07 dme TEB, altitude 800 feet, Vref+20, VASI was white/white.

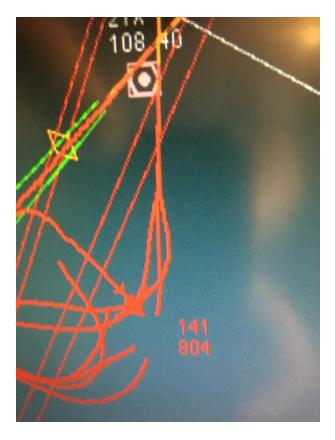
Photo 3: Simulator Instructor Panel display snapshot after approaching runway 01 centerline.

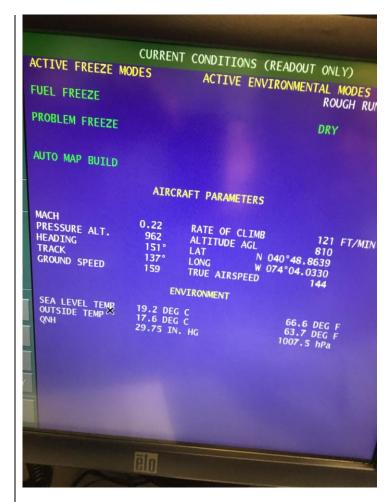
Photo 4: Simulator Instructor Panel display snapshot showing environmentals approaching runway 01 centerline.

Ground speed was noted to have increased to 159 kts due to tailwind component. Airspeed was 144 kts TAS.

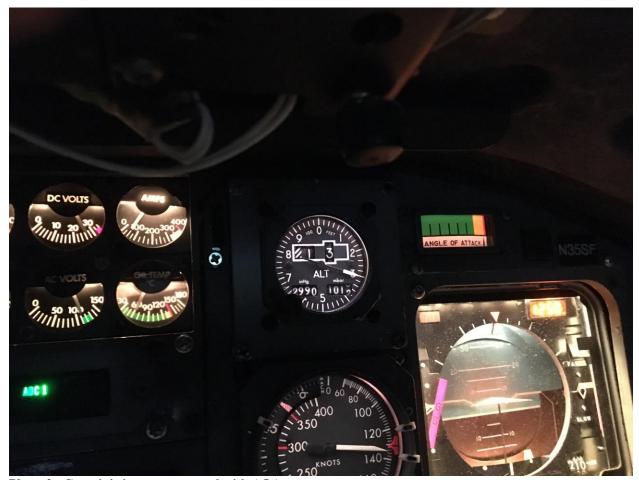
Photo 2: Captain's instrument panel with AOA gauge.

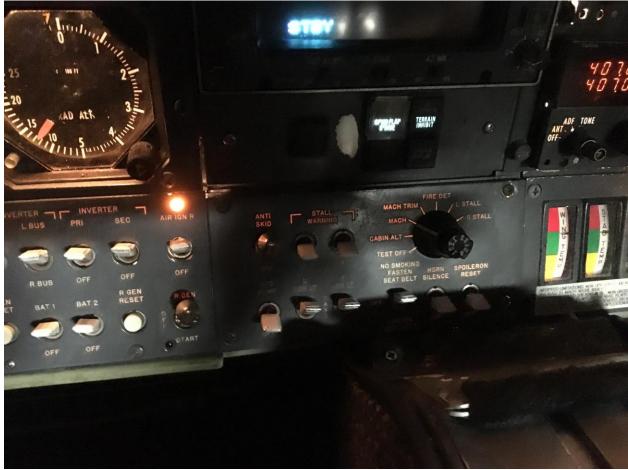
Photo 3: Stall switches (located on lower Captain's side forward panel).

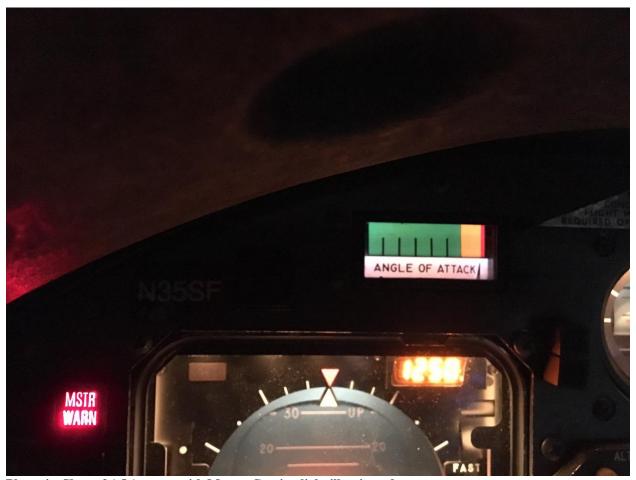
Time	Notes
	36. Aural/visual alerts:
	- When AOA indicator enters the yellow band, the red
	master caution light on Captain and FO sides
	illuminate, the red Stall L and R lights on the
	annunciator panel illuminate, and the stick shaker
	activates

Photo 4: Close of AOA gauge with Master Caution light illuminated.
