NATIONAL TRANSPORTATION SAFETY BOARD

CSX Freight Train Collision

NTSB Accident No. RRD19FR010

Railroad Operations – System Safety Factual Report

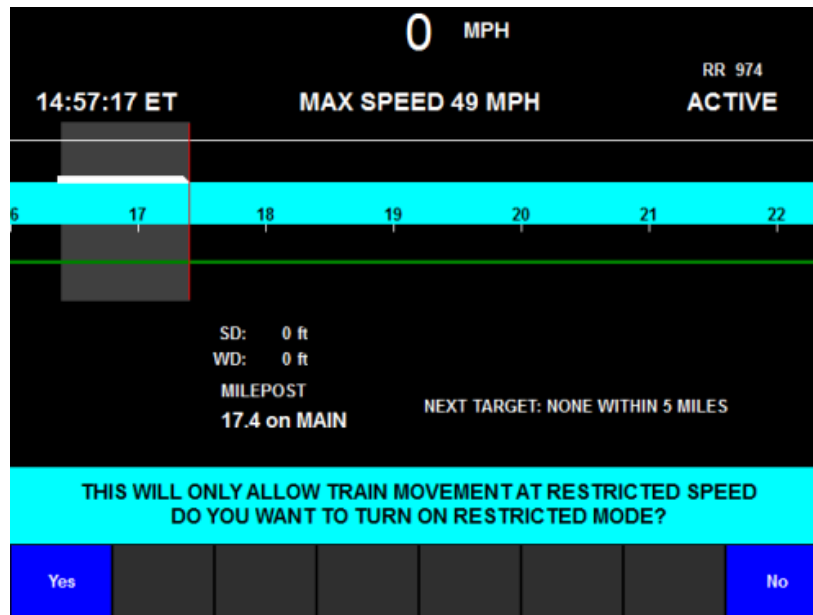
Figure 1: PTC system prompts for restricted mode.

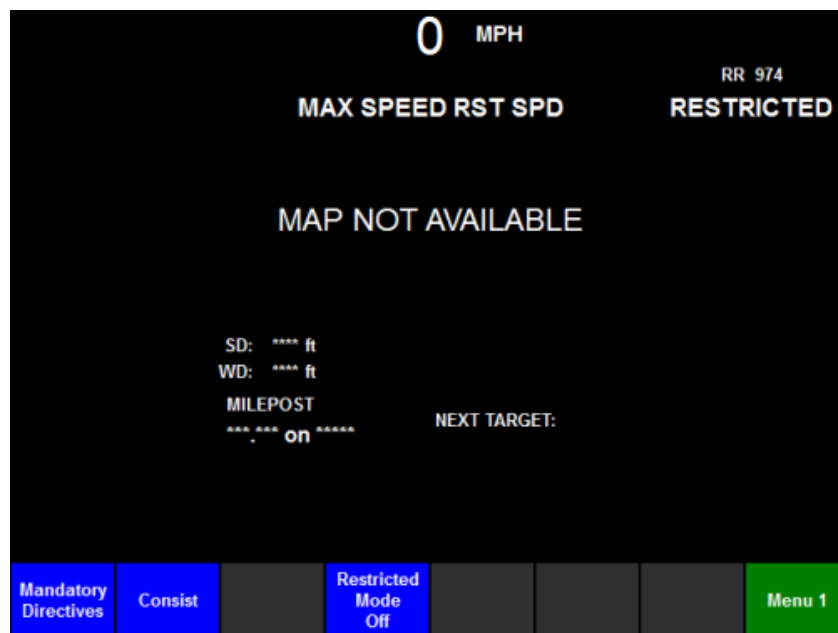
Figure 2: Restricted mode is turned on.

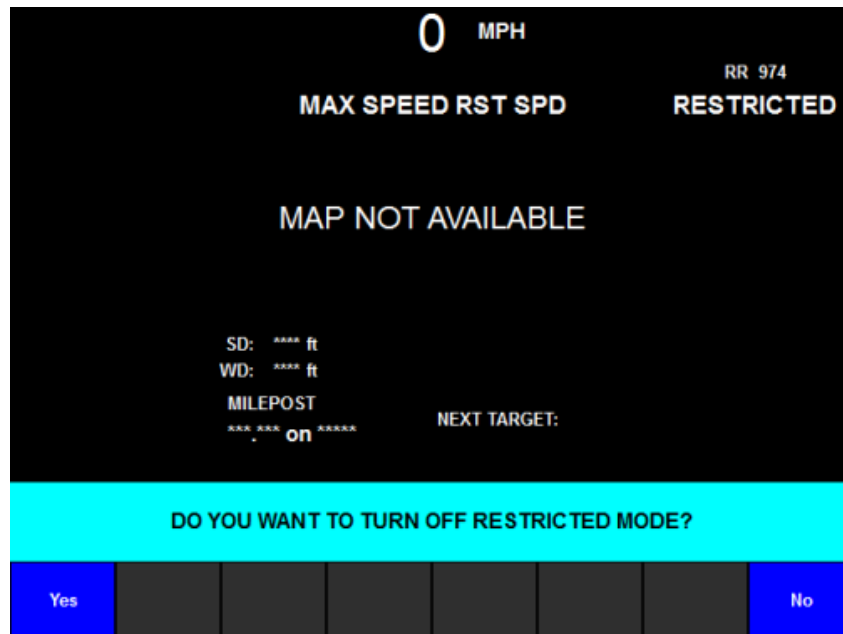
Figure 3: System prompts to turn off restricted mode.

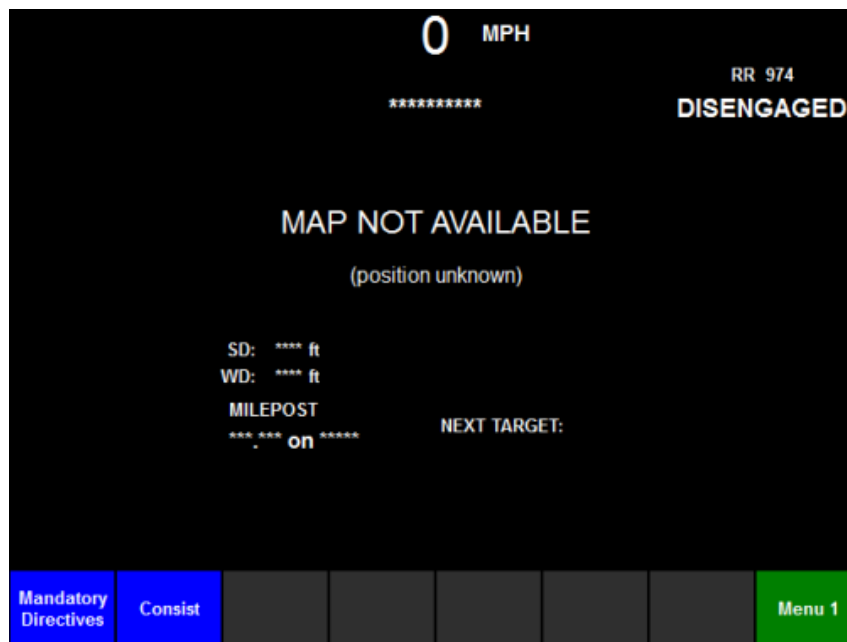
Figure 4: PTC screen display after turning off restricted mode and going back into active mode. There is a transition to disengaged until track is selected and system goes active
