National Transportation Safety Board

OPERATIONS CHAIRMAN FACTUAL REPORT ADDENDUM

A. Accident

Accident Number: DCA10MP008
Type of System: Natural Gas Transmission Pipeline
Accident Type: Pipeline Rupture
Location: San Bruno, California
Date: September 9, 2010
Time: about 6:11 pm
Owner/Operator: Pacific Gas and Electric Company
Material Released: Natural Gas
Pipeline Pressure: 386 - 396 psi at time of rupture
Component Affected: 30 inch diameter pipeline.

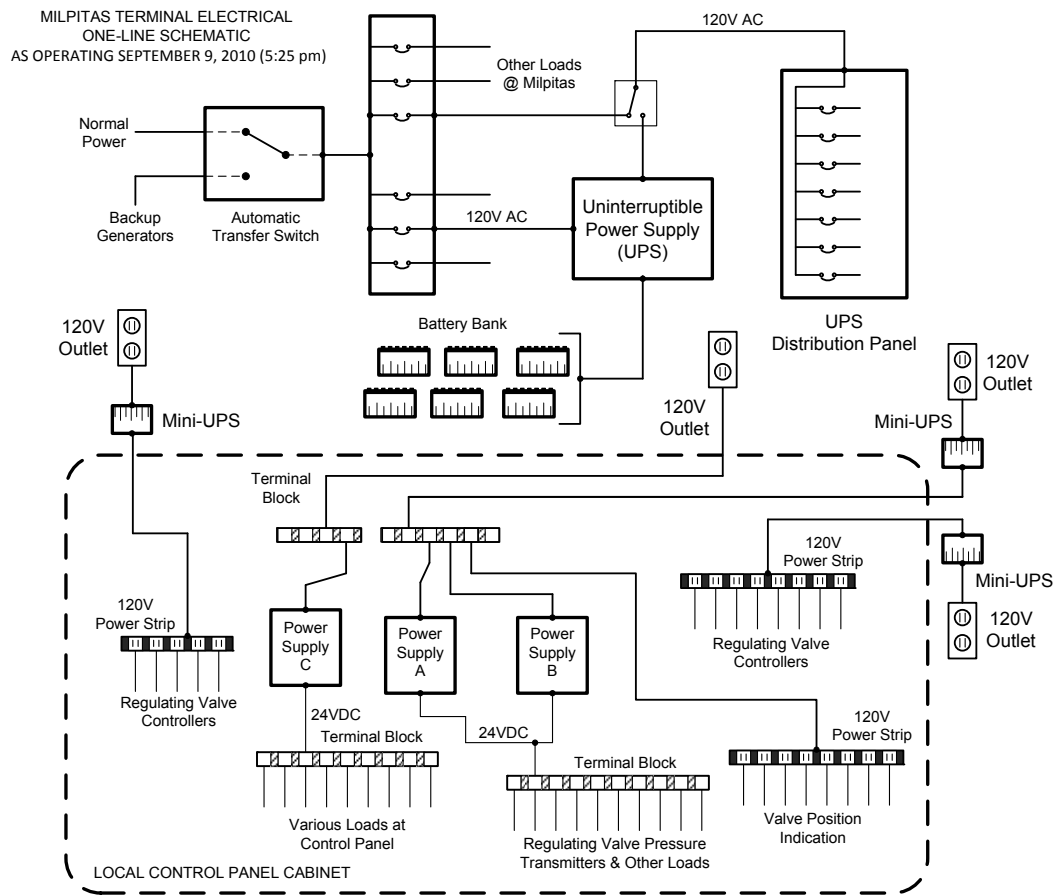
At approximately 5:22 pm, according to the SCADA trends, pressures increased at the Milpitas headers and downstream in the Peninsula lines. The erratic voltages from the two power supplies had caused the pressure transmitters, which provided a signal to each of the regulating valve controllers, to read zero resulting in the regulating valve controllers to command the valves open. The PG&E SCADA and Controls supervisor stated that the valve controllers did not lose power; however, the pressure transmitter signals were affected by the erratic voltages from the power supplies. According to PG&E, the valve controllers had been relocated to an alternate 120Vac power source in April of 2010 preventing them from being impacted by the work on September 9, 2010.

Figure 1: Electrical block diagram showing completed work at Milpitas on September 9, 2010
