National Transportation Safety Board

DCA16MR004

AMTRAK Derailment

Operations

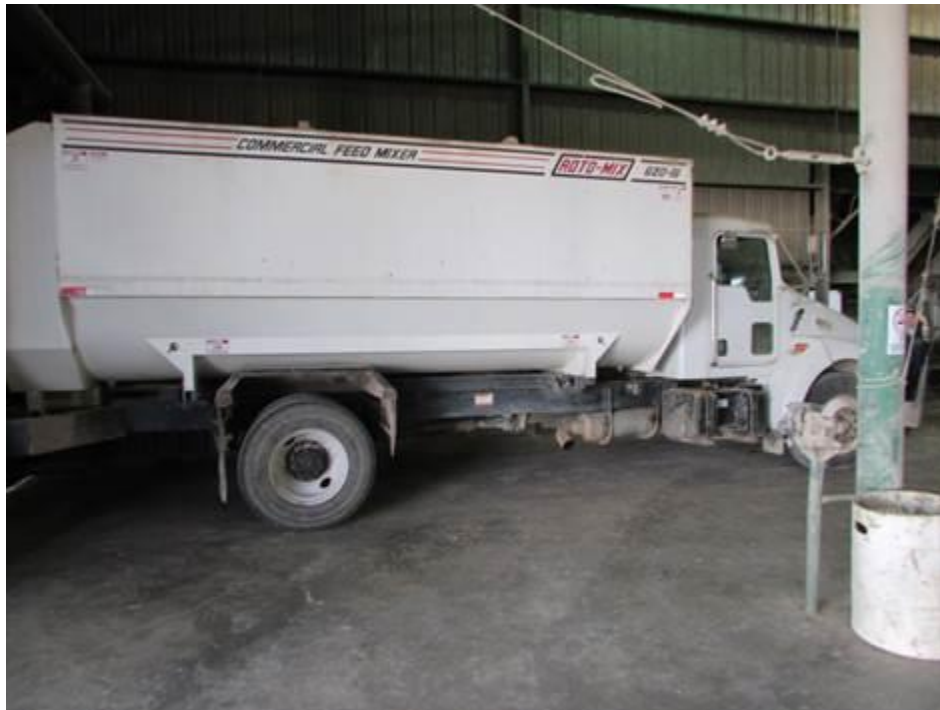
Figure 1 Picture of feed truck that rolled down the hill from feed plant.

Truck operator stated that on March 13, 2016 he reported to work at 6:00am. Made three or four loads on feed truck. At approximately 10:00am a coworker that was operating the loading bays asked him for his assistance and to get something unstuck in one of the pipes. Truck Operator stated that he came out of the chemical bay and parked the feed truck, and gets out to assist his co-worker. Sometime during the process when assisting the co-worker, the unattended feed truck that he was operating started rolling down the hill. The feed truck made an uncontrolled movement down the hill, crossed Highway 50 and then struck the railroad tracks. He got in his personal vehicle and drove down the hill, parked his vehicle on the south side of the tracks. He then got out of his vehicle crossed the tracks and got on the runaway feed truck, back out on to Highway 50 and drove it back up the hill to the feed plant. Upon arriving at feed plant he reported incident to his supervisor. No action was taken by the supervisor other than he did not want to hear about it. Truck operator stated that the end of tour of duty at 5:00 pm he picked up his personal vehicle that he had left on south side of right away of the railroad tracks.

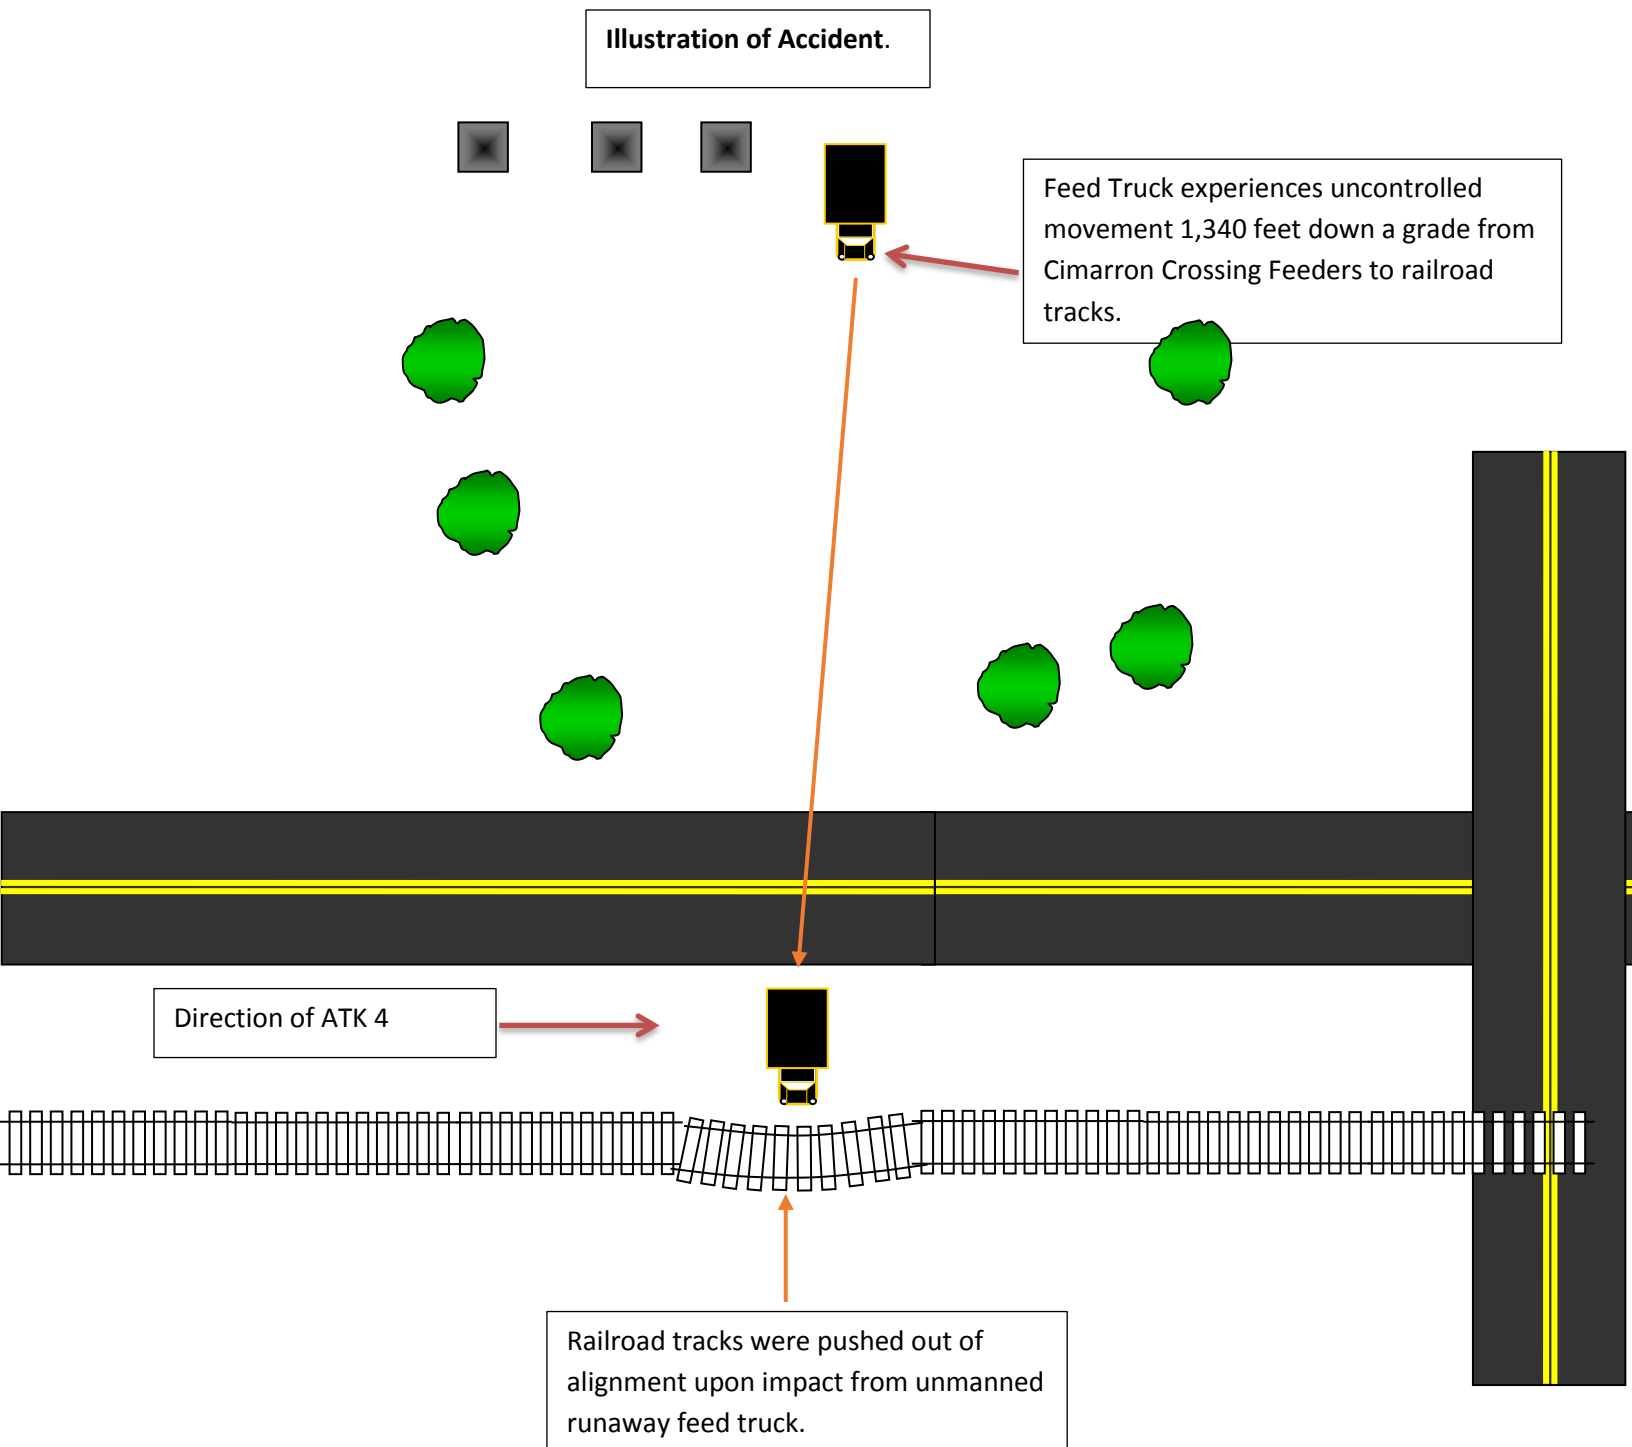
Illustration of Accident.

Figure 2. This is an illustration of the runaway feed truck.
