NATIONAL TRANSPORTATION SAFETY BOARD
OFFICE OF RAILROAD, PIPELINE AND HAZARDOUS
MATERIALS INVESTIGATIONS
WASHINGTON, D. C. 20594

Long Island Rail Road
Train Collision with end of track
Brooklyn, New York
January 4, 2017

NTSB Accident Number: DCA17FR007

Operations Group Factual Report
Long Island Rail Road
Bumping Post Collision
Atlantic Terminal, Brooklyn, New York
January 4, 2017

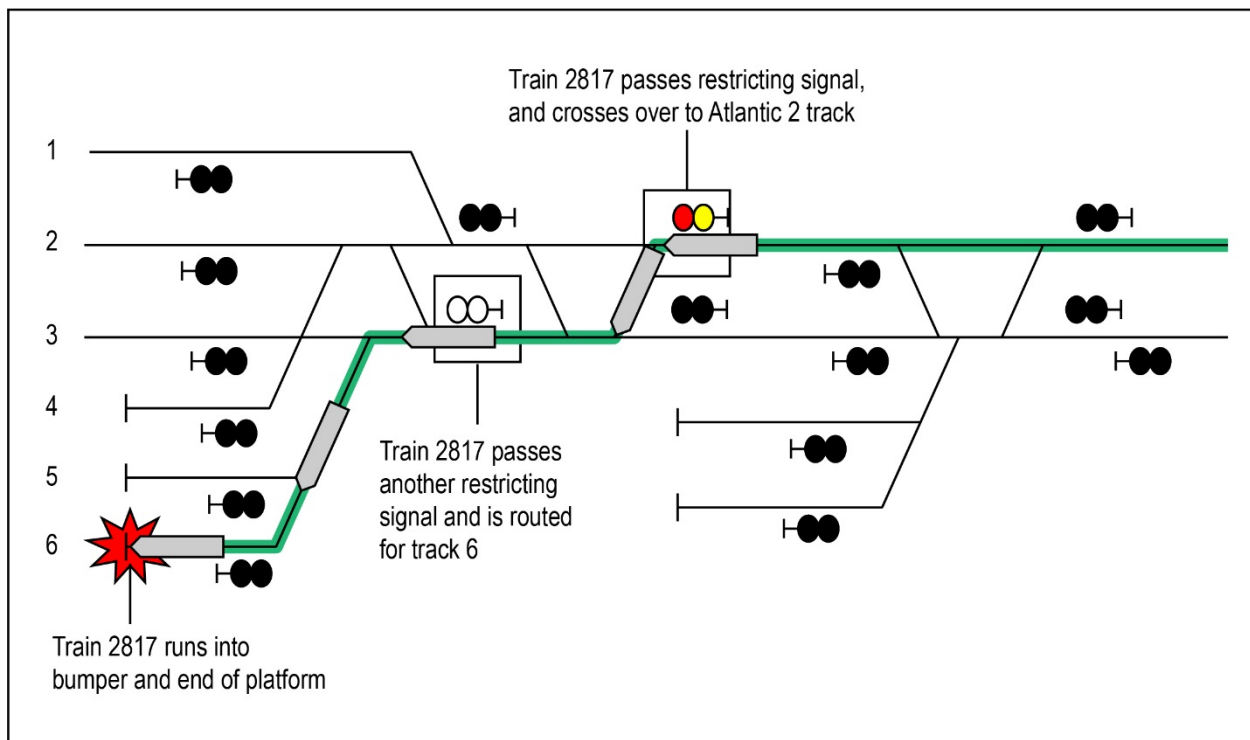
Figure 2. Accident site, diagram provided by NTSB.

At 1W on Atlantic track no. one, train 2817 received a restricting signal (signal aspect is red over yellow, as described by the locomotive engineer). Per LIRR operating rule 290, *Signal Indication*, the train was required to operate at restricted speed.¹²

At 22W on Atlantic track no. 2, train 2817 received a restricting signal (signal aspect was white over white, as describe by the locomotive engineer). Per LIRR operating rule 290 *Signal Indication*, the train was required to operate at restricted speed. Timetable Special Instructions 1038-B further restricts the speed in Atlantic Terminal Brook 1 location to 5 mph.
