NATIONAL TRANSPORTATION SAFETY BOARD

Group Chairman's Factual Report

OPERATIONAL FACTORS

DCA17FA109

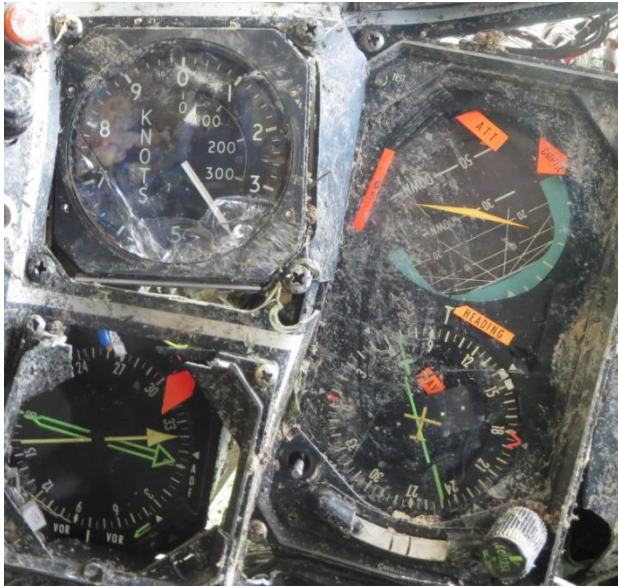
Photo 4. Captain's post-accident instrumentation.

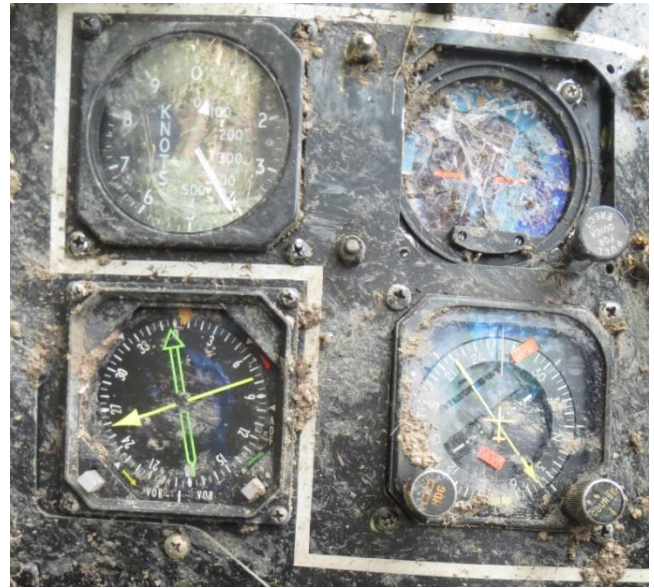
Photo 5. First Officer post-accident instrumentation.

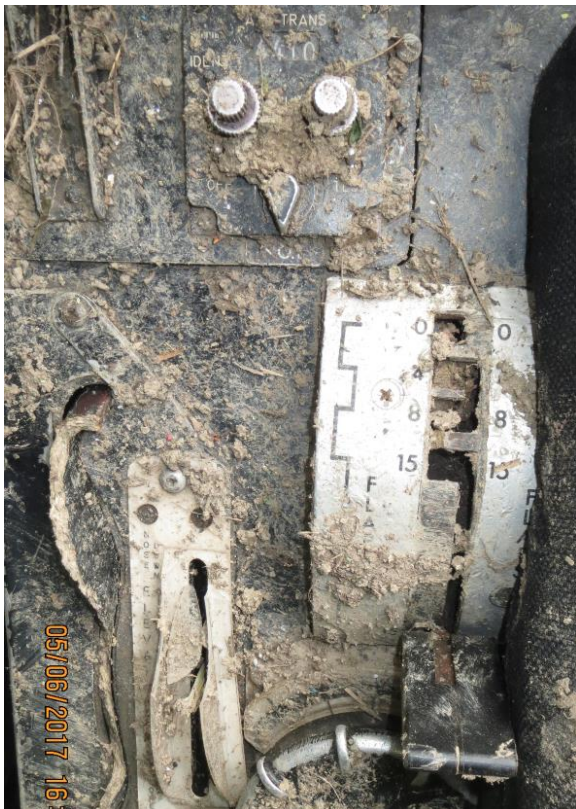
Photo 6. Flap handle location³⁷.

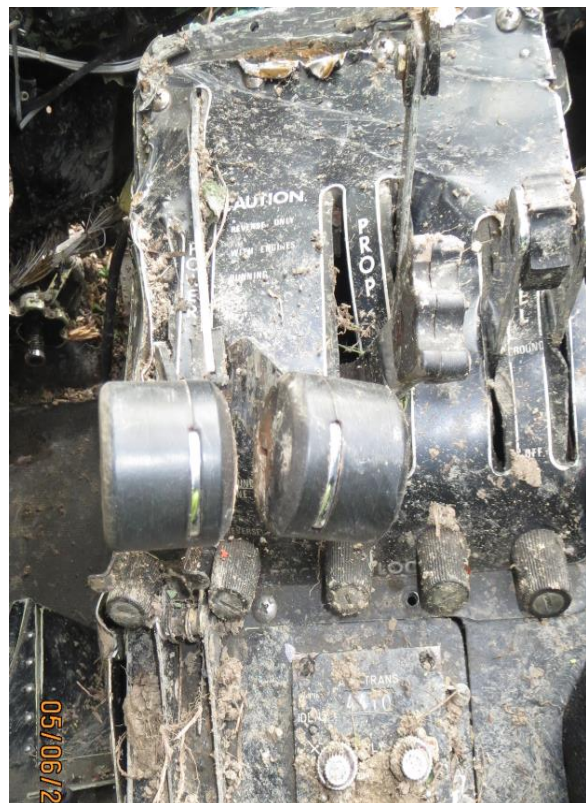
Photo 7. Power/Prop/Fuel.

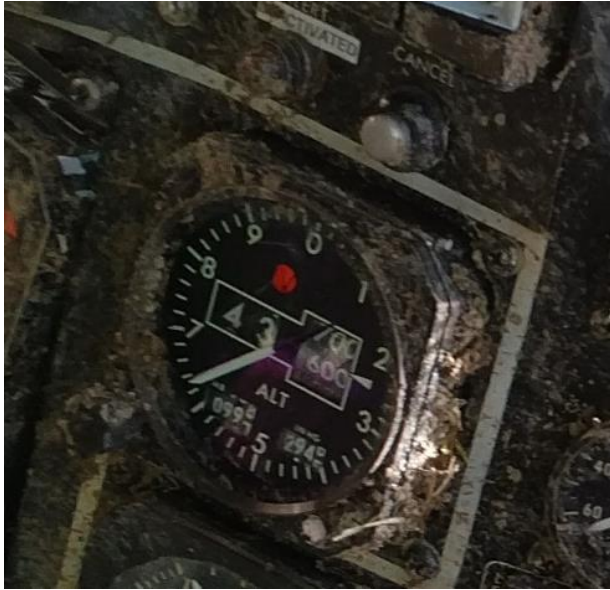
Photo 8. Captain altimeter post-accident.

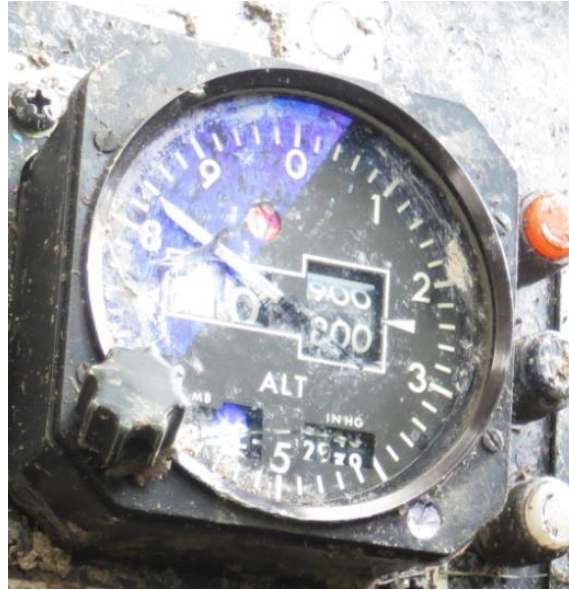
Photo 9. First Officer altimeter post-accident.

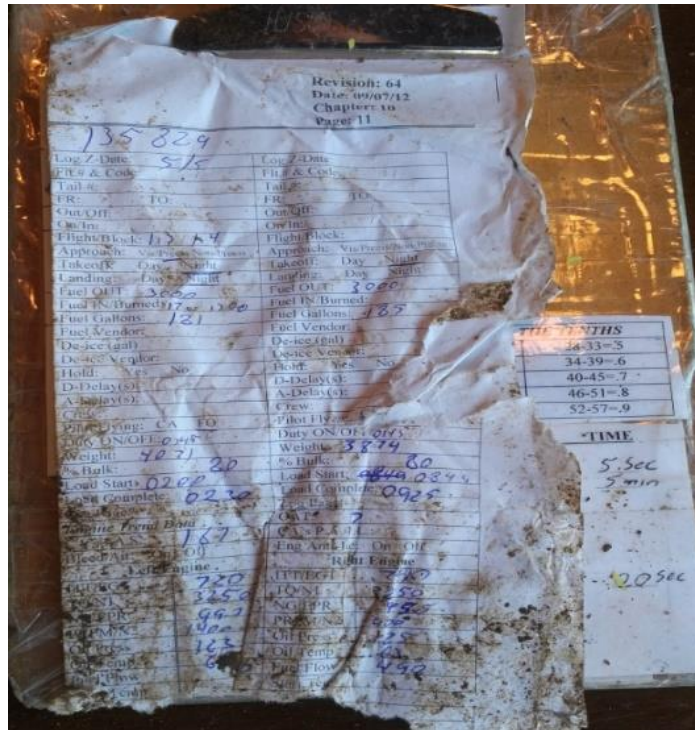
A clipboard for the initial and accident flight was discovered in the wreckage. It shows fueling of 185 gallons, cargo weight of 3,874 pounds of which 80% is bulk and a loading completed time of 0525.

Photo 14. Flight clipboard with times, fuel and weight discovered at accident site

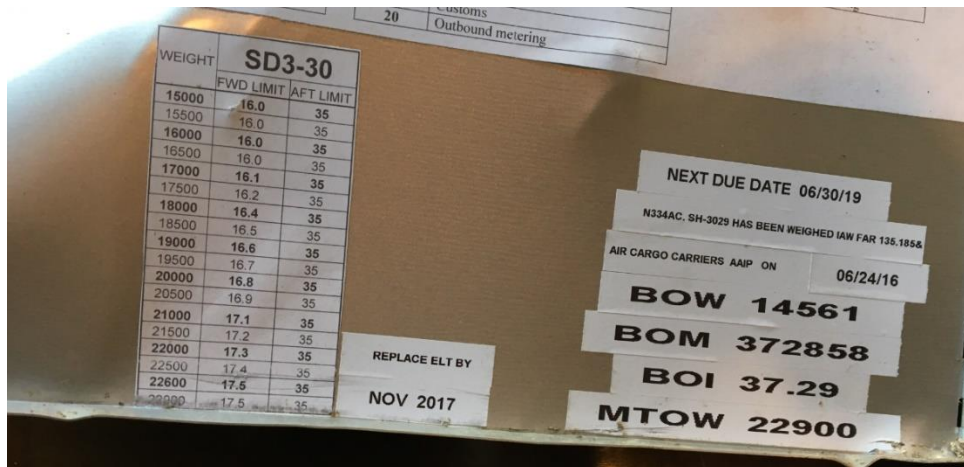
Photo 15. Placards in aircraft logbook “can” discovered at accident site

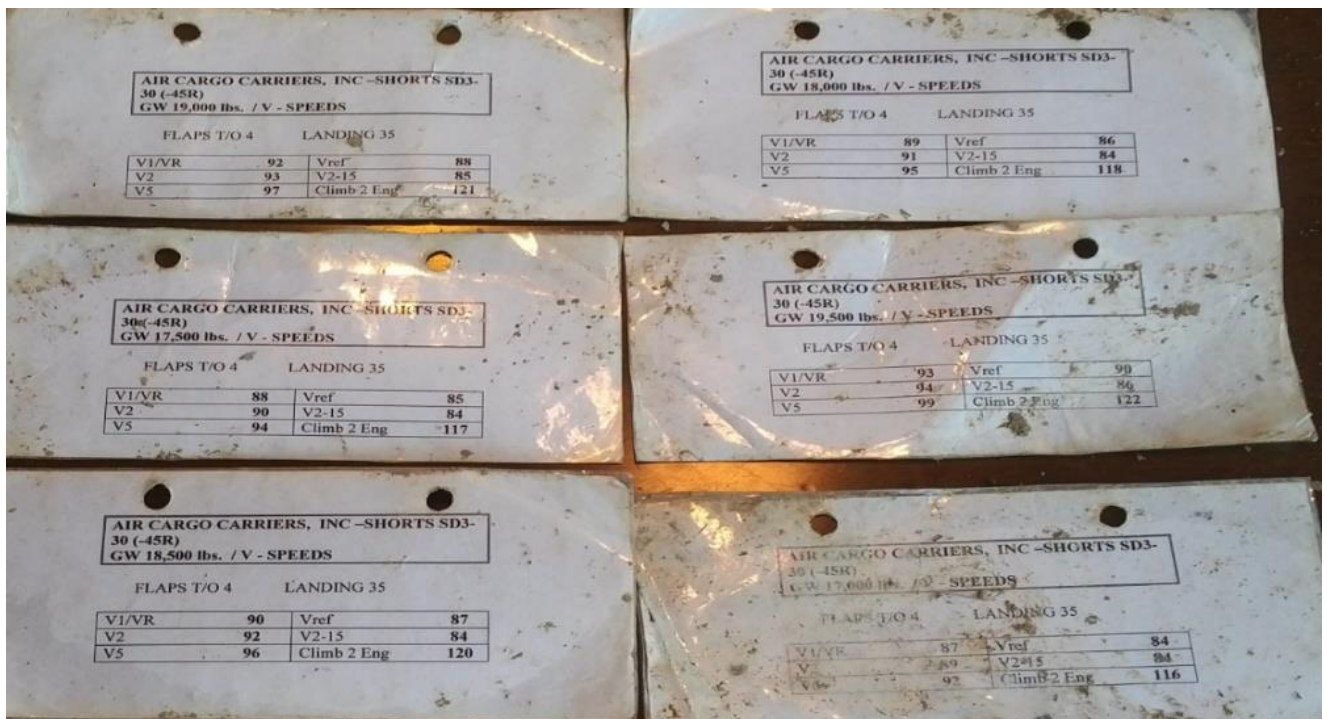
Photo 17. ACC V-Speed cards discovered at the accident site.

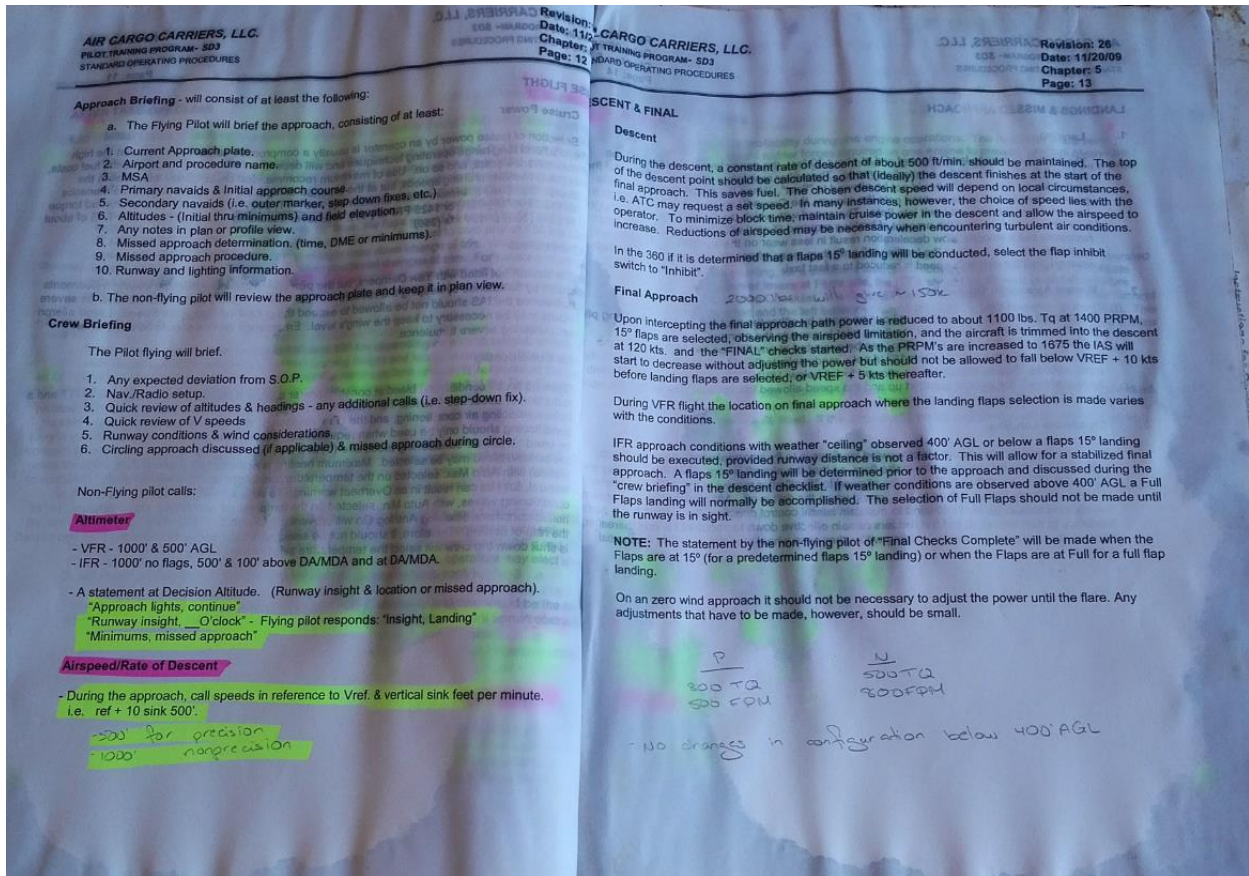
Photo 18. The ACC Standard Operating Procedures, dated November 20, 2009 was discovered in the wreckage. Note Airspeed/Rate of Descent notation highlighted.
