NATIONAL TRANSPORTATION SAFETY BOARD

Group Chairman's Factual Report

OPERATIONAL FACTORS

DCA13MA081

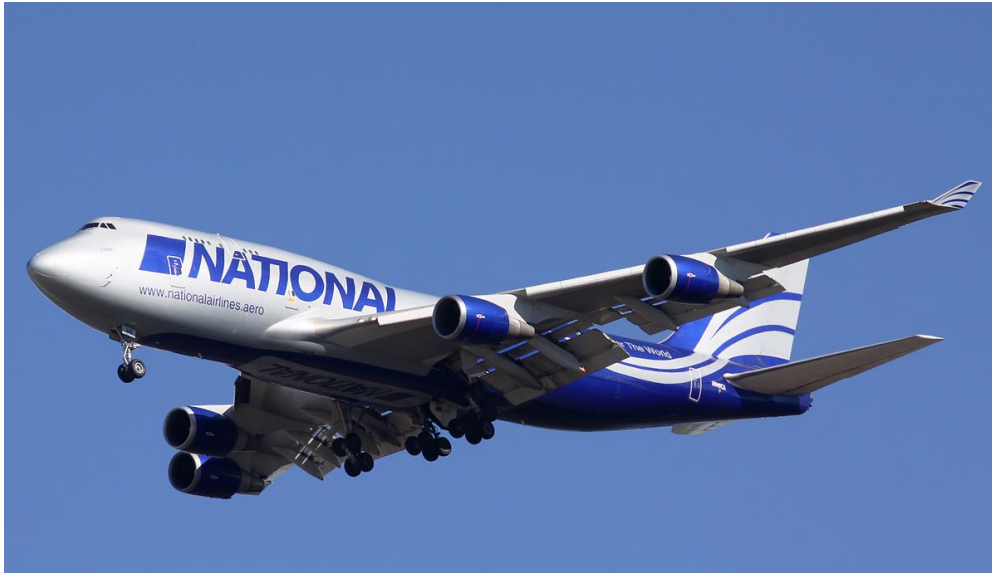
Photo 1: Accident Airplane (N949CA)

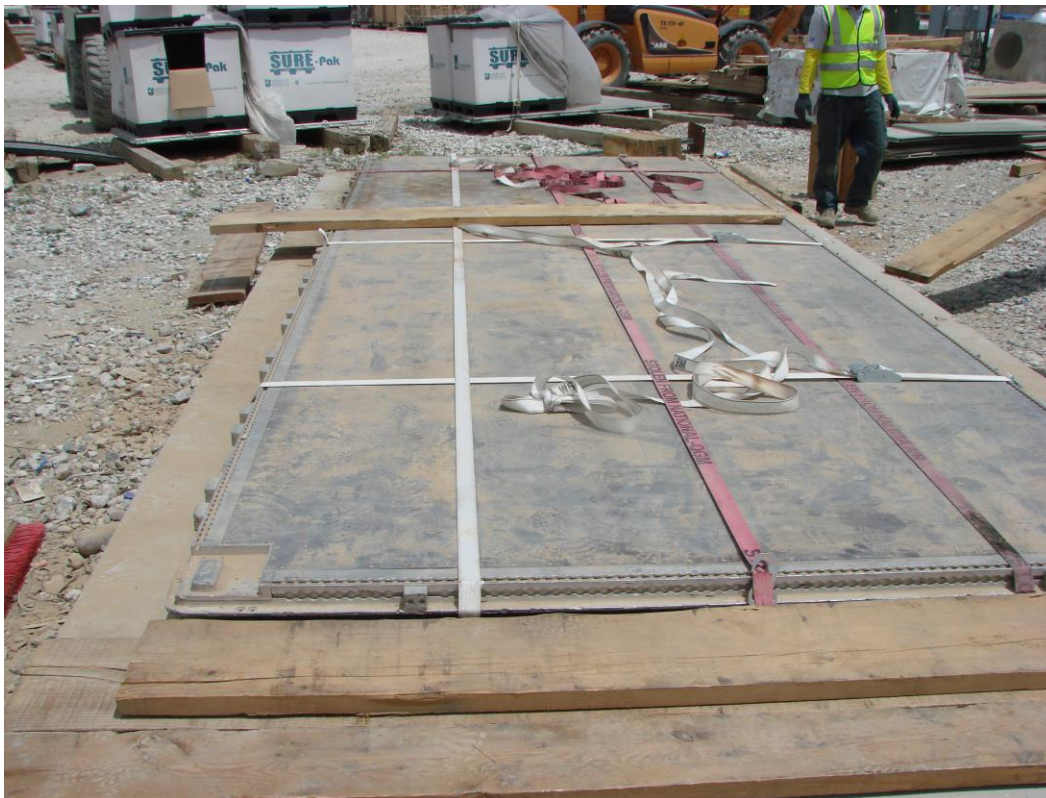
The Specialist then used 14 chains to secure the 12-ton MATV to the pallet.⁷¹ For the 18-ton Cougars, the Specialist built a “double-pallet” comprised of one pallet on top of another pallet, with plywood between the two pallets to reduce friction. The two pallets were attached to each other with straps, three lengthwise and two widthwise, for five straps total. Between the pallets was a thin sheet of plywood. According to the Specialist, they were the same straps used on the tie down to the airplane.

Photo 2: Photo of double pallet build-up demonstration for 18-ton Cougar.⁷²

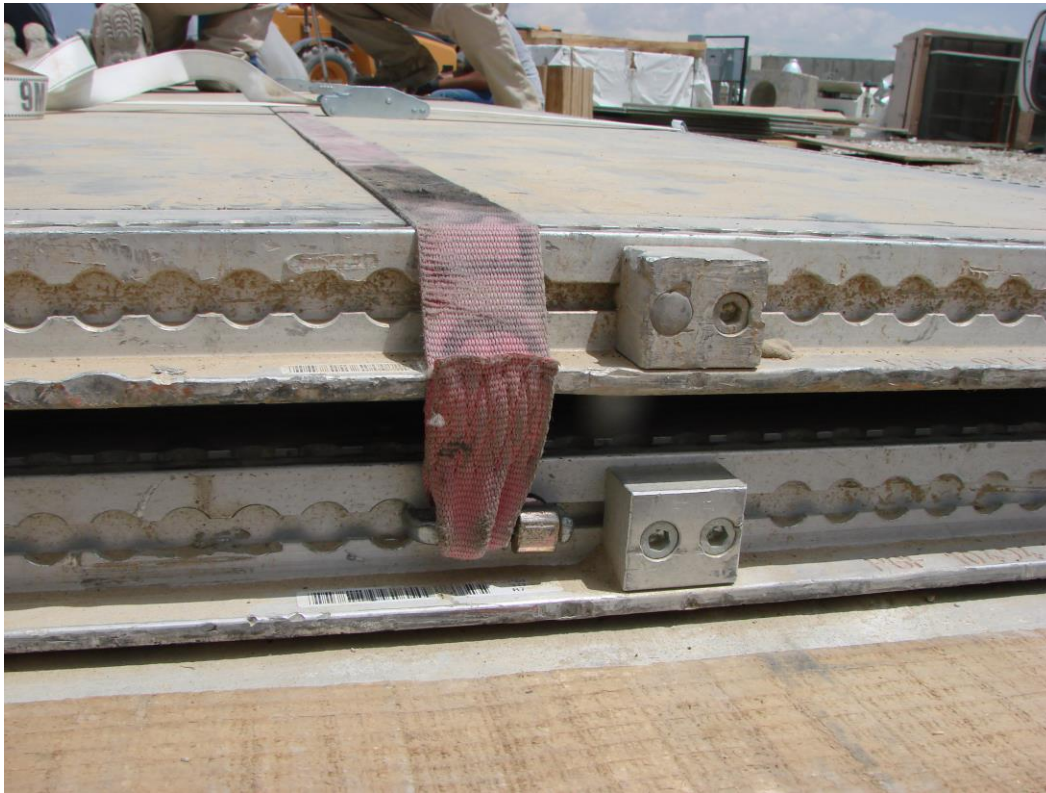
Photo 3: Close-up of double pallet strap securing the two pallets.⁷³

The Cougar was then placed on the double pallet, and chained to the pallet. The loaders were able to drive two of the Cougars onto the pallets, but they had to use a fork lift to lift the third onto the pallet. According to interviews, they chained the Cougars down with eight chains attached to the top pallet and six chains attached to the bottom pallet for a total of 14 chains. Two chains were attached to the bottom, and two backwards and forwards, and the same on the other side of the vehicle. The axle chains were the only ones attached to the top pallet.

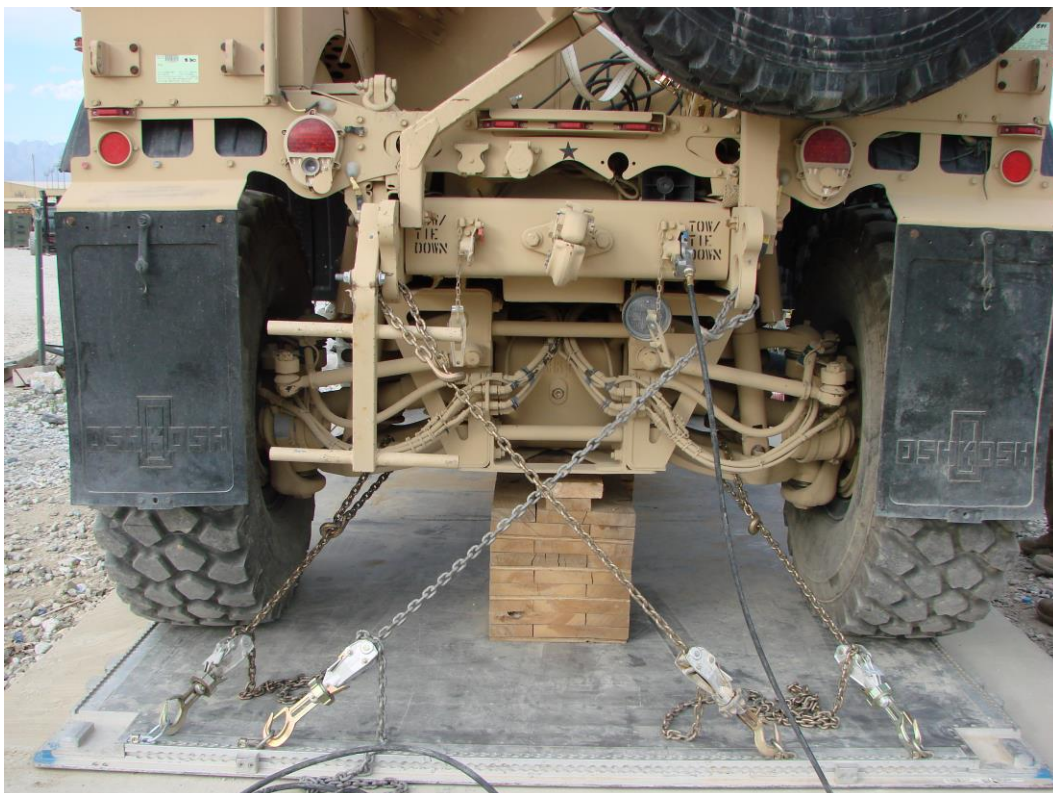
Photo 4: Photo of shoring demonstration of a 12-ton MATV (aft view).

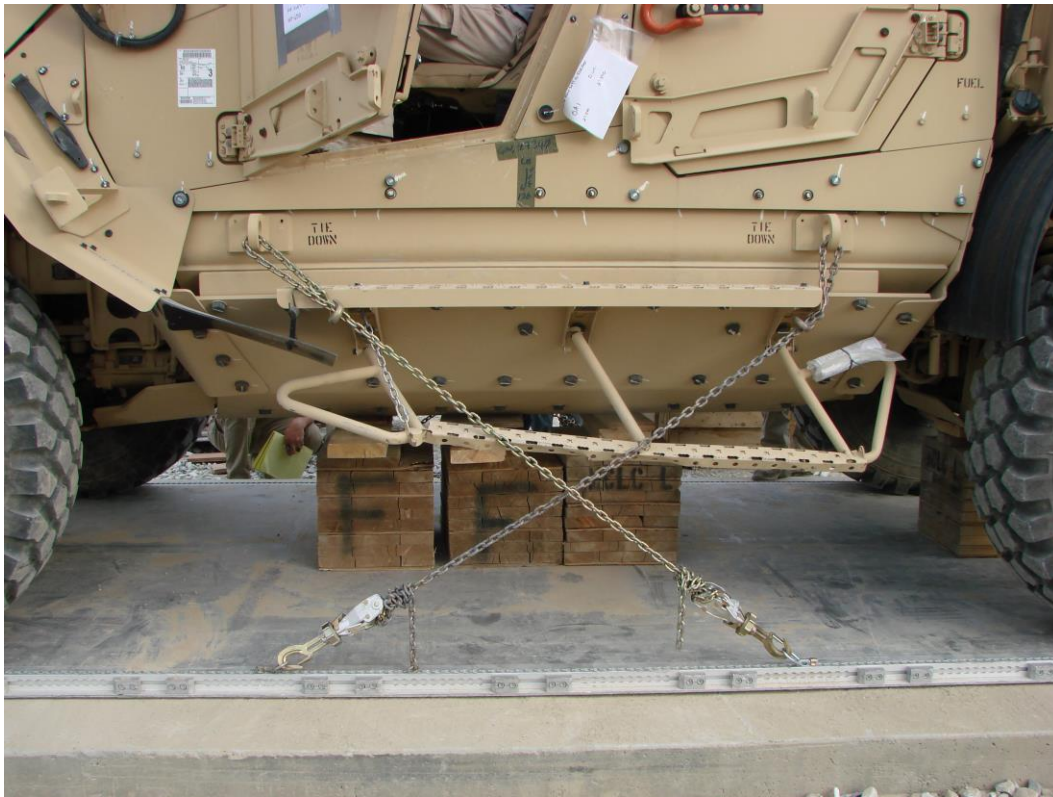
Photo 5: Photo of shoring demonstration of a 12-ton MATV (side view).

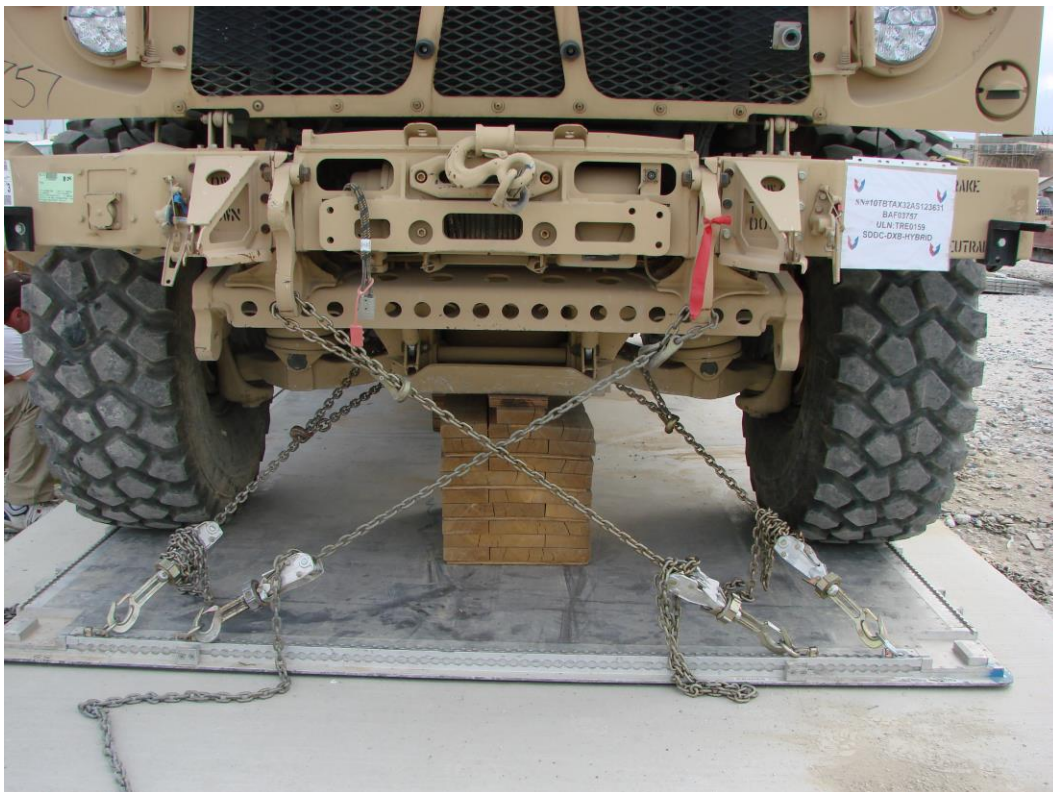
Photo 6: Photo of shoring demonstration of a 12-ton MATV (front view).

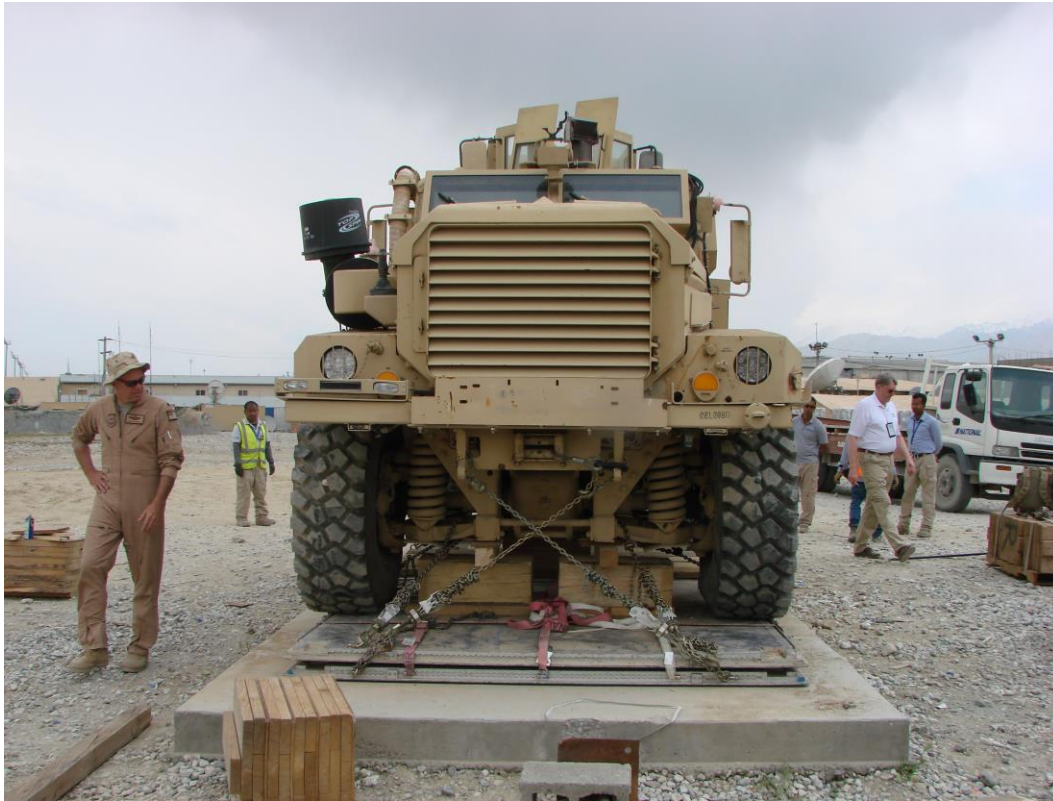
Photo 7: Photo of shoring demonstration of a 18-ton Cougar (front view).

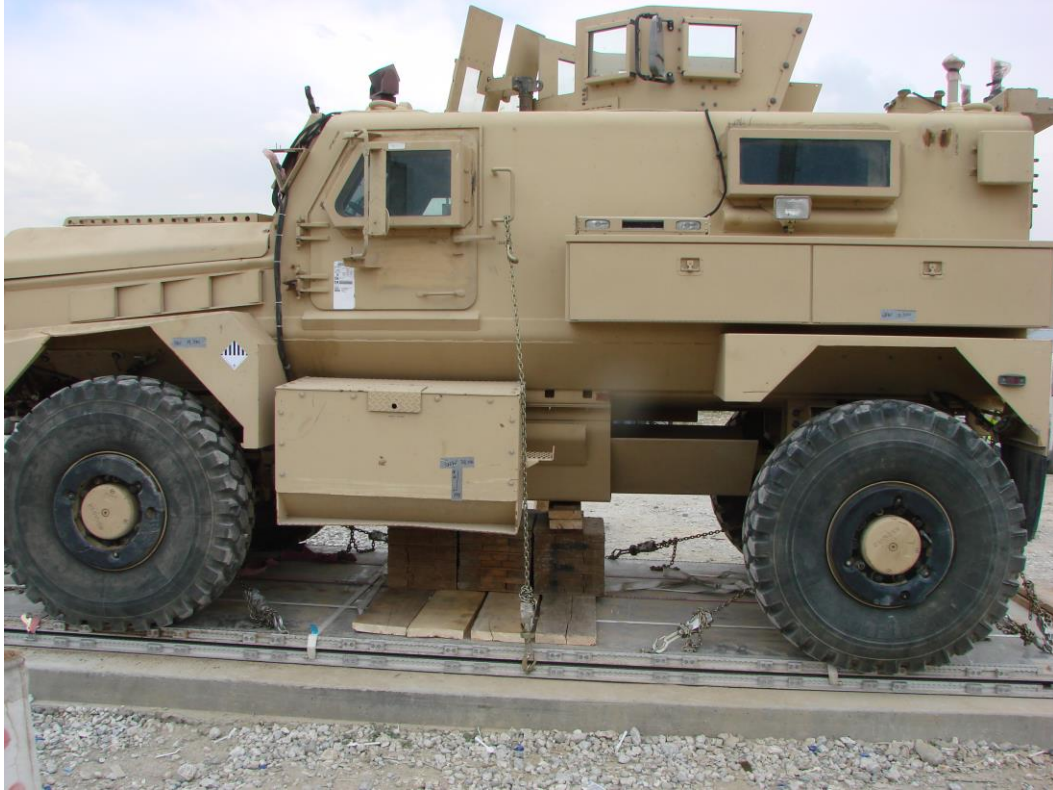
Photo 8: Photo of shoring demonstration of a 18-ton Cougar (side view).

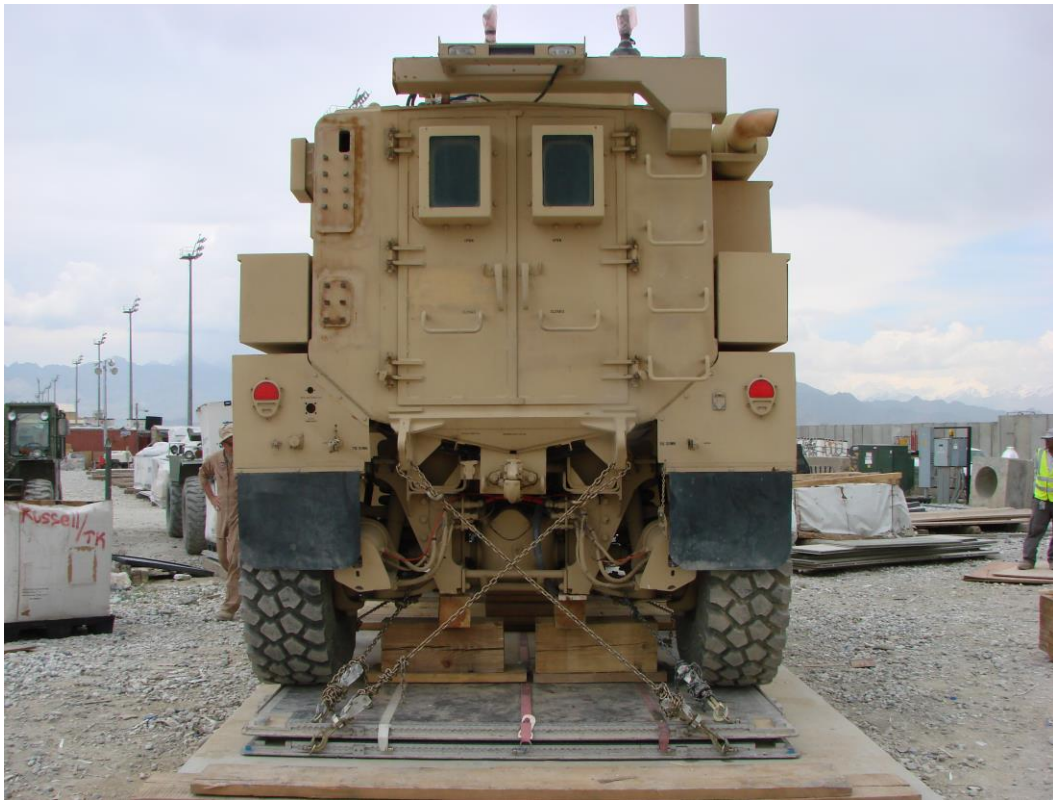
Photo 9: Photo of shoring demonstration of a 18-ton Cougar (aft view).

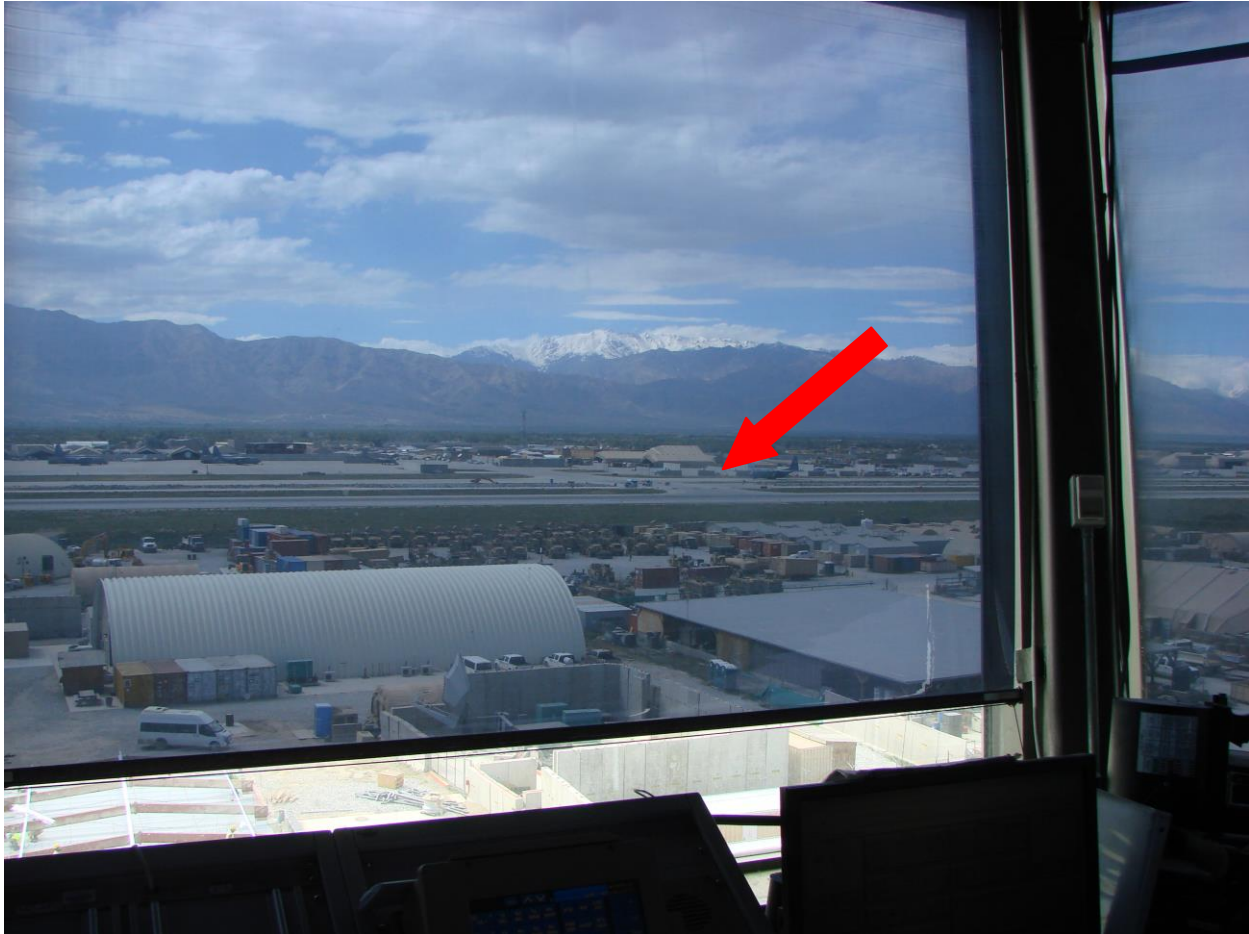
Photo 20: Tower view looking west. Arrow indicates location of taxiway “C”, the point closest to the rotation of the accident airplane.¹⁰⁸

According to interviews with ATC personnel in the control tower at the time of the accident, the taxi and takeoff of the accident airplane appeared normal, and rotation occurred around the Charlie intersection of runway 03. None of the controllers observed the accident airplane strike

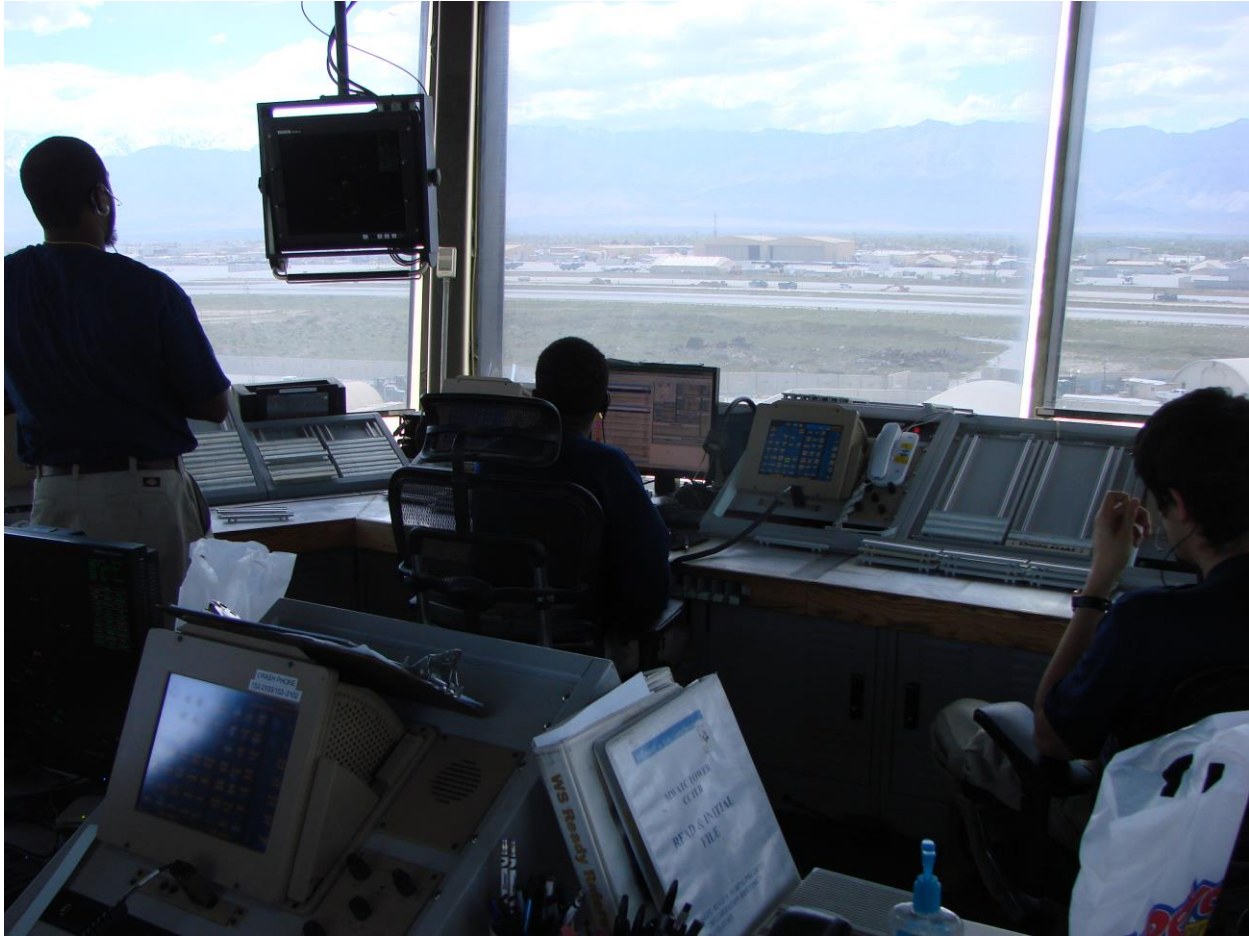
Photo 21: Tower view looking southwest toward the departure end of runway 03.¹⁰⁹
