NATIONAL TRANSPORTATION SAFETY BOARD

Group Chairman's Factual Report

OPERATIONAL FACTORS

DCA14MA081

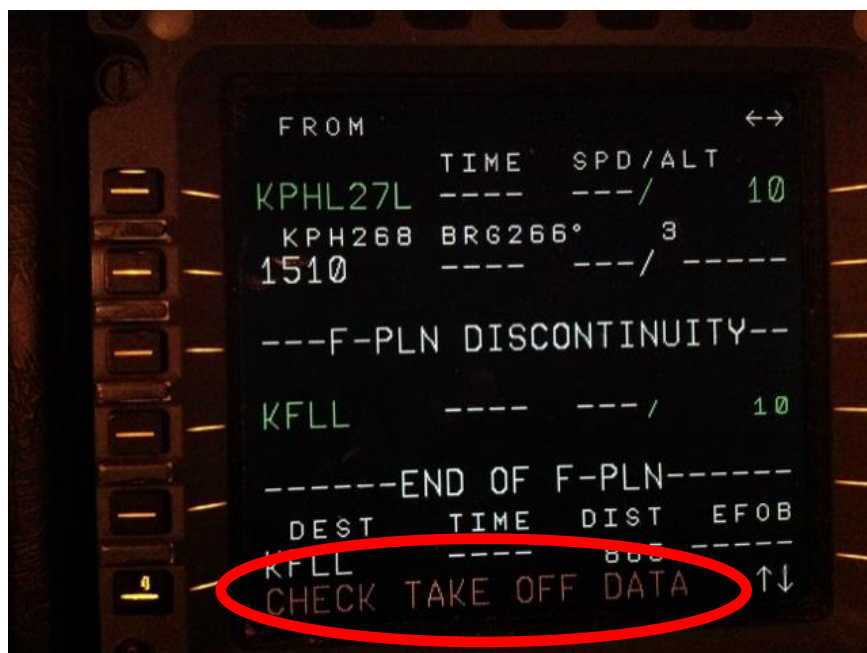
During the March 26, 2014 simulator testing in an A320 simulator at the USAirways training facility in Charlotte, North Carolina, NTSB staff conducted a runway change in the MCDU from runway 27R to 27L without entering the new takeoff V-speeds or a FLEX temperature, and documented the MCDU screen, the PFD and the ECAM. Following the runway change in the MCDU, the “CHECK TAKE OFF DATA” message was visible in the MCDU scratchpad and the upper ECAM indicated a TOGA target power setting since no FLEX temperature was entered (see Photos 5 and 6).

Photo 5: MCDU flight plan page after runway change (27R to 27L), with MCDU message (indicated).¹²³

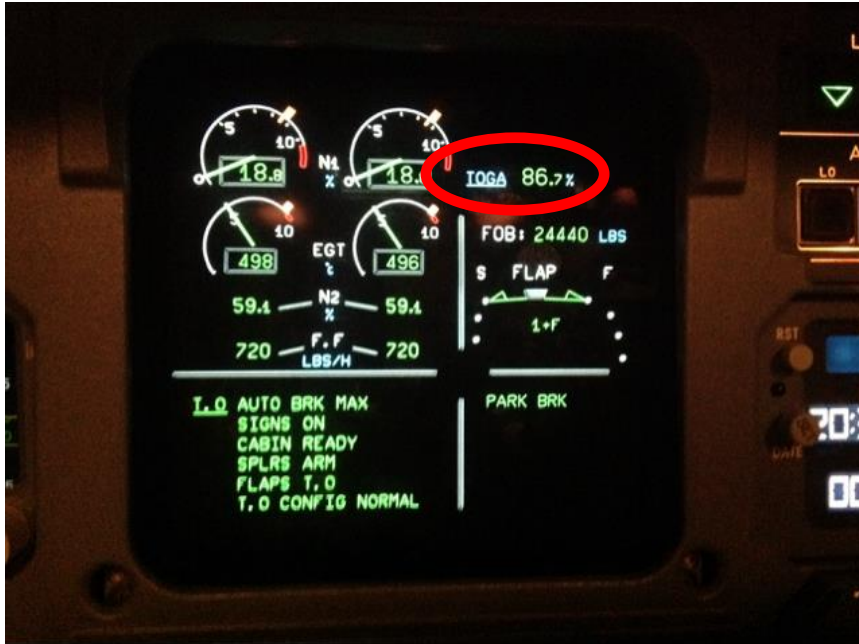
Photo 6: Upper ECAM without FLEX temperature inserted in MCDU (TOGA indicated).¹²⁴

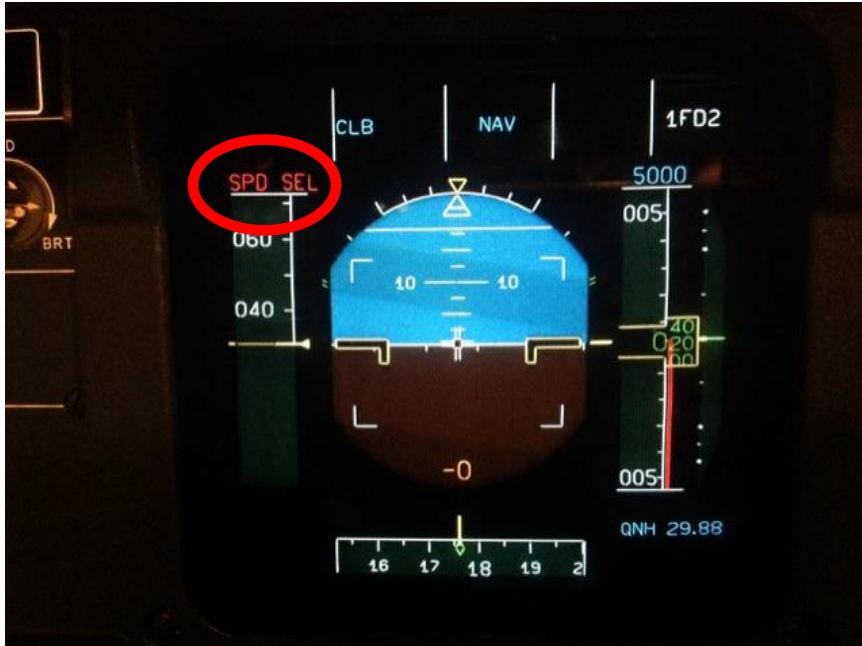
There were no V-speeds indicated on the PFD speed tape, and a red “SPD SEL” was visible at the top of the speed tape (see Photo 7). The USAirways A319/320/321 TM, Section 10.2.5 Indications on PFD, stated:

If the V speeds are not entered in the MCDU, a red “SPD SEL” message will appear on the top of the speed scale.

Photo 7: PFD after runway change with no V-speeds inserted in MCDU and SPD SEL on speed tape (indicated).¹²⁵

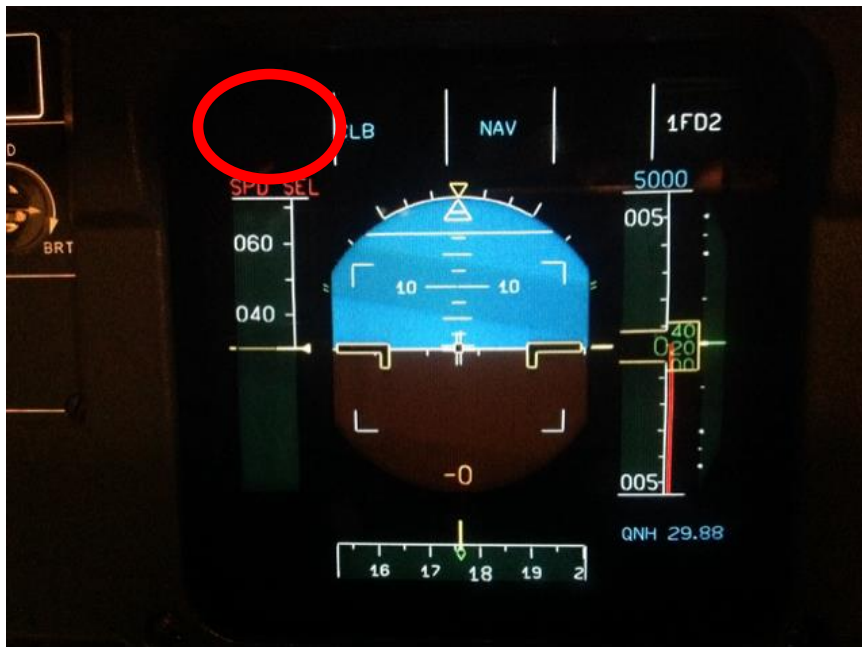
Further, column 1 of the FMA did not display any indication of autothrust operation (see Photo 8).

Photo 8: Autothrust column of the FMA (red circle).¹²⁶

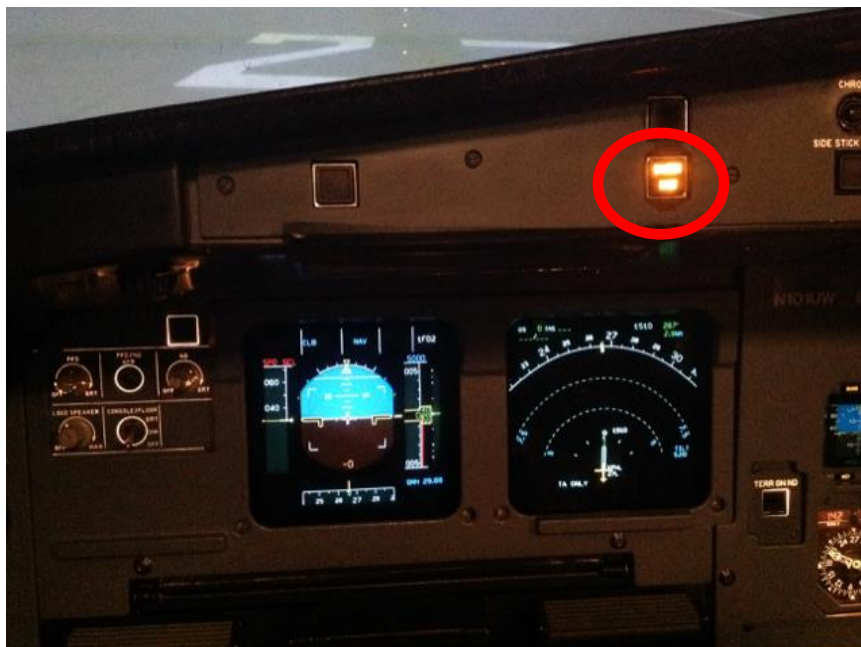
During the March 26, 2014 simulator testing in an A320 simulator at the USAirways training facility in Charlotte, NC., NTSB Staff simulated a thrust set to FLX with no FLEX temperature entered in the FMS, and a MASTER CAUTION alert triggered (see Photo 10) and the “ENG THR LEVERS NOT SET” was seen on the ECAM. In addition, the ECAM showed a message directing the pilot to place the thrust levers to TOGA (see Photo 11).

Photo 10: Forward displays with master caution (indicated) when FLEX thrust set without a FLEX temperature.¹³⁹

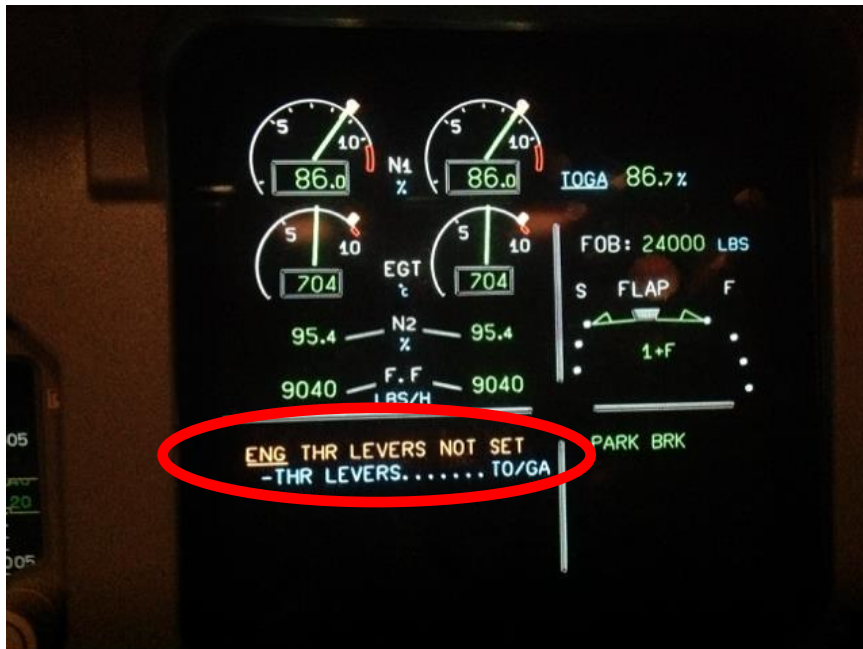
Photo 11: Upper ECAM when FLEX thrust set without a FLEX temperature, and ECAM message (indicated).¹⁴⁰

According to the FDR data and accident crew interviews, the thrust levers were never placed in the TOGA position on the accident flight.¹⁴¹ When asked why he did not push the thrust to TOGA after he received “ENG THR LEVERS NOT SET” ECAM and chime, the captain told NTSB Staff it was “no harm” and left the thrust in FLX, and the reason he did not reject was because he had already briefed a FLEX takeoff and he did not know the speeds and assumed temperature had dropped out.
