NATIONAL TRANSPORTATION SAFETY BOARD

Group Chairman's Factual Report

OPERATIONAL FACTORS

CEN16MA036

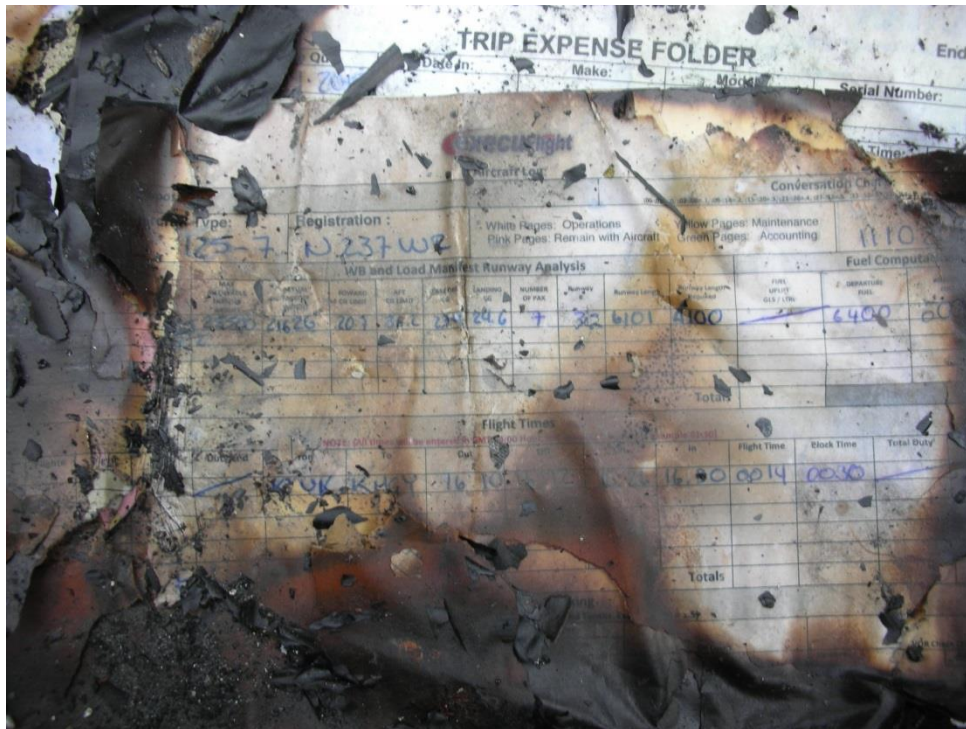
Portions of the accident aircraft logbook (Ops Form 19/M102) were recovered on scene. A review of the last page of logbook entries indicated completed entries for the LUK to MGY leg on November 10, 2015. There were no entries in the logbook for the MGY to AKR leg on the day of the accident.

Photo 2: Last logbook page recovered from the accident site showing LUK to MGY leg.

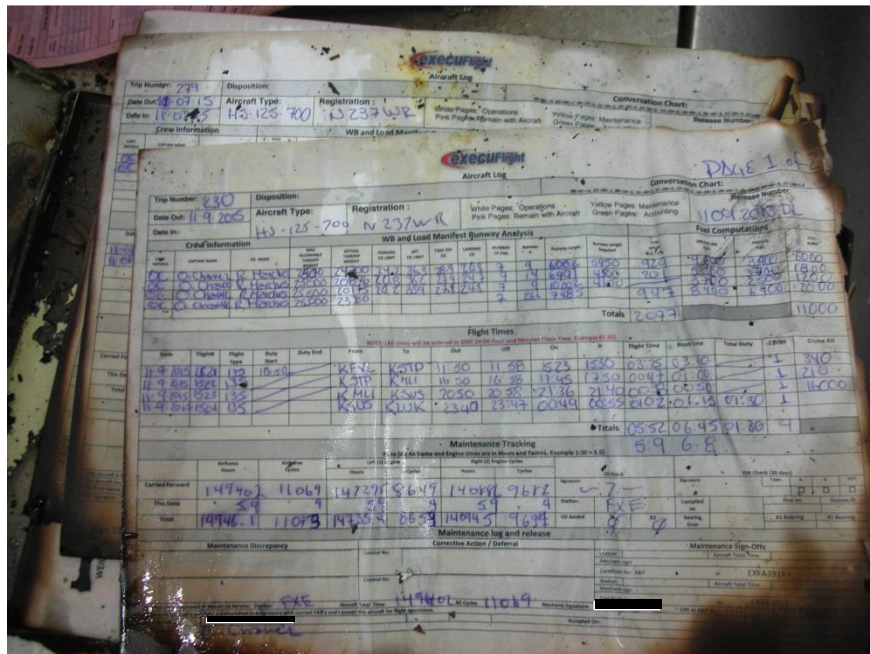
Photo 5: Photo of N237WR logbook entries for November 9, 2015.

The Execuflight Chief Pilot told the NTSB that there could be a circumstance where the pilot could populate the logbook field with numbers different than that produced by the Ultra-Nav program, for example if the weight and balance or performance numbers were computed well before the estimated takeoff time (i.e. the night before or, morning of) and then recalculated right before the departure to comply with the real time requirements considering a change in conditions, passenger or fuel.⁸⁸ The NTSB was not provided with the computations used by the accident pilots for the figures entered into the N237WR logbook for November 9 and 10, 2015.

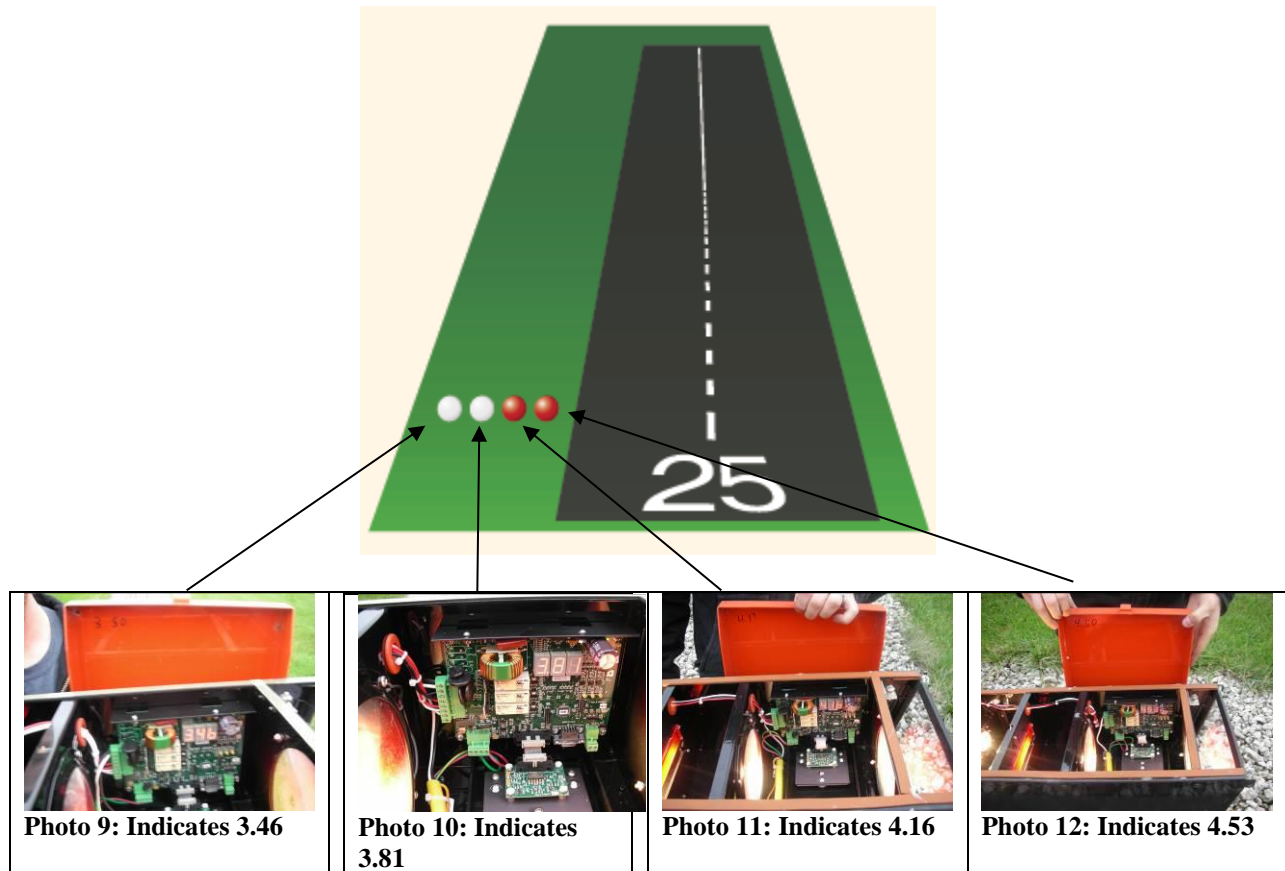
Figure 14: AKR runway 25 PAPI system location diagram, and NTSB photos with readings for each individual light panel.¹²⁷

According to the AKR Airport manager, the airport was responsible for the runway lights and the PAPI. Both were activated by PCL (pilot controlled lighting) with 3 clicks from a radio tuned to CTAF frequency of 123.07 MHz, and the runway lights would illuminate to low intensity with the 3 clicks, or medium intensity with 6 clicks, or high intensity with 8 clicks. The PAPI's were on a 15 minute timer that started when the PAPI's were first turned on. The timer would reset every time the radio was clicked three times within a 30 second time frame. According to an AKR maintenance technician, the PAPI's were visually checked post-accident and found operational.¹²⁸

(from airport vehicle with radio tuned to 123.07 MHz), and all PAPI lights and runway lights illuminated normally and were functional.

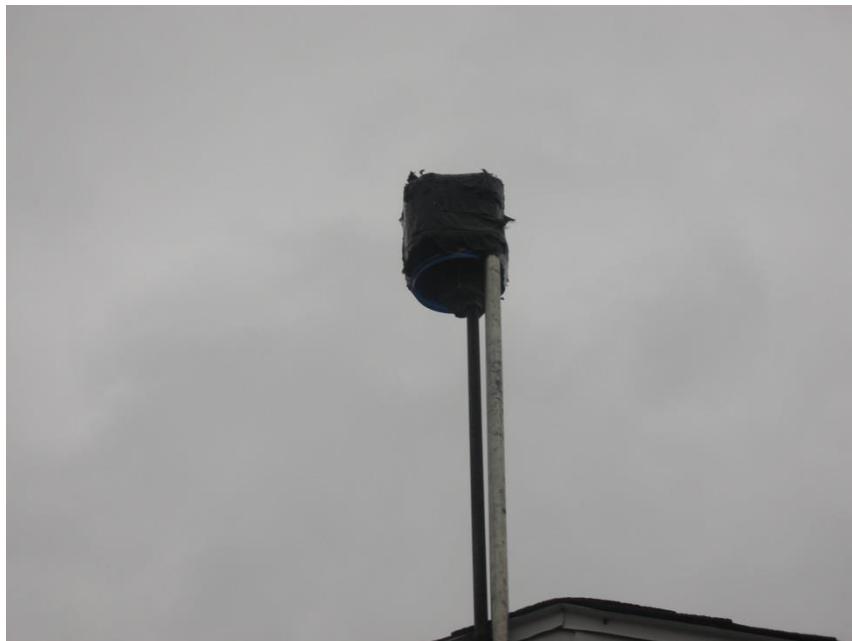
Photo 13: Photo of AKR runway light sensor covered.¹²⁹

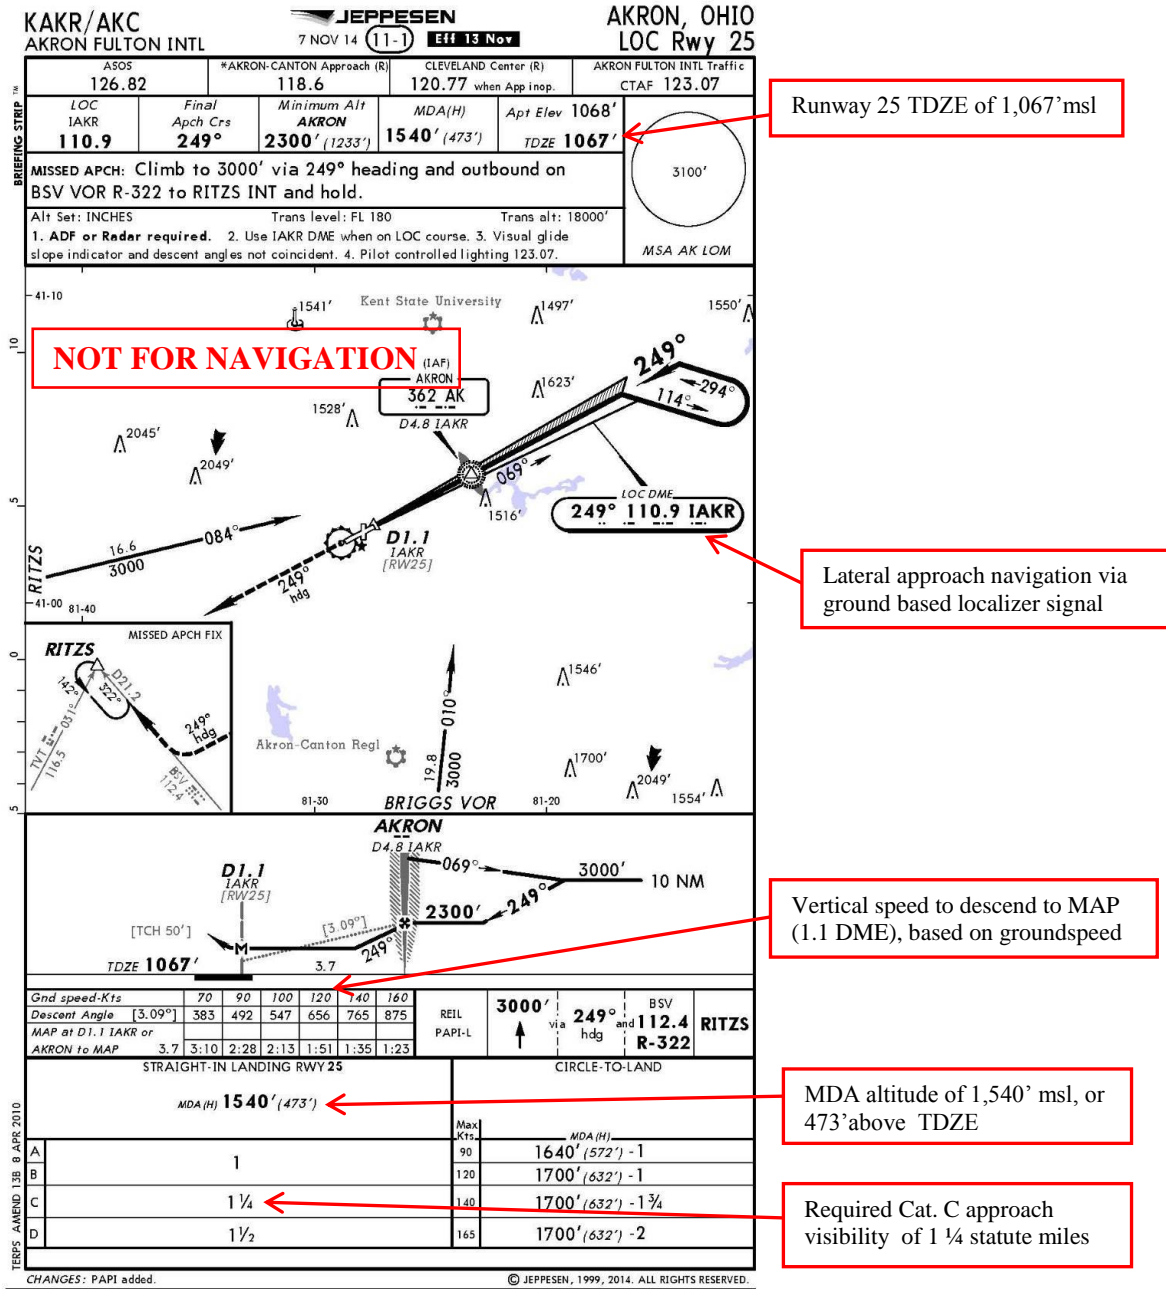
Figure 15: Jeppesen AKR Localizer 25 approach chart dated November 7, 2014. (Source: Jeppesen)

According to Jeppesen, the original touchdown zone elevation (TDZE) for runway 25 at AKR was officially recorded in May of 1993 on FAA Form 8260-5 as 1,048 feet (as shown on the

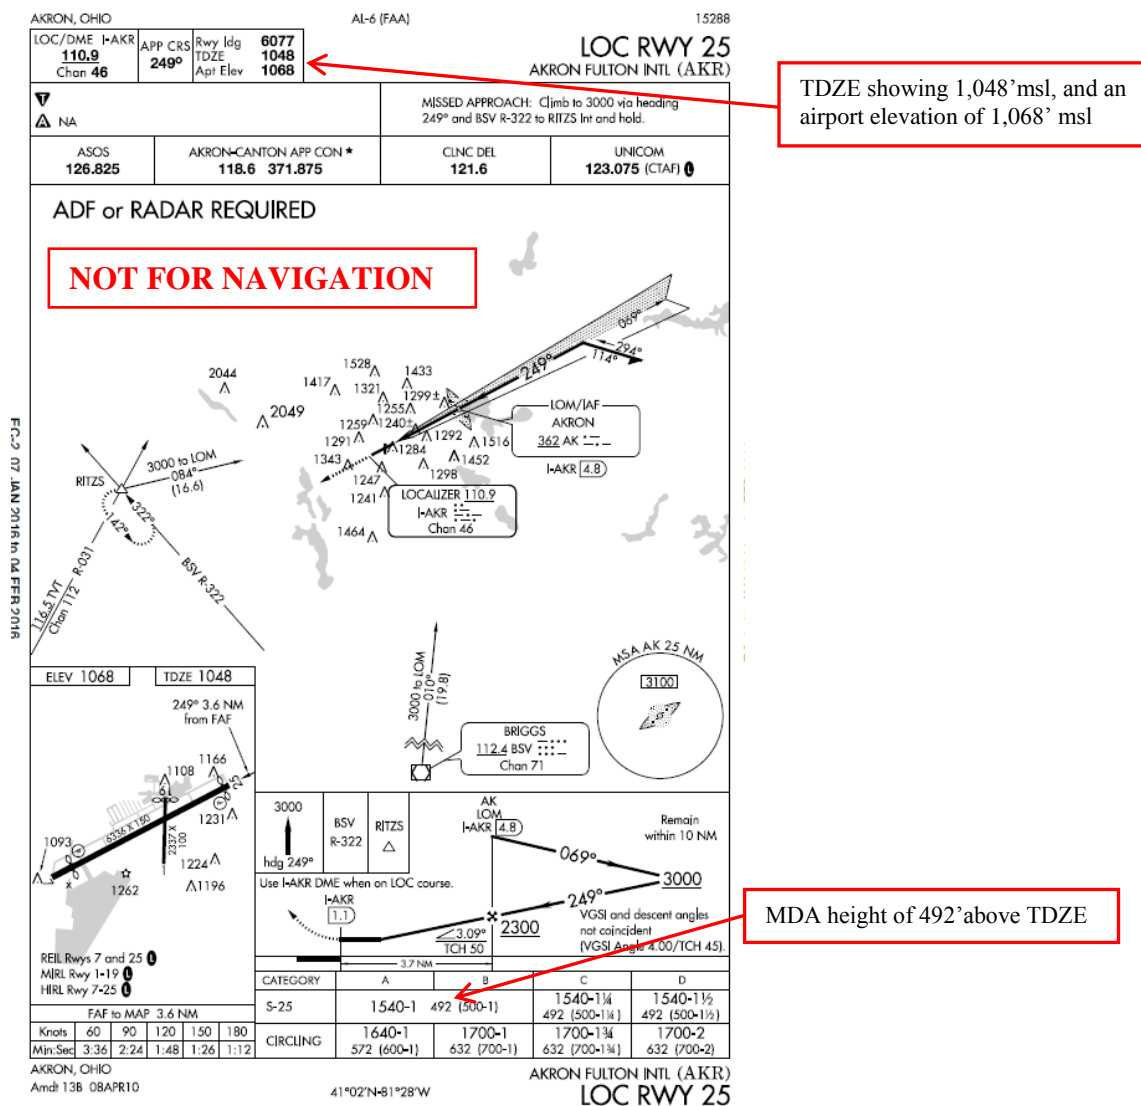
The FAA also published approach charts for runways, and the NTSB reviewed the FAA's version of the localizer 25 approach chart to AKR. The MDA published on the FAA's AKR Localizer 25 approach was 1,540 feet msl, or 492 feet agl. This agl height value reflected the MDA's height above the touchdown zone for the runway the approach was charted for. The FAA AKR LOC25 approach chart showed the same msl MDA altitude of 1,540 feet shown on the Jeppesen AKR LOC25 approach chart, but an agl altitude of 492 feet. This 492 foot agl altitude for the MDA depicted on the FAA AKR LOC25 differed from the 473 foot agl altitude depicted on the Jeppesen AKR LOC25 approach chart.

Figure 16: FAA AKR Loc25 approach chart, dated April 8, 2010. The (Source: FAA)

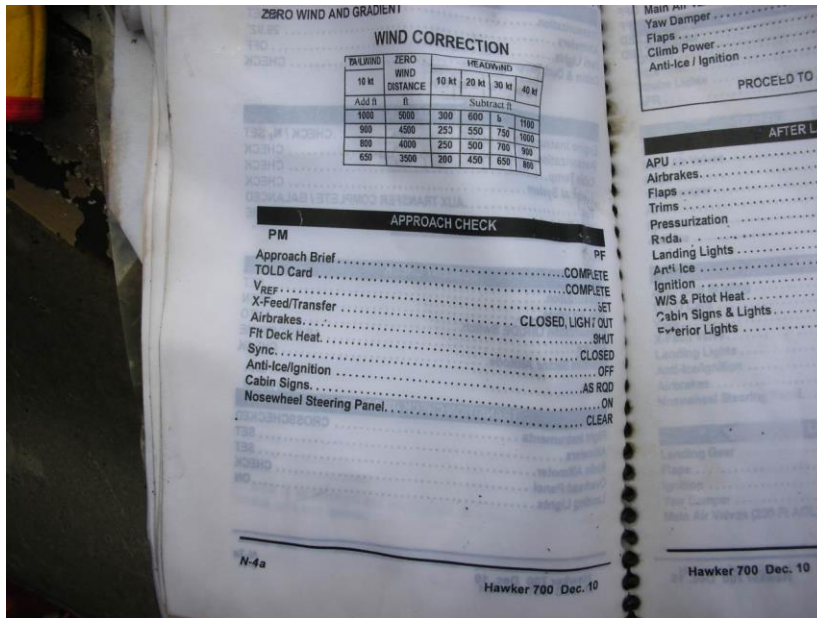
Photo 17: Photo of HS-125-700 Approach Check recovered from the accident site.¹⁵¹
