National Transportation Safety Board

Group Chairman's Factual Report

OPERATIONAL FACTORS

DCA15MA029

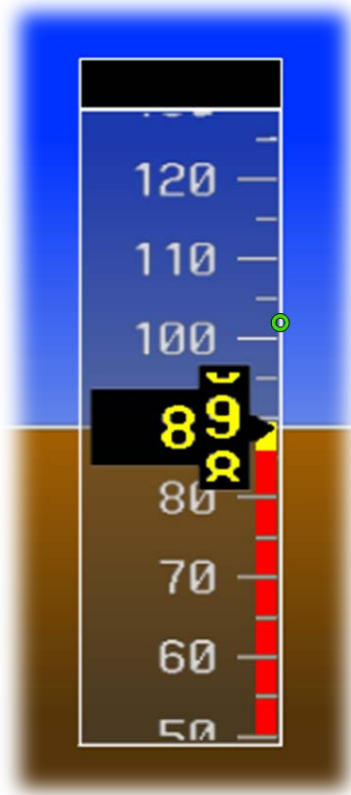
The airplane was equipped with an electronic display system that included two primary flight displays PFD, one for each pilot station. The PFD displayed airspeed, attitude, altitude, heading, and slip/skid indicators in a standard “Basic T”. Core primary information was complemented with other communication, navigation, flight control, annunciation, and planning information. The airspeed information was displayed on the PFD in a vertical tape format. The airspeed tape was overlaid with additional airspeed information, including cues for low speed awareness. The low speed awareness indicators consisted of red and yellow bands and a green circle that moved in conjunction with the main speed tape. The top of the red band denoted the airspeed for aural stall warning activation., the top of the yellow band just above the red band marked a three knot area prior to the activation of the aural stall warning, and the green circle denoted 1.3 times the speed at which stick pusher activation would be expected. The positioning of the low speed awareness cues was dependent on angle of attack measurements and airplane configuration, including the position of the wingstab switch. When a change to airplane configuration was made, the low speed awareness cues would be repositioned to reflect the current airplane configuration. Based on angle of attack measurements and the airplane’s configuration, with ice protection turned off during the landing approach at GAI, the airspeed tape display would have showed prior to autopilot disengagement the top of the red band at 86 knots, the top of the yellow band at 89 knots, and the green circle at 102 knots. With wingstab ice protection turned on, the display would have showed the top of the red band at 102 knots, the top of the yellow band at 105 knots, and the green circle at 121 knots.

Figure 7 - Simulated airspeed display with ice protection disabled

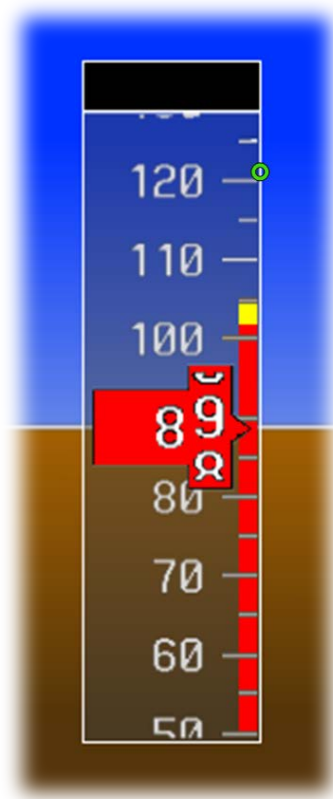
Figure 8 - Simulated airspeed display with ice protection enabled
