National Transportation Safety Board

Railroad Operations Factual Report of Investigation

DCA16FR005
Union Pacific Railroad
Collision
Granger, Wyoming
March 14, 2016

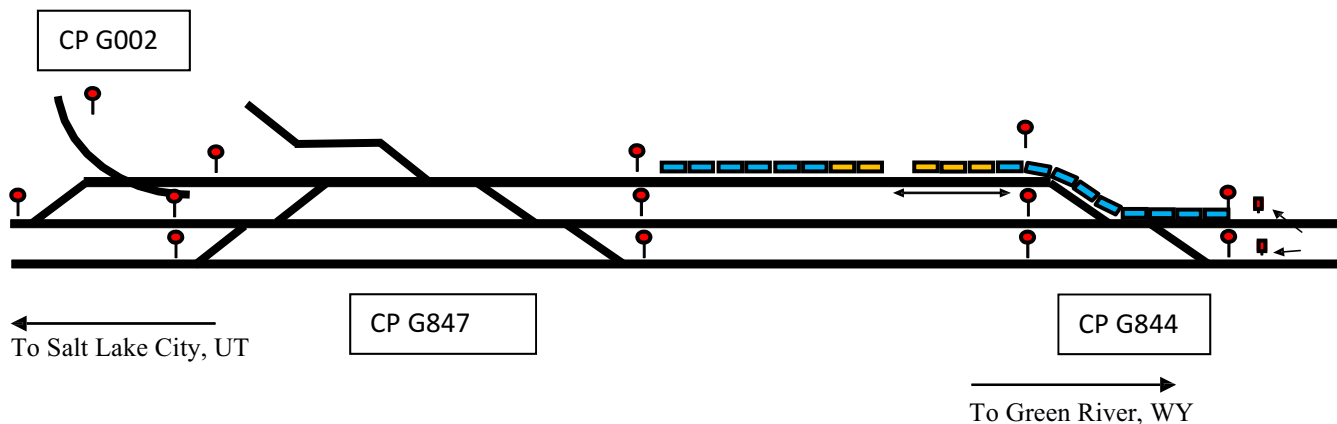
Figure 1. Diagram of track at accident site.

The last train movement through CP G844 was a train that had departed the long siding and entered main track 1. Since, the train dispatcher had not decided the order of the next train movements she had not changed the position of the switches.

When the crew on westbound train entered the limits at approximately 46 mph they noted that the switch for the long siding was lined so that their train would enter the long siding. The engineer immediately applied the emergency brakes and the train slowed to approximately 30 mph
