National Transportation Safety Board
Office of Railroad, Pipeline and Hazardous Materials Investigations
Washington, D.C.

Operations Group Factual Report
Union Pacific Railroad
Derailment with Employee Fatality – RCL Operations
Arlington, Texas
September 22, 2017

NTSB Accident Number DCA17FR013
Keys Number 96057

Prepared by: Georgetta Gregory, Group Chairman

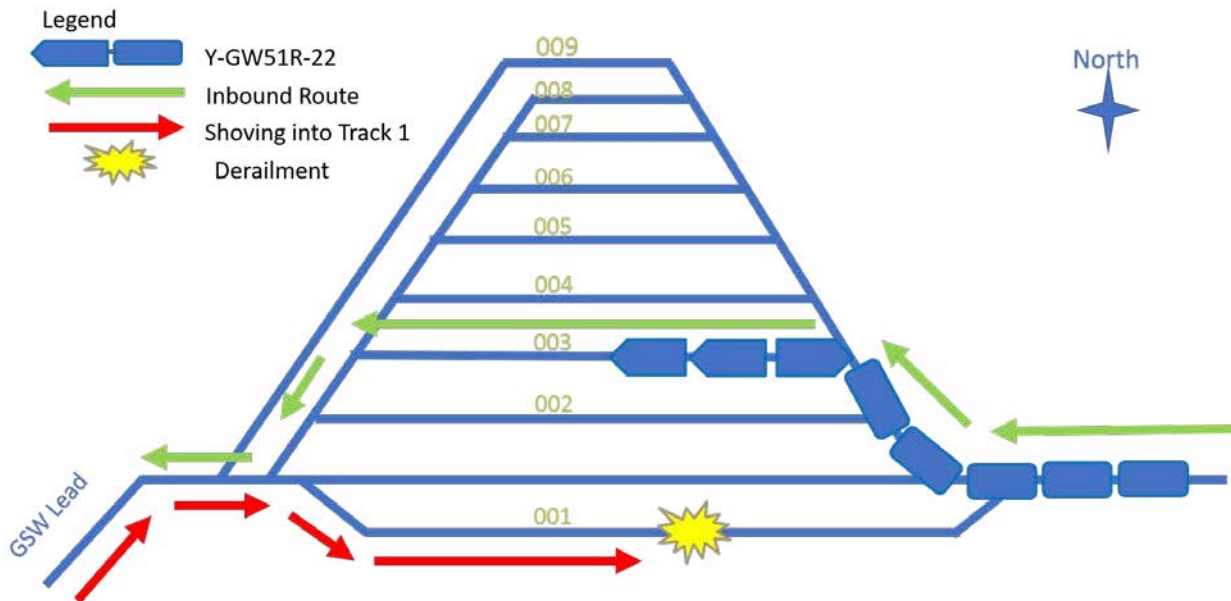
Figure 1. Y-GW51R-22 returning to the Great Southwestern Yard.
