NATIONAL TRANSPORTATION SAFETY BOARD

Group Chairmen's Factual Report

OPERATIONAL FACTORS/HUMAN PERFORMANCE

ANC15MA041

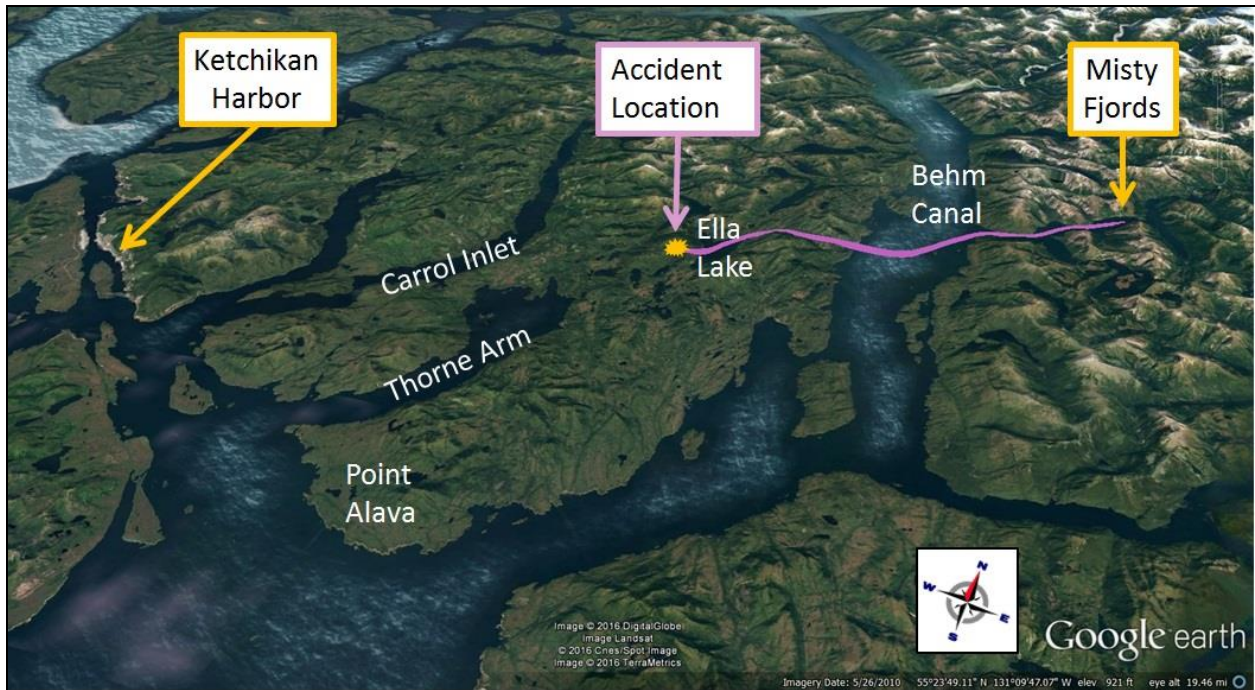
After reaching the northeast end of Ella Lake about 1,200 feet msl, the pilot turned southwest, and flew over the lake (surface elevation 250 feet) while climbing to about 1,300 feet msl. At 2015:48, after reaching the approximate center of the lake about 1,400 feet msl, the airplane turned west toward the shoreline. The airplane then climbed to 1,464 feet msl while crossing a 900-foot ridge on the lake's western shoreline. After crossing this ridge about 2016:03, the airplane continued on a relatively constant heading between 1,400 and 1,500 feet msl for about 30 seconds until it impacted a rock face on the northeast side of a 1,900-foot mountain. About two seconds before impact, the airplane's pitch increased and the airplane rapidly climbed to about 1,600 feet msl, where it collided with terrain (see Figure 1).

Figure 1. Accident flight path and wreckage location.

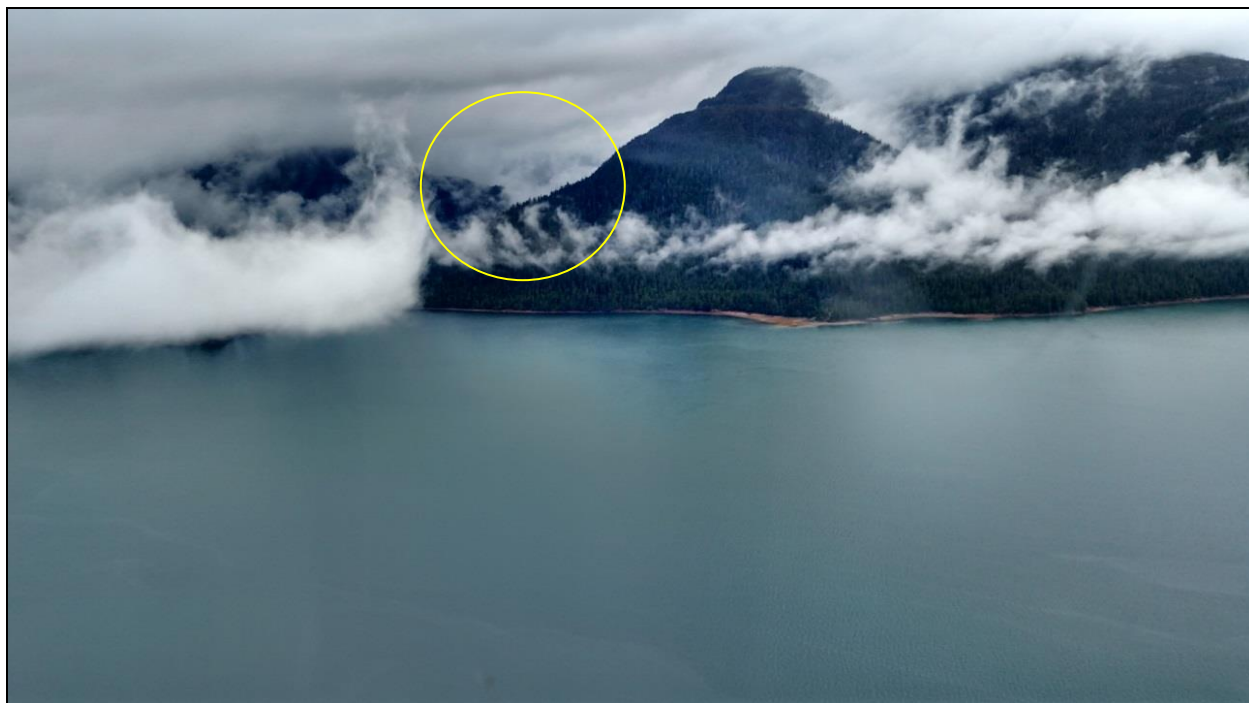
The first Promech flight (a DHC-3) reached Eddystone Rock and switched over to the new frequency. He observed a DHC-2 operated by Seawind Aviation flying slightly ahead of him. He had not flown the short route yet on that particular day, but he knew the pilot of the DHC-2 had recently done so. He told investigators that he radioed the DHC-2 pilot to ask about the weather conditions in Ella Lake and the other pilot told him that the conditions were good. Based on this report, his own observations of the weather in Ella Bay (which he saw to be generally improving), and his visual assessment of the conditions in Ella Narrows, he decided to return via the short route. Two photos from a passenger on this Promech flight provide some indication of the conditions in Ella Narrows at that time (see figure 3 below).

Figure 3. Photo of the entrance to Ella Narrows taken by a passenger on the first Promech airplane.

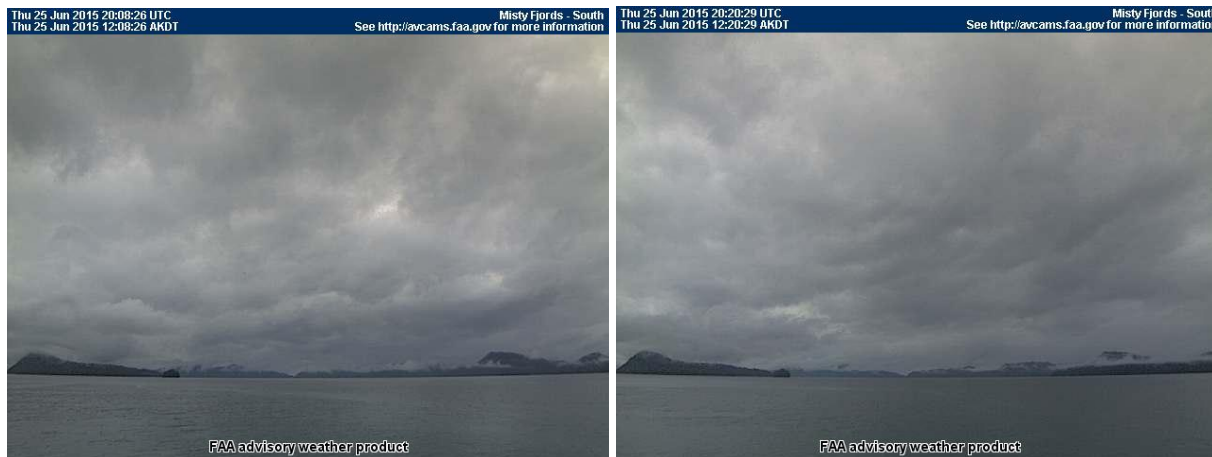
Photos taken by a weather camera installation located in the middle of Behm Canal between the entrance to Rudyerd Bay and Ella Bay showed no significant clouds and good visibility looking south down Behm Canal (figure 4). Looking west toward Ella Narrows, the cameras showed a scattered cloud layer near the ground with tops about 700 feet MSL, a higher overcast layer with bases about 1,300 to 1,500 feet MSL, and scattered clouds hanging down some hillsides. The most distant visible landmarks inside Ella narrows are about 1.5 nautical miles from the shoreline (figure 5).

Figure 4. Weather camera view looking south down Behm Canal at 1208 and 1220.

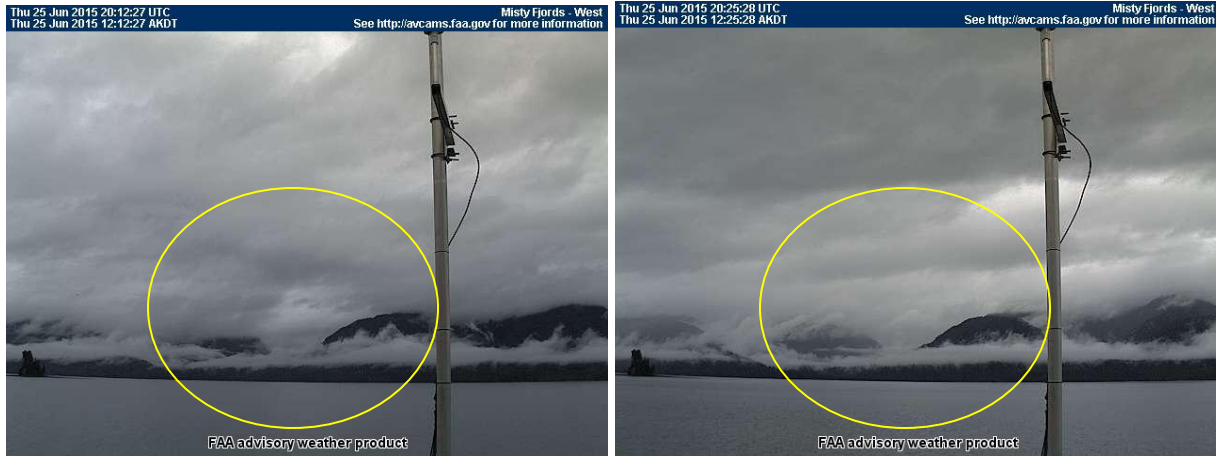
Figure 5. Weather camera view looking west toward Ella Narrows (highlighted by the yellow circle) at 1212 and 1225.

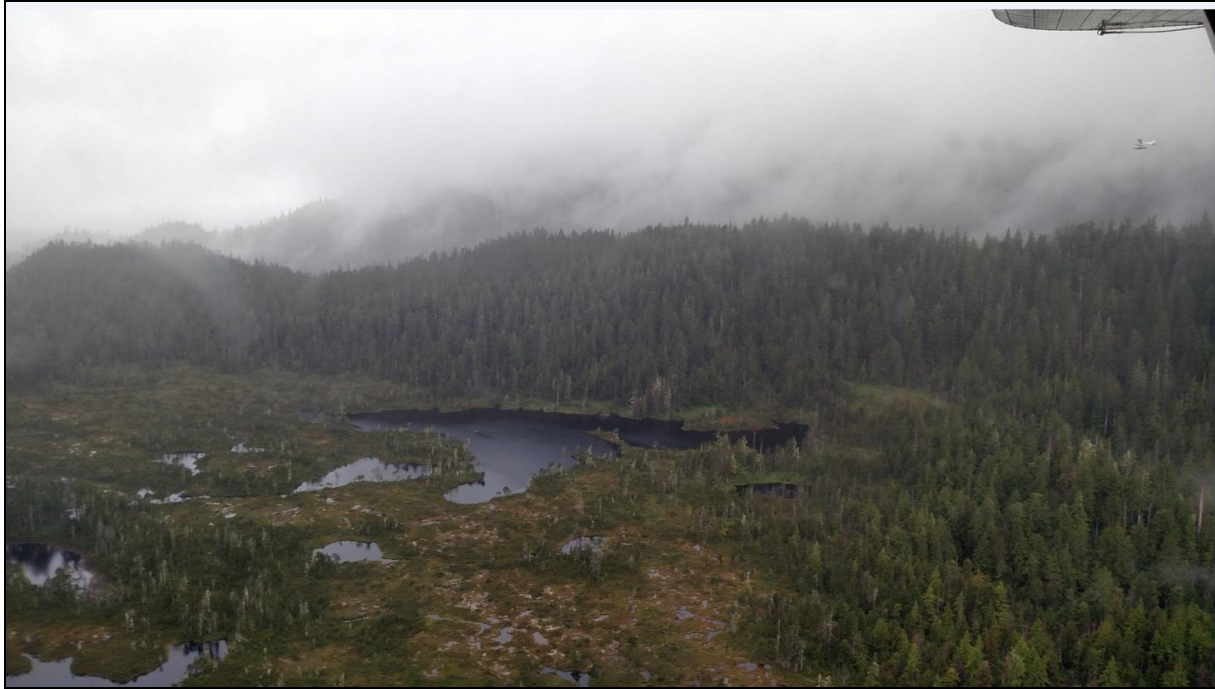
Conditions encountered by the first Promech pilot about ½ nautical mile south of Ella Lake were documented in two passenger photos obtained by investigators (one of which is shown in figure 6). These photos show a southwesterly view (see figure 7). The most distant visible landmarks are about 1.5 nautical miles away. These photos indicate that the first Promech airplane transited the area south of Ella Lake about 900 to 1,000 feet msl over terrain that is at least 600 feet in elevation. The southeastern face of a large mountain is visible in the photo. It is completely obscured by clouds above about 1,000 feet msl, with scattered clouds hanging down the mountainsides to lower elevations. This is the same mountain that was subsequently impacted by the accident airplane about 1.3 nautical miles north of the area shown in this photo. The Seawind Aviation DCH-2 referenced in the previous section of this report is visible in the upper right-hand corner of this photo.

Figure 6. Southwest-looking photo taken about 1/3rd nautical mile southwest of Ella Lake and 1.3 nautical miles southeast of the accident location by a passenger on the first Promech airplane.

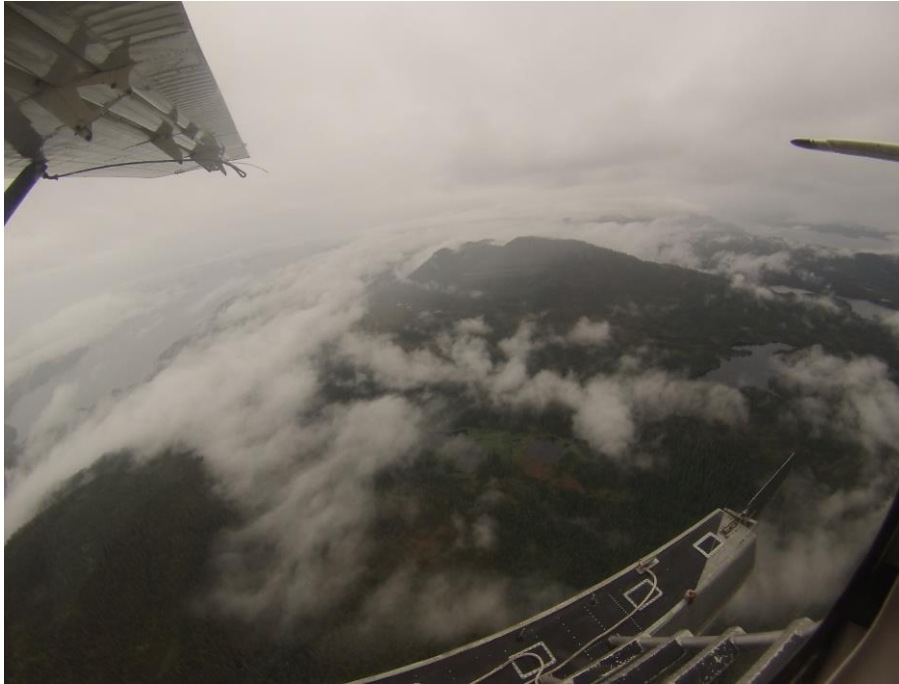
Figure 8. Passenger photo showing a southern view from the vicinity of Gokachin Lakes.

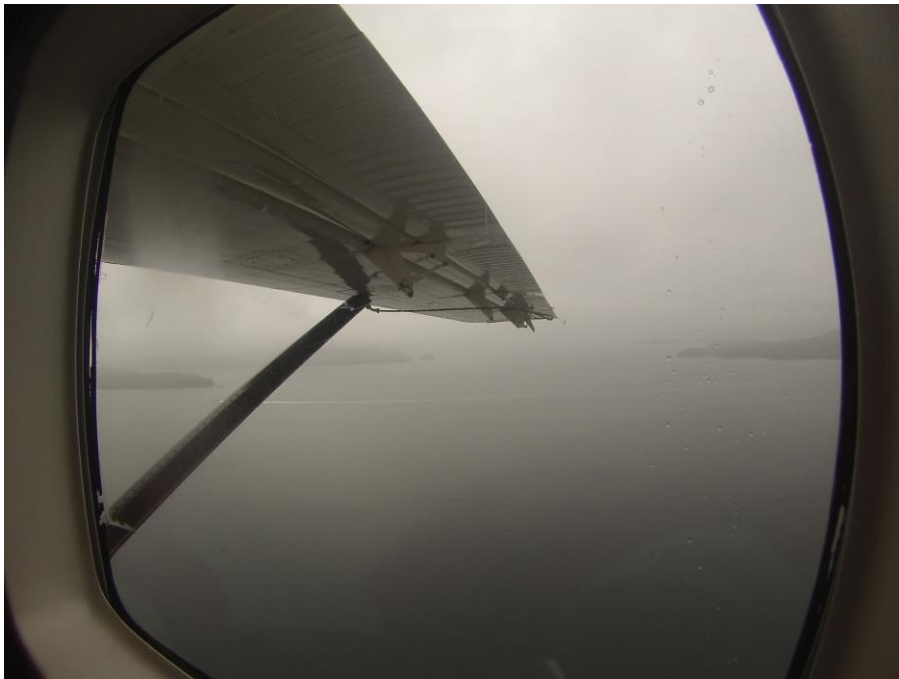
Figure 9. Passenger photo showing an eastern view from the entrance to Carroll Inlet.

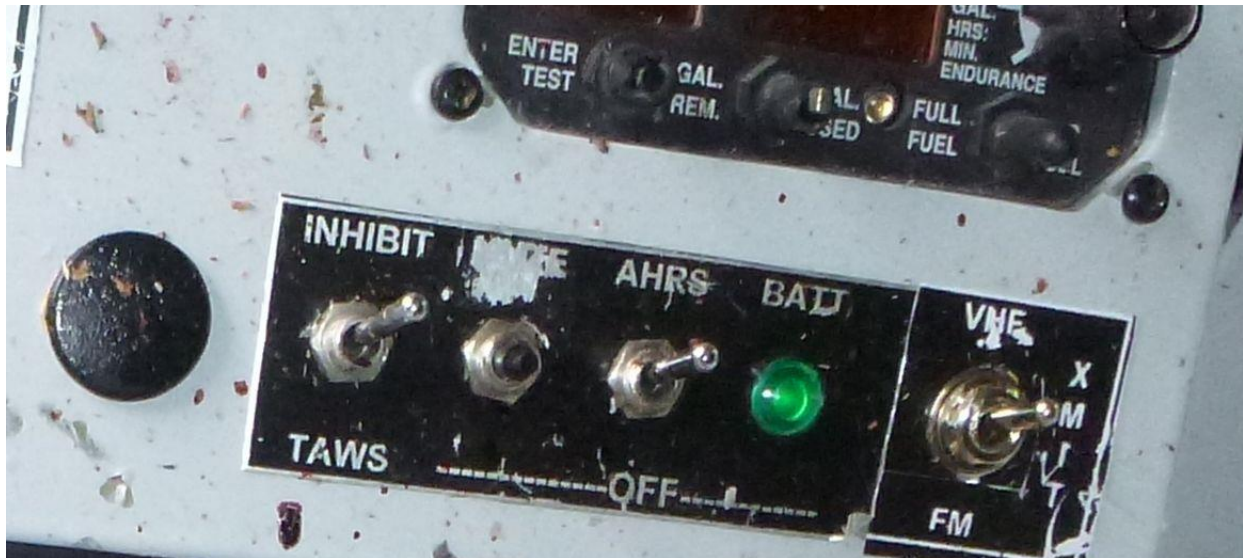
A TAWS Inhibit Switch is used for manual inhibiting of TAWS alerting functions. The TAWS Inhibit Switch is of the latching type and gives an obvious indication of actuation (i.e., toggle / rocker or pushbutton with indicator light). The TAWS Inhibit Switch is connected directly to the EFIS IDU. The TAWS Inhibit Switch is activated when manual inhibiting of TAWS alerting functions is desired. The TAWS inhibit switch on the accident airplane was found in the “inhibit” mode at the accident site.

Figure 10. Photo of TAWS inhibit switch as found at accident site.
