NATIONAL TRANSPORTATION SAFETY BOARD

Operations / Human Performance Group Factual Report

Description: Train Head-On Collision

Location: Cayce , South Carolina

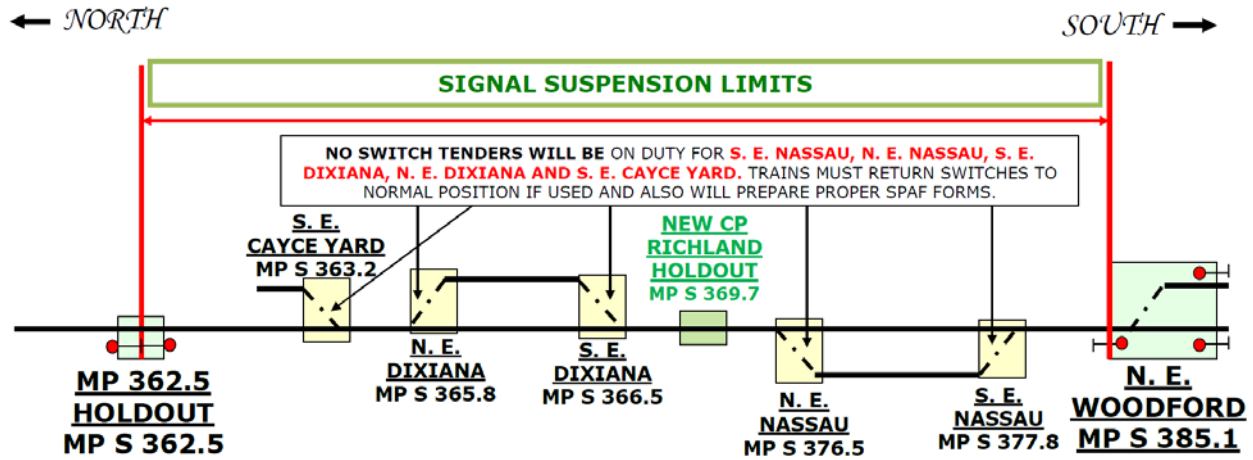
Figure 1. Diagram of the Signal Suspension Limits

The Southbound absolute signal at MP 362.5 Holdout MP S362.5 governs movement into the signal suspension only. According to CSXT Bulletin 105 southbound trains must have both a signal to proceed and EC-1 authority from the FF train dispatcher at Jacksonville before passing the southward absolute signal at MP 362.5 Holdout MP S362.5.

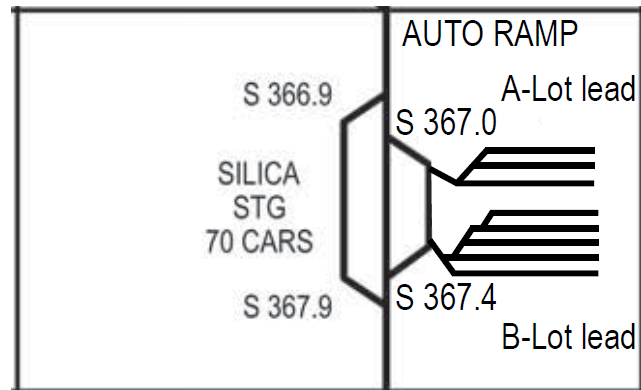
Figure 2. Diagram of the tracks at Silica Storage Track and A and B Lots tracks

F777-03 traveled northbound out of A-Lot with light engines past Silica Storage Track switch and operated the switch from main track to the siding. As the locomotives traveled southbound into the siding, the conductor instructed the engineer to stop the locomotives just past the derail. Engineer said that when he stopped the locomotives just past the derail, “I noticed he was already there, that is the reason I asked him did he get the switch.” The engineer explained he saw the conductor line the Silica Storage Track derail for derailing position, walk east towards the main track switch that leads to the runaround track, and line it for normal movement (main track). The conductor then lined the derail on the runaround track for the derailing position. The conductor returned to Silica Storage Track, the crew proceeded south and coupled the locomotives against the standing auto racks that been placed earlier in the siding.

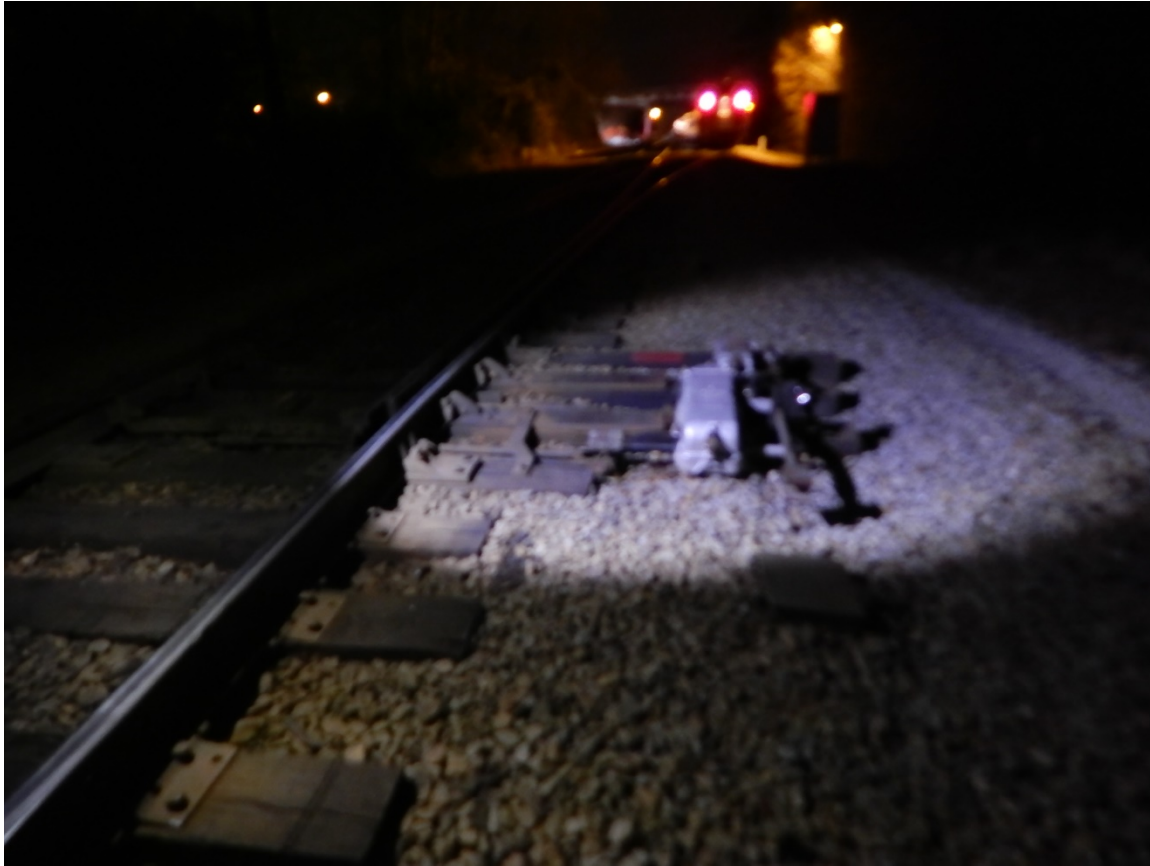
Figure 5. View of T21 switch at night with added light.

The railroad tracks to the left side of the photo are largely dark, except were illuminated by artificial light sources. The T21 switch is illuminated by a circular light near the top of the photo, several light sources are present, which partially illuminate an area of the track. Photo taken by CSXT on 2/4/2018.

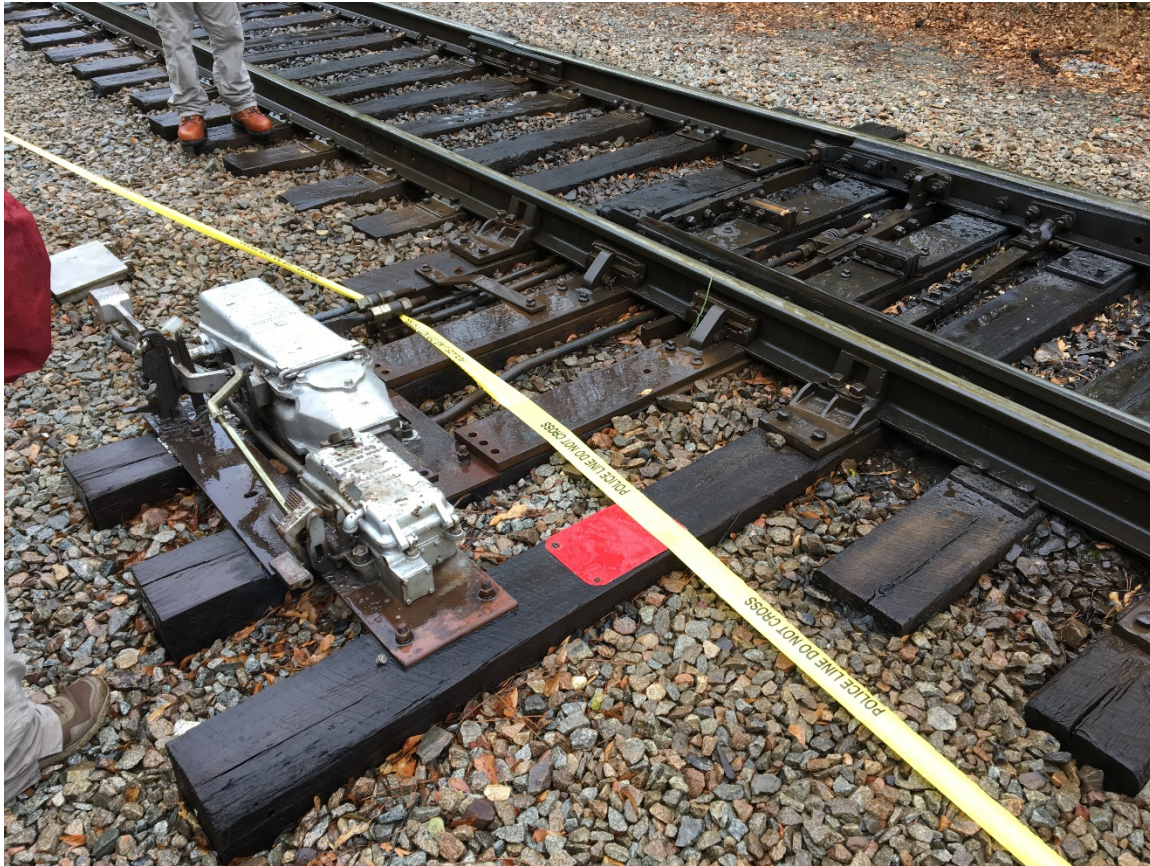
Figure 6. T21 hand throw switch with electric timeout.

Investigators found the handle for the T21 switch positioned opposite of the red square, indicating that the switch was lined for the siding. It was also determined that a physical lock was holding the switch in this position. The following photos illustrate these features.

The switch has been lined for the siding, as indicated by the handle positioning away from the red square. Photo taken by NTSB on 2/4/2018.

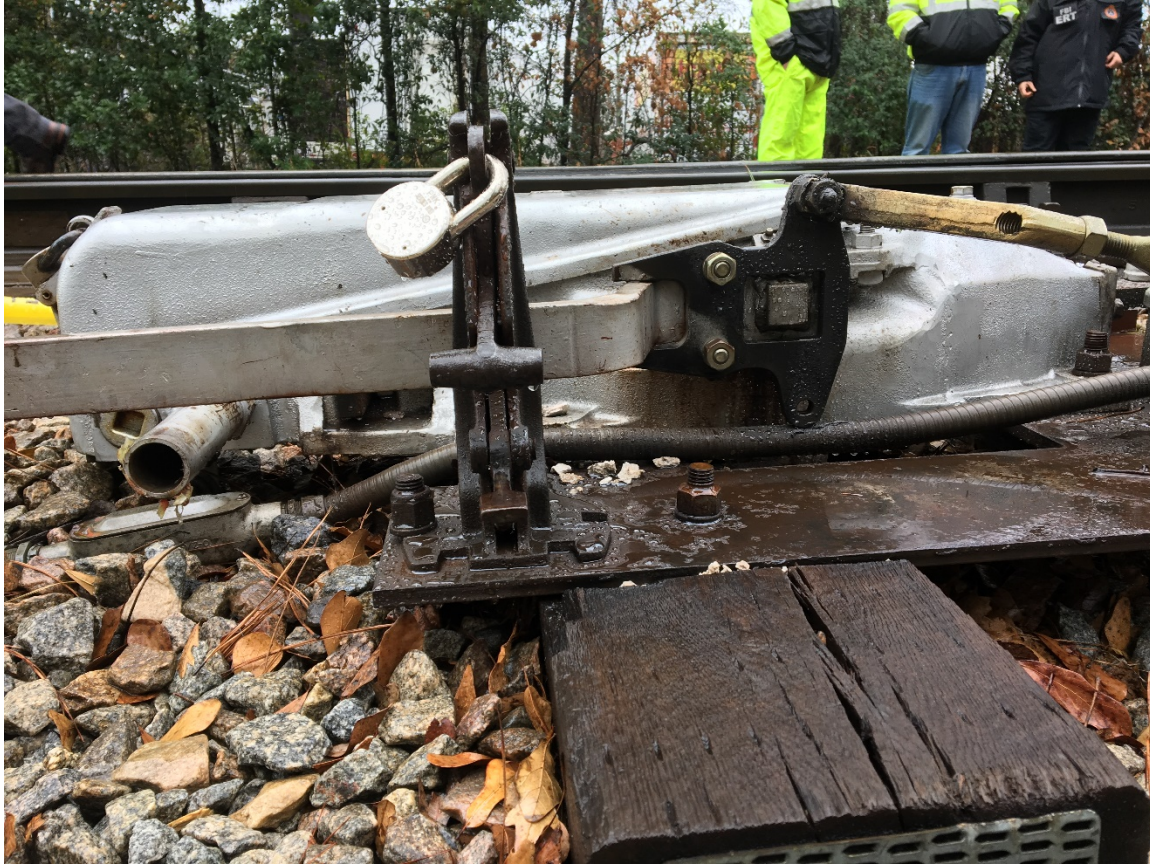
Figure 7. Side view of the T21 switch lined and locked for the siding.

A metal lock is shown near the center of the photo. The lock is closed, barring access to change the position of the switch. Photo taken by NTSB on 2/4/2018.
