NATIONAL TRANSPORTATION SAFETY BOARD

OPERATIONS

Factual Report

CEN14FA046

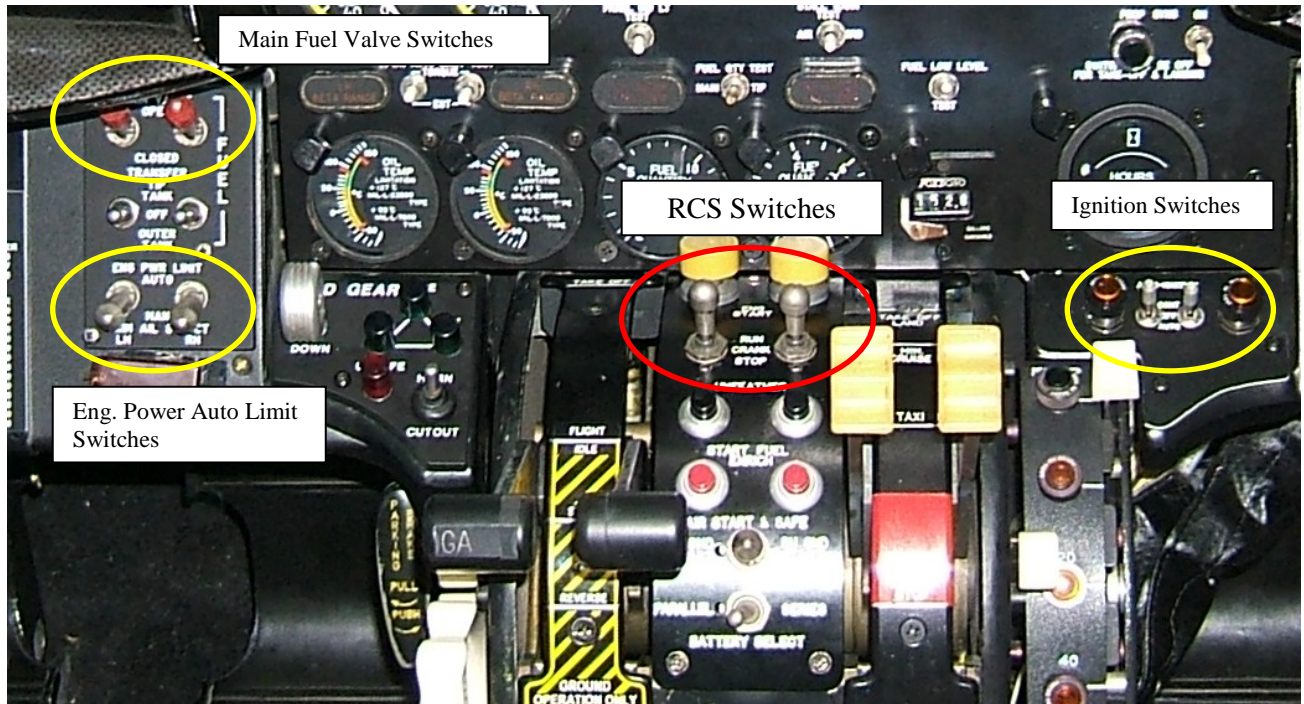
Figure 4. Location of Switches

In addition to the pilot's radio communication that he had a left engine shutdown, examination of the wreckage discovered that the left engine's fuel shutoff valve was in the closed position. The examination did not detect any other anomalies with either engine.

The fuel shutoff valve is electrically actuated through the Run-Crank-Stop (RCS) switch located on the center pedestal between the power and condition levers. The switch is a three position gated switch with a single gate between the run and crank positions. The switch is spring loaded to move the switch from the stop to the crank position. During normal operations, the switch is moved to the run position for engine start and not moved until the engine is shutdown on the ground. Two RCS switches exist, one for each engine.

The only switches similar to and in the vicinity of the RCS switch, circle in red on Figure 4, are two gated switches main fuel valve switches, two gated engine power auto limit switches, and two gated ignition switches, each set circled in yellow. The main fuel valve switches and engine power auto limit switches are two position switches with a single gate. These switches are located to the left of the center pedestal and behind and to the right the pilot's control wheel. The ignition switches are three position switches with two gates to select continuous, off, or auto ignition. These switches are located to the right of the center pedestal.

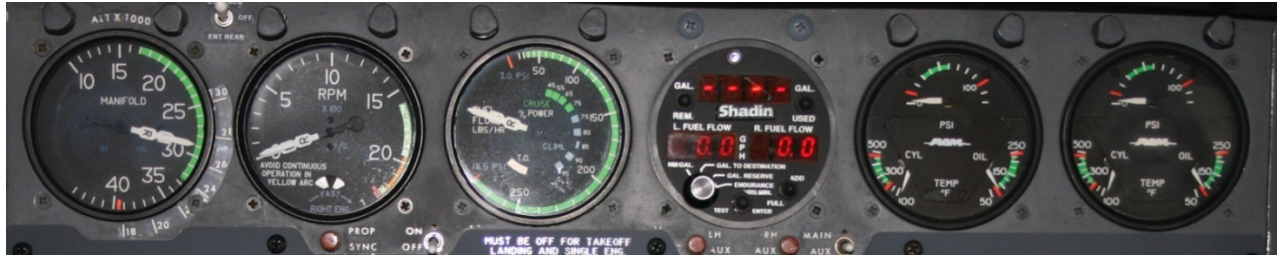
Figure 5. Photo of engine gages from pilot's Cessna 421B

The Cessna 421B’s engine instrument is arranged horizontally on the upper center of the cockpit instrument panel unlike the MU-2B which is arranged vertically. Rather than individual engine gages, the 421B has dual pointers on each gage labelled “L” and “R” to discern between the engine readings unlike the MU-2’s engine gages which were arranged in two columns.
