## ERA17FA327 – Revised Factual Report

On September 16, 2017, about 1300 eastern daylight time, a Mooney M20C, N53CP, was substantially damaged when it impacted trees and terrain near North Branford, Connecticut. The airline transport pilot and the passenger were fatally injured. The airplane was owned by the pilot who was operating it as a Title 14 *Code of Federal Regulations* Part 91 personal flight. Visual meteorological conditions prevailed, and no flight plan was filed for the flight, which departed from Robertson Field Airport (4B8), Plainville, Connecticut, and was destined for Francis S. Gabreski Airport (FOK), Westhampton Beach, New York.

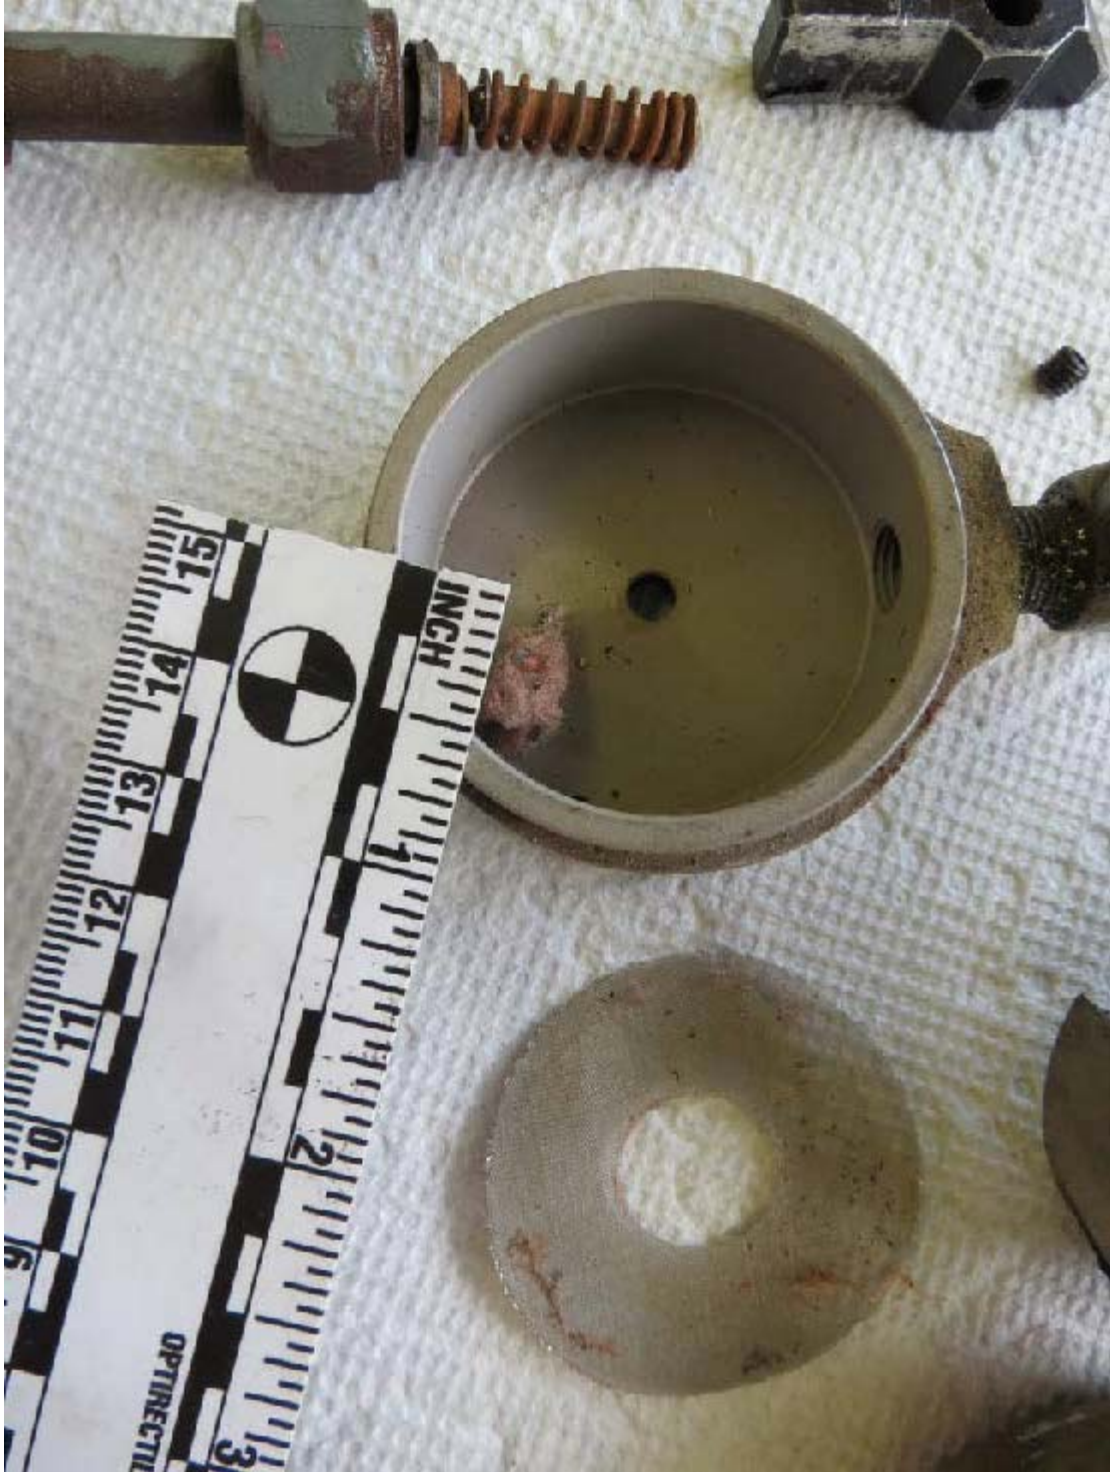
Figure 1-

Liquid with an odor consistent with aviation fuel was observed in the engine-driven fuel pump, the hose from the pump to the servo, in the servo, and in the fuel selector. The fuel selector valve was removed from the airframe and air pressure applied to the valve fuel outlet port. Air did not pass through the selector valve when the handle was in the position marked "LEFT." The handle was moved to the "OFF" position, then back to the "LEFT" position, and it remained blocked. Air did not pass through the valve when the actuator handle was placed in the position marked "OFF" or in the rearward, unmarked position. Air passed freely when the handle was placed in the position marked "RIGHT." When the handle was returned to the position marked "LEFT," no air passed through the selector valve. The selector handle moved normally with no unusual resistance between the settings.

The valve was disassembled and a spongy mass of reddish fibers consistent in appearance with red cotton shop towel fibers were observed in the selector cavity (see figure 1). The rounded mass was about 5/8 inches in length and about 3/8 inches in width. Fibers also covered about 5% of the fuel drain screen.

Debris discovered in the fuel selector.

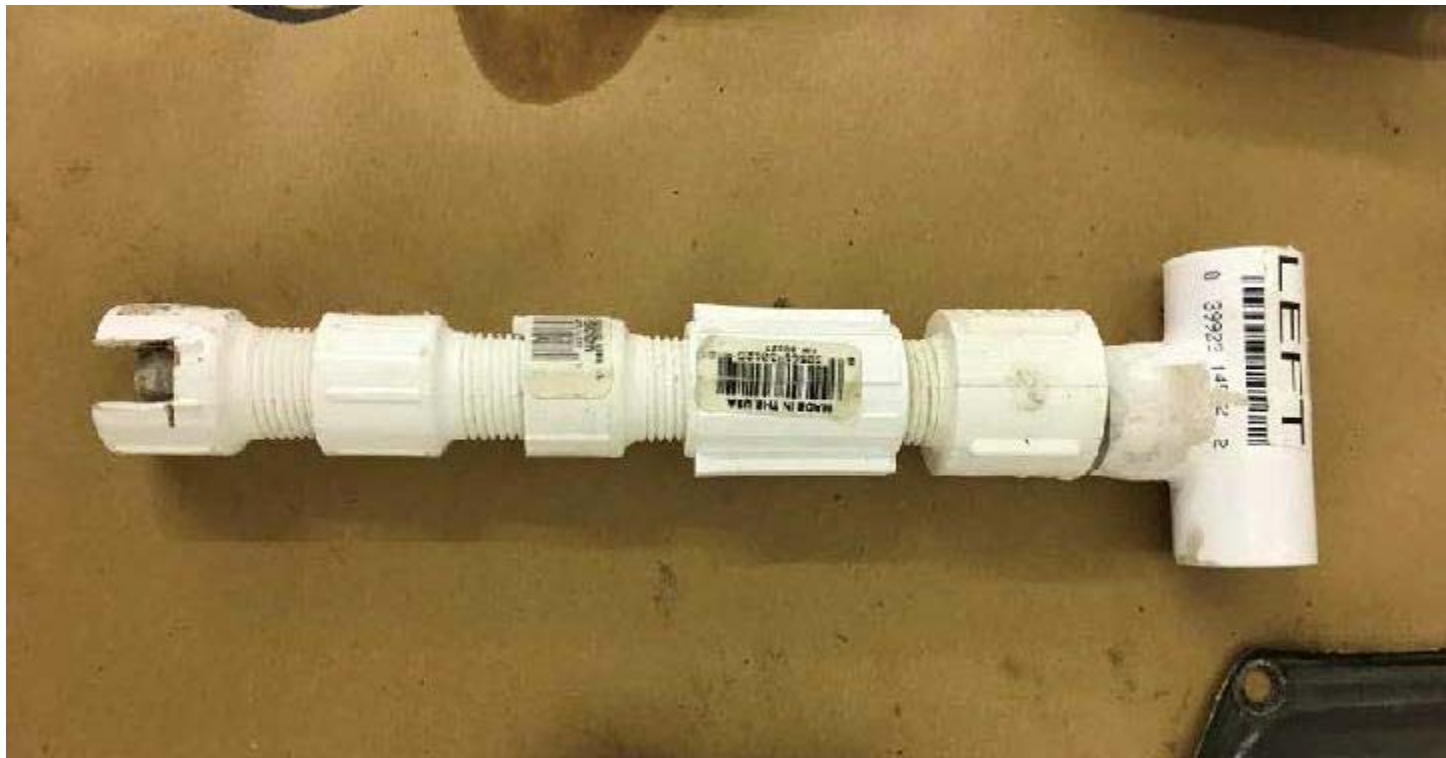
A section of PVC similar to plumbing or electrical conduit was discovered in the wreckage (see figure 2). It was made up of five individually-threaded, male-to-female connections which, when threaded together, measured about 9 inches long. On the top of the device was a PVC pipe in the

shape of a handle. The entire device was in three separate pieces when discovered; the top of the t-handle was broken from the device and the bottom section was unscrewed. On each side of the handle was a label indicating "LEFT" and "RIGHT." The top of the handle was labeled "FUEL." On the bottom of the T-handle connection, the vertical pipe appeared to be hand carved/shaved so that it would fit into the top section of the device. There was a 3/4-inch notch cut out on the bottom of the device. When the device was reassembled during the examination, it fit into the airplane fuel selector handle, and appeared to be designed to switch the fuel tanks; however, the reason for its fabrication and use was unknown.

Figure 2-Homemade fuel selector tool after partial reassembly.
