INVESTIGATION OF SWIVEL ASSEMBLY FAILURE, P/N 7438-4, S/N 0748

ATS JOB # D166449 Rev. 1*

Investigation of Swivel Assembly Failure, P/N 7438-4, S/N 0748 removed from A/C 5305

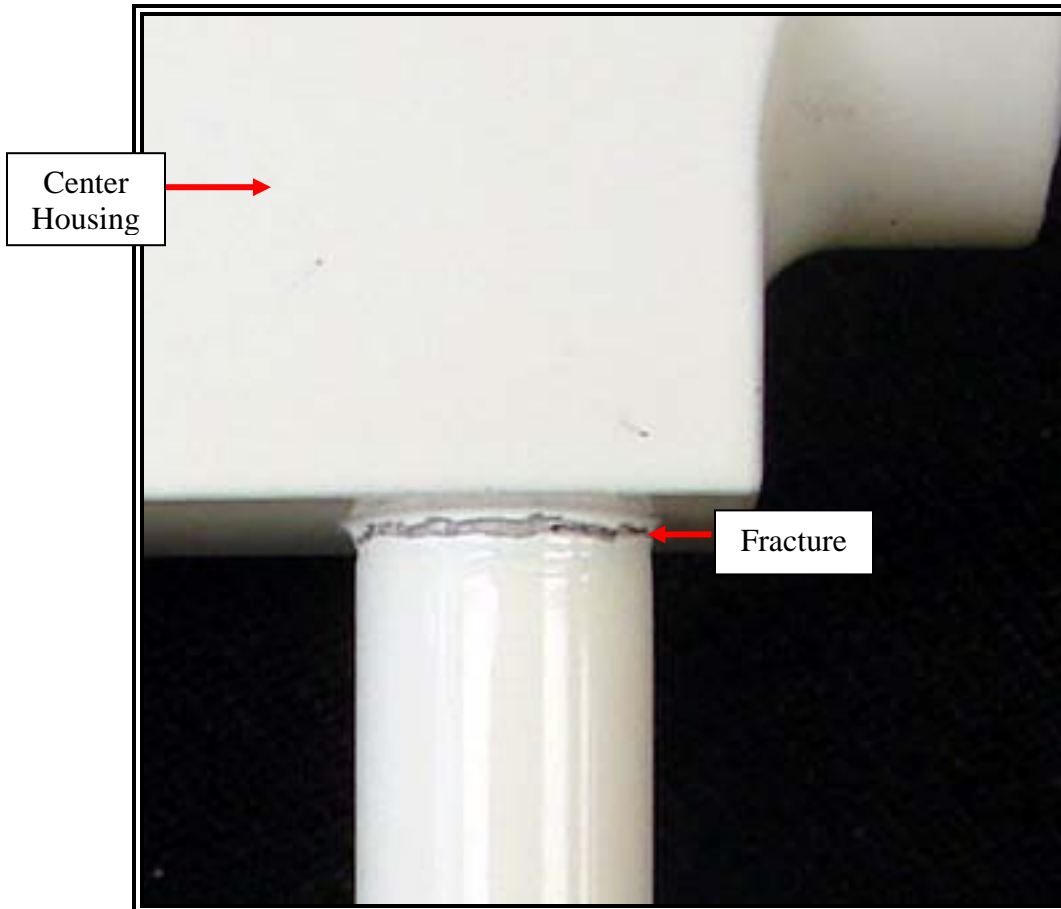
The inboard connecting tube between the center and the aft housing was fractured near the braze joint to the center housing end (Figure 4). Only a small area around the circumference of the tube remained intact (Figure 5). The adjacent tube exhibited multiple parallel paint cracks near the braze joint at the center housing end, showing a distinct angle approximately 30°-45° from the tube axis, a possible indication of torsional stress (Figure 6). Similar paint cracks were also observed on the fractured tube (Figure 7).

Figure 4: Photograph of the fractured tube

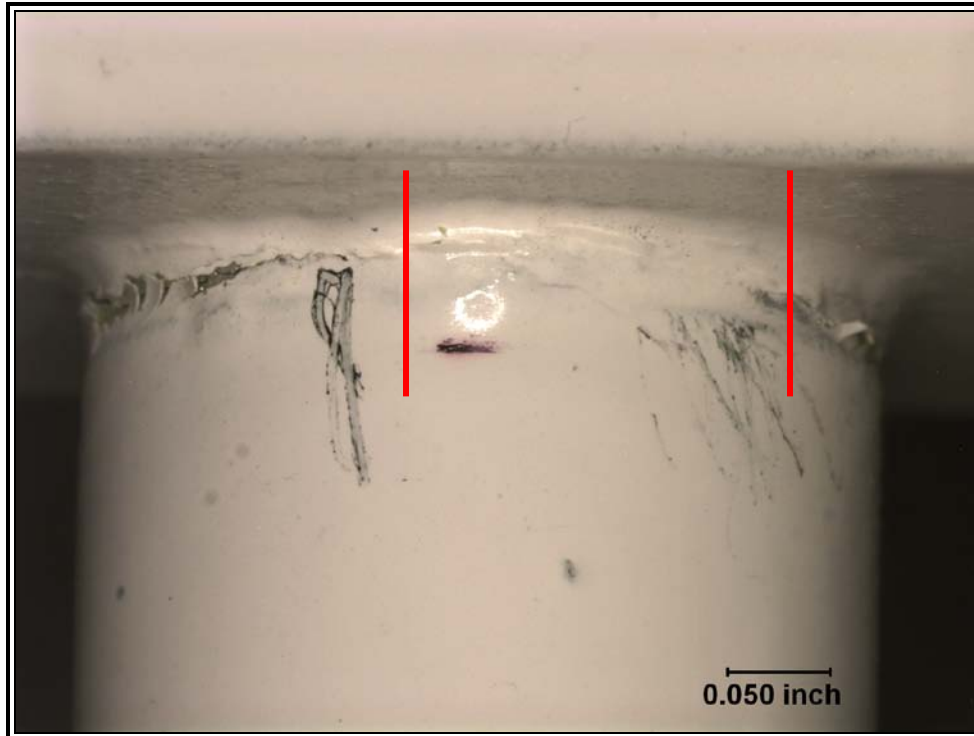
Figure 5: Photomicrograph of the fractured tube showing the intact area between two red lines

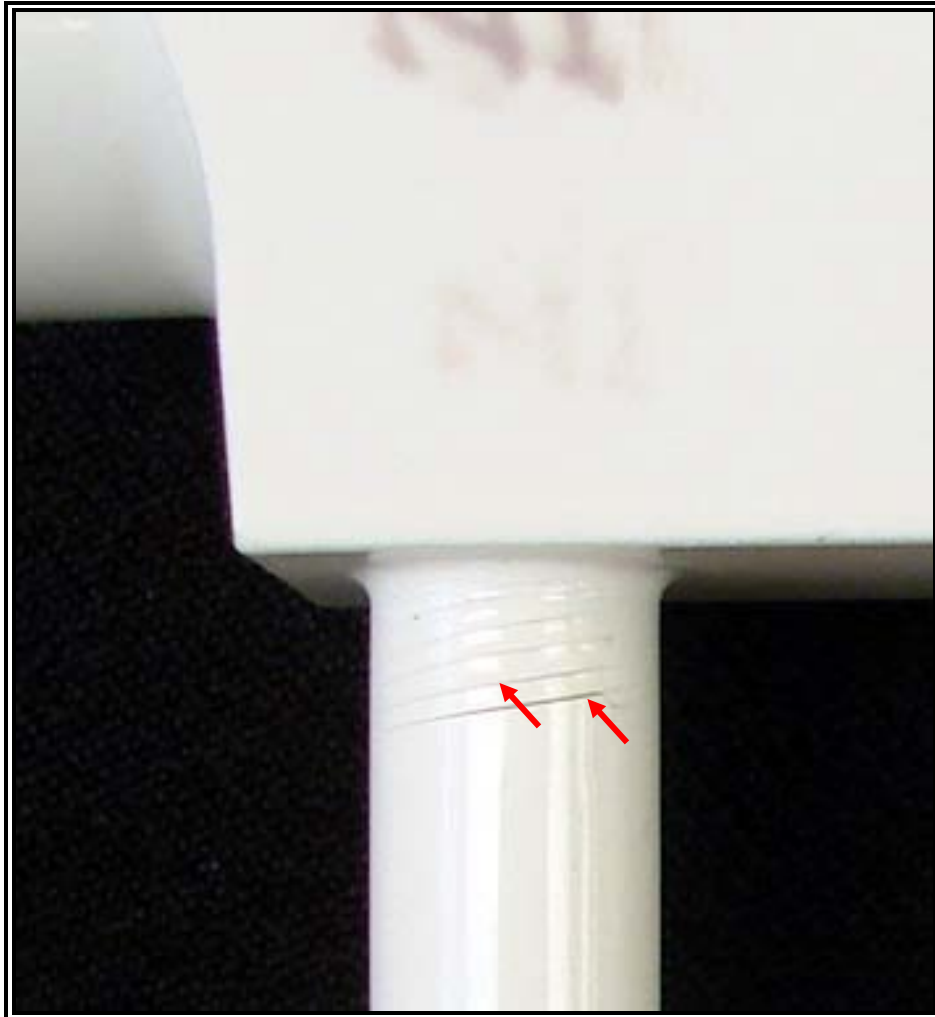
The connecting tube sample from the swivel assembly most likely fractured due to a single overload event. The angled paint cracking in the failed and adjacent intact tubes suggests that the component experienced a torsional/twisting type of stress. The customer reported that under normal conditions, the connecting tubes should not be subjected to these types of stresses. No evidence of progressive cracking (i.e. fatigue or corrosion) was observed. The failed tube met the hardness requirement of the specified heat treatment condition requirements and no microstructural abnormalities were observed. Even though lack of braze coverage was observed in some areas of the failed and intact tube joints, it is not believed to have contributed to the failure since the tube was fractured in the braze fillet which was an area with full braze coverage.

Figure 6: Photograph of the adjacent tube with paint cracks (arrows)

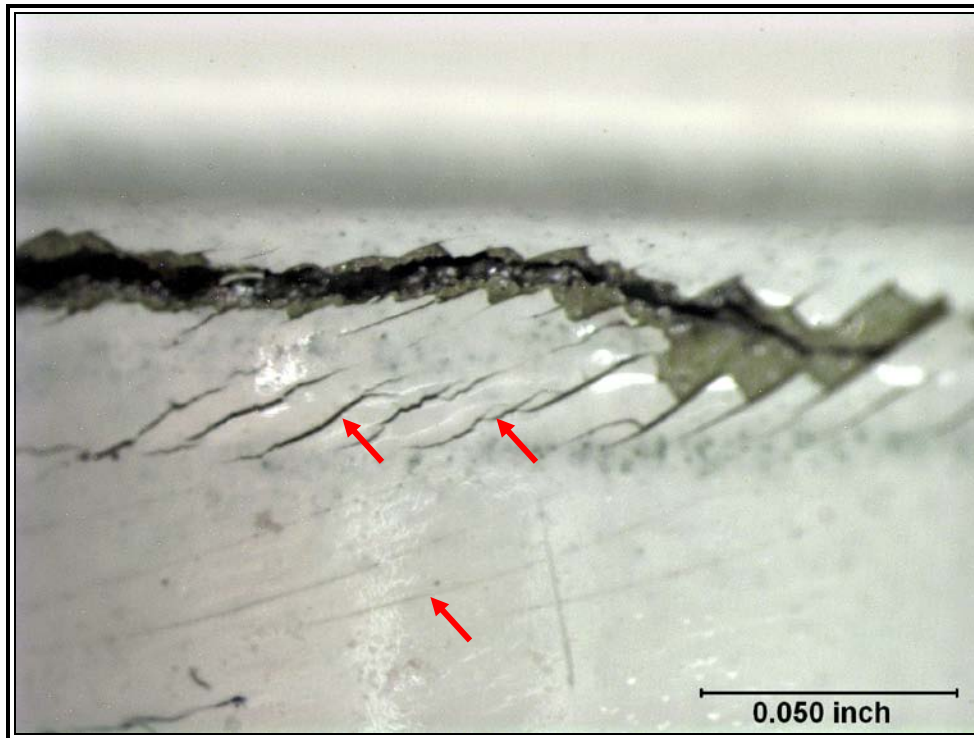
Figure 7: Photomicrograph of the fractured tube with paint cracks (arrows)

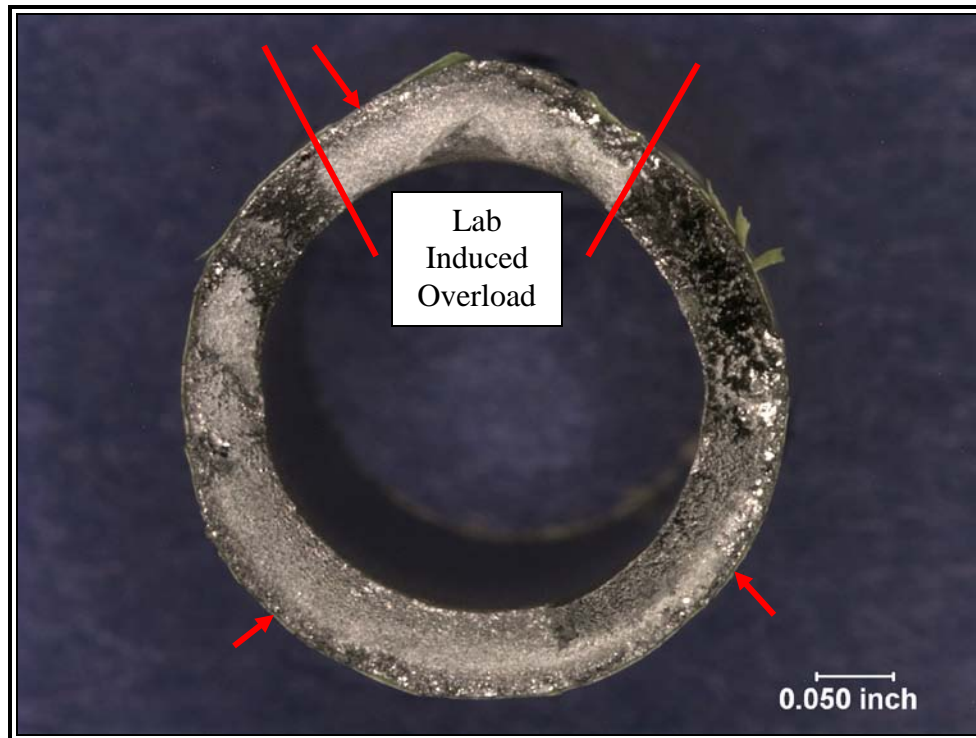
The crack on the connecting tube was opened to expose the fracture surface. In order to open the fracture surface, the center-to-aft housing assembly was sectioned as shown in Figure 8. See Figures 9 and 10 for the overall views of the fracture surface. The fracture surface exhibited a thin area of flat, shiny faceted appearance near the outer diameter around the circumference including the lab induced overload area, consistent with brittle fracture. The rest of the fracture surface was angled and exhibited a dull appearance.

Figure 9: Photomicrograph of the tube fracture surface showing shiny faceted appearance near the OD (arrows)

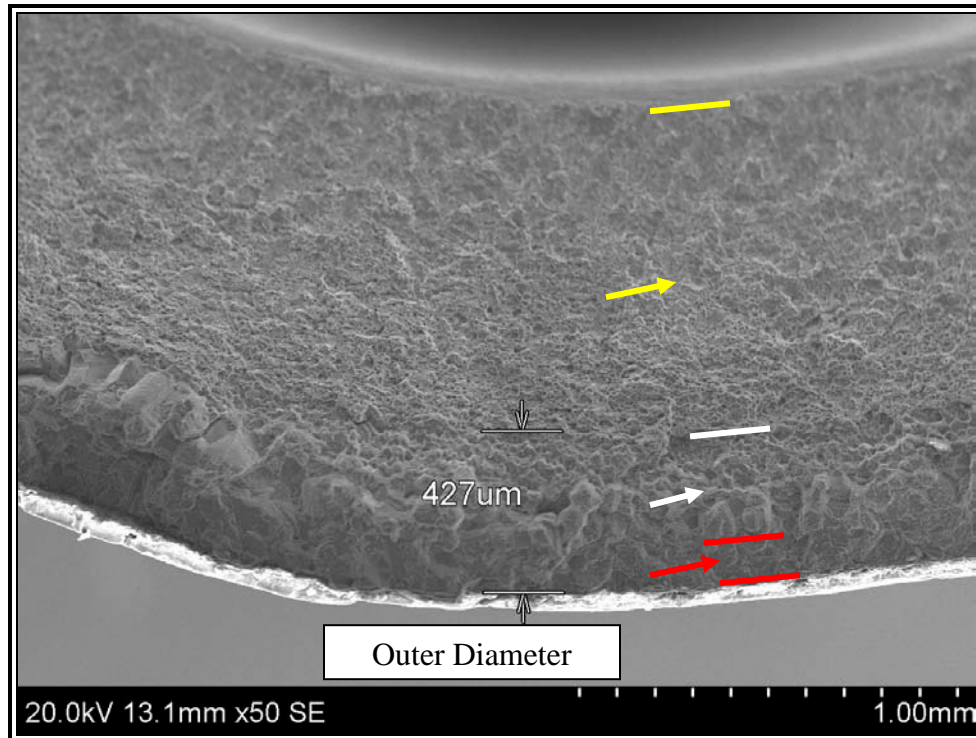
The fracture surfaces were examined using a scanning electron microscope (SEM) equipped with energy dispersive spectroscopy (EDS). See Figures 11 through 15 for SEM images from the fracture surface. The tube exhibited a thin area of interdendritic fracture at the OD, followed by a thin area of intergranular fracture appearance zones, consistent with a brittle fracture of the braze and alloyed tube areas. The rest (majority) of the fracture surface exhibited microvoid dimples, indicating ductile overload. The lab induced overload fracture surface exhibited the same zones and characteristics. No evidence of progressive cracking (i.e. fatigue) was observed.

Figure 11: SEM image of the fracture surface exhibiting interdentritic (red arrow), intergranular (white arrow), and ductile (yellow arrow) areas

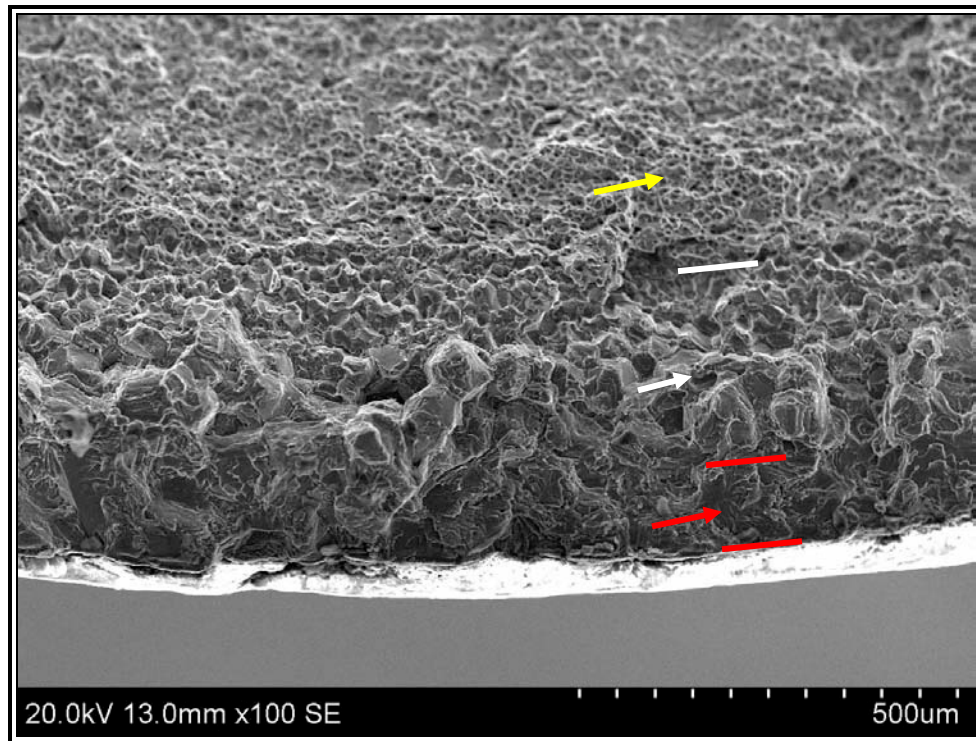
Figure 12: SEM image of the fracture surface exhibiting interdentritic (red arrow), intergranular (white arrow), and ductile (yellow arrow) areas

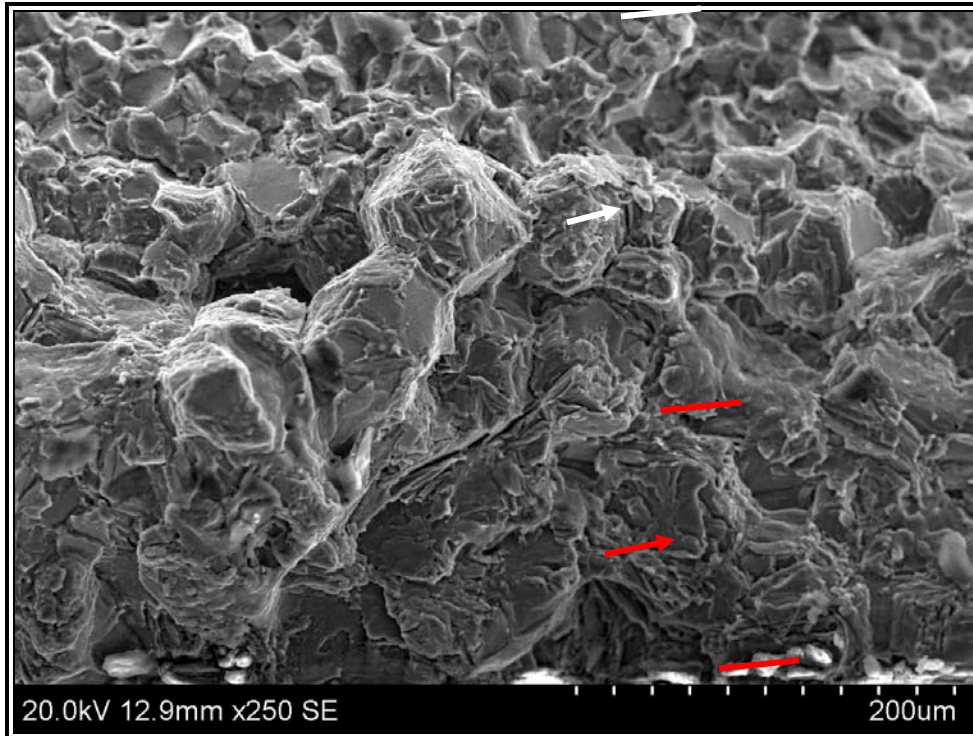
Figure 13: SEM image of the fracture surface exhibiting intergranular (red arrow) and interdendritic (white arrow) areas

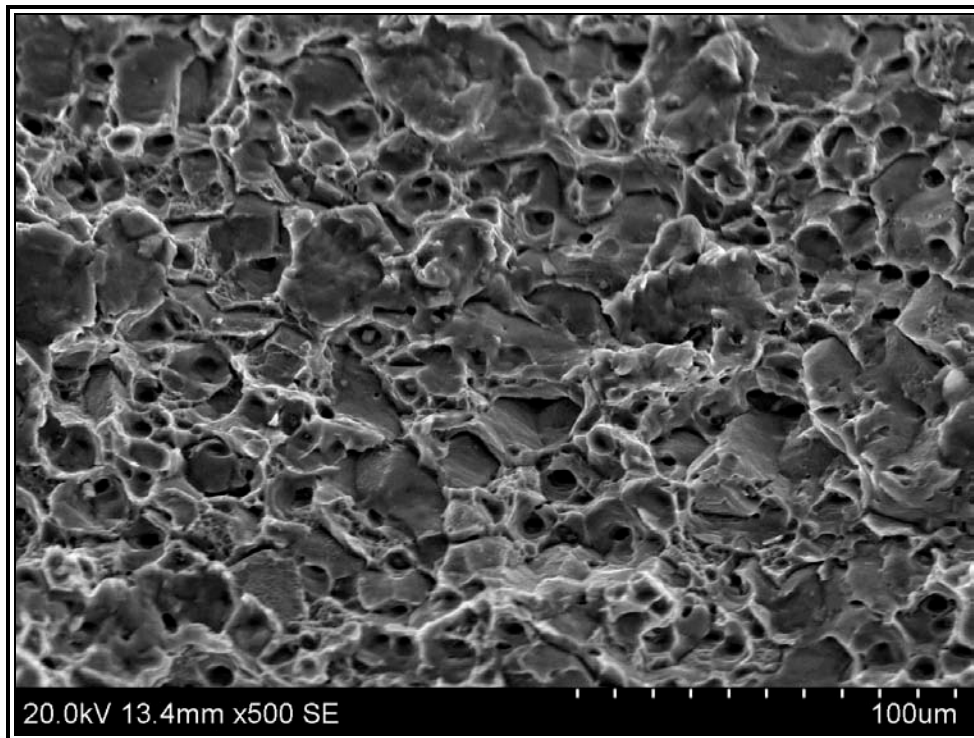
Figure 14: SEM image of the fracture surface exhibiting ductile area

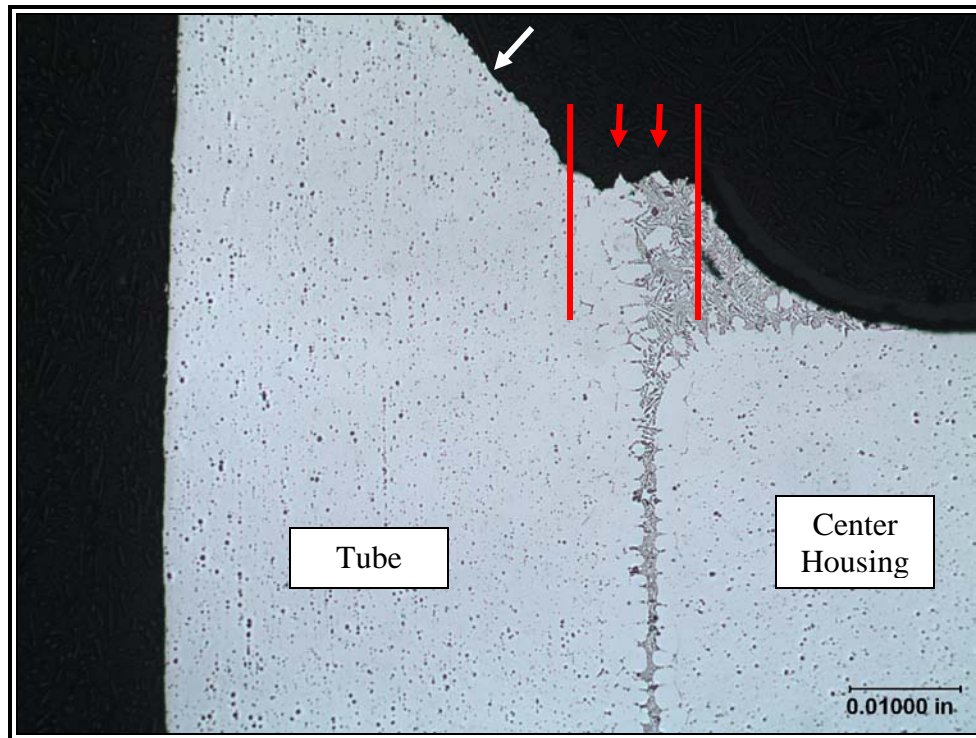
The fractured and adjacent connecting tubes were sectioned longitudinally and metallographically prepared per ASTM E 3-01(07), *Standard Practice for Preparation of Metallographic Specimens*. See Figures 17 through 22 for the photomicrographs. The failed tube fractured at the braze fillet exhibiting interdendritic/intergranular features and the crack progressed as ductile overload into the original tube material. No microstructural abnormalities were observed. Some alloying of the braze material with the tube material was observed; however, no maximum alloying depth requirement was specified in MIL-B-7883B brazing specification. Both tubes exhibited some areas with no braze coverage; however, these areas were not near the fracture location. The adjacent tube sample exhibited cracks in the coating. Some shallow cracks were observed in the braze fillet area, which aligned with the paint cracks.

Figure 17: Photomicrograph of the failed tube sample's section showing the fracture origin at the braze fillet (red arrows) and the ductile fracture of the original tube material (white arrow)

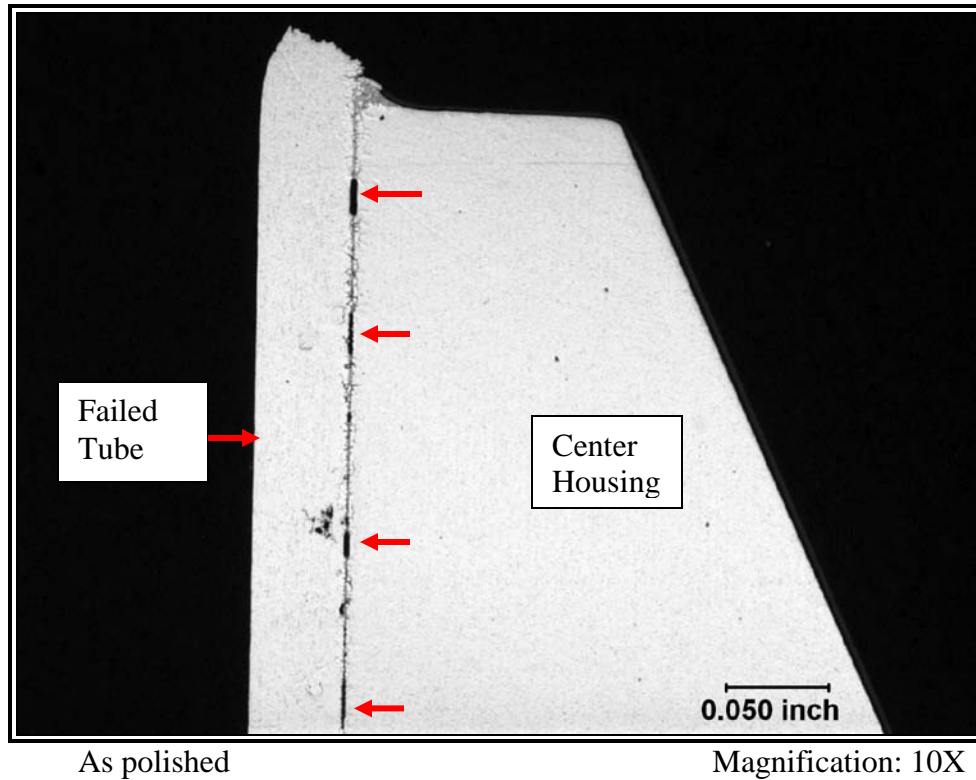
Figure 20: Photomicrograph of the failed tube sample's section showing the areas with lack of braze coverage (arrows)

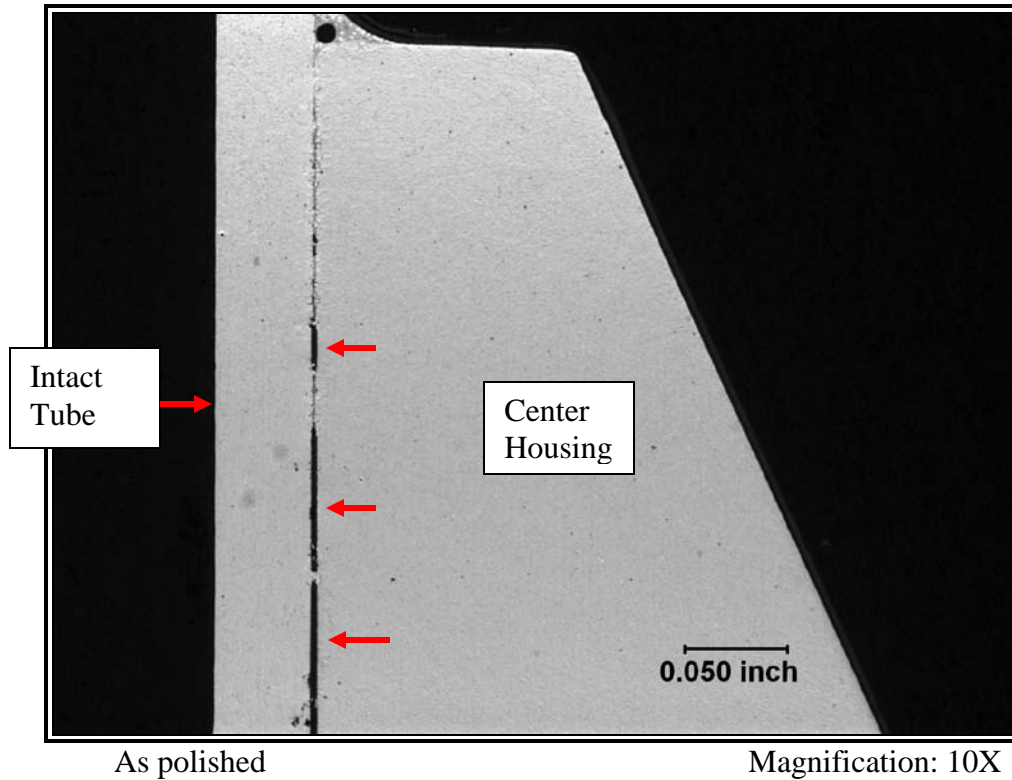
Figure 21: Photomicrograph of the intact tube sample's section showing the areas with lack of braze coverage (arrows)

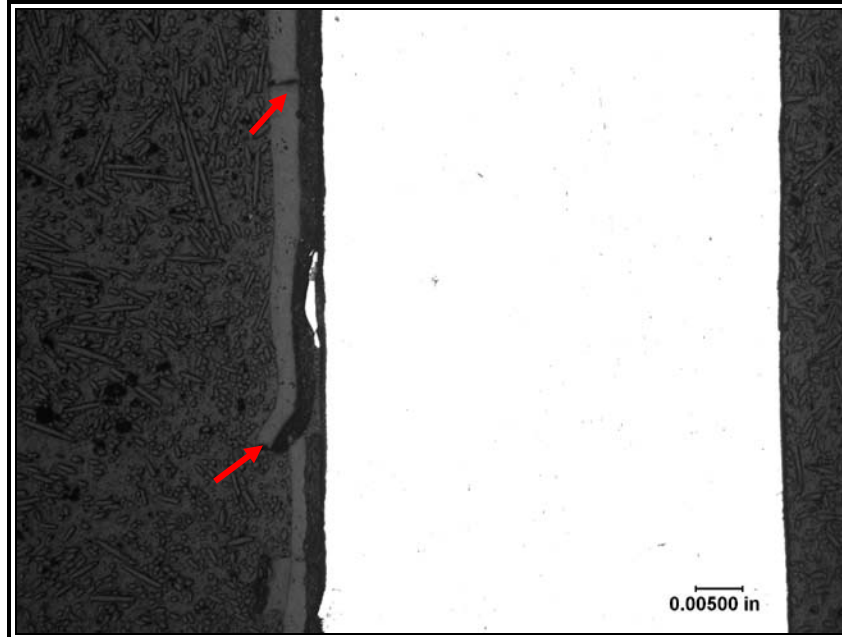
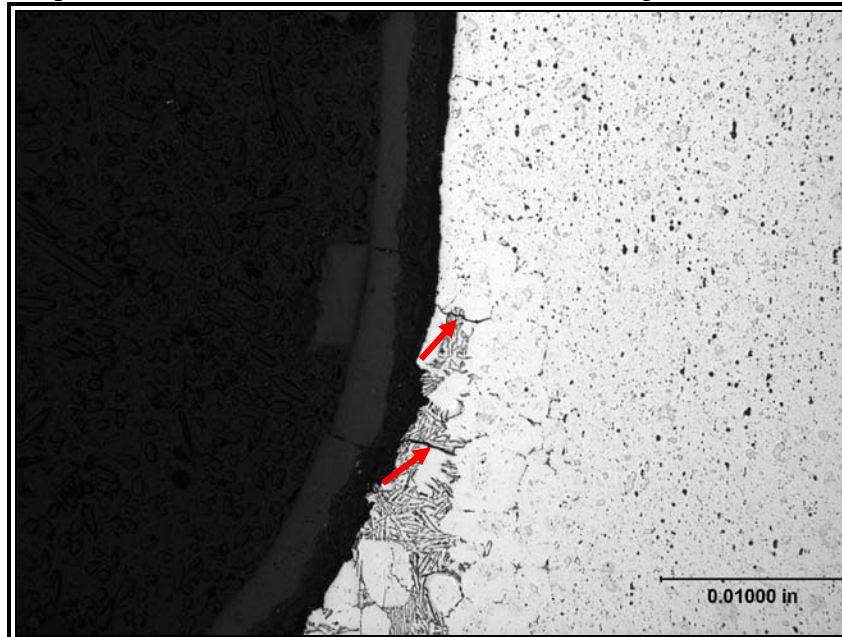
Figure 22: Photomicrographs of the intact tube sample's section showing the paint cracking (top, arrows) and some cracks in the braze fillet, aligned with paint cracking (bottom, arrows)

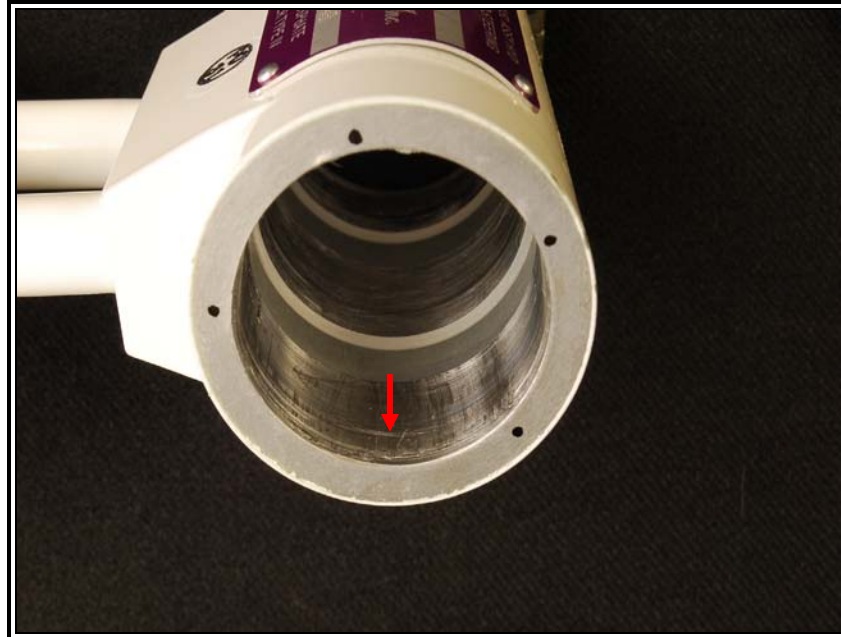
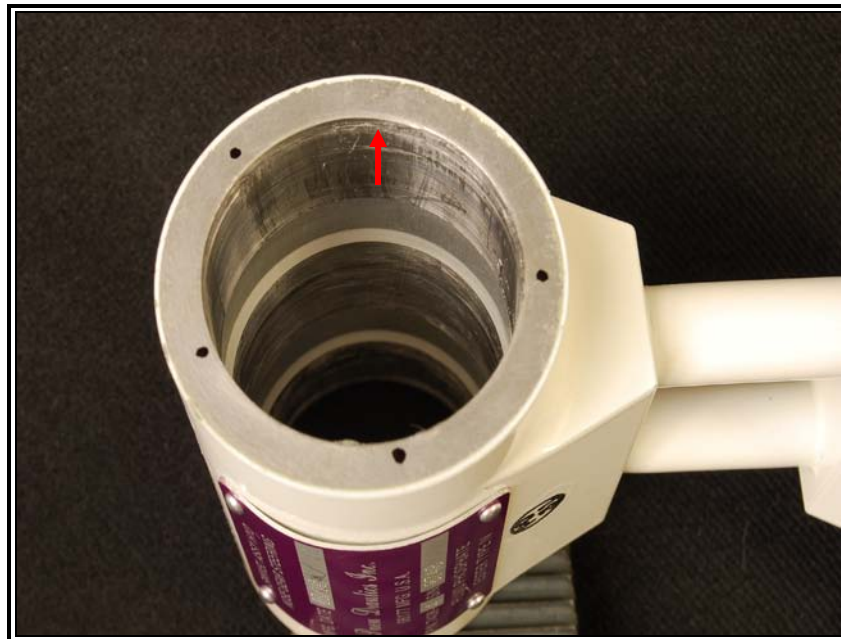
The visual examination of the housing and spool samples revealed some wear/galling on the inner diameters of the housings and the matching spool samples (Figures 23 through 29). The center housing and the spool exhibited severe galling around the circumference on the matching surfaces at the outboard and inboard side of the swivel assembly. The other housings and spools also exhibited some damage in similar areas; however, they were more localized and less severe.

The spool and housing components exhibited wear/galling at the matching surfaces that reportedly should not have been in contact. The center spool and housing at the outboard locations exhibited the most severe damage. No evidence of a foreign abrasive material contamination that may have caused this damage was observed. The spool and housing samples did not exhibit any microstructural abnormalities and mostly met the heat treatment requirements with the exception of the aft spool and center housing having slightly lower hardnesses than AMS 2658B requirements. The housing samples did not exhibit anodized layers on the spool contact surfaces. The rest of the areas of the spool and housing samples exhibited thicker anodized layers than the customer supplied requirements. Possible contributions, if any, of the lack of anodizing at the housing side of the contact surfaces and thicker than the required anodizing at the spool side of contact surfaces are unknown at this time. The t-seals and backing rings from the spools exhibited normal hardness and material properties.

Given the above observations, the swivel assembly failure was most likely caused by overloading of the connecting tube due to seizure of the spool/housing assembly. The seizure may have been caused by dimensional and/or assembly (i.e. misalignment) issues, which could not be fully assessed from the supplied components, already disassembled. The root cause of the housing/spool seizure should be investigated by the involved parties using the supplied and/or additional analyses, including but not limited to dimensional, stress, and evaluation of the assembly procedures/practices.

Figure 23: Photographs of the center housing outboard side showing wear (arrows)

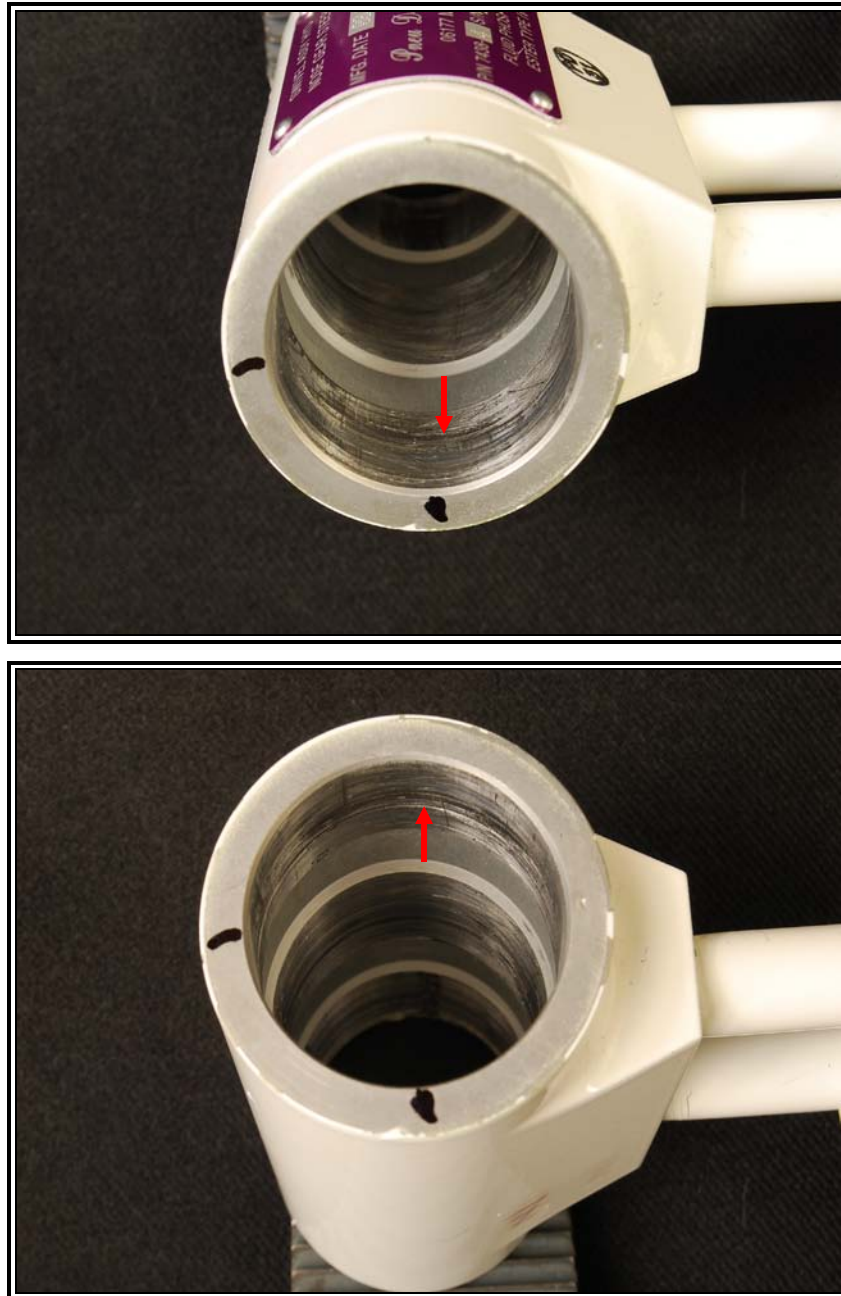
Figure 24: Photographs of the center housing inboard side showing wear (arrows)

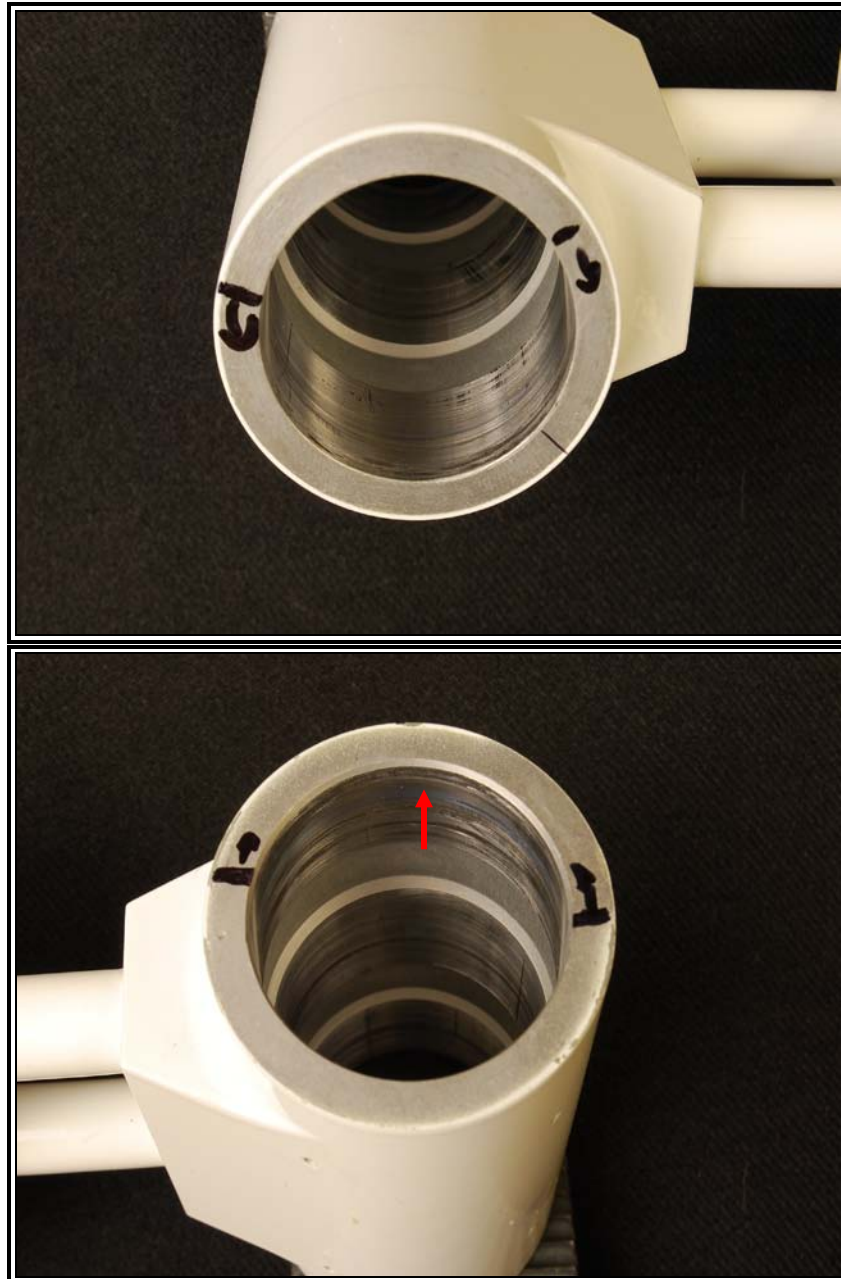
Figure 25: Photographs of the aft housing outboard side showing wear (arrow)

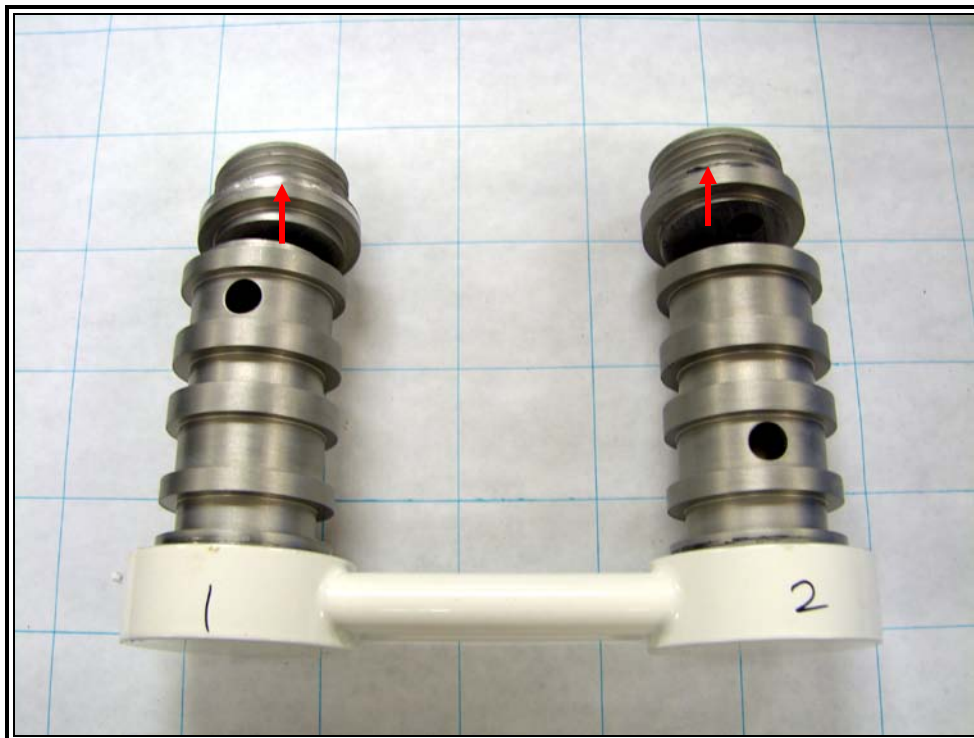
Figure 28: Photograph of the sectioned center (left) and the forward (right) spools showing wear (arrows)

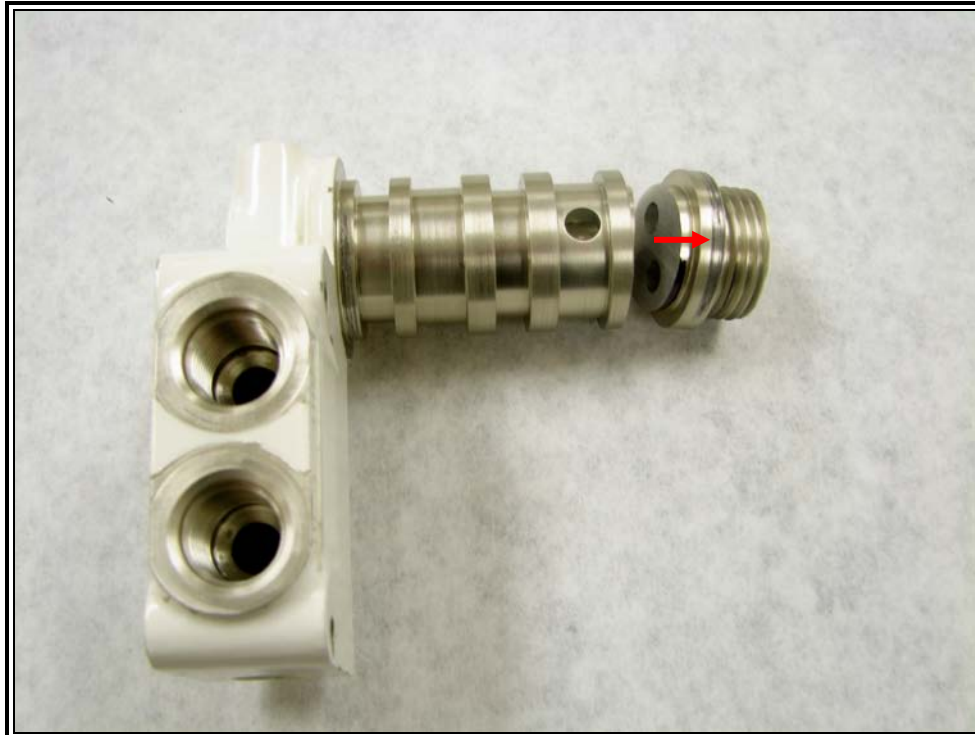
Figure 29: Photograph of the sectioned aft spool showing wear (arrow)

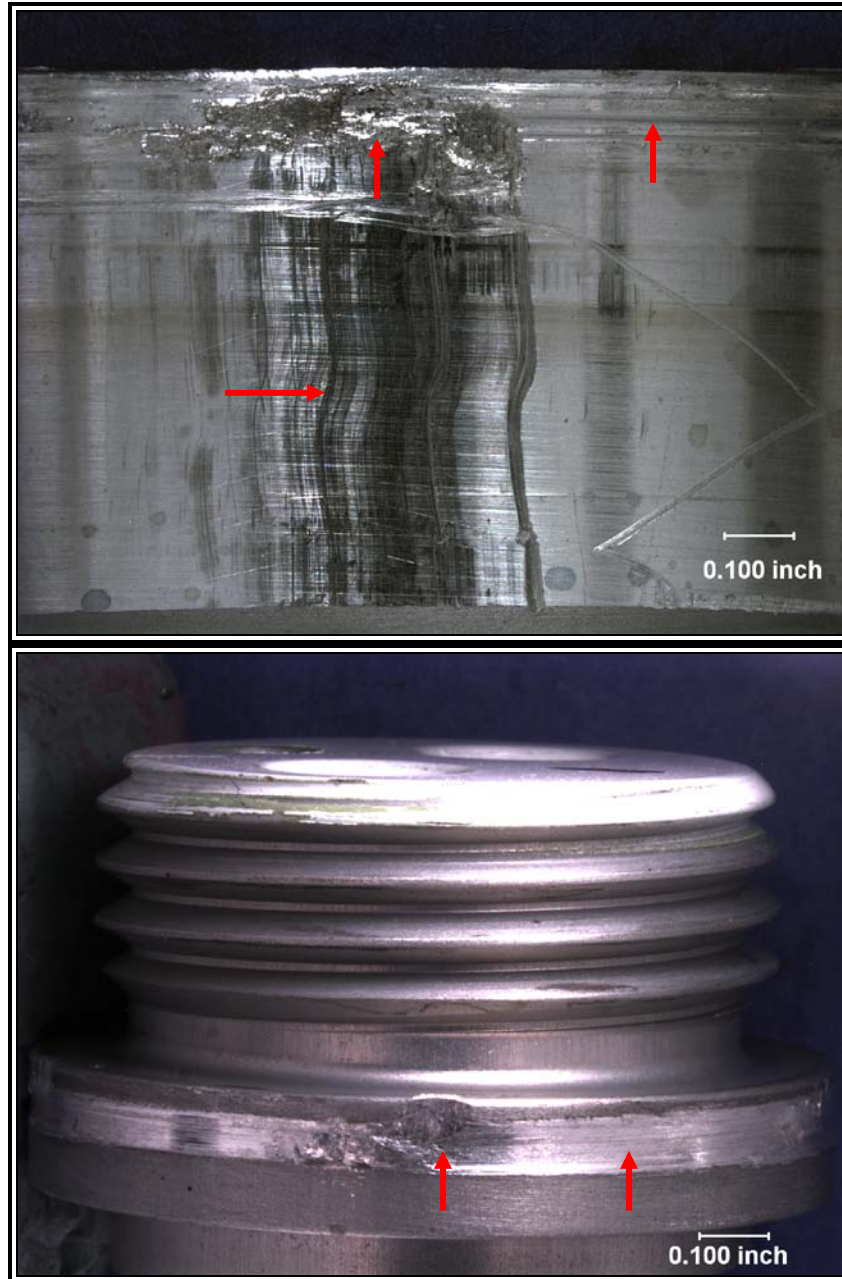
The housing and spool samples were sectioned to expose worn/galled areas for further examination. See Figures 30 through 32 for photomicrographs. The center housing sample exhibited a circumferential wear pattern at the inner diameter at the outboard location. Also, other wear marks that were perpendicular to the circumferential wear were observed approximately every 90°. The matching area of the center spool showed a similar pattern. Pneudralics personnel reported that these longitudinal marks may have been due to post-incident disassembly. The aft and forward components exhibited partial wear and were less severe.

Figure 30: Photomicrographs (4X magnification) of the center housing (top) and the spool (bottom) showing severe wear (arrows)

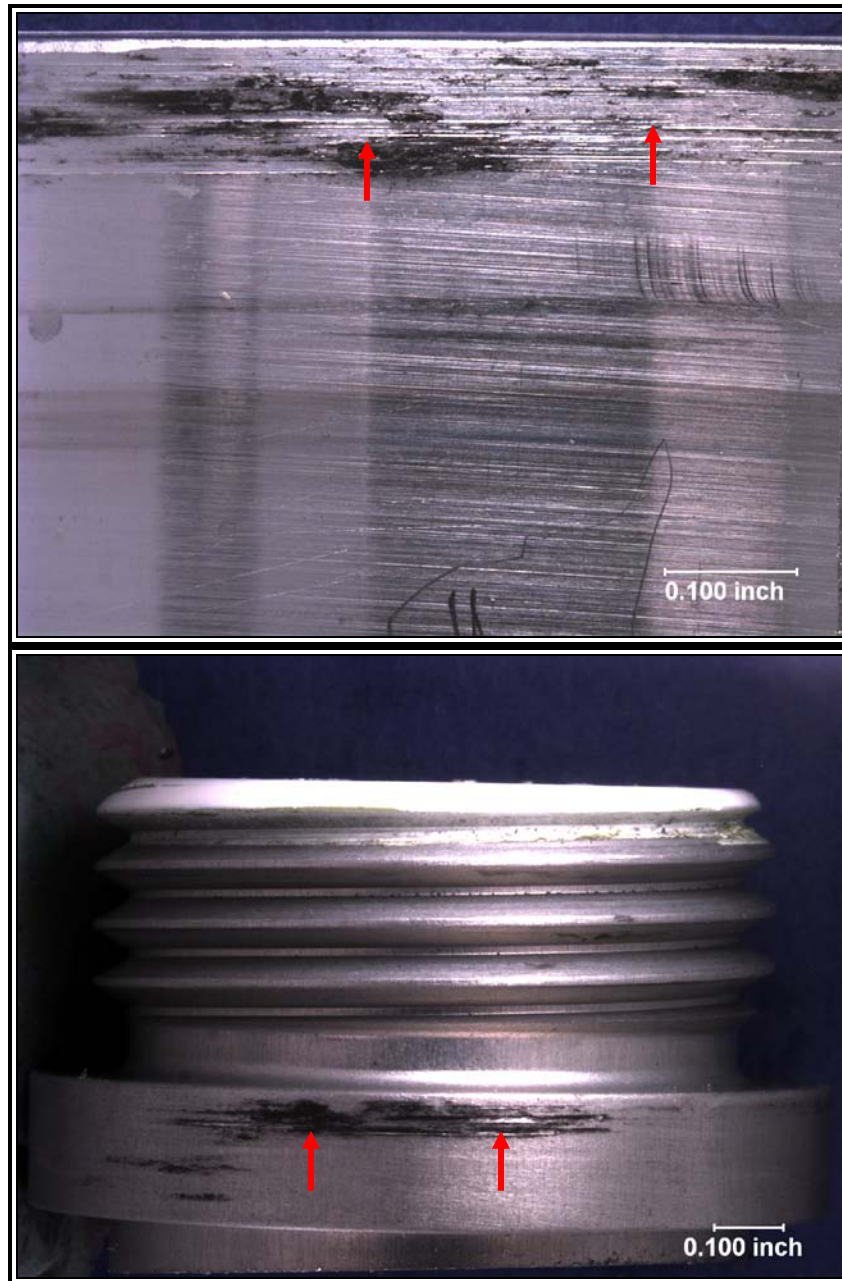
Figure 31: Photomicrographs (4X magnification) of the forward housing (top) and the spool (bottom) showing wear (arrows)

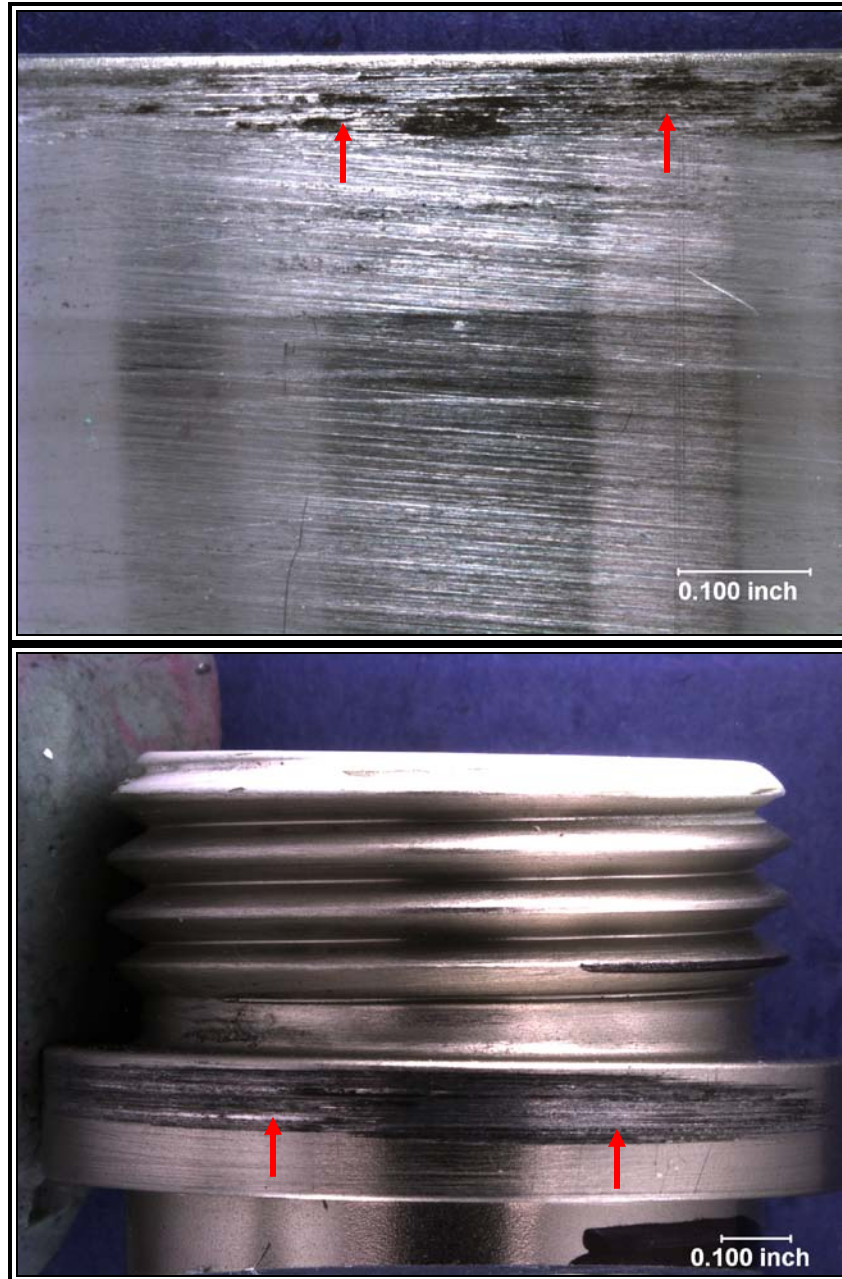
Figure 32: Photomicrographs (4X magnification) of the aft housing (top) and the spool (bottom) showing wear (arrows)

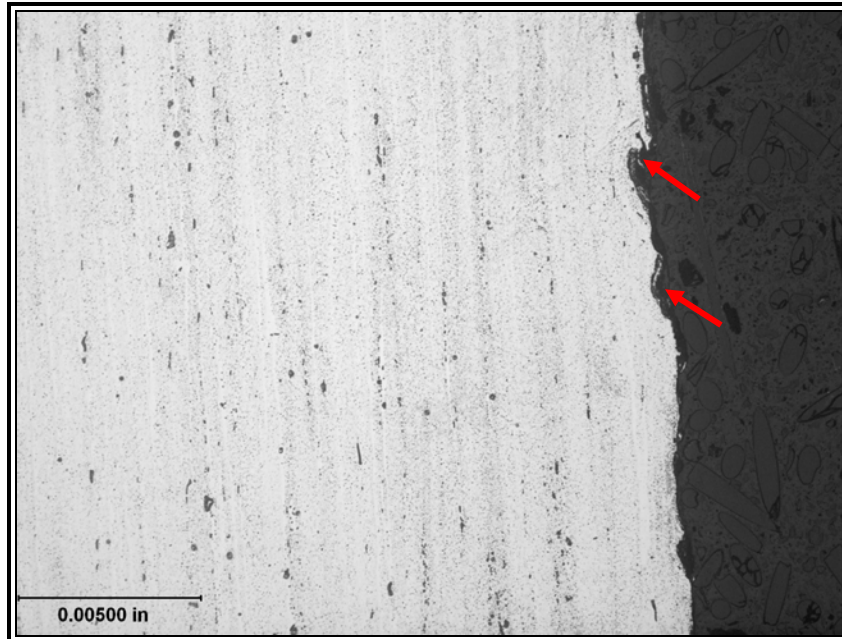
Figure 42: Photomicrographs of the aft housing sample's section showing the damaged (top, arrows) and unaffected (bottom) areas

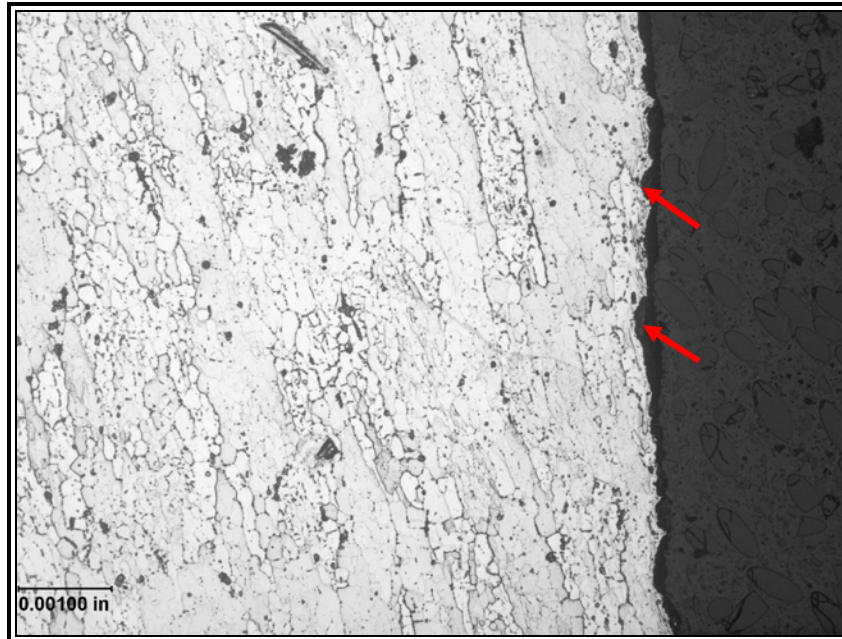
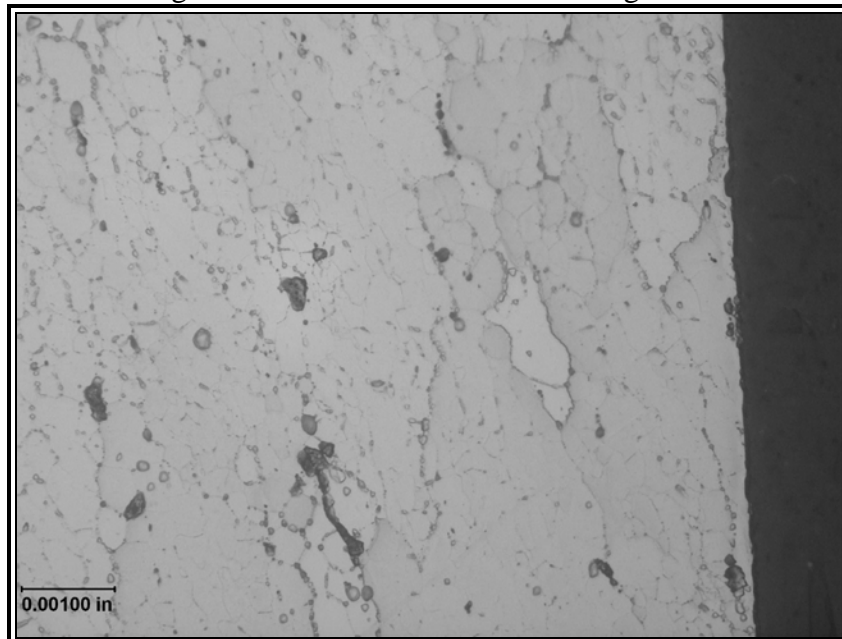
Figure 43: Photomicrographs of the forward housing sample's section showing the damaged (top, arrows) and unaffected (bottom) areas
