INVESTIGATION OF SWIVEL ASSEMBLY FAILURE, P/N 7438-4, S/N 0748

ATS JOB # D166449 Rev. 1*

Investigation of Swivel Assembly Failure, P/N 7438-4, S/N 0748 removed from A/C 5305

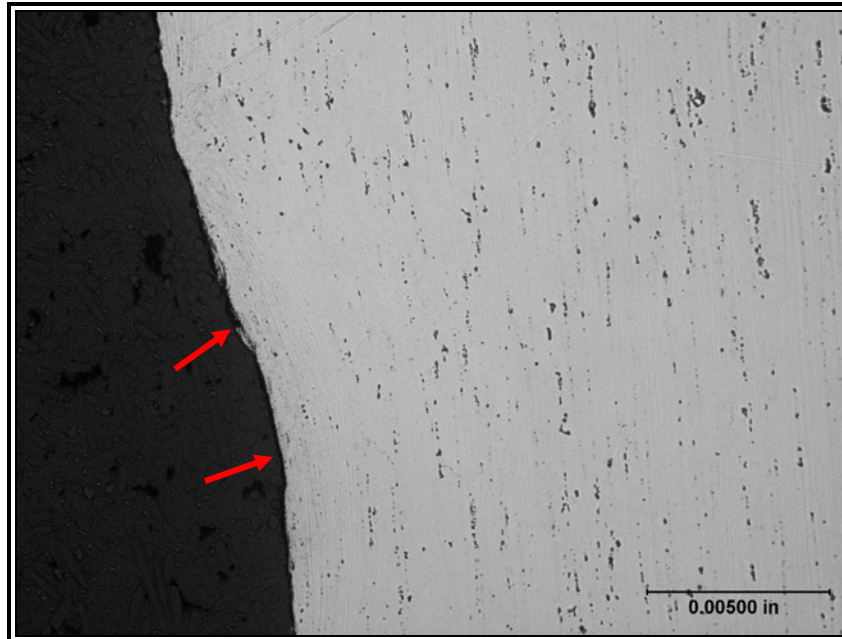
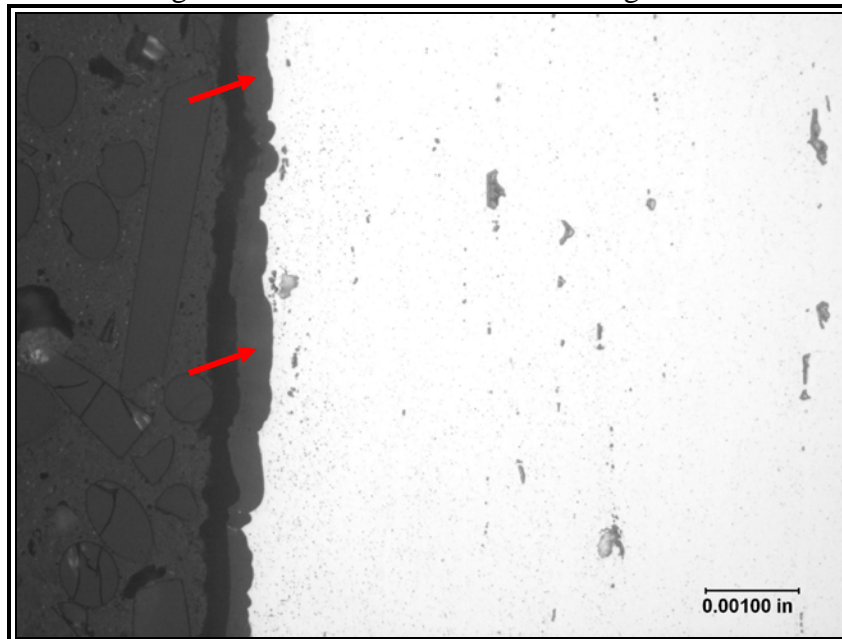
Figure 44: Photomicrographs of the center spool sample's section showing the damaged (top, arrows) and unaffected (bottom) areas

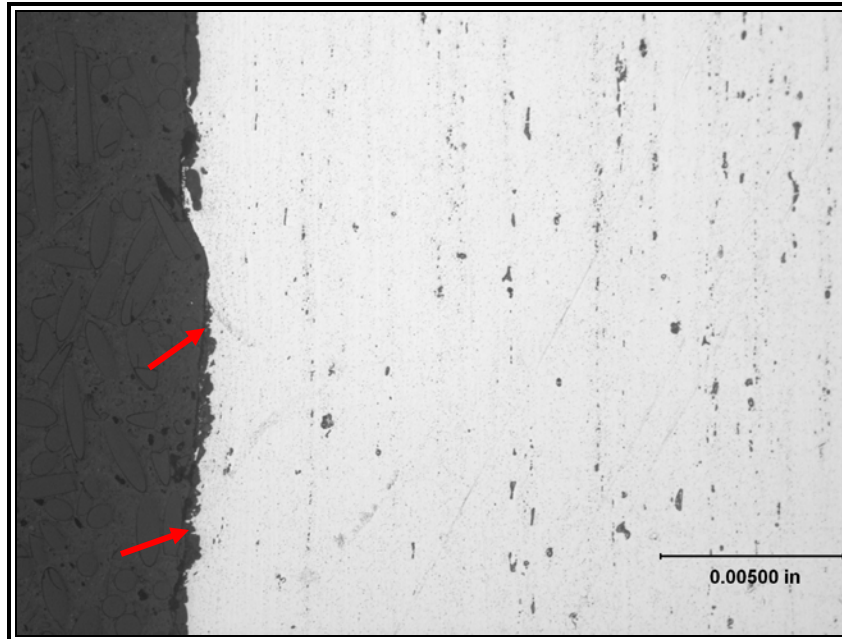
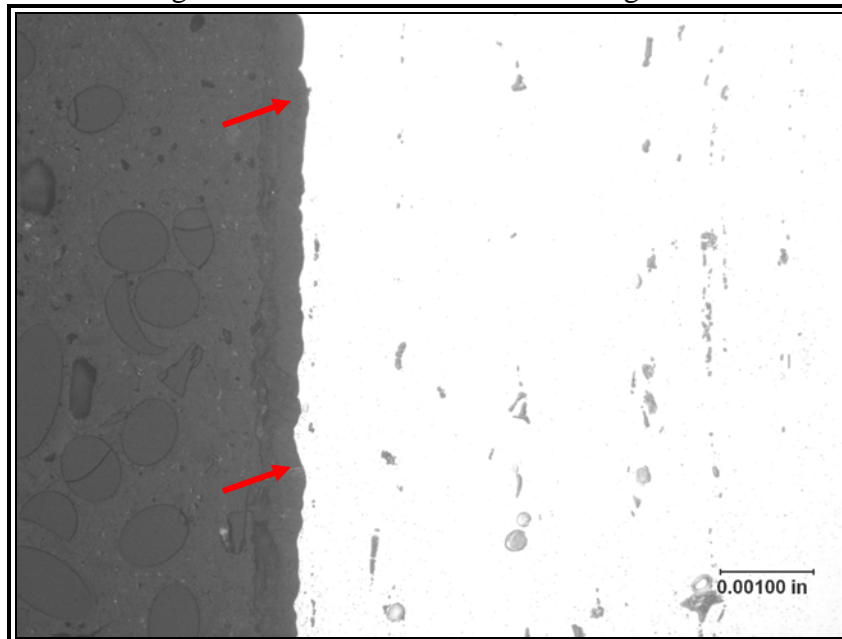
Figure 45: Photomicrographs of the forward spool sample's section showing the damaged (top, arrows) and unaffected (bottom) areas

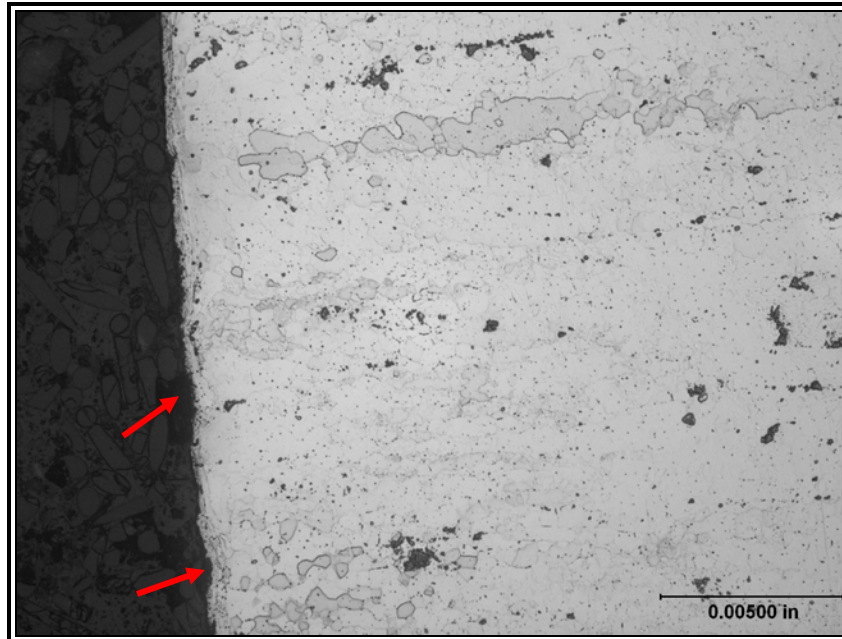
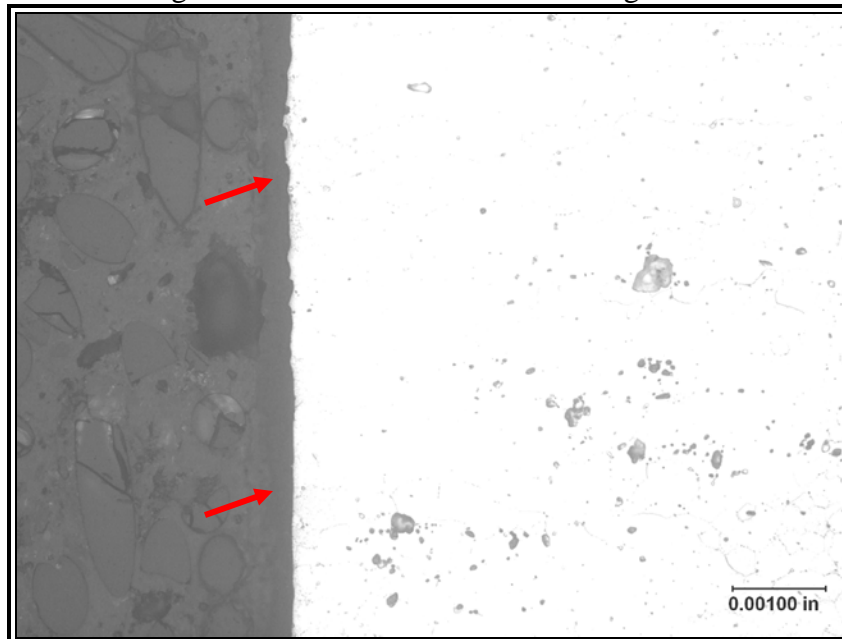
Figure 46: Photomicrographs of the aft spool sample's section showing the damaged (top, arrows) and unaffected (bottom) areas
Note the anodizing in the unaffected areas (bottom, arrows)
