Communication Summary

October 17, 2017

Left Main Landing Gear Bolt

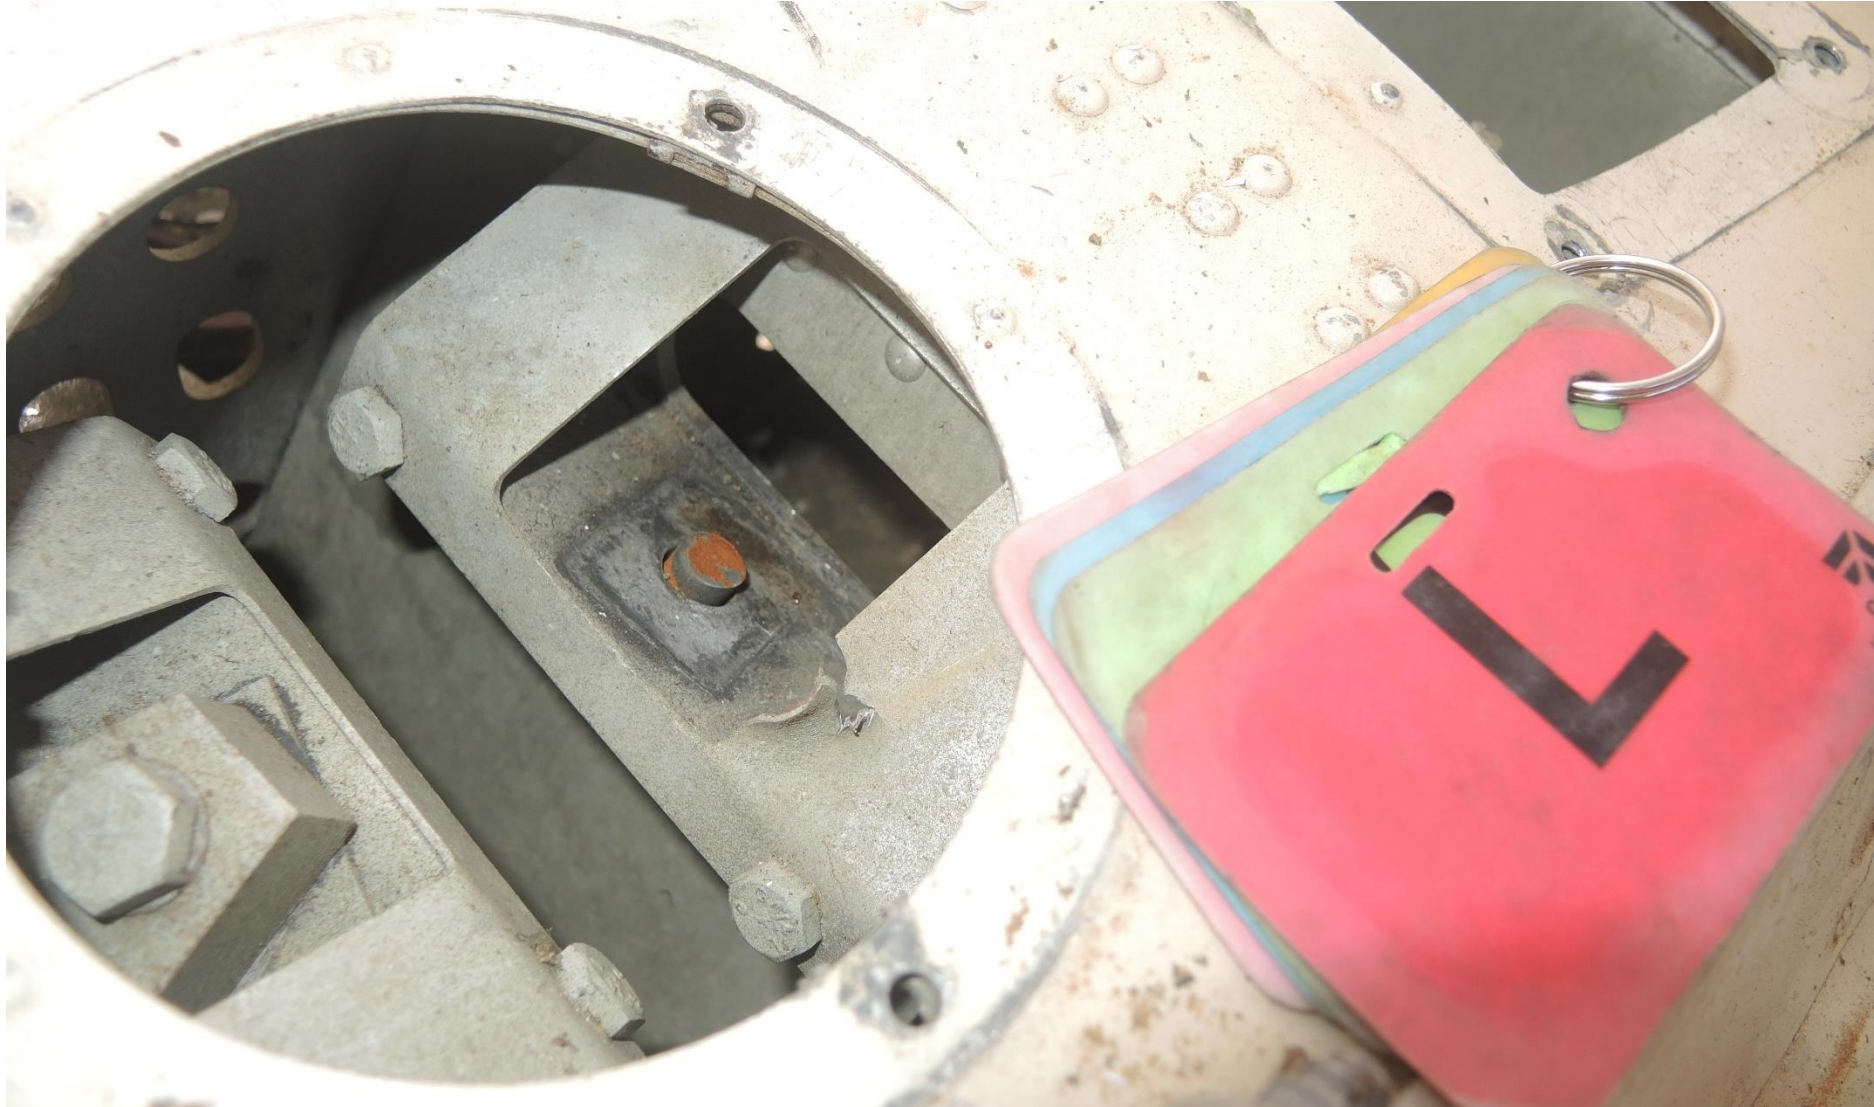
Summary & Factual Information: Mr. Bauer reported that he took a look at the bolt section with a microscope and also with a couple of Materials Laboratory personnel. The bolt had signs of reverse bending fatigue in the area of the threads and then an overload condition to complete the break on both ends.
