Communication Summary

February 27, 2019

Information from: Ms. Nancy McAtee, NTSB Chemist

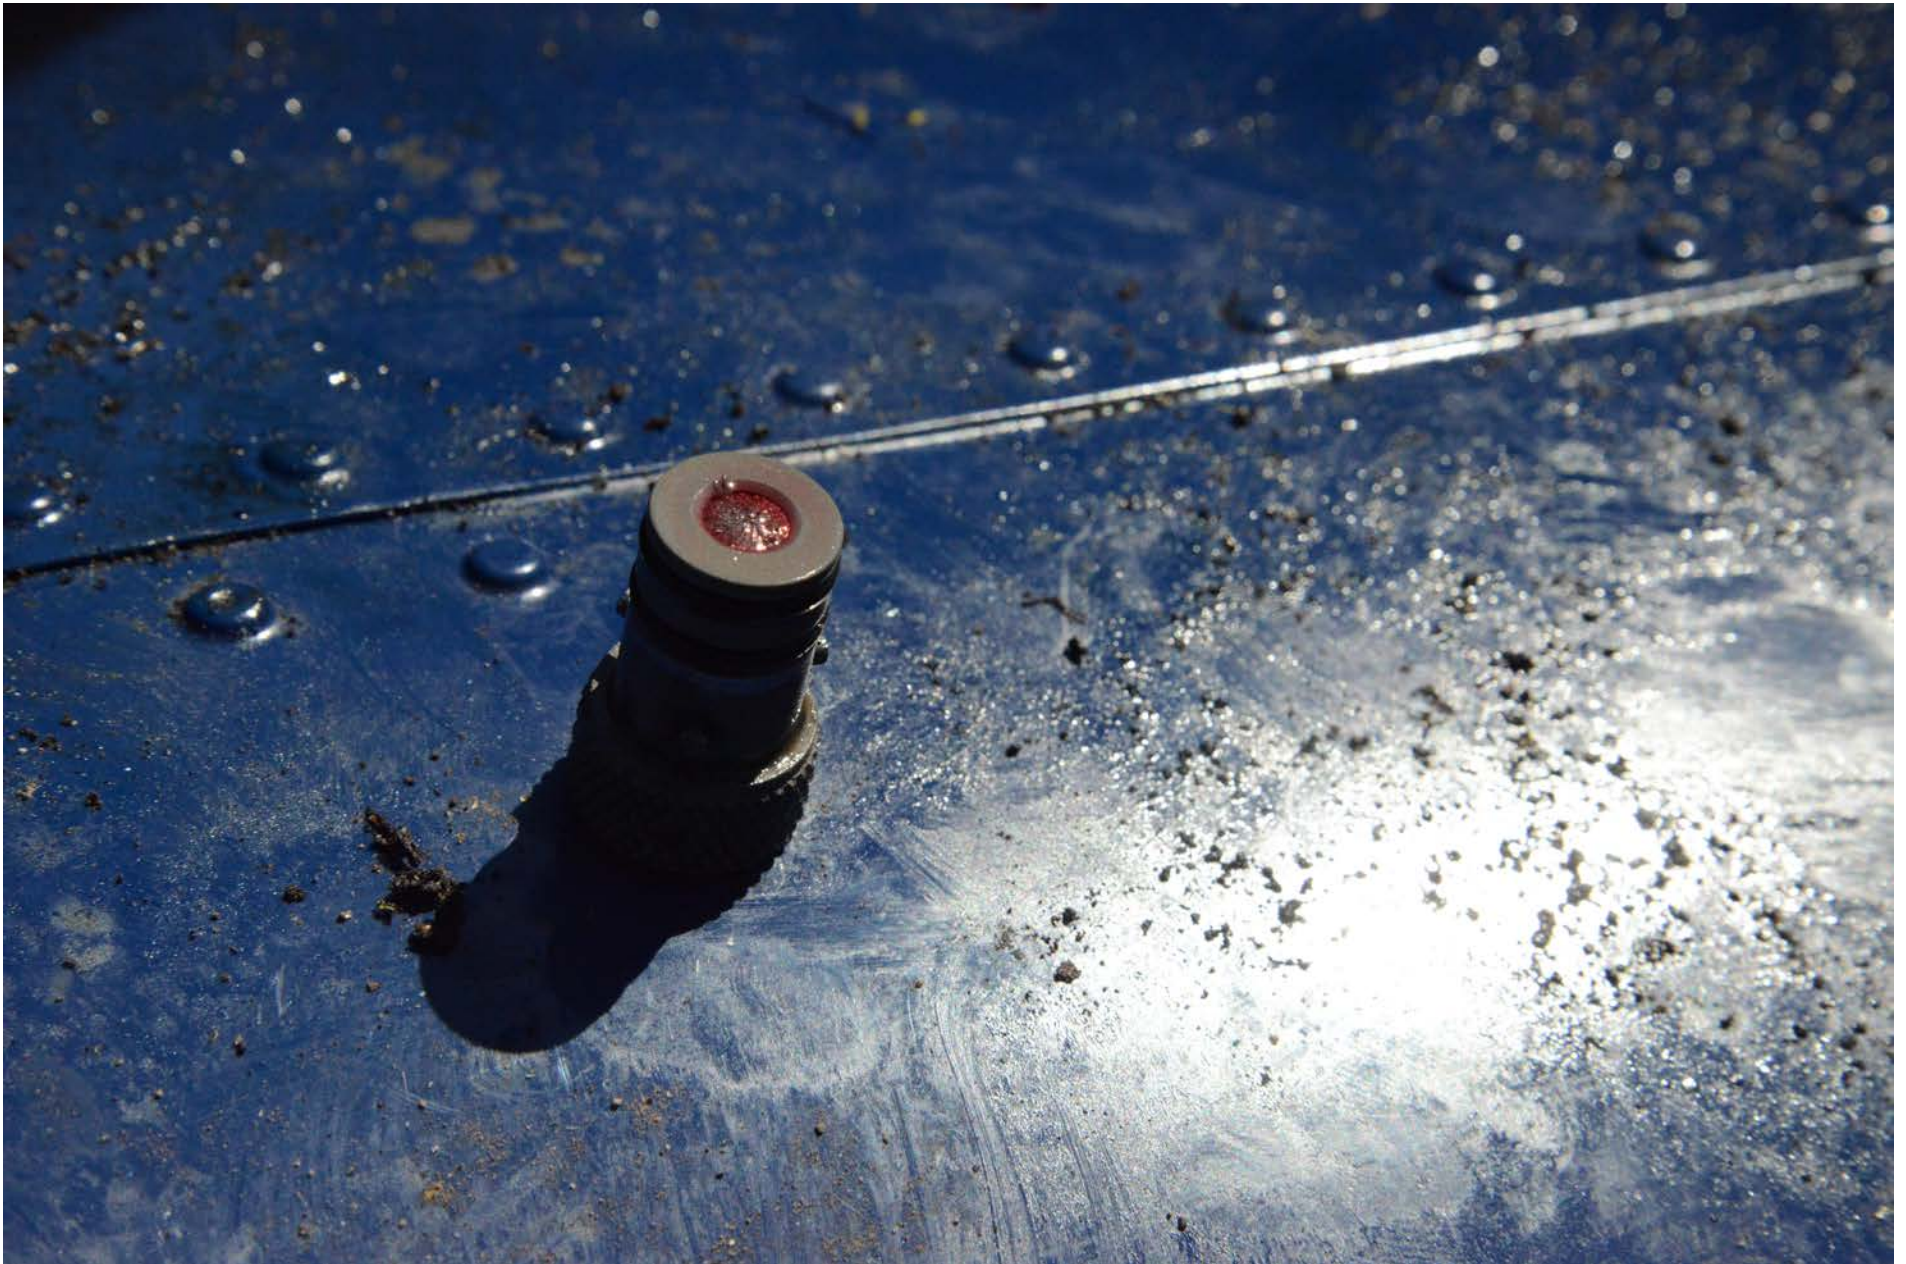
Summary & Factual Information: Ms. McAtee was sent a magnetic plug from the hydraulic system on N127LN along with an exemplar magnetic plug. The top of the magnetic plug was not recovered in the field. She was asked to examine the accident plug for any material that may be present on it and to characterize it.

Photo 1 – View of the removed hydraulic system magnetic plug during recovery of the helicopter.

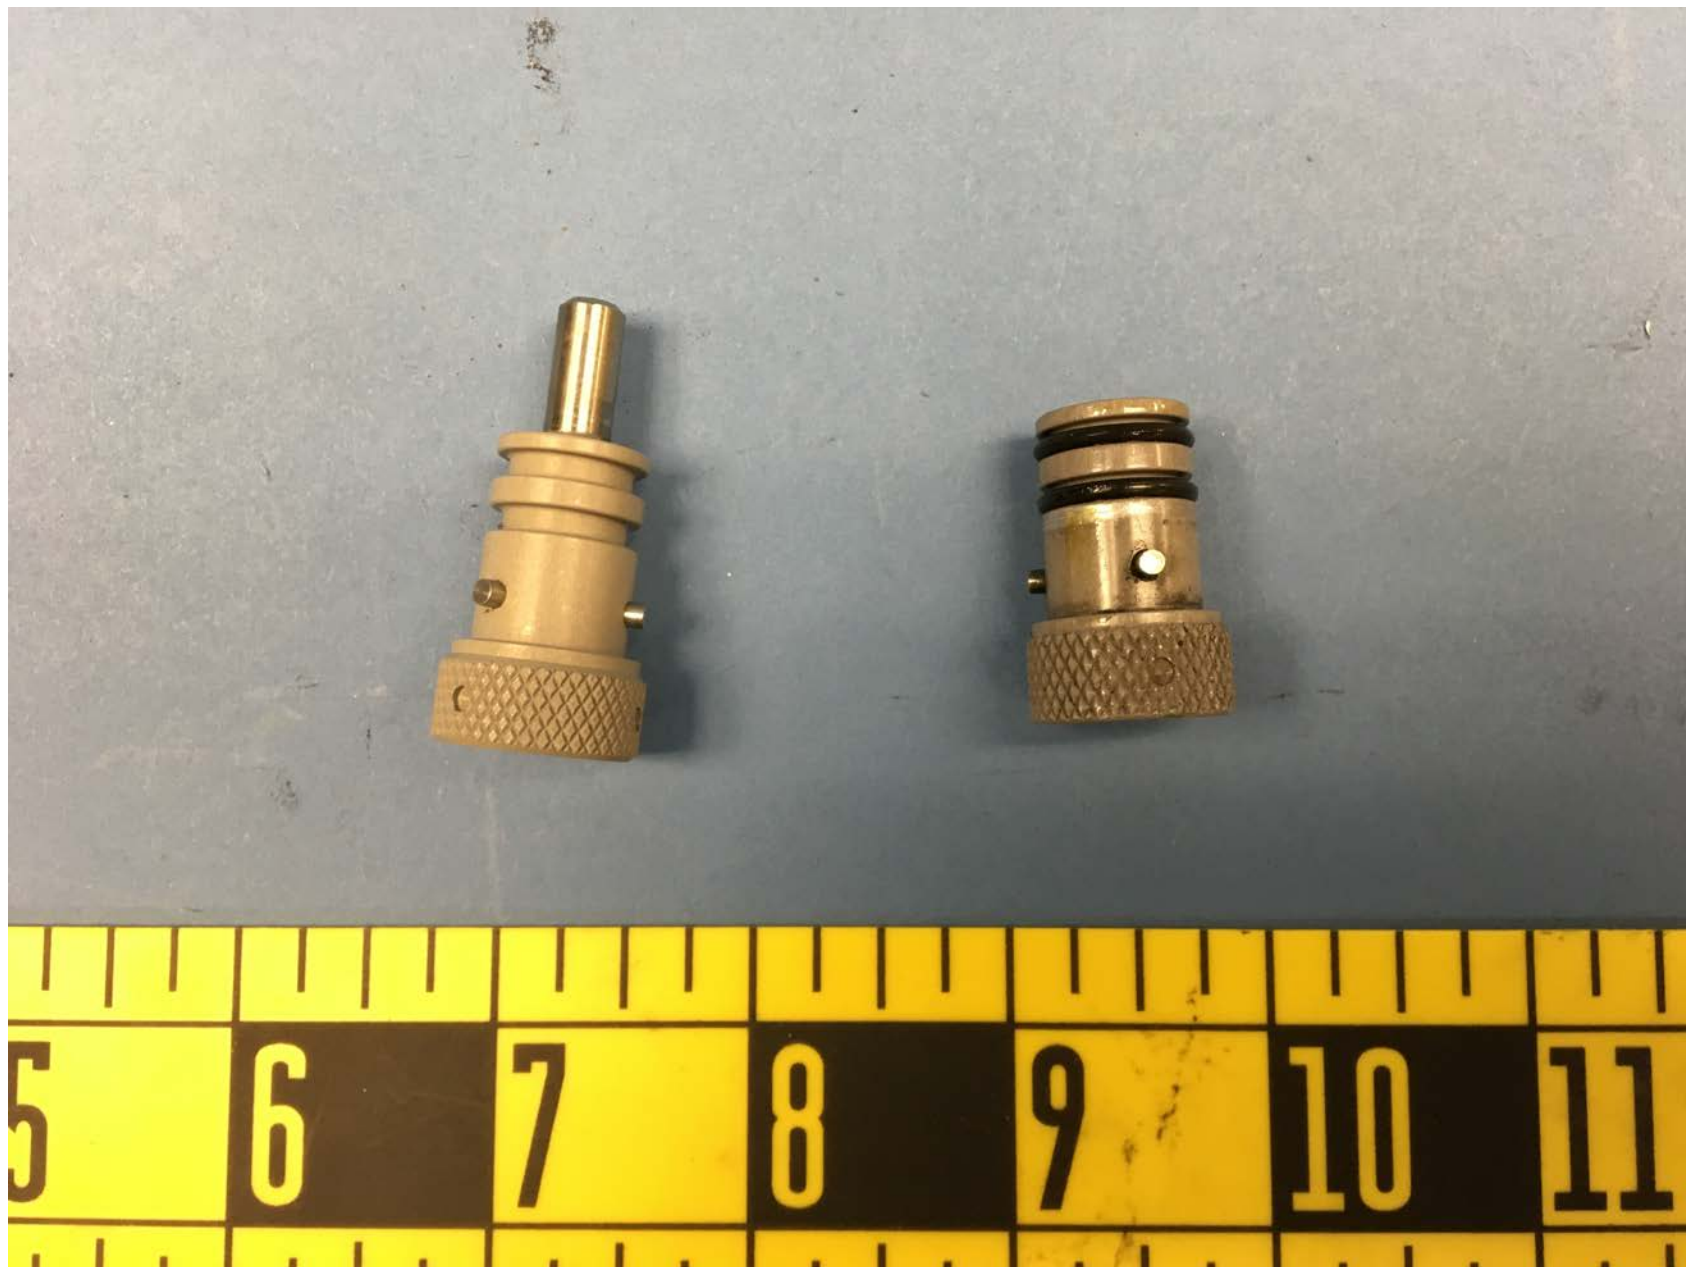
She, in part, reported that, "A fractured mag plug from the accident aircraft was submitted to the Materials Laboratory for examination. The top of the fractured area was swabbed with a cotton swab to remove any potential residue present. The swab was examined using a Fourier Transform Infrared (FTIR) spectrometer with a diamond attenuated total reflectance (ATR) accessory in accordance to ASTM E1252-98 (American Society for Testing Materials E1252-98: Standard Practice for General Techniques for Obtaining Infrared Spectra for Qualitative Analysis). The spectrometer was used to collect and process infrared wavelength absorbance spectra of the unknown material(s).

Photo 2 - Side view of the removed hydraulic system magnetic plug and an exemplar magnetic plug during the laboratory examination.

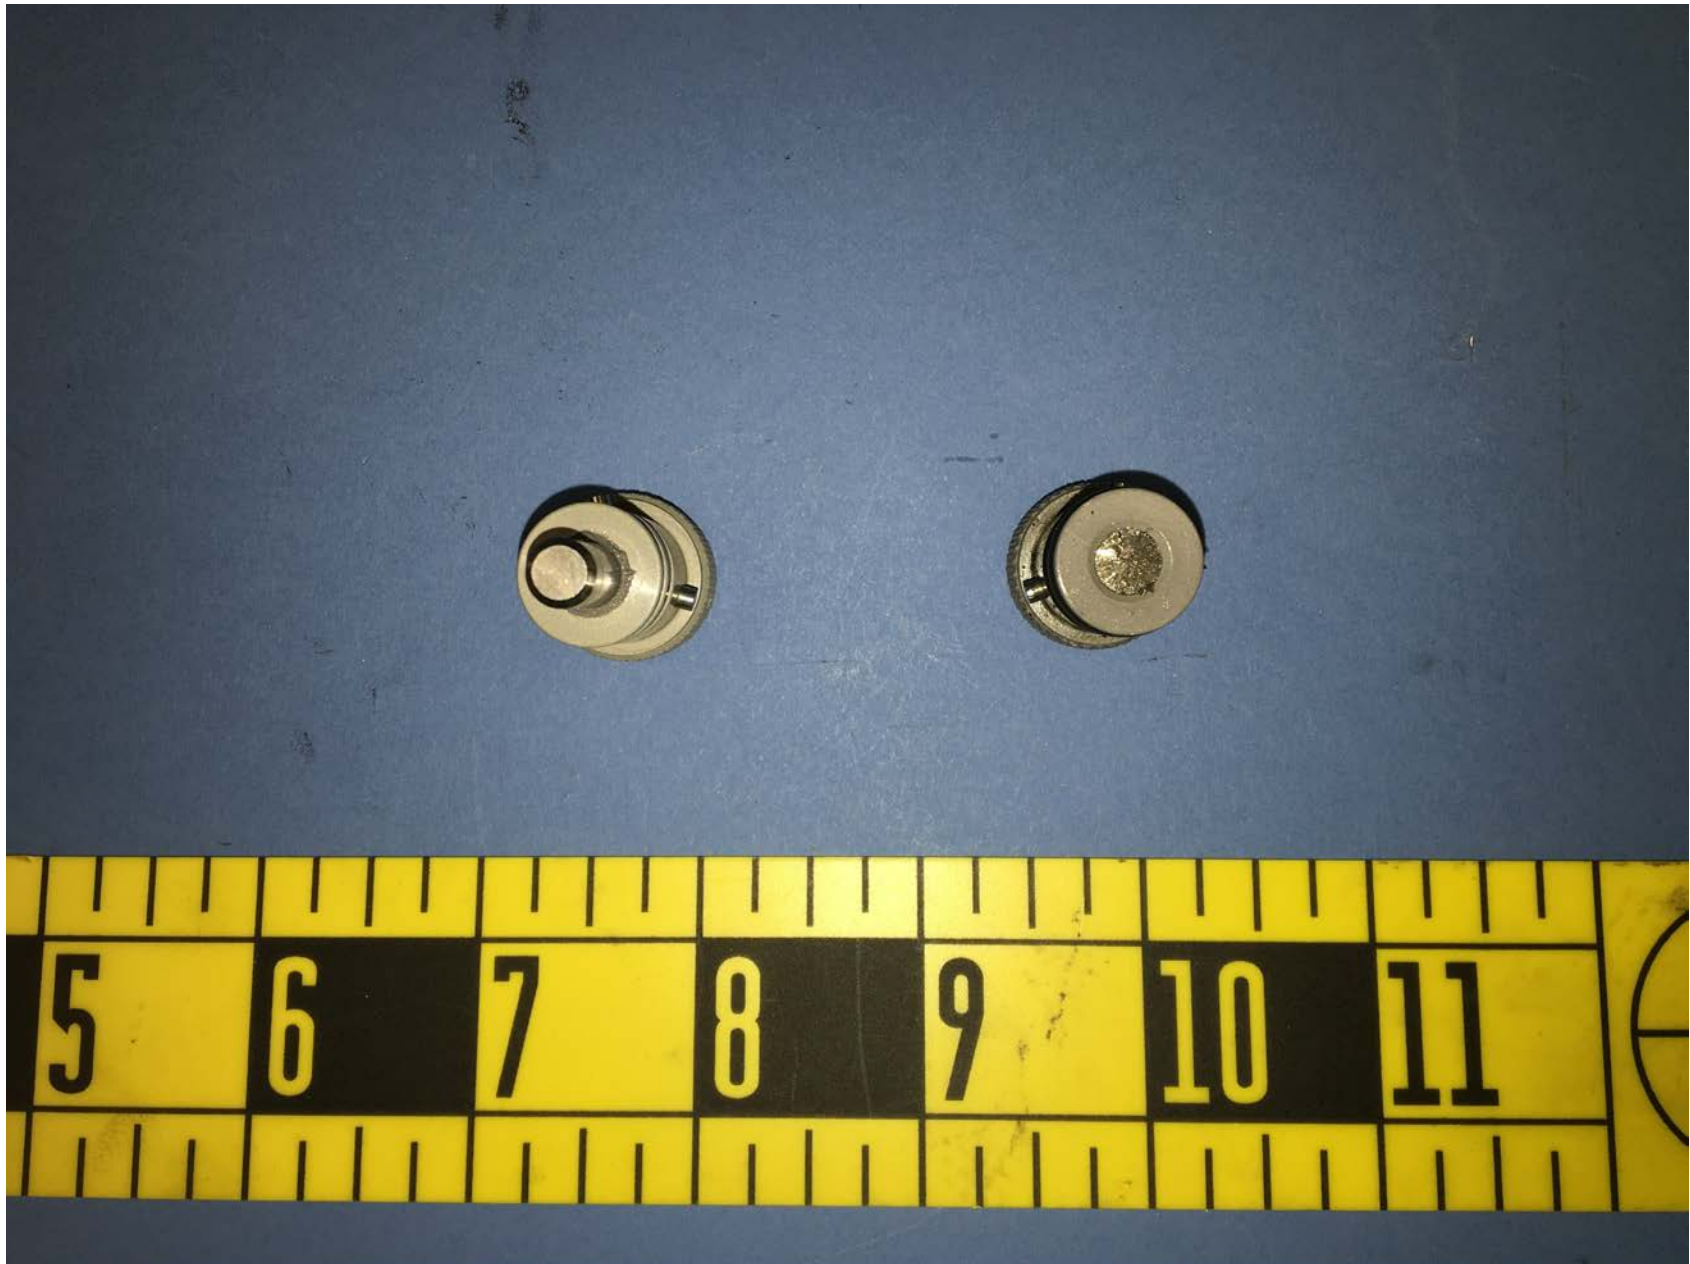
Photo 3 - Overhead view looking down at the removed hydraulic system magnetic plug and an exemplar magnetic plug during the laboratory examination.
