PREPARED BY Greg Burns	<i>PneuDraulics, Inc</i> (R) CA 91730-4591	PAGE 1 of 11	
DATE 4/15/2011		TITLE INVESTIGATION REPORT	REV B

INVESTIGATION REPORT RELATING TO
NTSB/GULFSTREAM/GOODRICH/PDI
JOINT INVESTIGATION ON
PN 7438-4, SWIVEL ASSEMBLY, NOSE GEAR
SERIAL NUMBER 0748
AS USED ON GULFSTREAM G550 AIRCRAFT N535GA

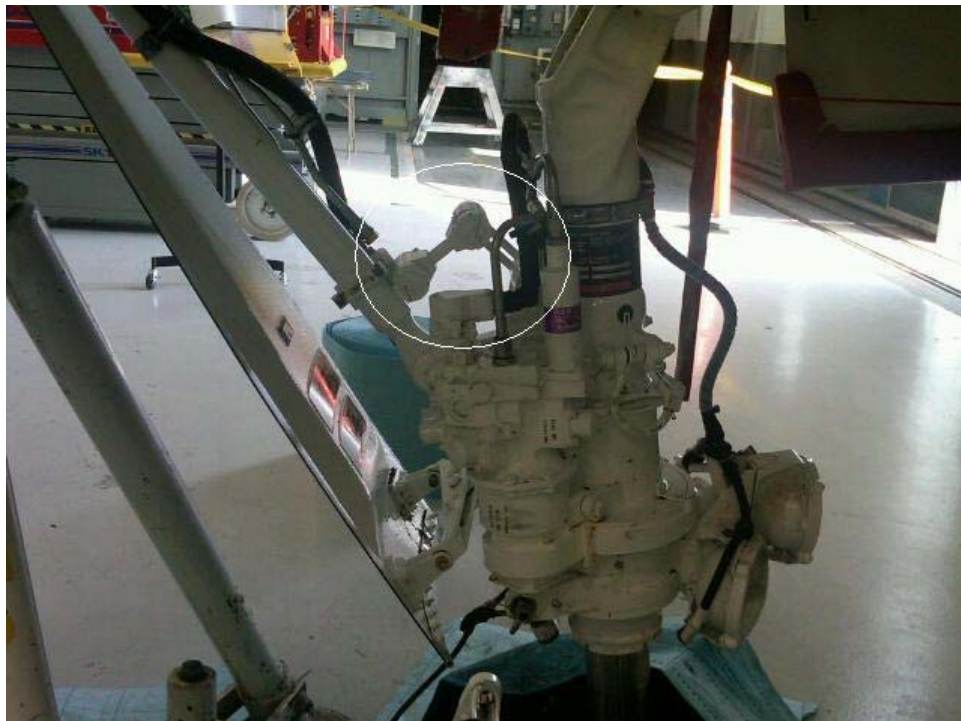
Photo 1, Swivel Location

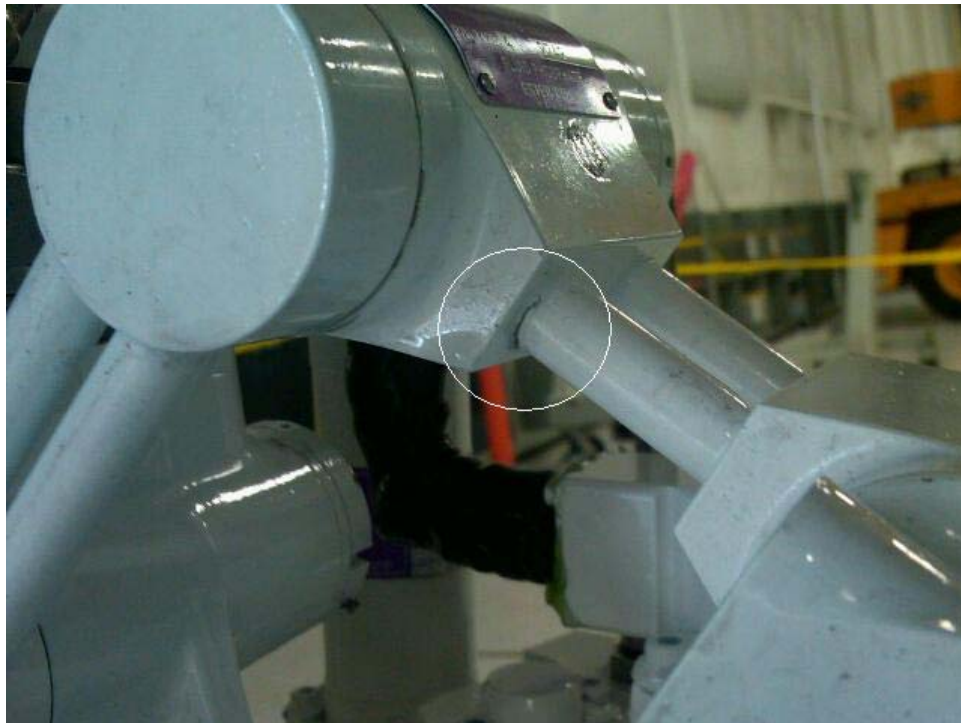
After the noted incident (see scope statement) it was observed that the swivel exhibited a crack in one of the short tubes connecting the center and aft swivels.

Photo 2, View of Cracked Tube

The fact that one of the two 6061-T6 Transfer Tubes failed at the tube joint immediate next to the hot-braced socket in the swivel housing and the other one of the two 6061-T6 Transfer Tubes show definite signs of highly distressed painted surface at the tube joint immediate next to its hot-braced socket in the same swivel housing.

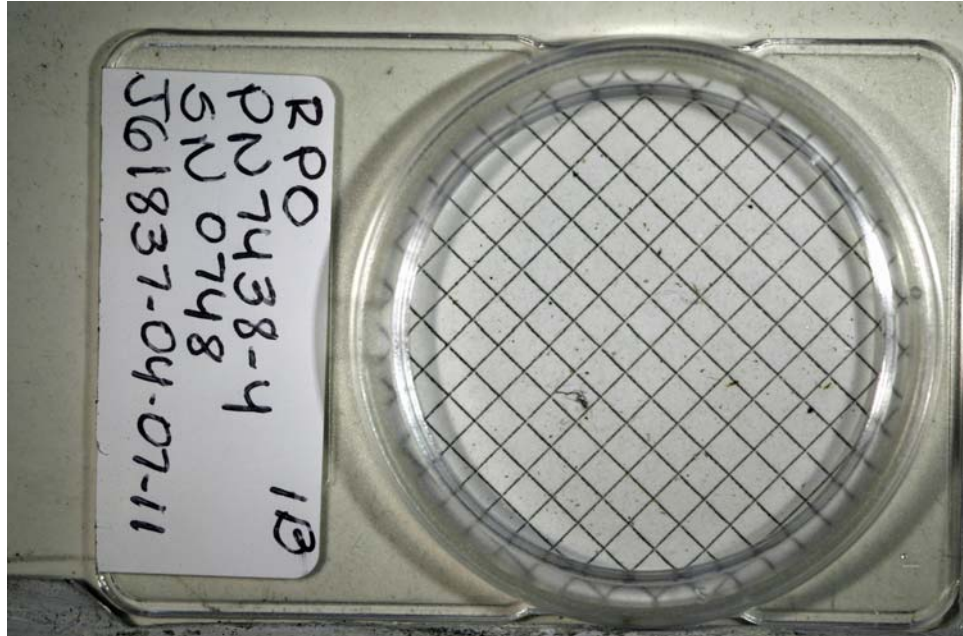
A standard filter patch was taken and various contaminates noted, metallic, fibrous, etc. – none of which were judged to be relevant to the frozen condition of the center swivel segment. Note that later filter patches taken during/after disassembly showed gross contamination from metallics, the consensus being that they came from the galling apparent on the interior working surfaces of the swivel components described later in this report.

Photo 3, Inbound Filter Patch

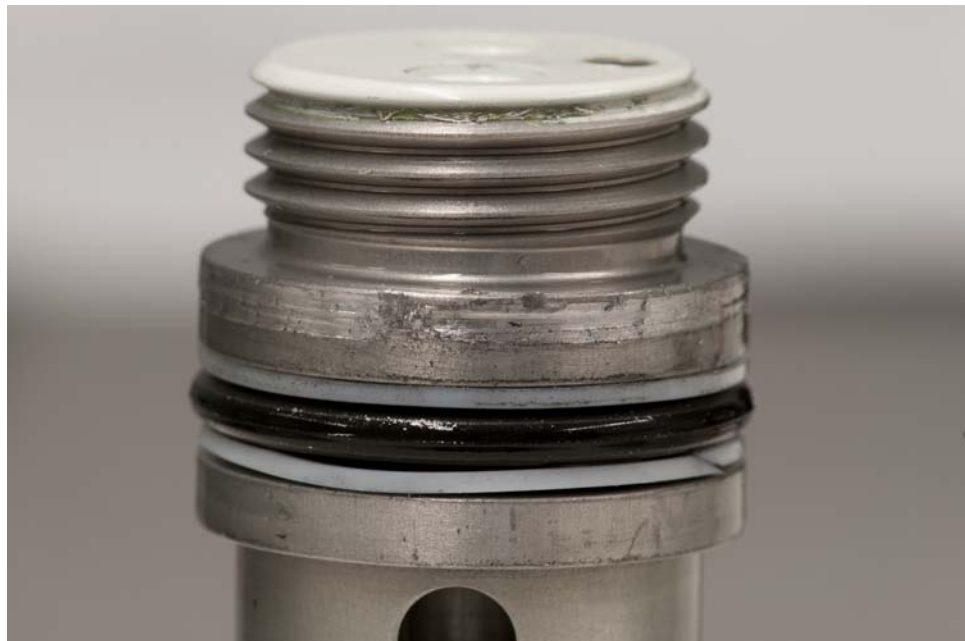
Disassembly could only be accomplished by forcefully extracting (careful hammering) the center shaft segment from out of the center housing. Once removed it was apparent that the frozen state was due to galling that had developed on the shaft outside diameter and the housing inner diameter. Representative photos of the galled areas of both the shaft OD and the housing ID are included here (additional photos and views are available).

Photo 4, Galled Areas – Center Shaft OD – Upper End

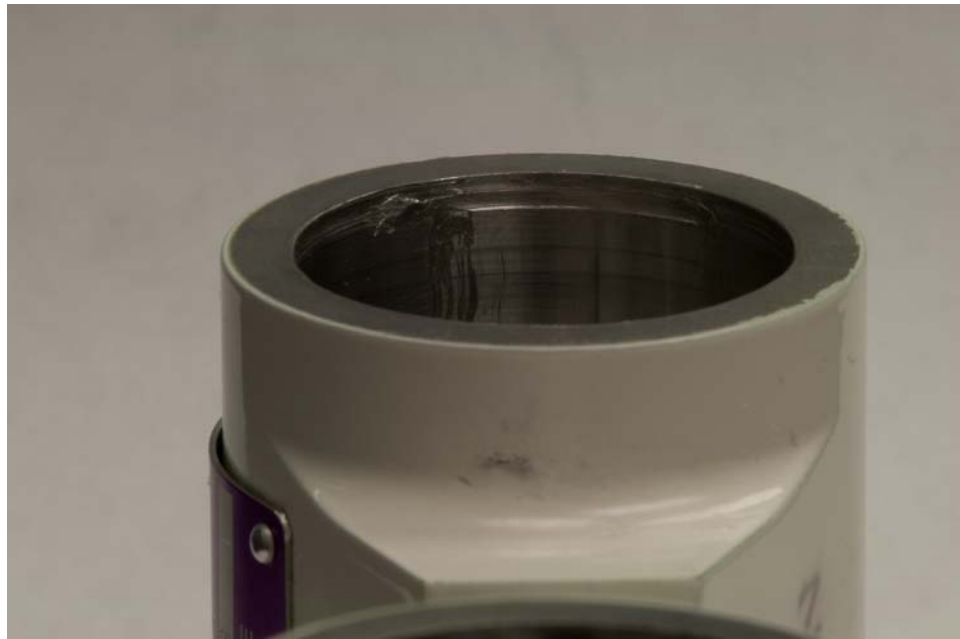
Photo 5, Galled Areas – Center Housing ID – Upper End

Note: the galled area showed galling buildup measuring up to 1.1779"
