Accident / Incident Report

Report No.: 19-122

**JRM Air LLC
Textron Aviation 680A, N8JR
Elizabethton, Tennessee
August 15th 2019
PW306D1
Left Hand Engine S/N CN0015
Right Hand Engine S/N CN0016**

**Written By: Jeff Davis
Service Investigation Department**

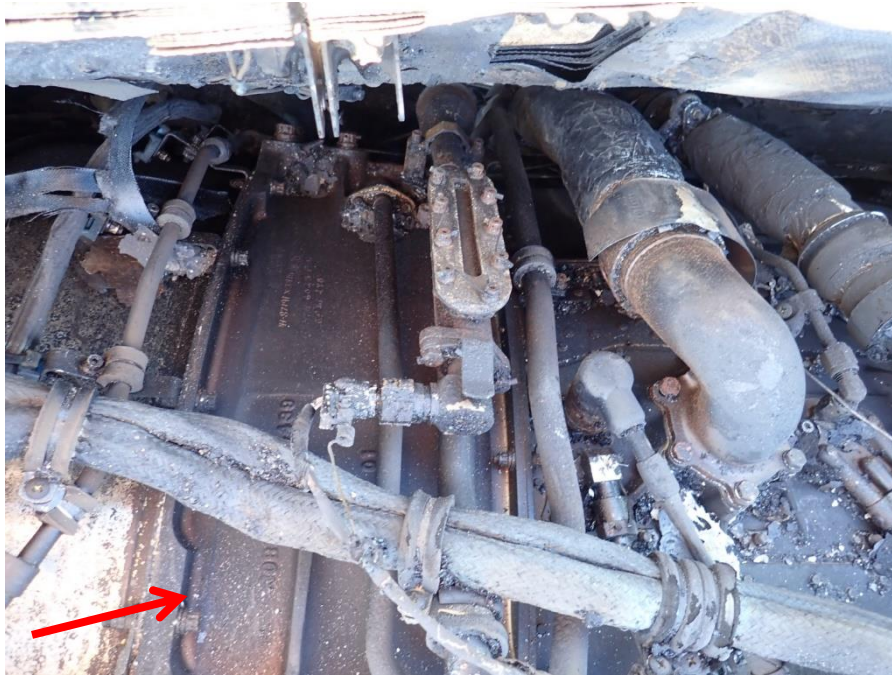
Photo No. 7

Intermediate Case: The visible exterior regions of the case were covered in soot and the paint was discoloured (Ref. Photo No. 7, red arrow).

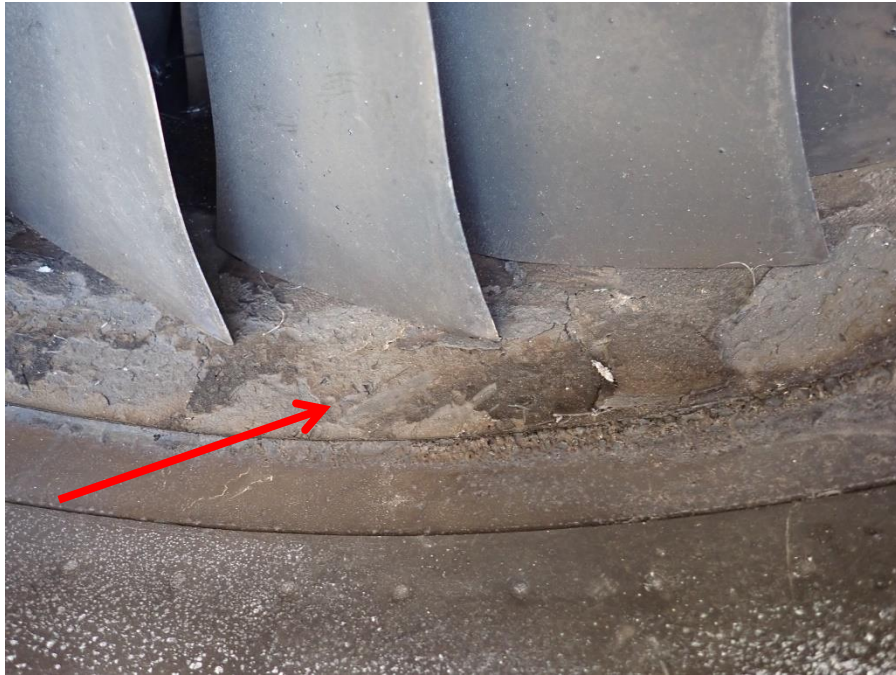
Photo No. 8

Fan Case: The shroud region of the case was thermally damaged from exposure to the post impact fire (Ref. Photo No. 8, red arrow). The visible regions of the case exterior were partially coated in soot.

LP Fan Case and Shroud: The abradable shroud was deteriorated from exposure to the post impact fire (Ref. Photo No. 8, red arrow). The visible portions of the external section of the case were partially coated in soot. The case was not removed for the purpose of this investigation.

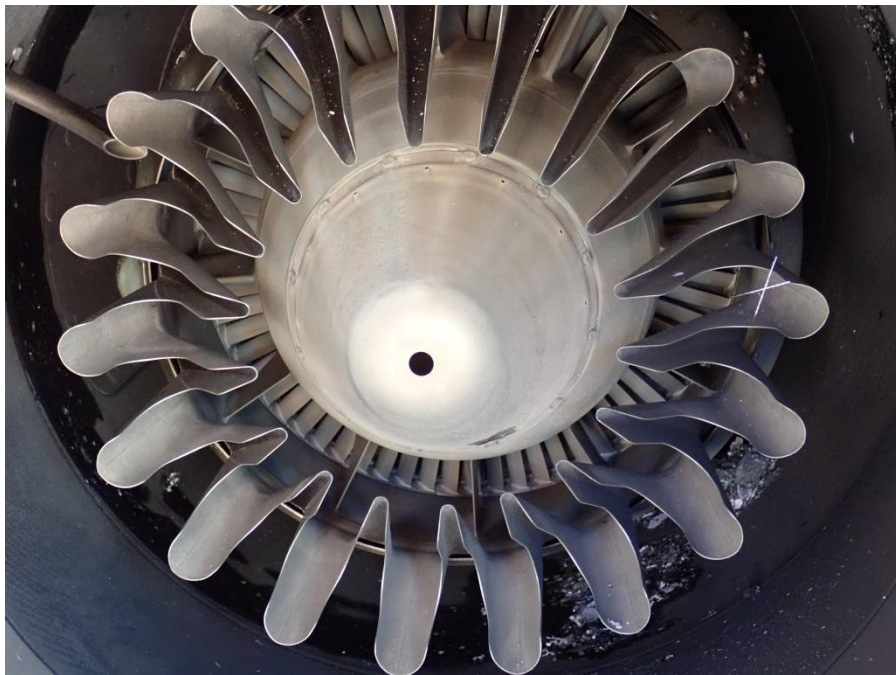
Photo No. 9

Exhaust Duct: Soot and ash attached to the visible portion of the exterior of the case at numerous locations (Ref. Photo No. 9).

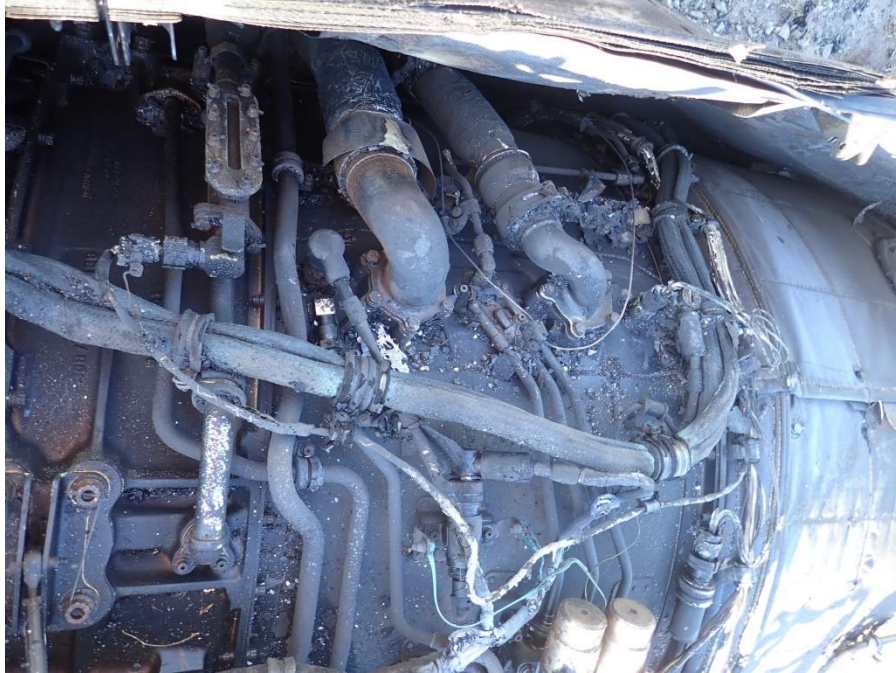
Photo No. 10

Outer and Inner Bypass Ducts: The visible sections of the outer and inner ducts were discoloured and stained with soot from exposure the post impact fire (Ref. Photo No. 10).

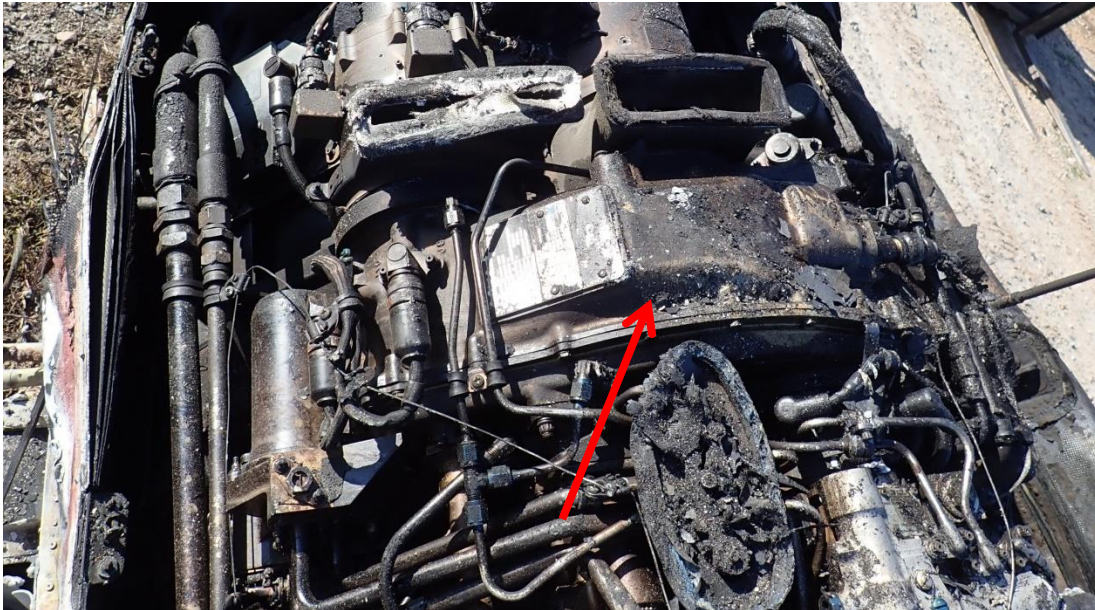
Photo No. 11

Accessory Gearbox: The gearbox was coated with soot and the paint was discoloured (Ref. Photo No. 11, red arrow). The externally mounted accessories were attached to their respective mounting pad on the gearbox.

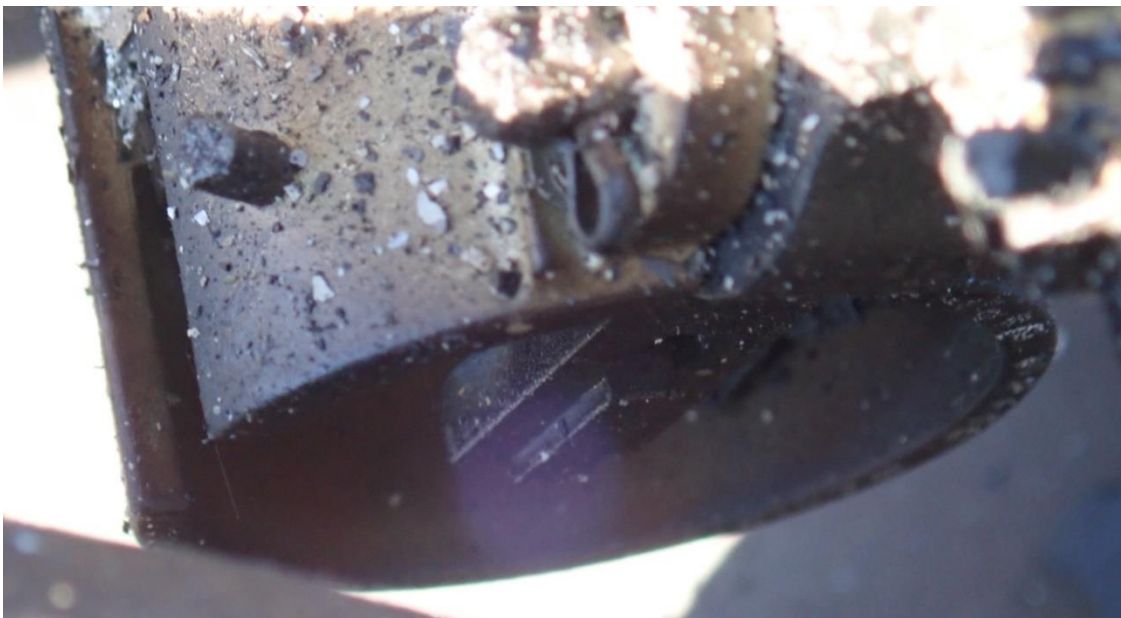
Photo No. 12

3.1.2 **Fuel Shut Off Valve Cable/Linkage:** The tripper lever was not extended above the valve housing, showing that the valve was not tripped (Ref. Photo No. 12). This indicates that the fuel flow through the valve was not interrupted. The valve housing was discoloured and ash/debris from post impact fire was adhered to the exterior of the housing. The visible section of the cable was unremarkable. The cable was not removed for the purpose of this investigation.

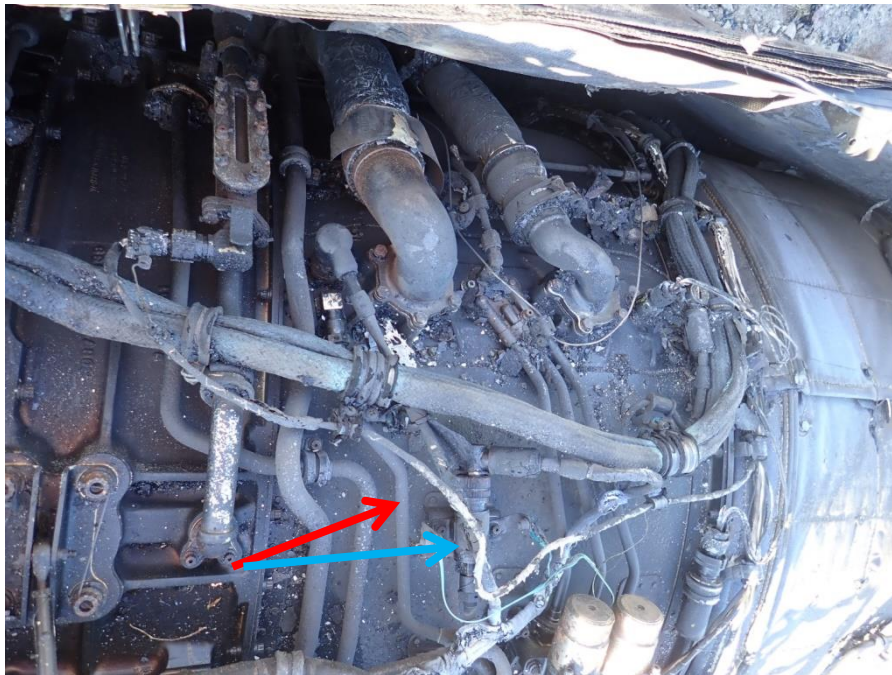
Photo No. 13

Compressor Discharge Air (P3) Transducer Tube: The line was in place and secure (Ref. Photo No. 13, red arrow).

P3 Pressure Transducer: The transducer was secure on its respective mounting pad on the bypass duct (Ref. Photo No. 13, blue arrow).

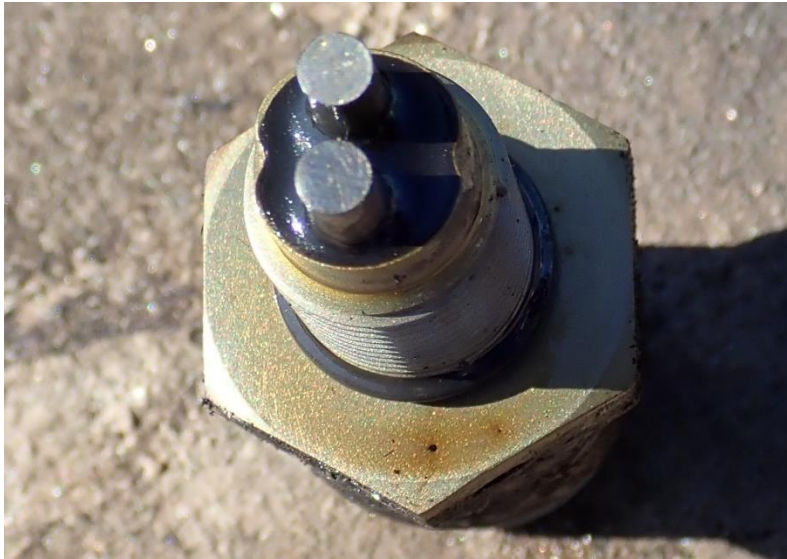
Photo No. 14

Accessory Gearbox Chip Detector: No metallic debris was adhered to magnetic poles of the chip detector (Ref. Photo No. 14).

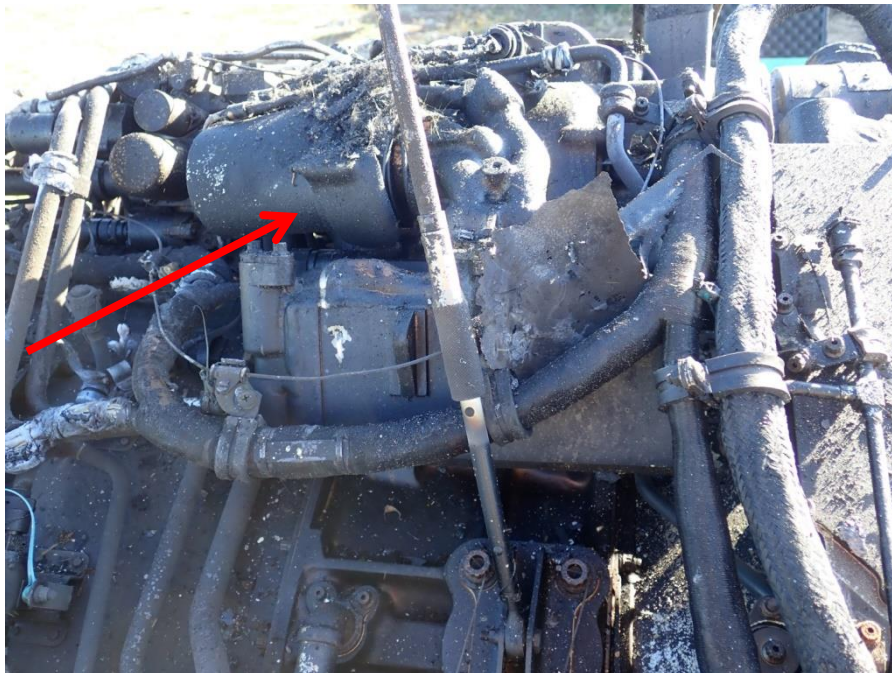
Photo No. 15

Oil Filter: The oil filter cover was distorted from impact damage (Ref. Photo No. 15, red arrow). The damage to the cover prevented removal of the filter element (Ref. Photo No. 16). The filter was stained with soot from the post impact fire but the visible regions of the element did not display contamination that was related to engine operation (Ref. Photo No. 16).

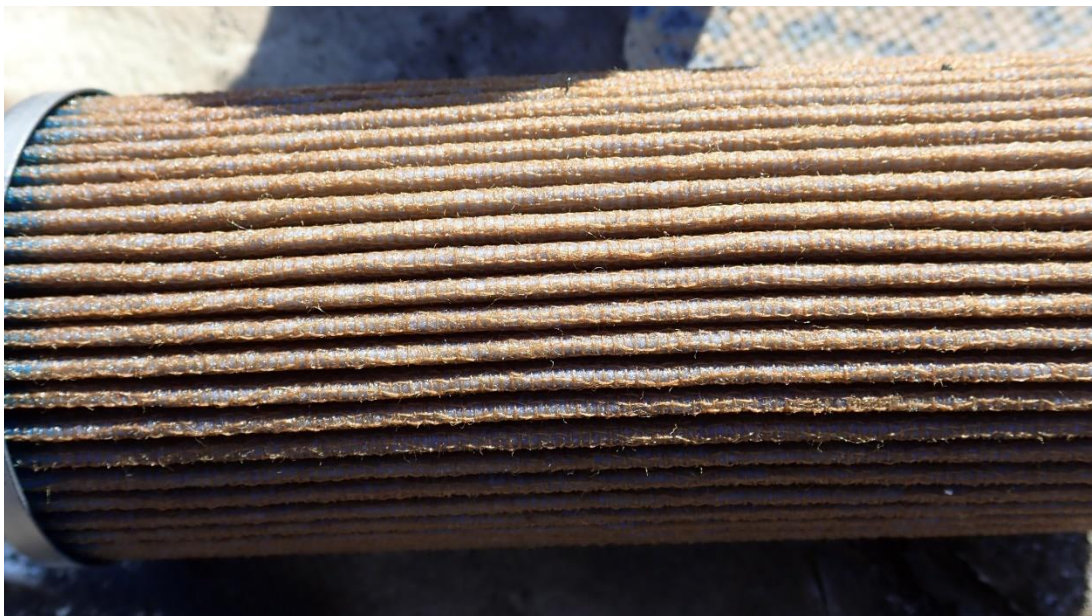
Photo No. 17

Fuel Filter: No visible contamination was evident in the fuel filter (Ref. Photo No. 17). The residual fuel in the filter cover had a pungent fuel smell and it contained some dark coloured particulate (Ref. Photo No. 18).

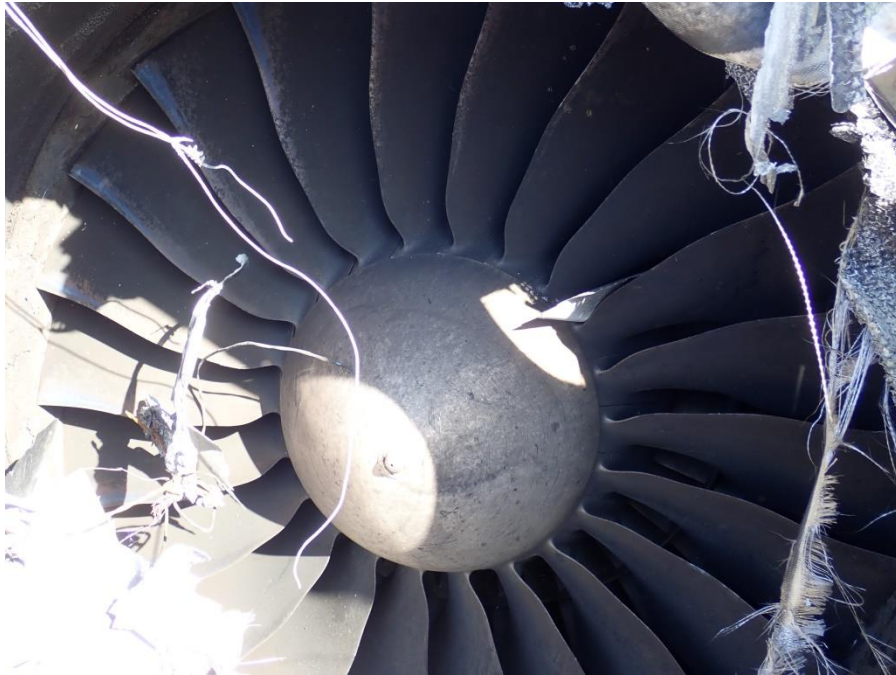
Photo No. 19

LP Compressor Fan: The fan blades were discoloured with soot from the post impact fire (Ref. Photos No. 19 & 20). The fan was not capable of manual rotation. The fan was not removed for the purpose of this investigation. The nose cone was discoloured and stained.

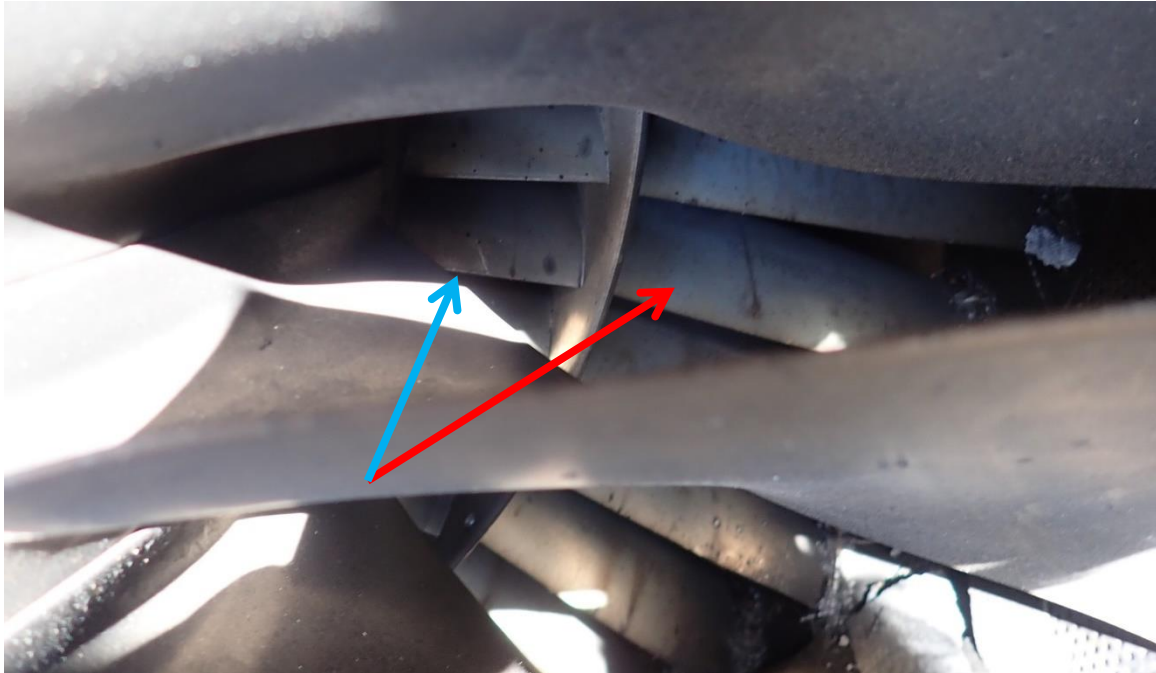
Photo No. 21

Fan Exit Stator: The stator was viewed through/between the fan blades. Some of the stator airfoils exhibited impact damage, and the airfoils were stained (Ref. Photo No. 21, red arrow). The stator was not removed for the purpose of this investigation.

Compressor Inlet Stator: The stator was viewed through/between the fan blades. The stator airfoils were stained (Ref. Photo No. 21, blue arrow). The stator was not removed for the purpose of this investigation.

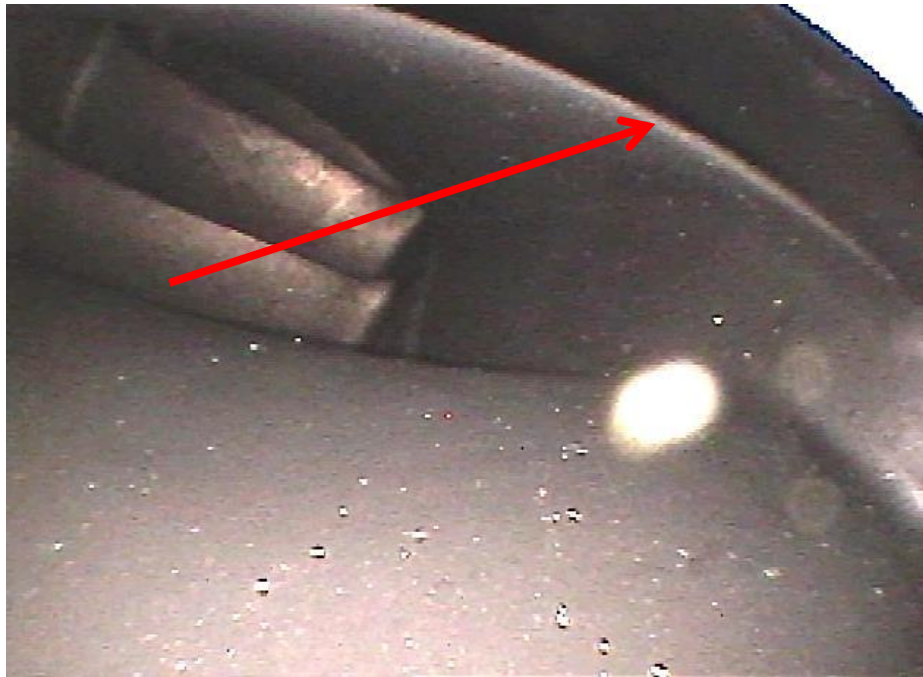
Compressor 1st, 2nd, 3rd, and 4th Stage Blades: A borescope inspection of the 1st, trailing edge of the 3rd stage, and the leading edge of the 4th stage compressor blades was conducted and no visible damage was evident (Ref. Photos No. 22, red arrow). The 2nd stage blades were not accessible with the borescope.

Photo No. 22, view of the 1st stage compressor blades

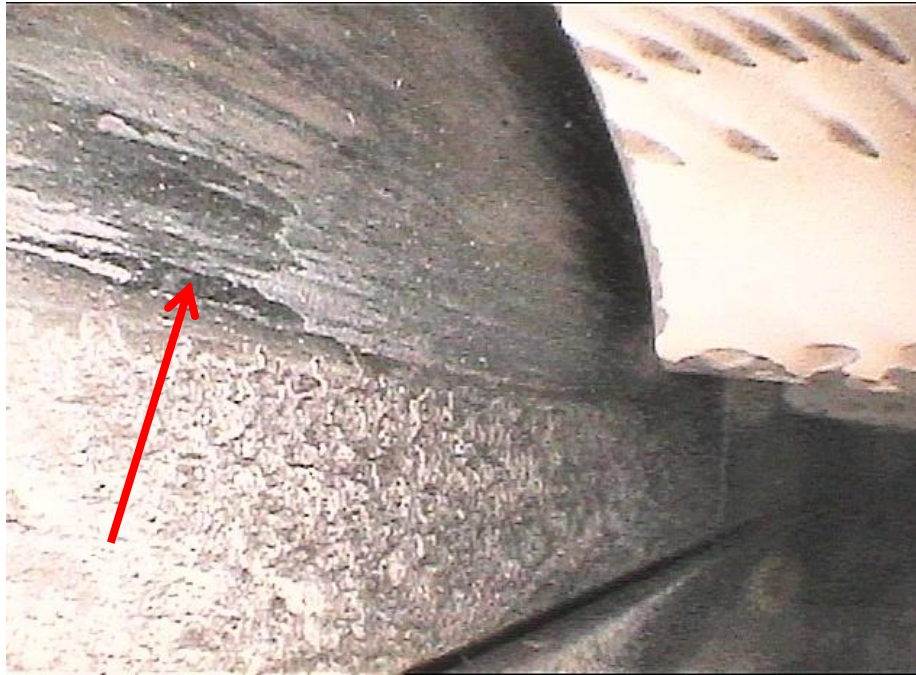
Photo No. 23

1st Stage High Pressure Turbine Shroud: The shroud segments exhibited a localized rubbed region from contact with the 1st stage turbine blade tips (Ref. Photo No. 23, red arrow).

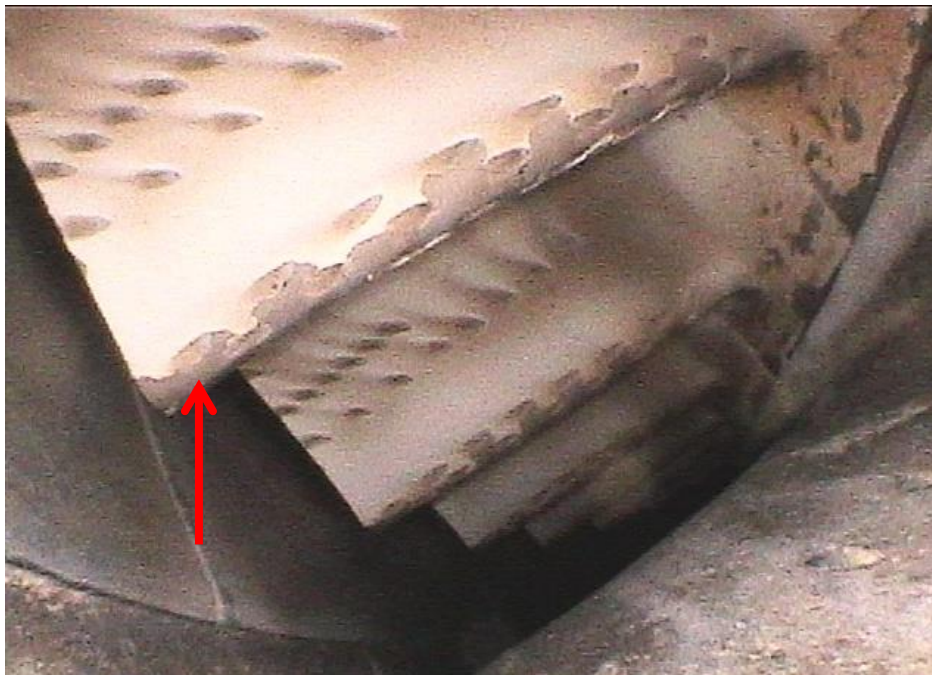
Photo No. 24

1st Stage High Pressure Turbine: The leading edge of the blade airfoils and blade platforms exhibited some erosion of their protective coating (Ref. Photo No. 24, red arrow).

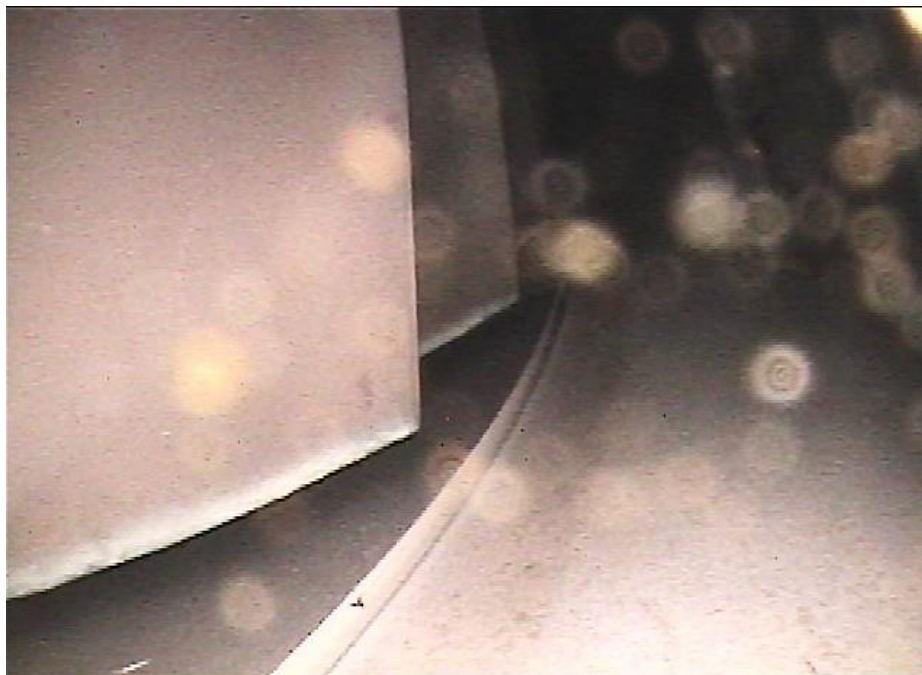
Photo No. 25

2nd Stage High Pressure Turbine: The turbine blades did not exhibit any visible damage except some tip discoloration (Ref. Photo No. 25).

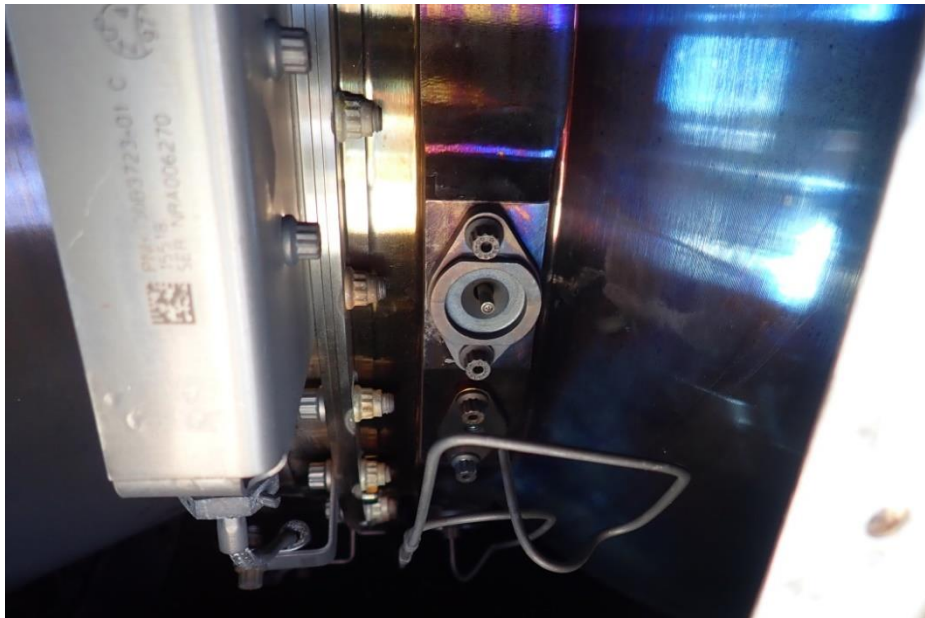
Photo No. 26

ITT Probes, Busbar and Terminal Box: The visible probes were unremarkable. One of the busbars was fractured adjacent to thermocouple mounting flange (Ref. Photo No. 26). The box was secured in place on its respective mounting position (Ref. Photo No. 26).

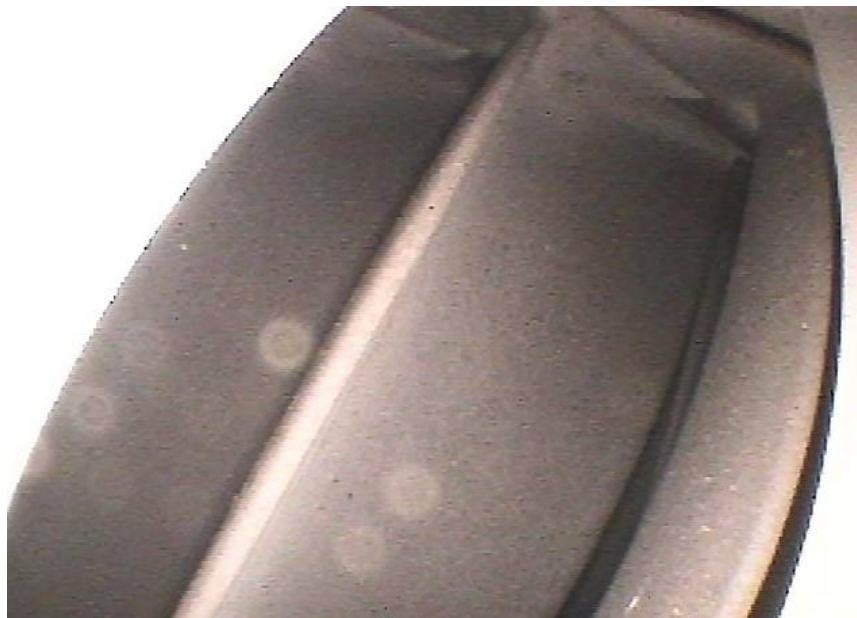
Photo No. 27

3rd Stage Low Pressure Turbine: No visible damage was evident on the blades (Ref. Photo No. 27).

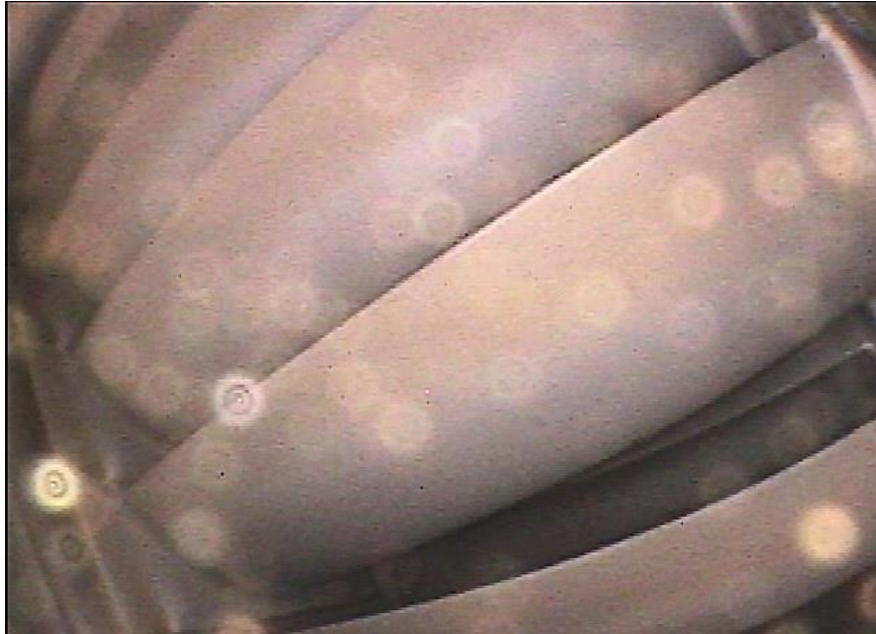
Photo No. 28

5th Stage Low pressure Turbine: No visible damage was evident on the blades (Ref. Photo No. 28).

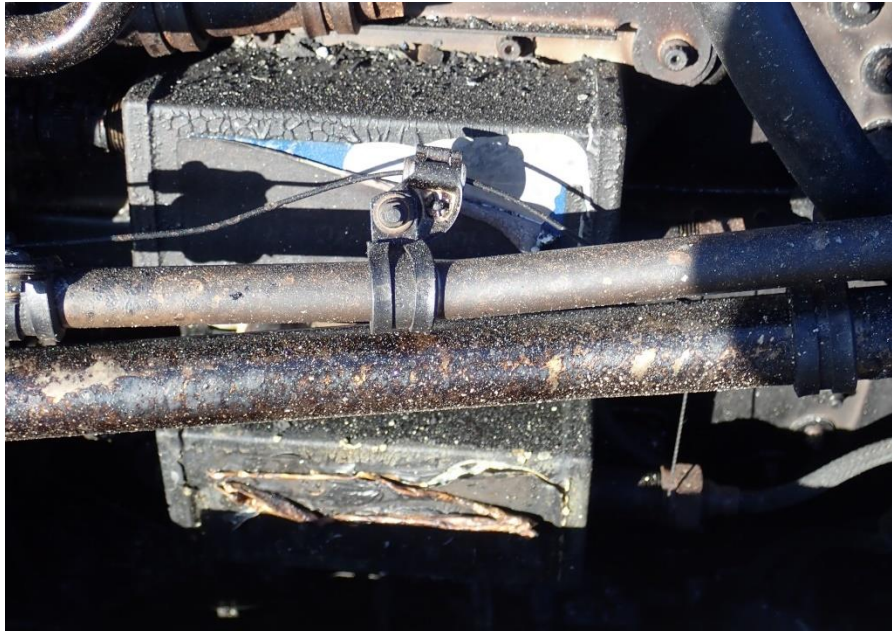
Photo No. 29

Exciter Boxes: The boxes were in place. The exterior of both boxes were thermally damaged from exposure to the post impact fire (Ref. Photo No. 29).

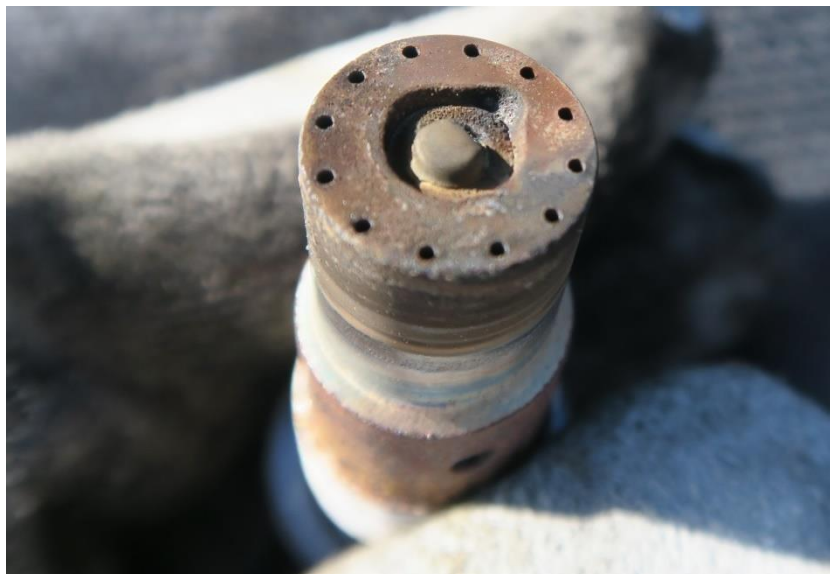
Ignition Plugs: The plugs were removed and the tips were eroded adjacent to the central conductor (Ref. Photo No. 30). The erosion is consistent with operational use.

Photo No. 30 (Textron supplied Photo)

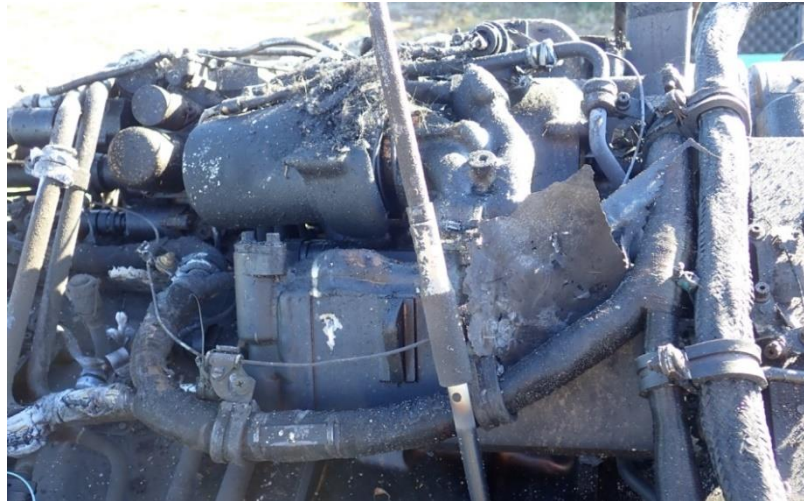
Photo No. 31

Fuel Heater: The heater exhibited some impact damage, the mounting bosses were fractured and the exterior housing was coated in soot (Ref. Photo No. 31, red arrow).

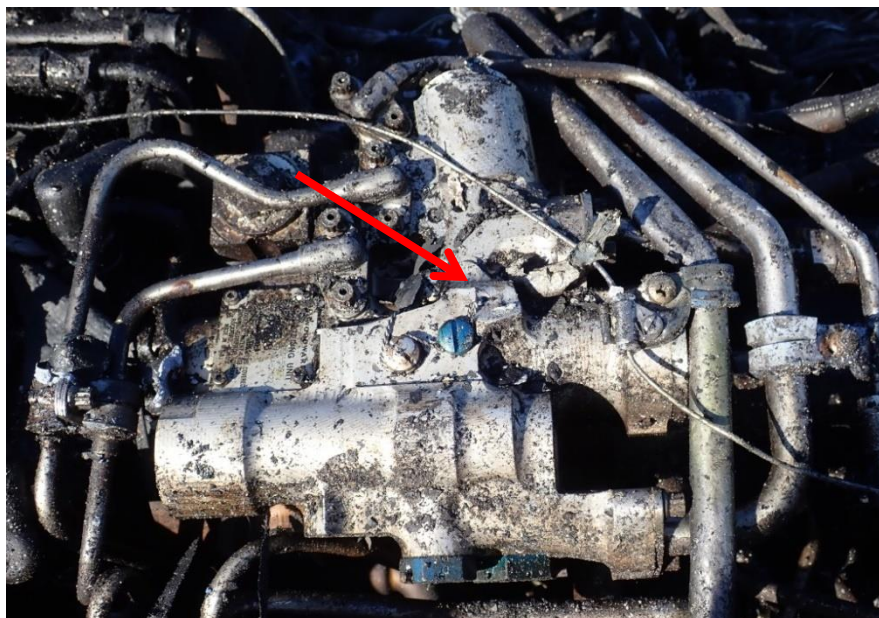
Photo No. 32

Hydromechanical Fuel Control Unit: The control was in place, the housing was fractured, and the exterior housing was partially coated in soot (Ref. Photo No. 32, red arrow shows the fractured area).

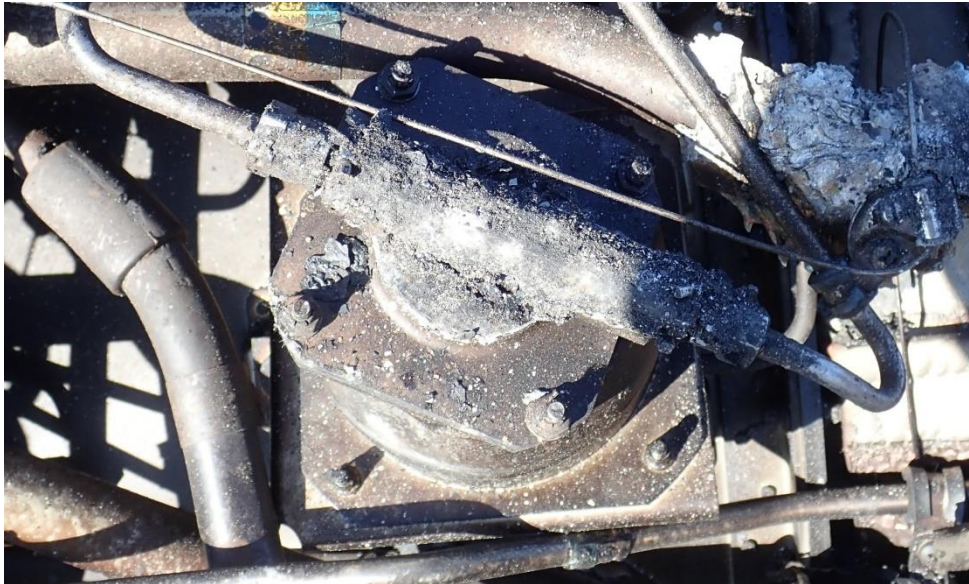
Photo No. 33

Fuel Waste Ejector: The ejector was in place, coated in soot, and exhibited some thermal distress from exposure to the post impact fire (Ref. Photo No. 33).

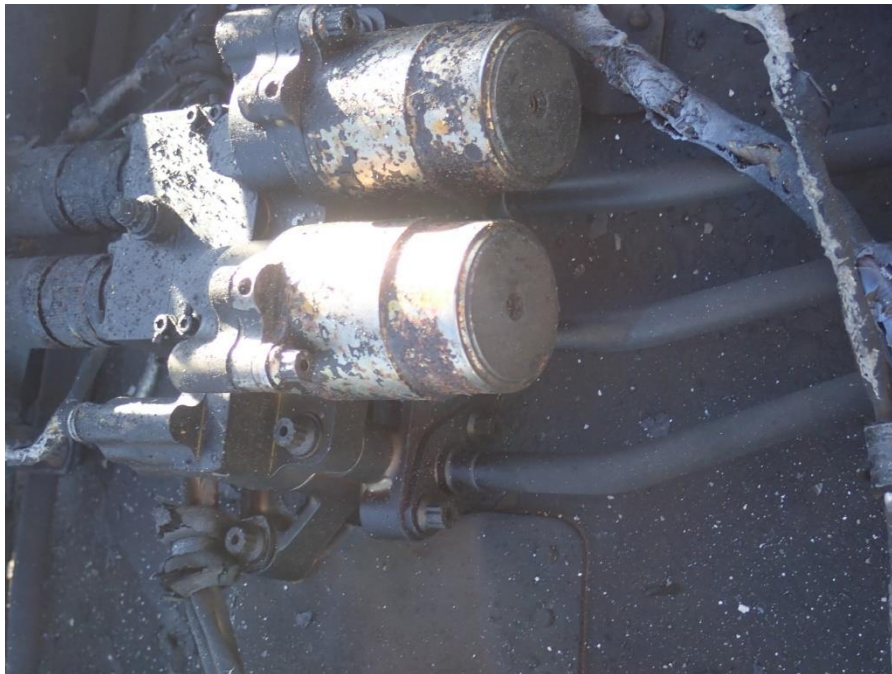
Photo No. 35

Compressor Bleed Valve Solenoid: The solenoid was in place and coated with soot (Ref. Photo No. 35).

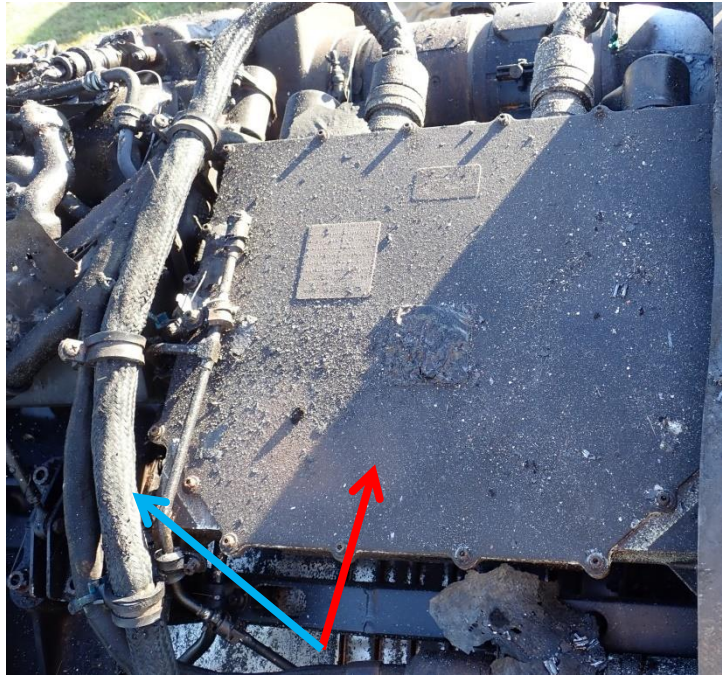
Photo No. 36

Engine Electronic Control (EEC): The control was secured in place on its respective mounting pad (Ref. Photo No. 36, red arrow). The exterior housing was burnt and discoloured from exposure to the post impact fire.

Outer Electrical Wiring Harness: The harness was in place and all of the visible connections were attached to their respective components (Ref. Photo No. 36, blue arrow). The outer protective sheath was discoloured.

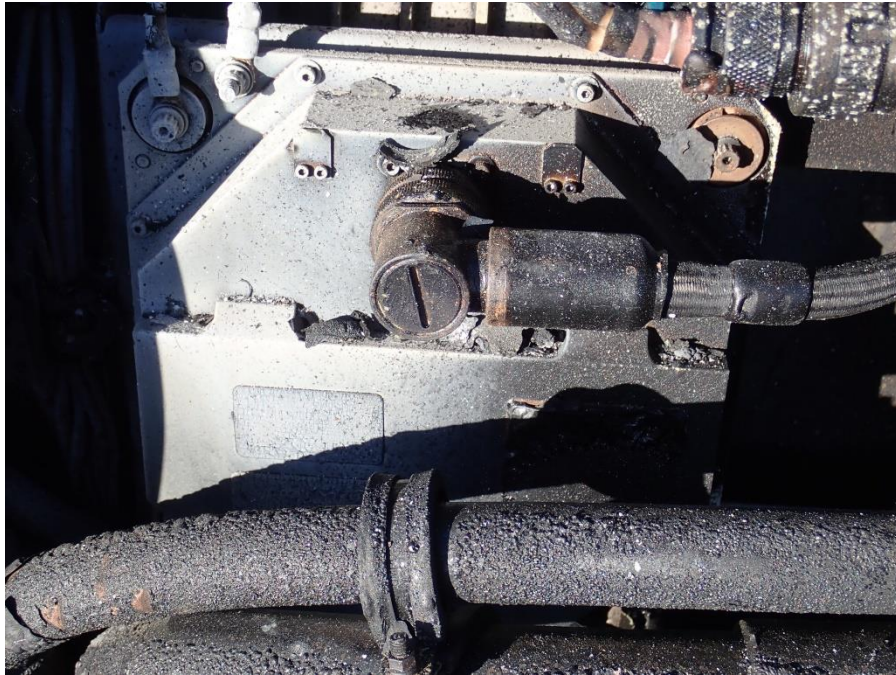
Photo No. 37

Engine Diagnostic Unit (EDU): The unit was discoloured and partially coated in soot (Ref. Photo No. 37). The EDU was forwarded to P&WC's Accessory Investigations for data recovery.

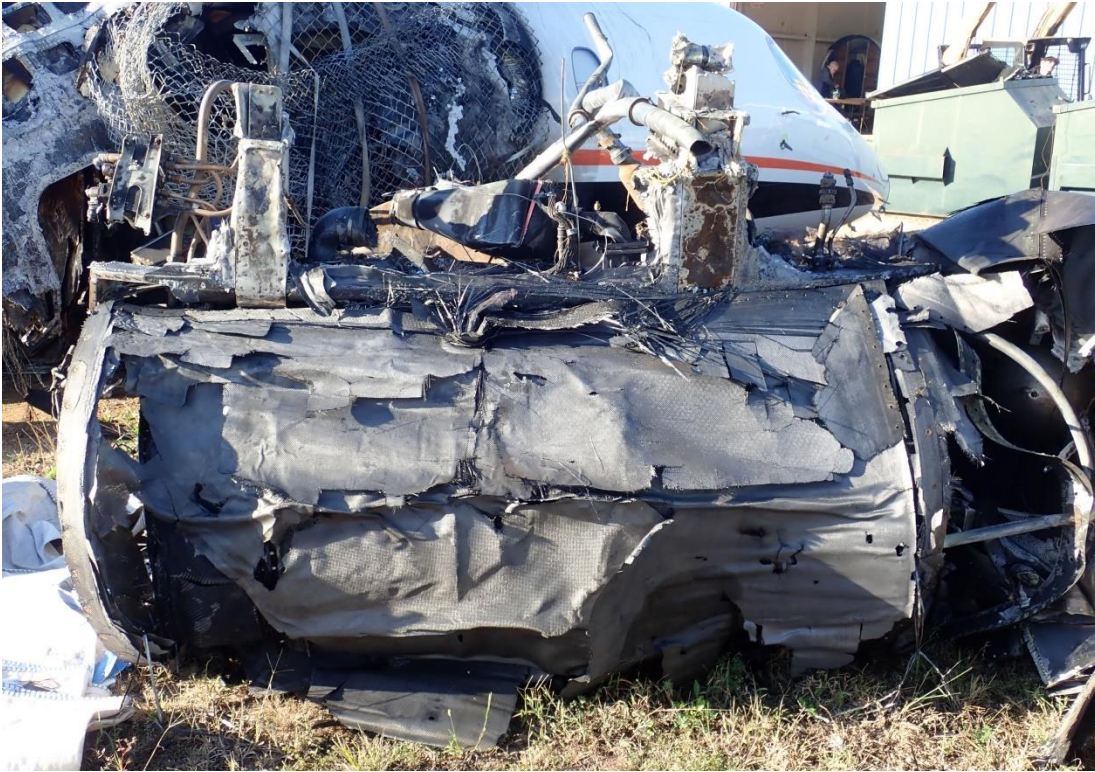
Photo No. 38

- 5.1 **External Condition:** The right hand engine was lying on its right hand side of the heat distressed airframe cowling (Ref. Photos No. 38 & 39). The engine was moved to the inverted position to access the bottom of the aircraft cowling. The external engine components and the bypass ducts were coated in soot and exhibited heat distress from exposure to the post flight fire (Ref. Photo No. 40). The engine data plate showed the engine serial number was PCE-CN0016 (Ref. Photo No. 41).

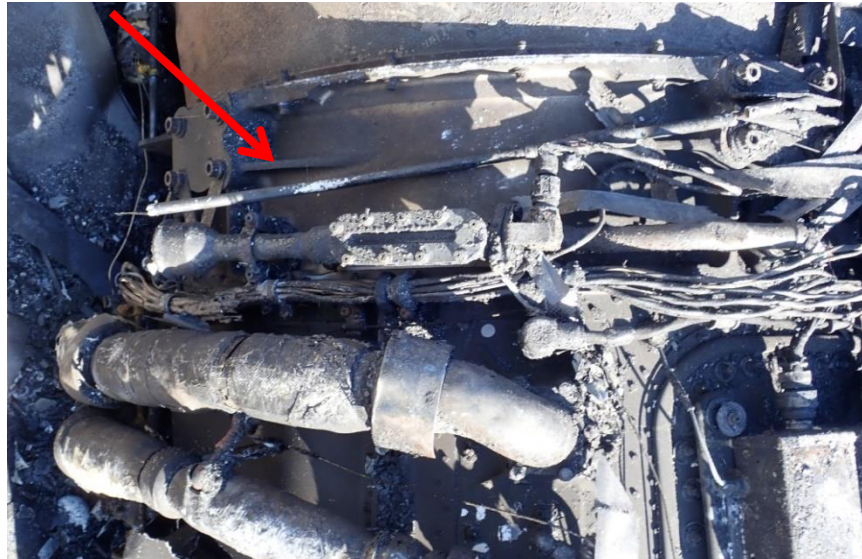
Photo No. 42

Intermediate Case: The visible exterior regions of the case were covered in soot and the paint was discoloured (Ref. Photo No. 42, red arrow).

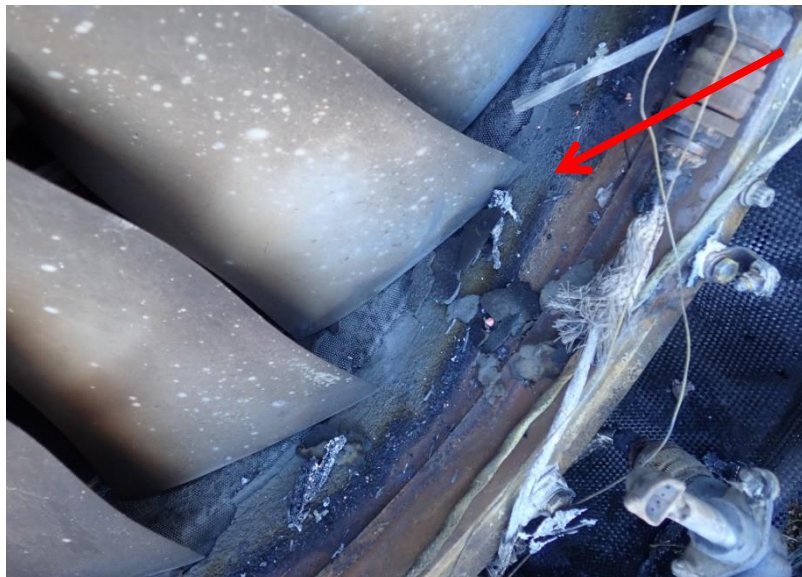
Photo 43

Fan Case: The shroud region of the case was thermally damaged from exposure to the post impact fire (Ref. Photo No. 43, red arrow). The visible regions of the case exterior were coated in soot.

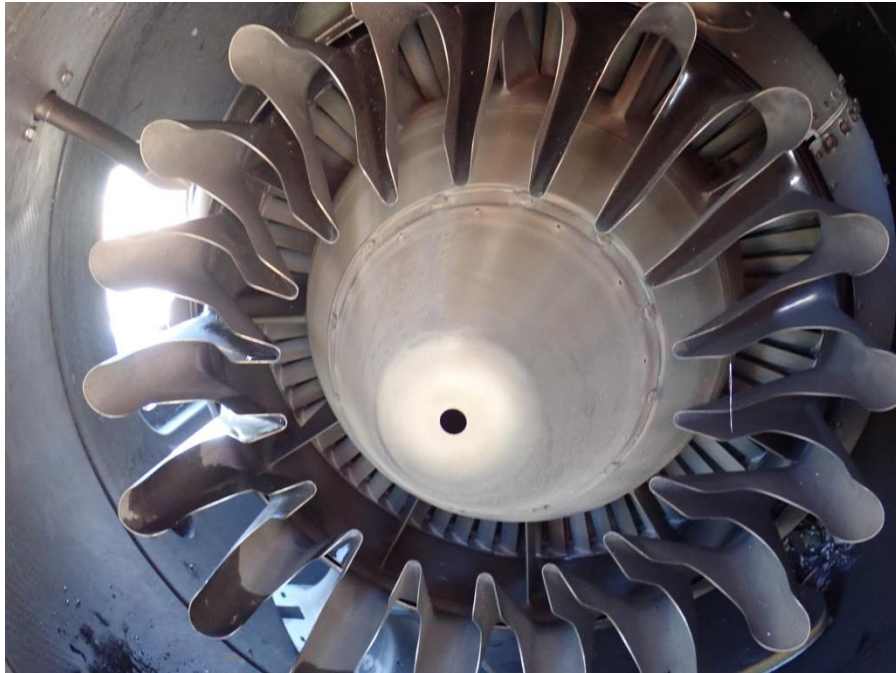
Photo No. 44

Exhaust Duct: Soot and ash were attached to the visible portion of the exterior of the case at numerous locations (Ref. Photo No. 44).

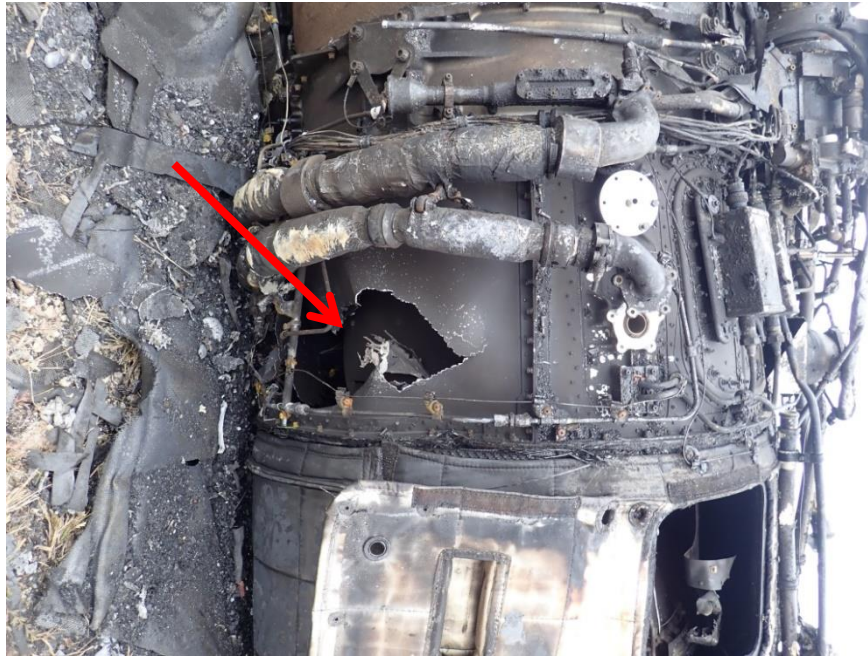
Photo No. 45

Outer and Inner Bypass Ducts: The visible sections of the lower section outer duct was discoloured and stained with soot from exposure the post impact fire (Ref. Photo No. 45). The upper section of the outer bypass duct and the visible portions of the inner bypass ducts were thermally distressed and partially burned from the post impact fire (Ref. Photo No. 45, red arrow).

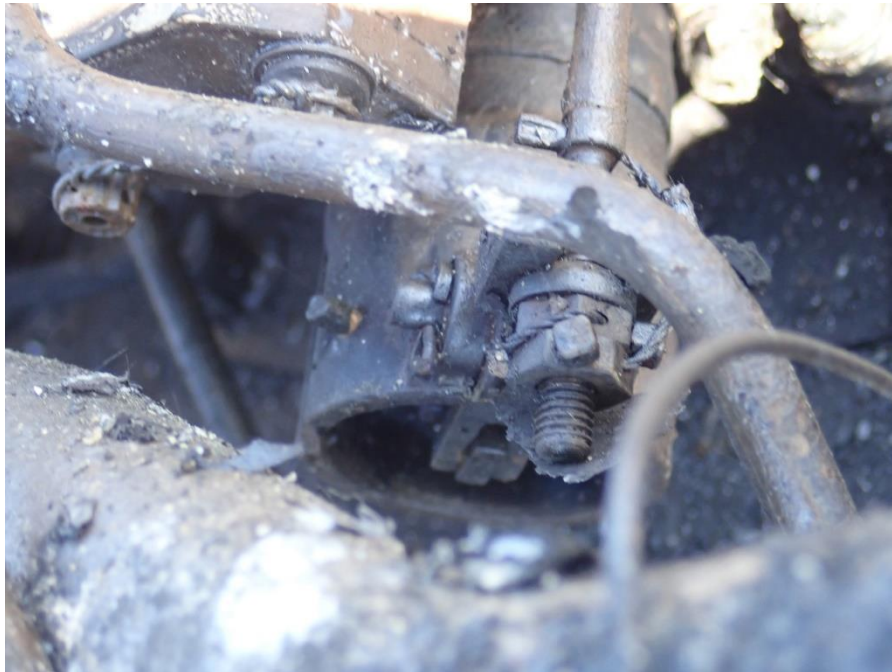
Photo No. 47

5.1.2 Fuel Shut Off Valve Cable/Linkage: The tripper lever was not extended above the valve housing, showing that the valve was not tripped (Ref. Photo No. 47). This indicates that the fuel flow through the valve was not interrupted. The valve housing was discoloured and ash/debris from post impact fire was adhered to the exterior of the housing. The visible section of the cable was unremarkable. The cable was not removed for the purpose of this investigation.

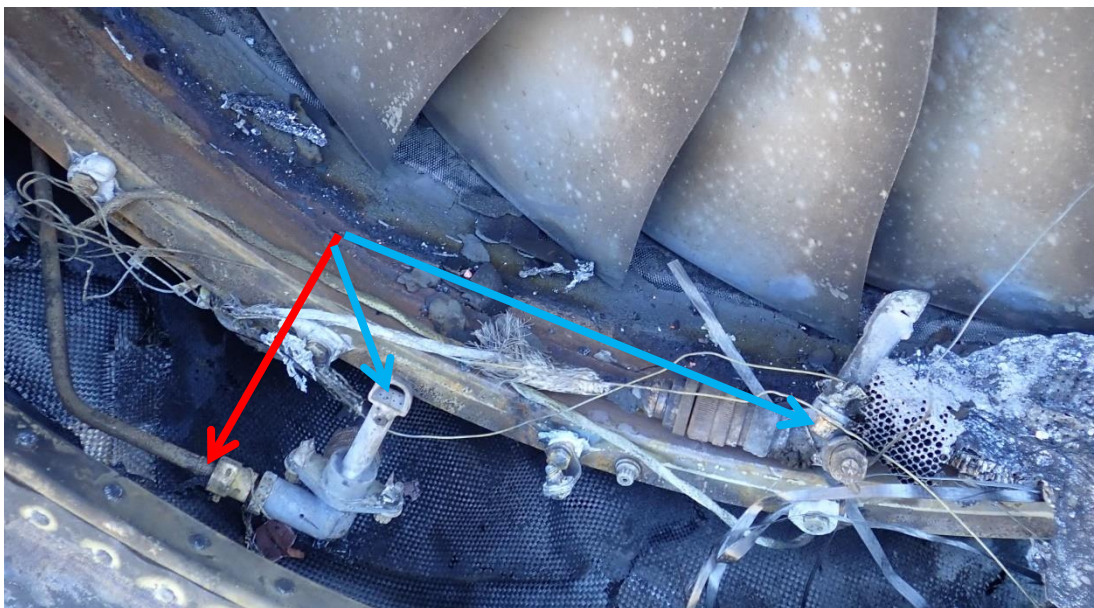
Photo No. 49

P1 Pressure Sensing Tube: The visible section of the tube was coated with soot (Ref. Photo No. 49, red arrow).

P1/T1 Sensors: The mounting pads for the sensors were burned away. The sensors were discoloured and coated with soot (Ref. Photo No. 49, blue arrows).
