Accident / Incident Report

Report No.: 19-122

**JRM Air LLC
Textron Aviation 680A, N8JR
Elizabethton, Tennessee
August 15th 2019
PW306D1
Left Hand Engine S/N CN0015
Right Hand Engine S/N CN0016**

**Written By: Jeff Davis
Service Investigation Department**

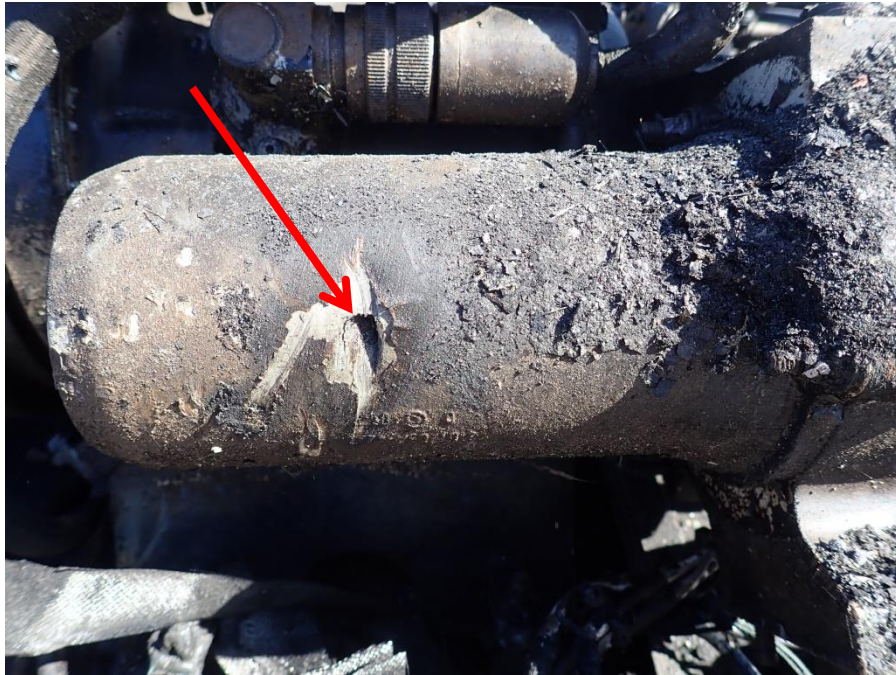
Photo No. 52

Fuel Filter: The fuel filter cover was penetrated from impact damage (Ref. Photo No. 52, red arrow). No visible contamination was evident in the filter (Ref. Photo No. 53).

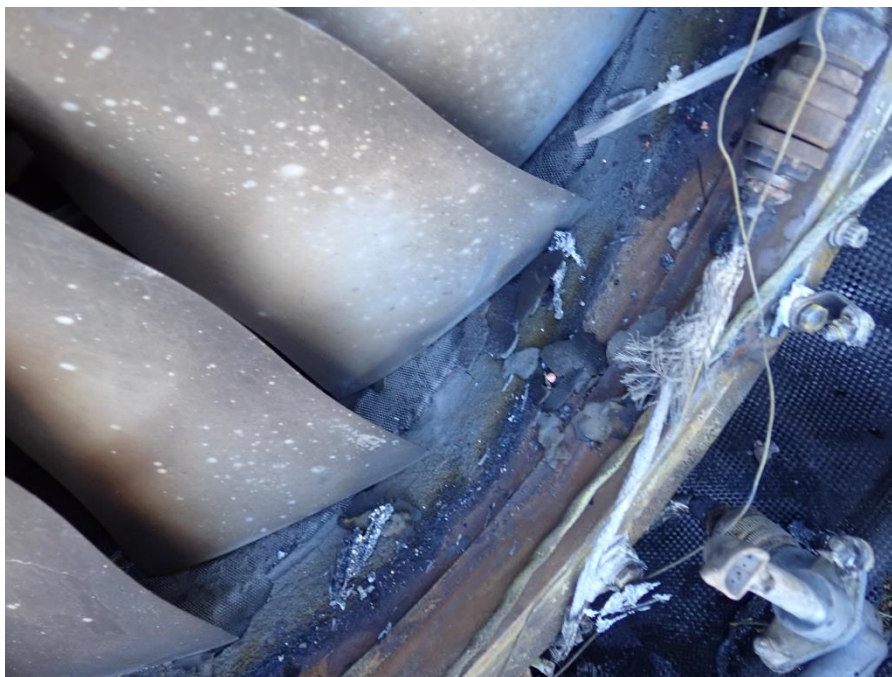
Photo No. 54

LP Fan Case and Shroud: The abrasible shroud was deteriorated from exposure to the post impact fire (Ref. Photo No. 54, red arrow). The visible portions of the external section of the case were coated in soot. The case was not removed for the purpose of this investigation.

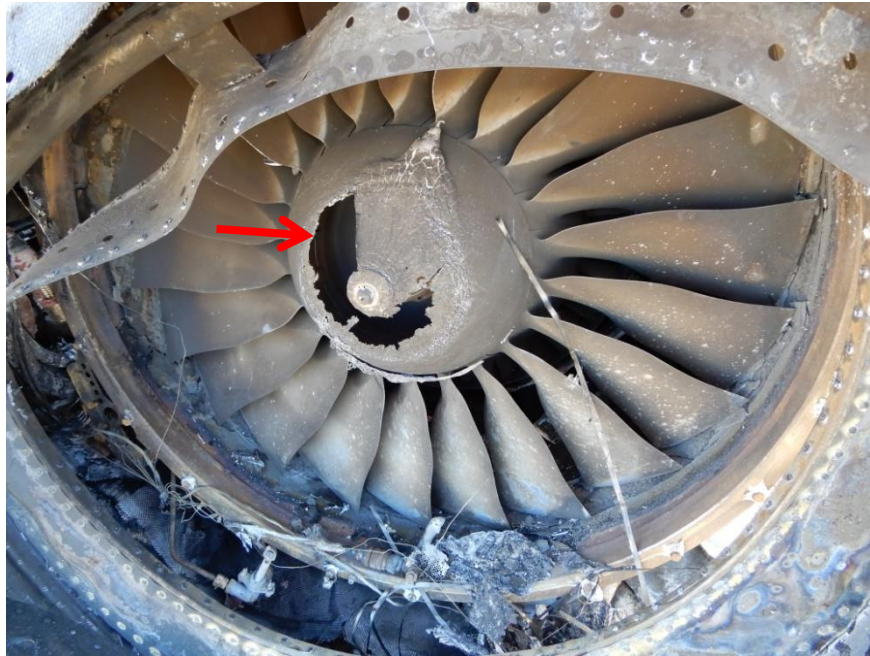
Photo No. 55 (NTSB supplied Photo)

LP Compressor Fan: The fan blades were discoloured with soot from the post impact fire (Ref. Photos No. 55 & 56). The fan was not capable of manual rotation. The fan was not removed for the purpose of this investigation. The nose cone was missing material and melted from the post impact fire (Ref. Photo No. 55, red arrow).

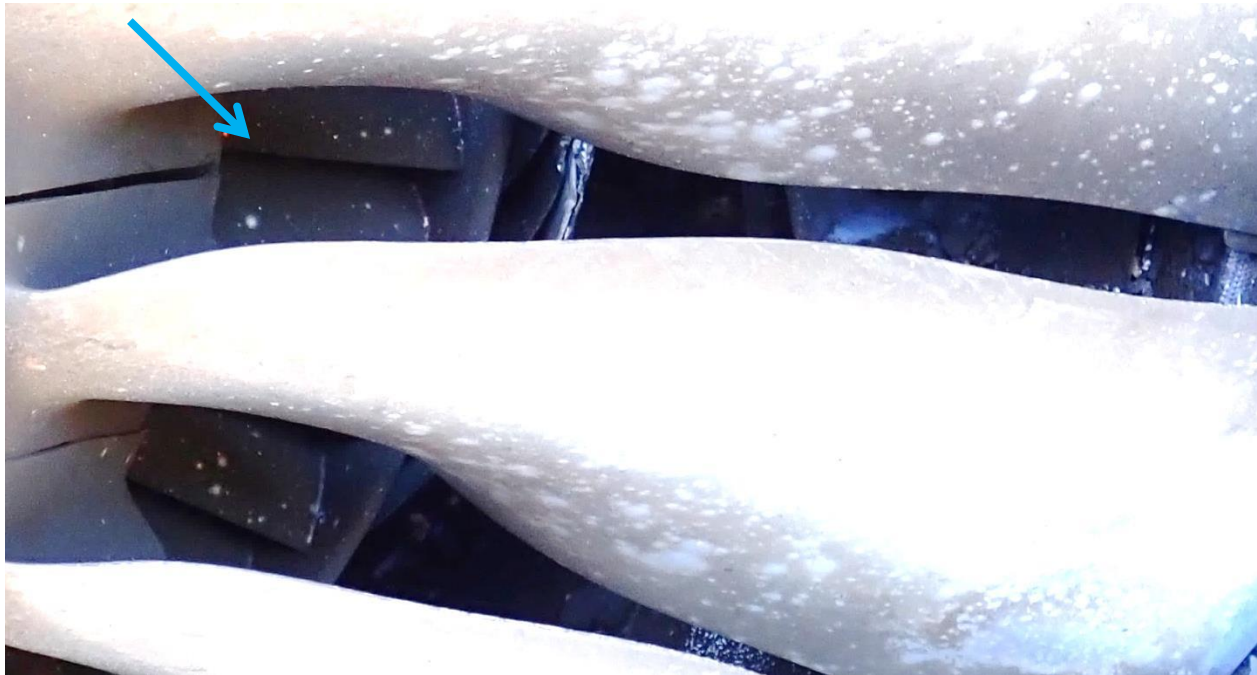
Photo No. 57

Compressor Inlet Stator: The stator was viewed through/between the fan blades. The stator airfoils were stained (Ref. Photo No. 57, blue arrow). The stator was not removed for the purpose of this investigation.

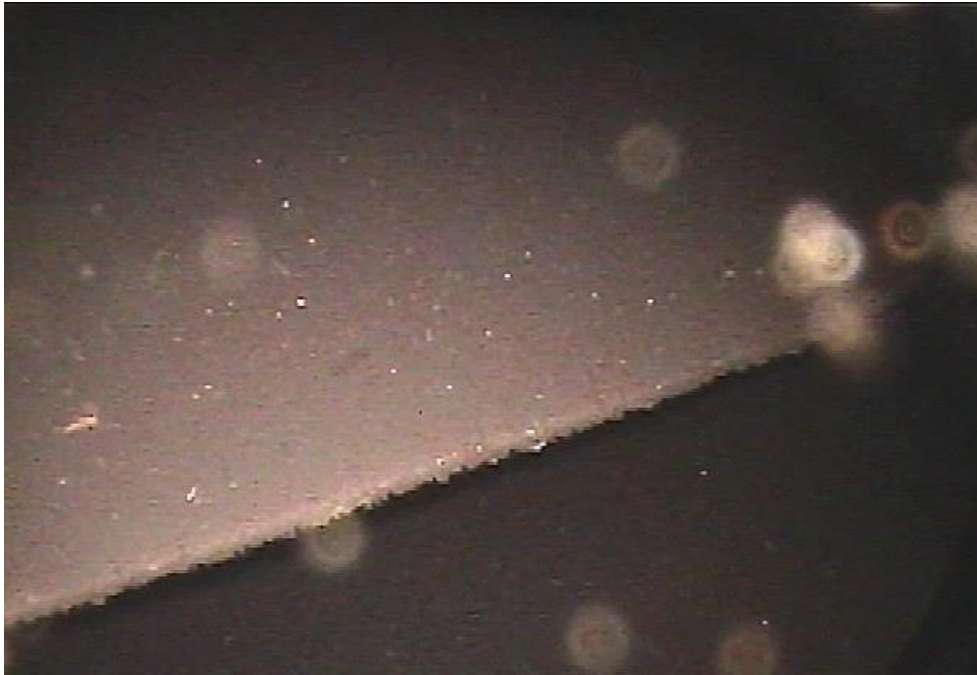
Compressor 1st, 2nd, 3rd, and 4th Stage Blades: A borescope inspection of the 1st, trailing edge of the 3rd stage, and the leading edge of the 4th stage compressor blades was conducted and no visible damage was evident (Ref. Photos No. 58). The 1st stage blades were coated in soot. Some staining was evident on the 3rd and 4th stage blades. The 2nd stage blades were not accessible with the borescope.

Photo No. 58, view of the 1st stage compressor blades

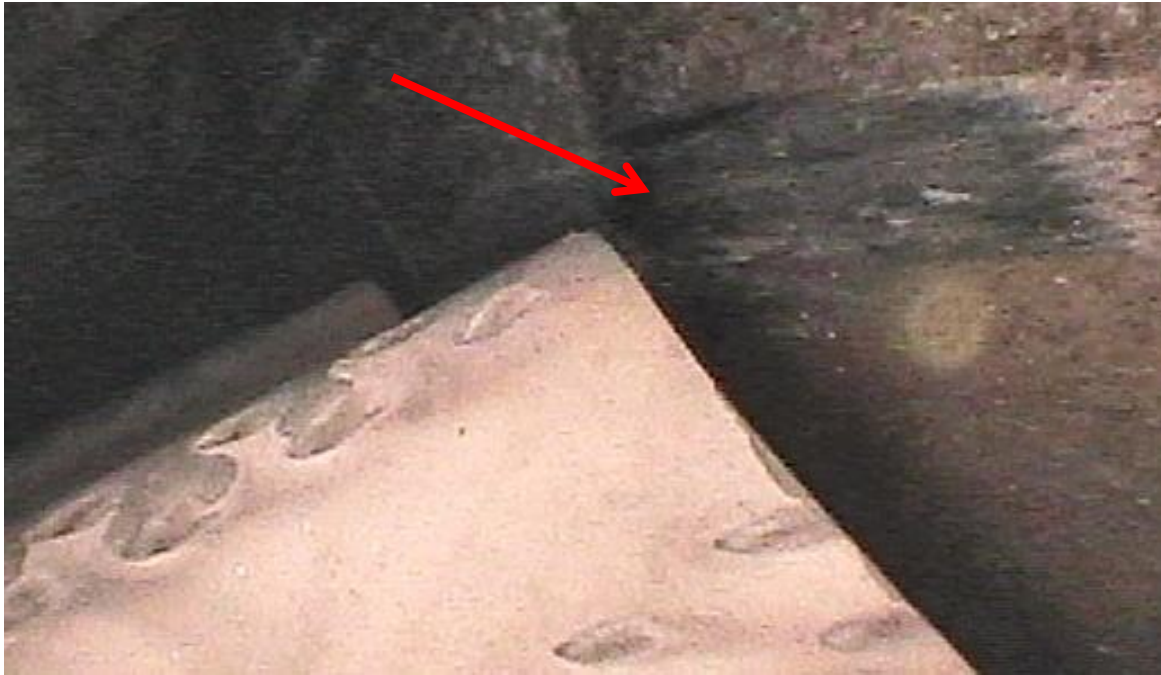
Photo No. 59

1st Stage High Pressure Turbine Shroud: The shroud segments exhibited a localized rubbed region from contact with the 1st stage turbine blade tips (Ref. Photo No. 59, red arrow).

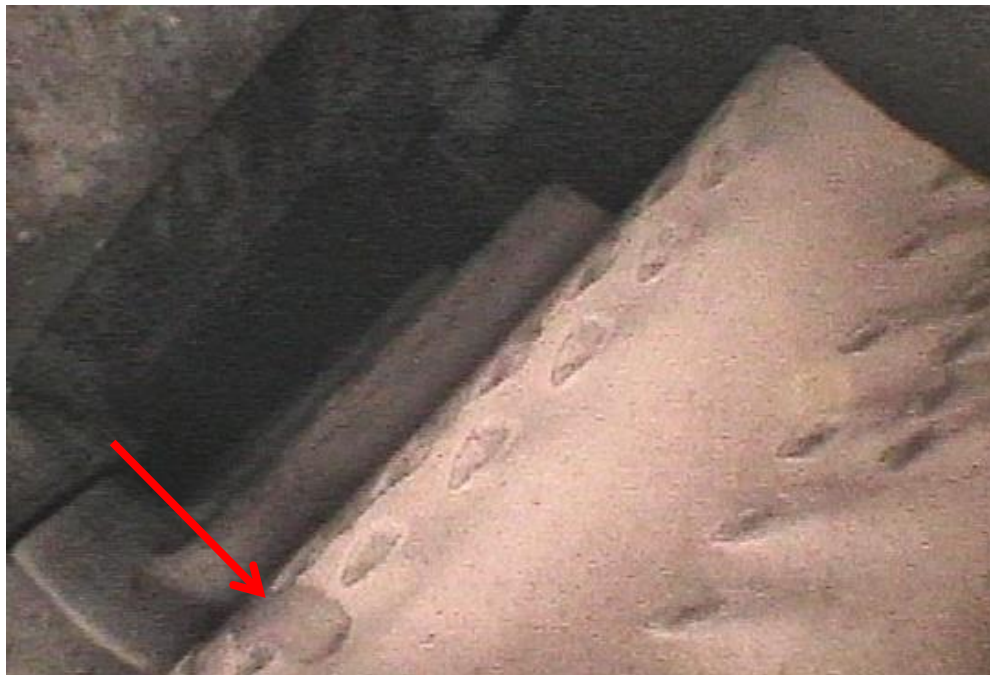
Photo No. 60

1st Stage High Pressure Turbine: The leading edge of the blade airfoils and blade platforms exhibited some erosion of their protective coating (Ref. Photo No. 60, red arrow).

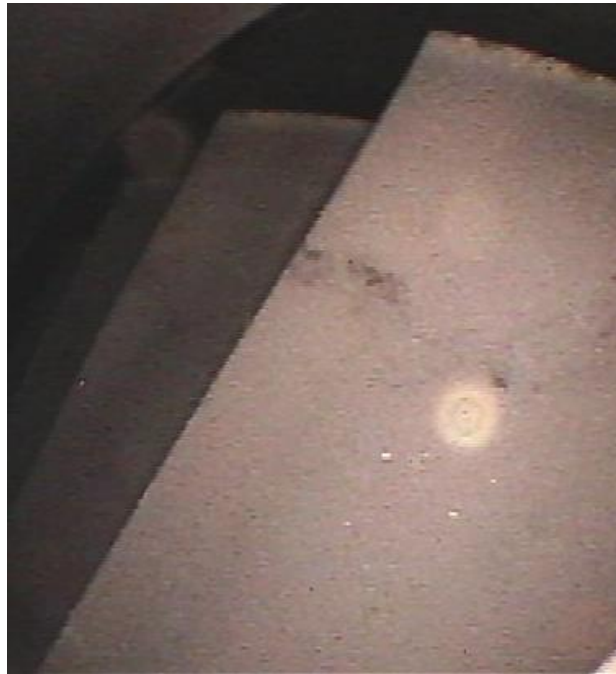
Photo No. 61

2nd Stage High Pressure Turbine: The turbine blades did not exhibit any visible damage except some tip deformation from the rubbing with the shroud segments (Ref. Photo No. 61).

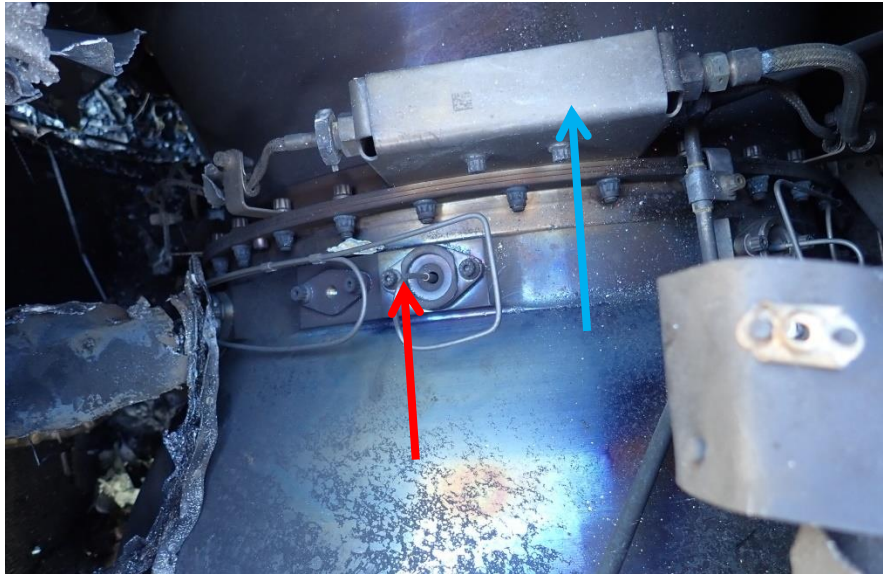
Photo No. 62

ITT Probes, Busbar and Terminal Box: The visible probes were unremarkable. The visible portions of the busbars were unremarkable except for thermal discoloration (Ref. Photo No. 62, red arrow). The box was secured in place on its respective mounting position and was thermally discoloured (Ref. Photo No. 62, blue arrow).

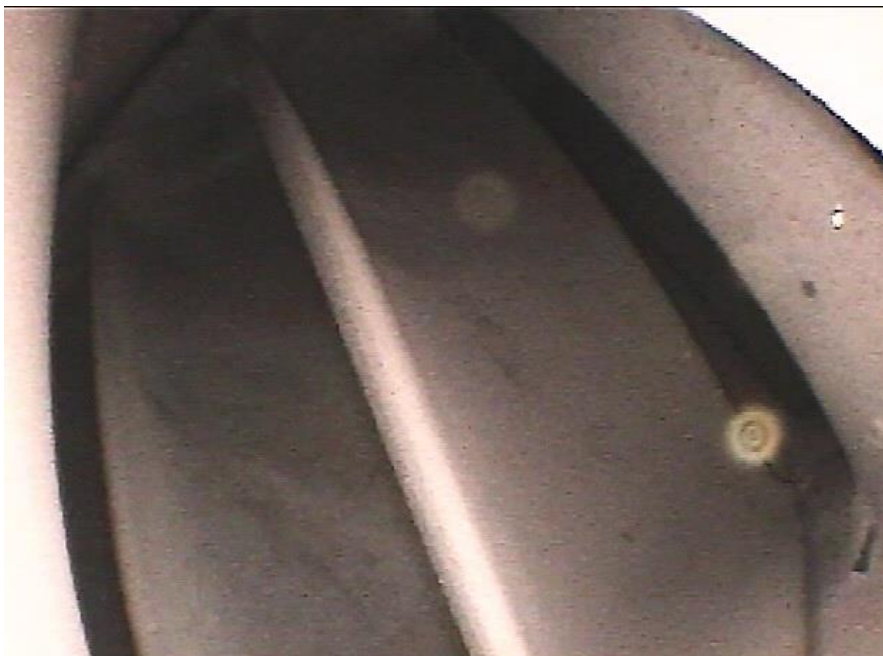
Photo No. 63

3rd Stage Low Pressure Turbine: No visible damage was evident on the blades (Ref. Photo No. 63).

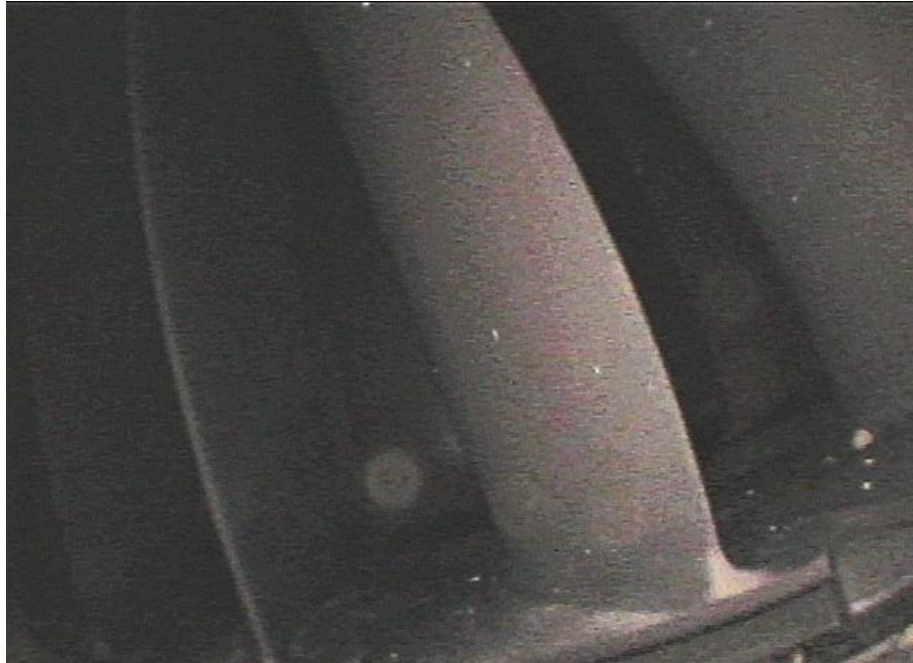
Photo No. 64

5th Stage Low Pressure Turbine: No visible damage was evident on the blades (Ref. Photo No. 64).

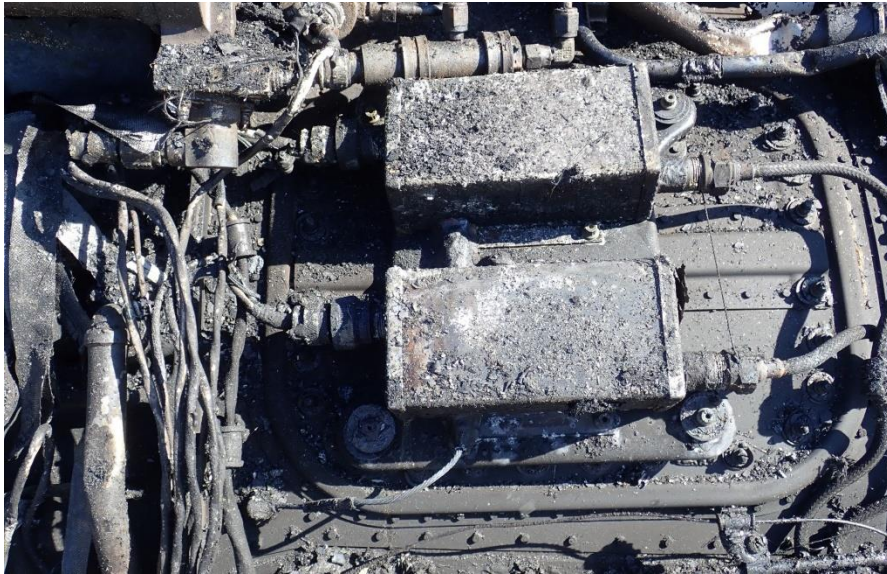
Photo No. 65

Exciter Boxes: The boxes were in place. The exterior of both boxes were thermally damaged from exposure to the post impact fire (Ref. Photo No. 65).

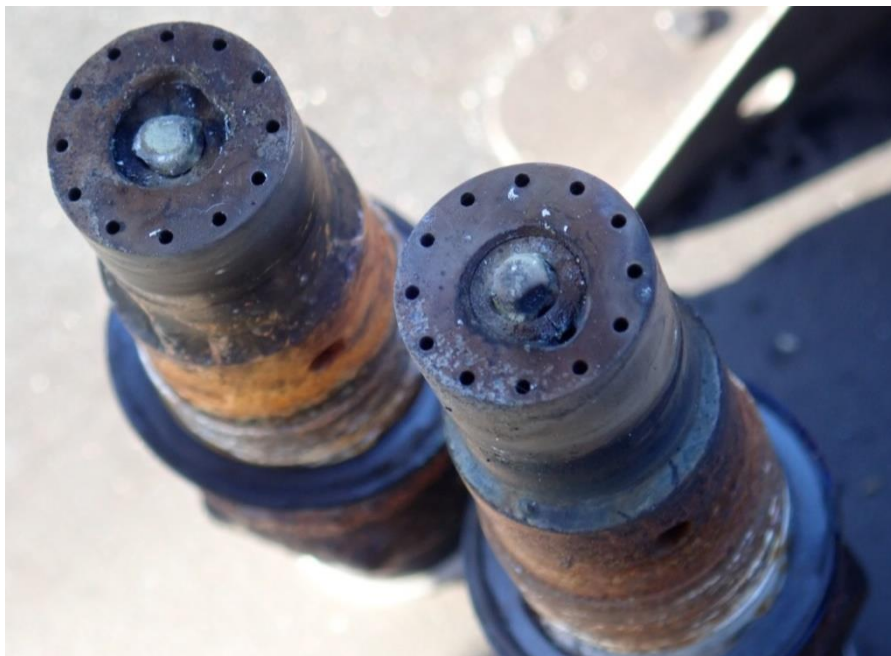
Photo No. 66

Ignition Plugs: The plugs were removed and the tips were eroded adjacent to the central conductor (Ref. Photo No. 66). The erosion is consistent with operational use.

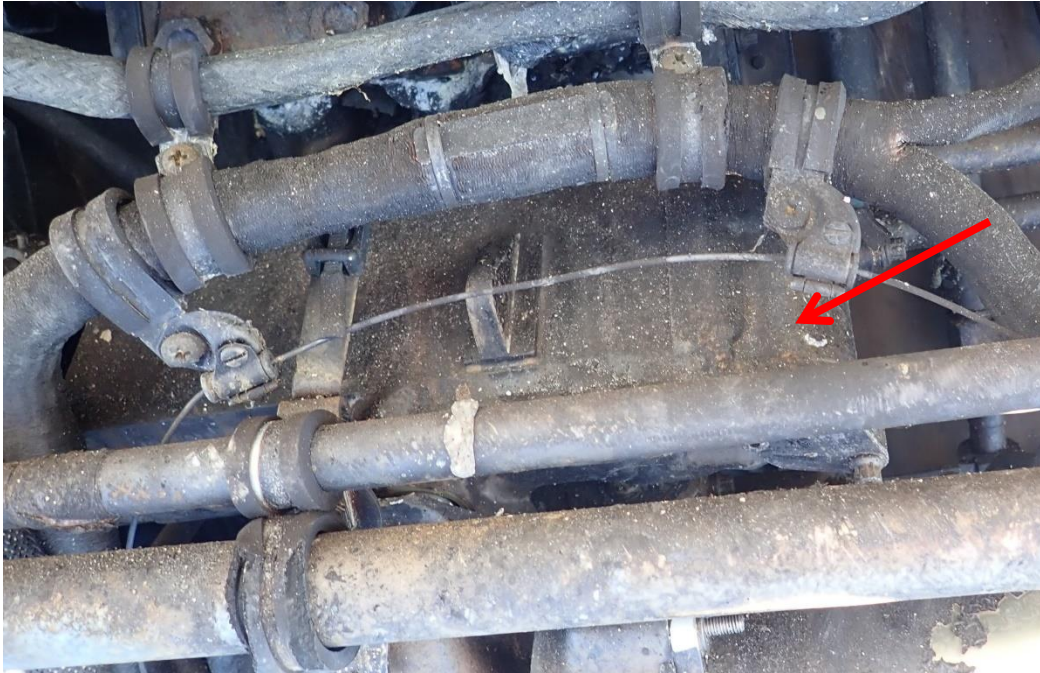
Photo No. 67

Fuel Heater: The heater was coated in soot (Ref. Photo No. 67, red arrow).

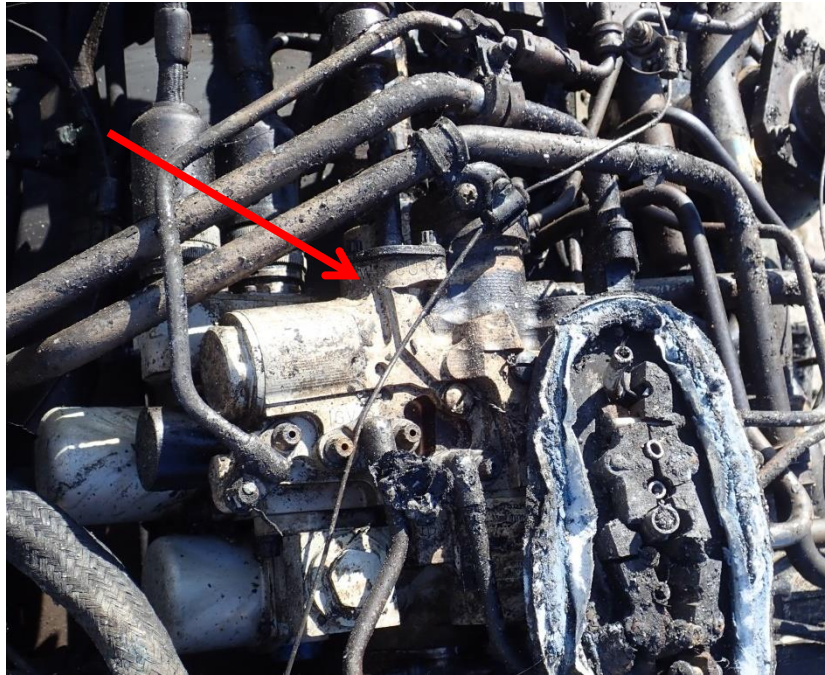
Photo No. 68

Hydromechanical Fuel Control Unit: The control was in place and the exterior housing was partially coated in soot (Ref. Photo No. 68, red arrow).

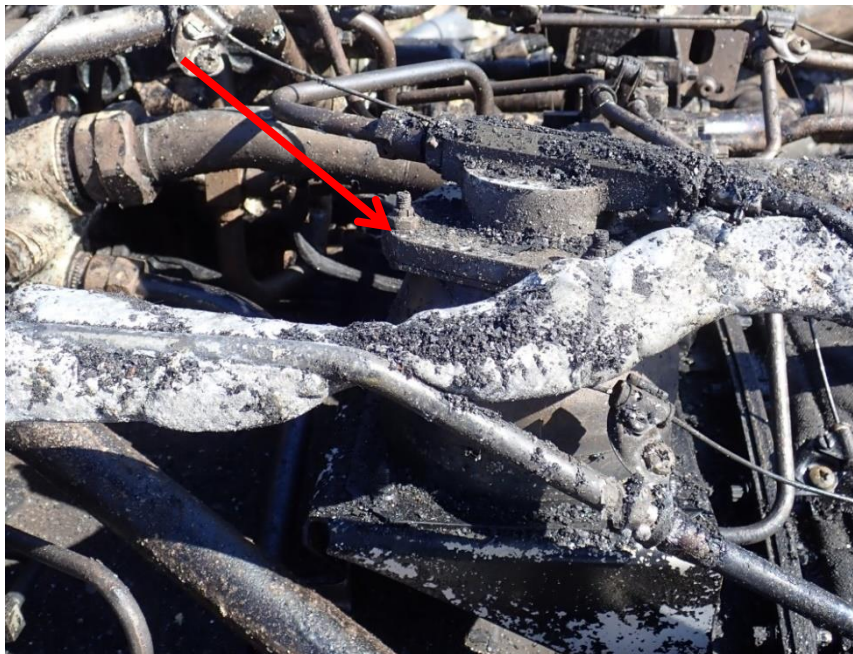
Photo No. 69

Fuel Waste Ejector: The ejector was in place and exhibited thermal distress from exposure to the post impact fire (Ref. Photo No. 69, red arrow).

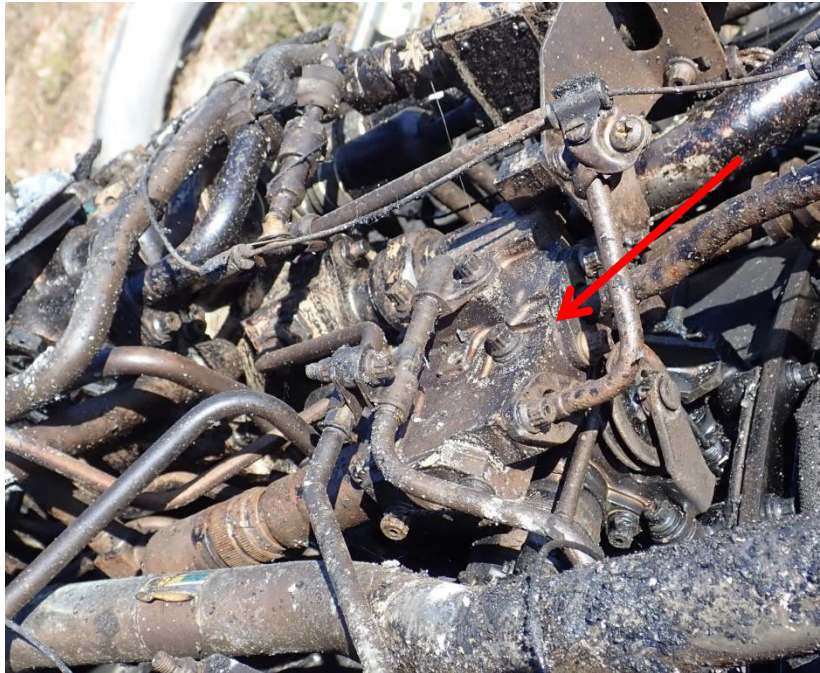
Photo No. 70

Start and Dump Valve: The valve was in place and the exterior was discoloured from exposure to heat from the post impact fire (Ref. Photo No. 70, red arrow).

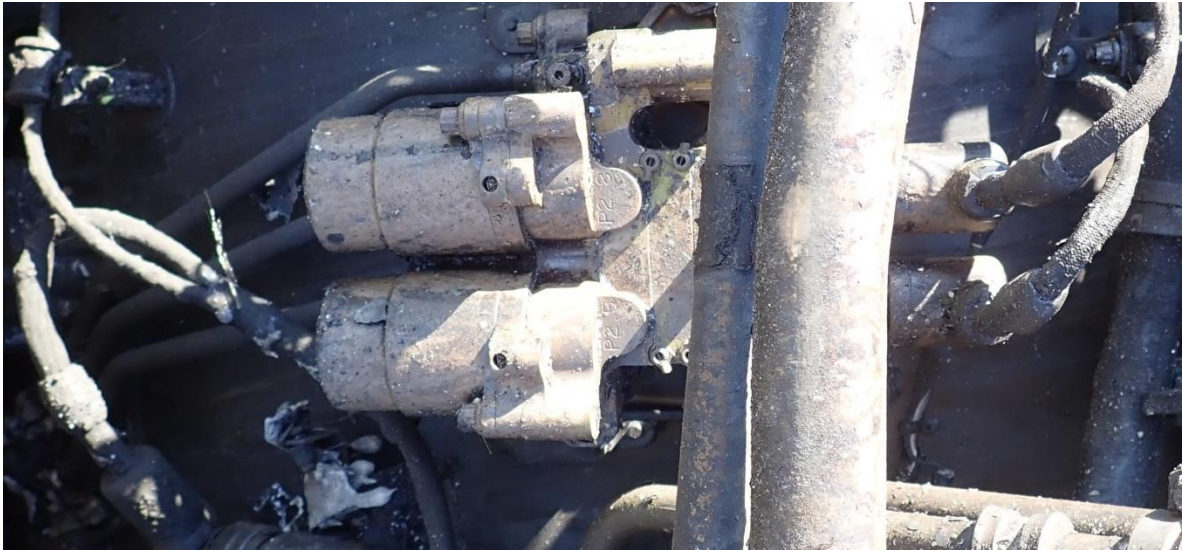
Photo No. 71

Compressor Bleed Valve Solenoid: The solenoid was in place and coated with soot (Ref. Photo No. 71).

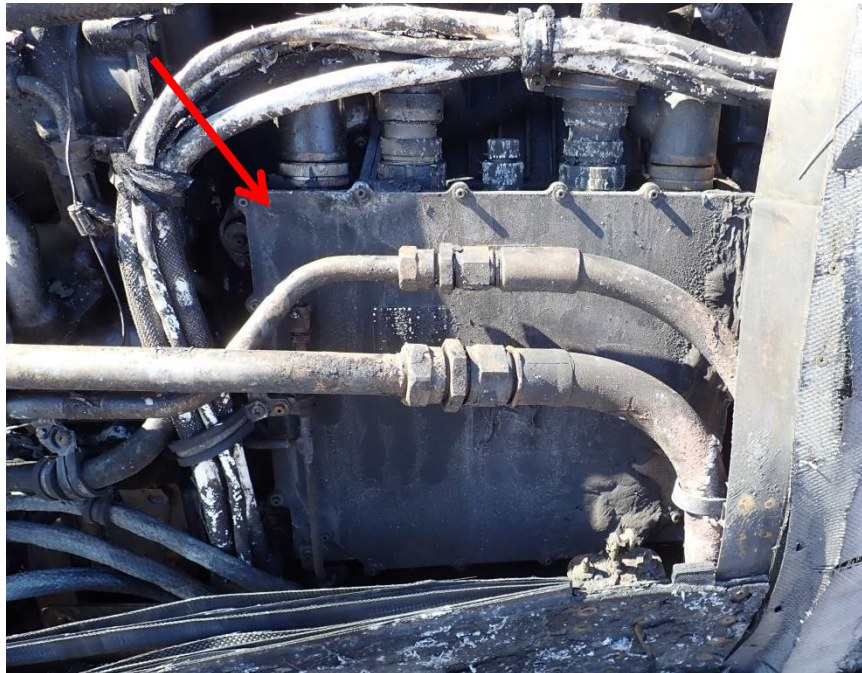
Photo No. 72

Engine Electronic Control (EEC): The control was secured in place on its respective mounting pad (Ref. Photo No. 72, red arrow). The exterior housing was burnt and discoloured from exposure to the post impact fire.

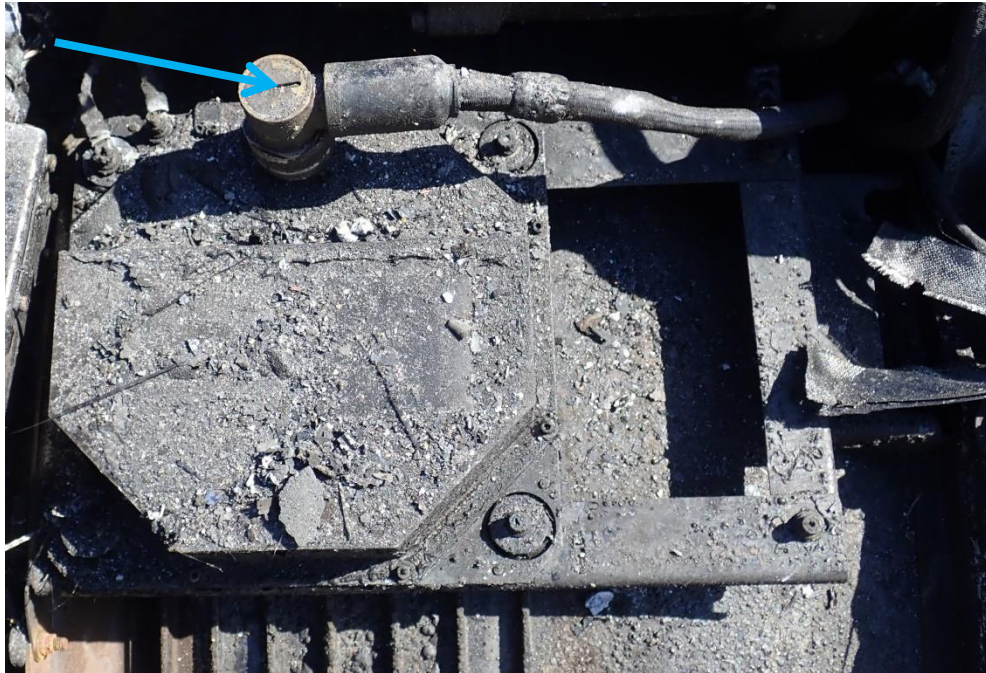
Photo No. 73

Outer Electrical Wiring Harness: The harness was in place and all of the visible connections were attached to their respective components (Ref. Photo No. 73, blue arrow). The outer protective sheath was discoloured.

Engine Diagnostic Unit (EDU): The unit was discoloured and partially coated in soot (Ref. Photo No. 73). The EDU was forwarded to P&WC's Accessory Investigations for data recovery.
