I ANALYSIS

1.0 Accident Synopsis

- 1.1 The subject engine was removed from an Agusta A119 Aircraft Registration No.N403CF following an aircraft mishap.
- 1.2 It was reported that the aircraft was found substantially damaged when it impacted terrain while approaching to land to a remote landing zone (LZ) approximately 8 miles northeast of Mancos, Colorado. The pilot, nurse, and paramedic were fatally injured.

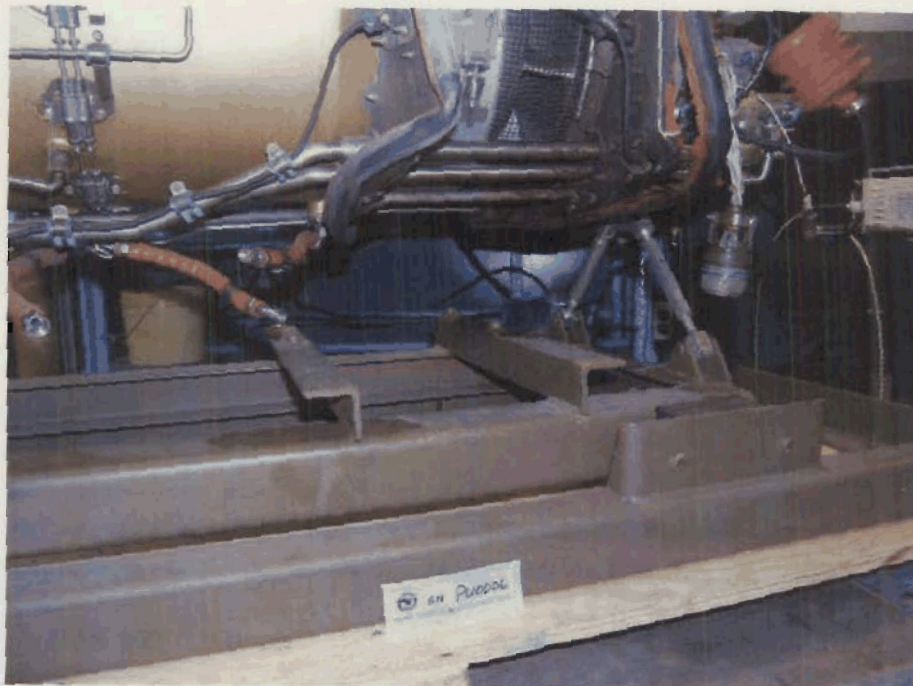
Photo no. 8

RH bottom view (intake area) showing the damage to the front & central fireseals and oil scavenge lines

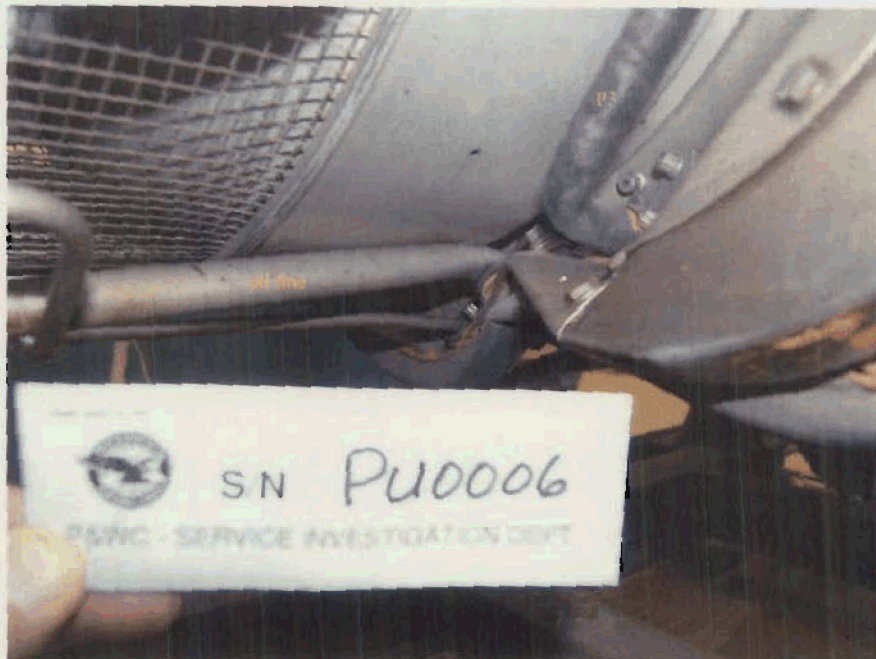
Photo no. 9

Bottom LH view (intake area) shows the impact damage to the central fireseal with the P3 pneumatic and main oil pressure lines.

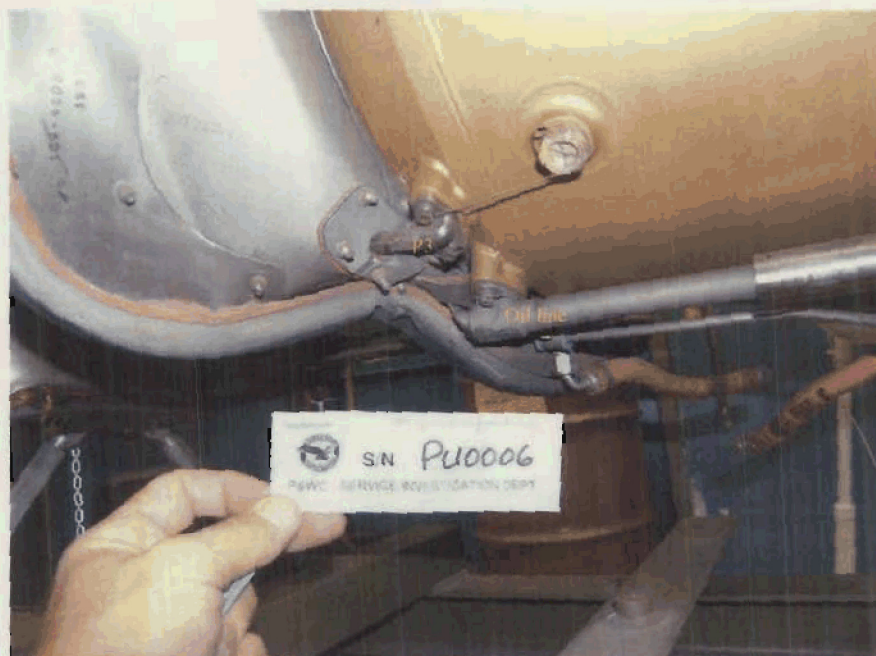
Photo no. 10

Bottom LH view (gas generator case side) shows the impact damage to the central fireseal with the P3 pneumatic and main oil pressure lines

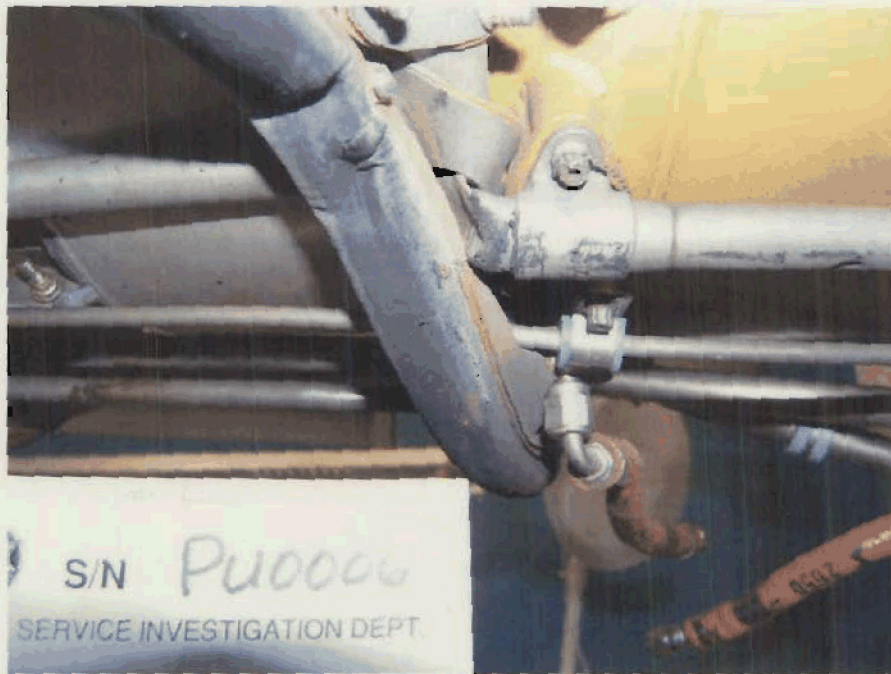
Photo no. 11

Closer view of photo no. 10 shows the damage to the central fireseal with the main oil pressure line.

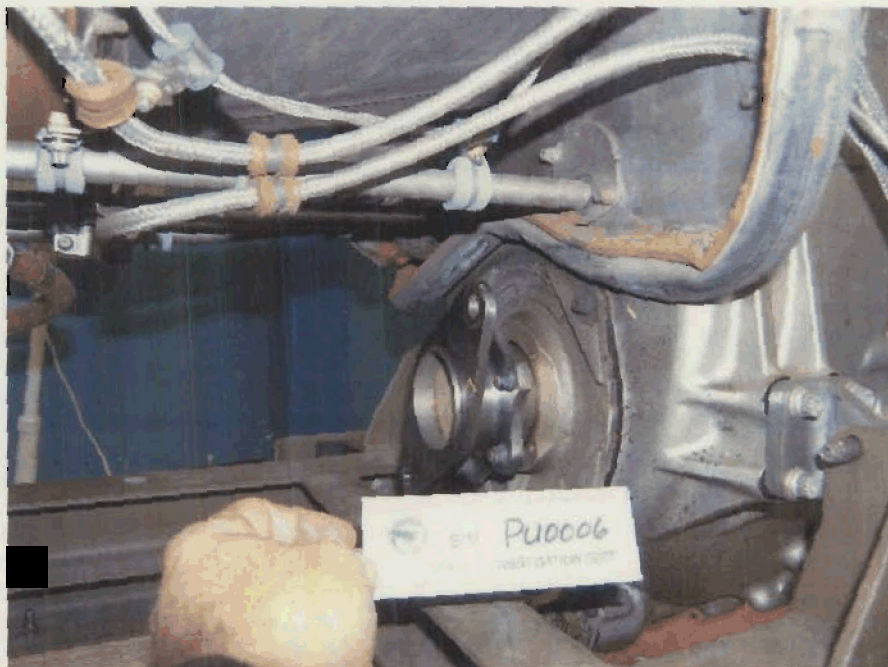
Photo no. 12

Bottom LH view shows the damage to the rear fireseal, and the aircraft main rotor coupling (A) still attached on the RGB output coupling/clutch gearshaft.

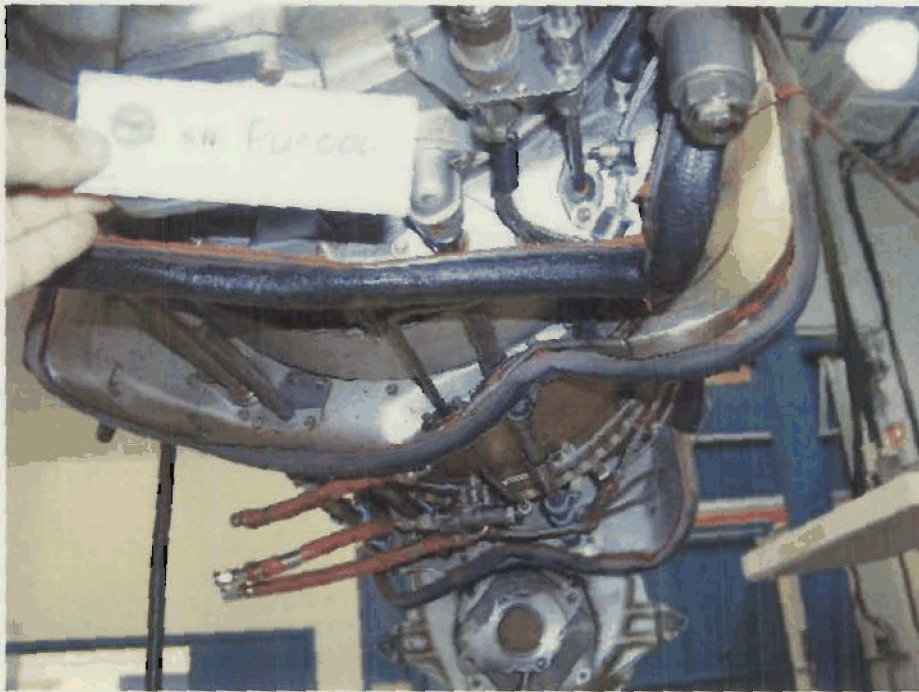
Photo no. 13
Engine bottom view shows the impact damage.

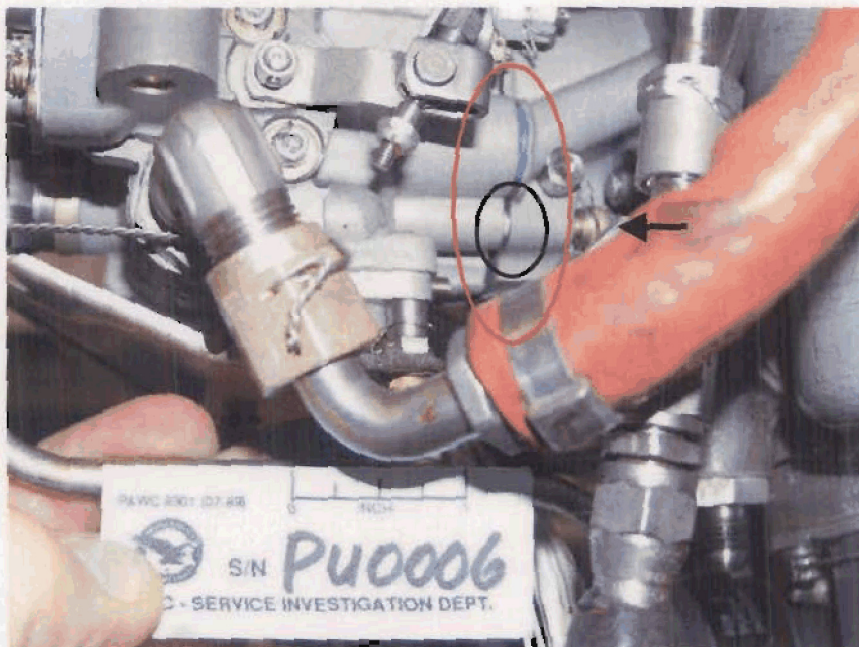
Photo no. 18

The FCU drive body flange mating with the flow body was found to have an irregular surface flatness. The drive body boltholes had markings matching the bolt thread spacing. Raised material was observed in boltholes No. 3 and No. 4. Furthermore, the raised material was flattened and rubbed in bolthole No. 3. The rubbing marks and flattening in bolthole No. 3 was consistent with relative movement between the drive body and the bolt.

The large circle shows the opened mating flange of the drive/flow bodies with the extruded Po fuel packing. Arrow points to the disengaged bottom left bolt No. 3. The small circle shows the fractured flow body threads coiled on the bolt threads.

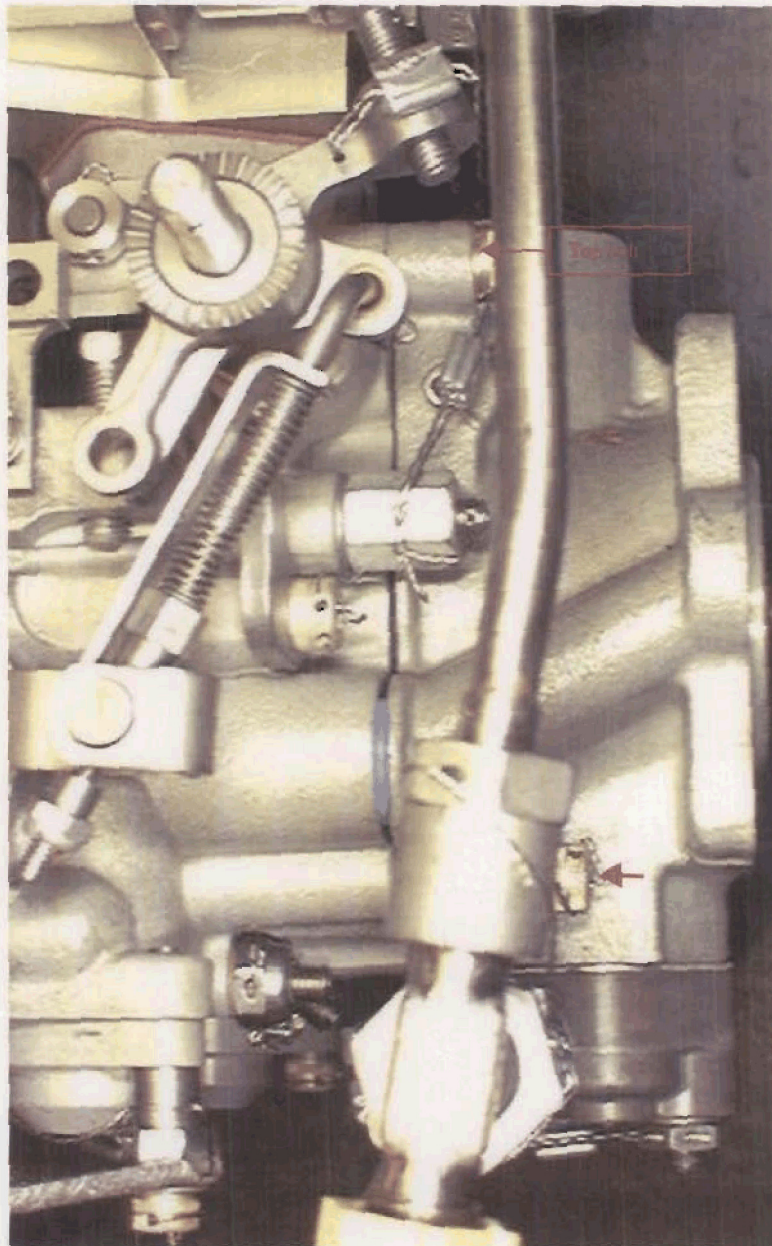
Photo no. 21

Close up LH view of the opening & the extruded Po packing of the mating flange of the drive/flow bodies. Arrows point to the disengaged bottom left retention bolt No. 3.

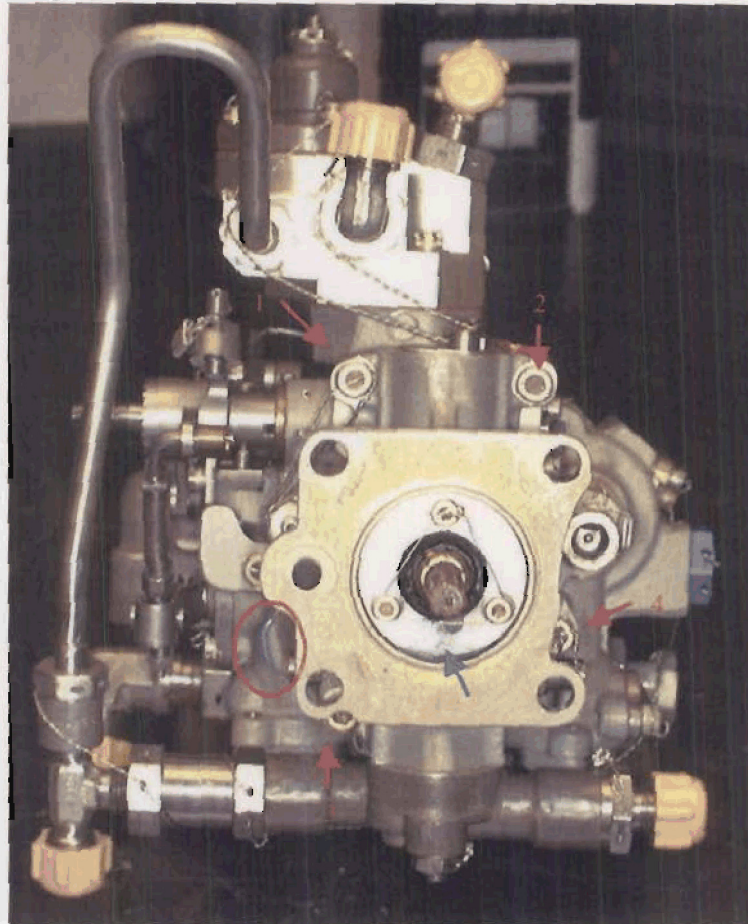
Photo no. 22

FCU back view shows the drive body pad and the drive shaft Teflon coupling. Arrows point to the retention bolts of the drive body to the flow body. The circle shows the extruded Po packing. A blue stain (blue arrow) noted on the drive bearing cover.

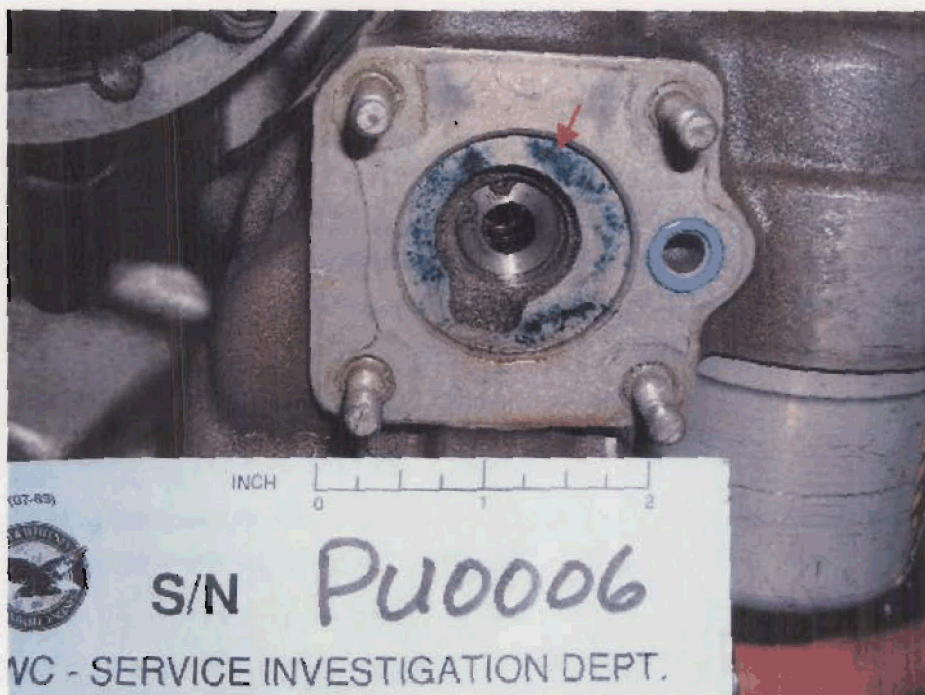
Photo no. 25

A blue stained residue (arrow) noted in the vicinity of the drive cavity of the fuel pump drive pad.

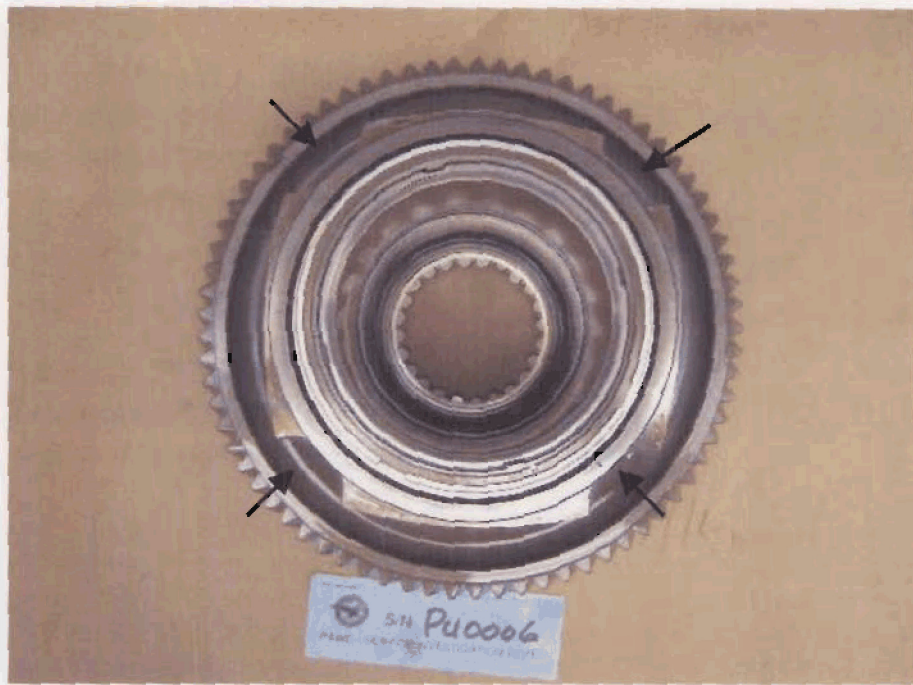
Photo no. 55
View of the No. 12 ball bearing attached to the idler gearshaft, which shows all four (4) fractures of the flanged outer ring.

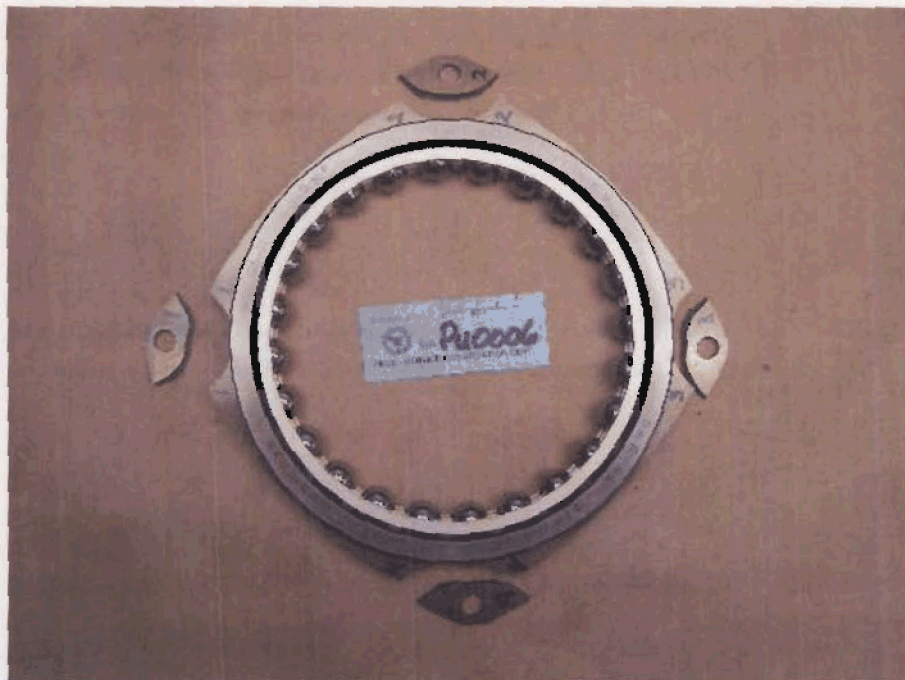
Photo no. 56
View of the four (4) fractured areas of the flanged No. 12 bearing outer ring

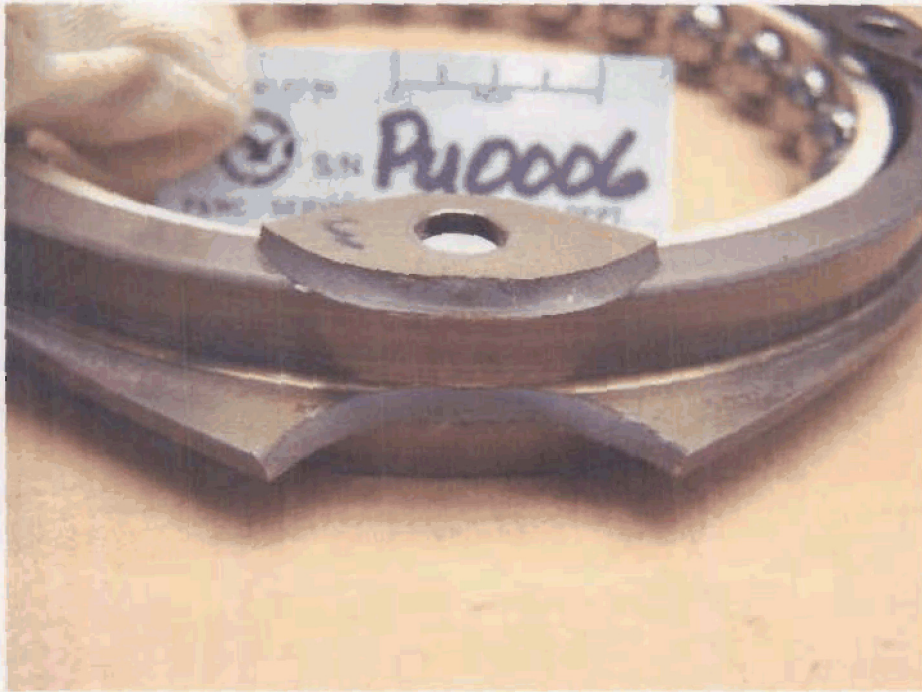
Photo no. 57
Detail view of the fracture surface of one of a fractured No. 12 bearing outer ring lug

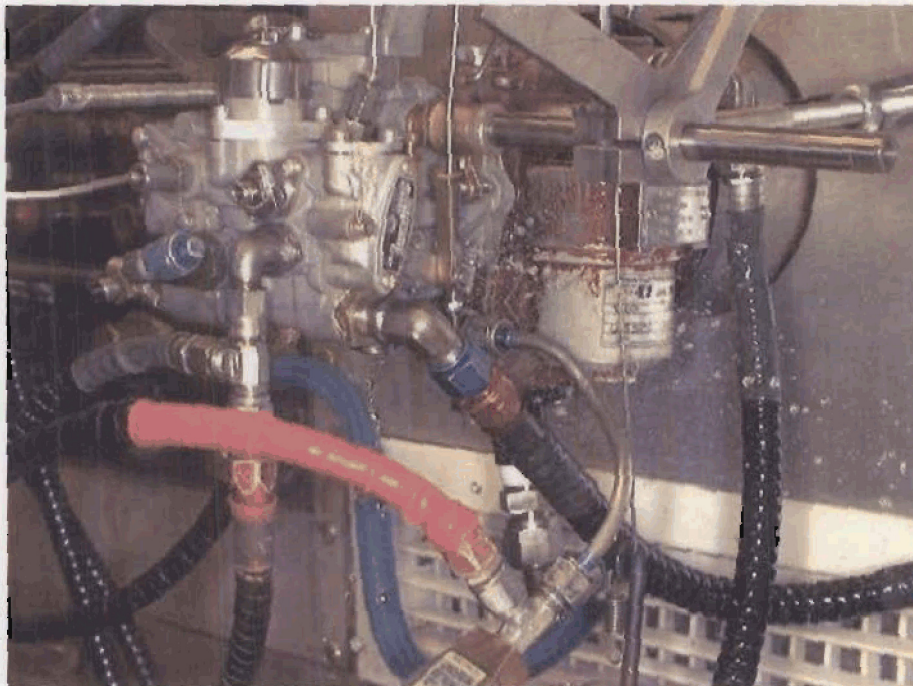
Photo no. 58
Leak test of FCU S/N C68008 drive body S/N 0005 shows the spray of fuel due to fuel and air leaks at the mating flange of the drive and flow bodies.

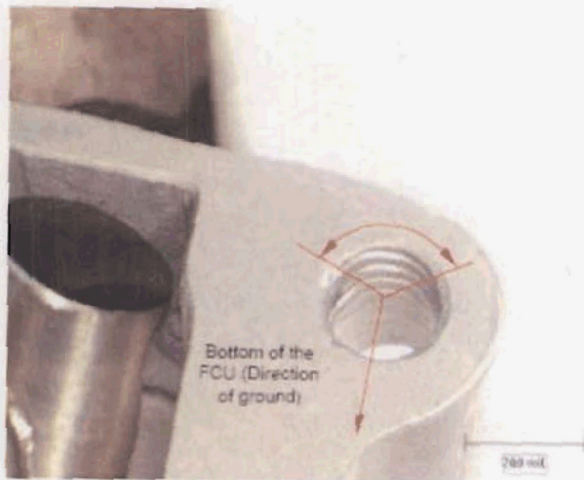
Figure 2

General aspect of the inner surface of bolt hole No. 1 in the drive body showing a circumferential marking suggesting that the surface was damaged by a threaded component. The damage is located approximately between 9 and 1 o'clock position.

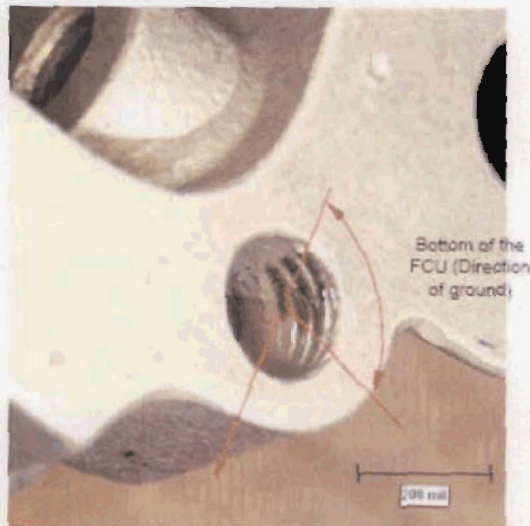
Figure 4

General aspect of the inner surface of bolt hole No. 3 showing pronounced circumferential markings. The damage is mainly located between 12 and 4 o'clock in the hole and next to the interface between the drive and the flow body.

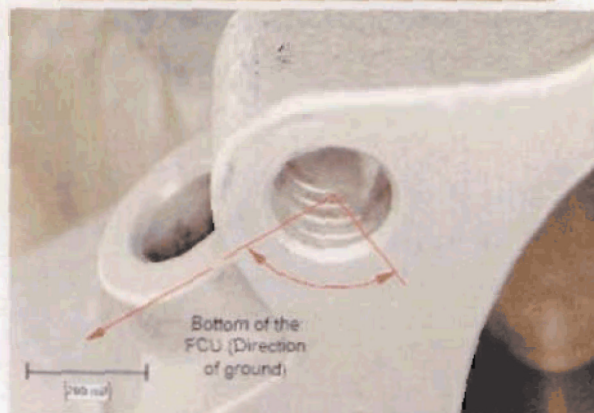
Figure 5

General aspect of the inner surface of bolt hole No. 4 showing deep circumferential markings. The markings are similar to thread-like features observed in other bolt holes. The damage is located approximately between 3 and 6 o'clock.

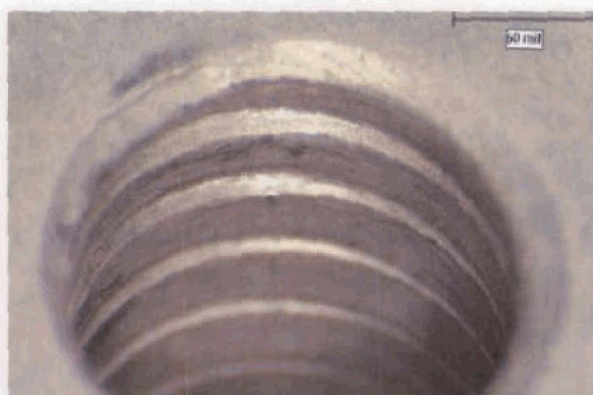
Figure 7

Examination of the circumferential threadlike pattern in bolt hole No. 1. The groove associated with the threading pattern is consistent with what was observed in bolt hole No. 4. However, there is no evidence of raised material associated with the threads.

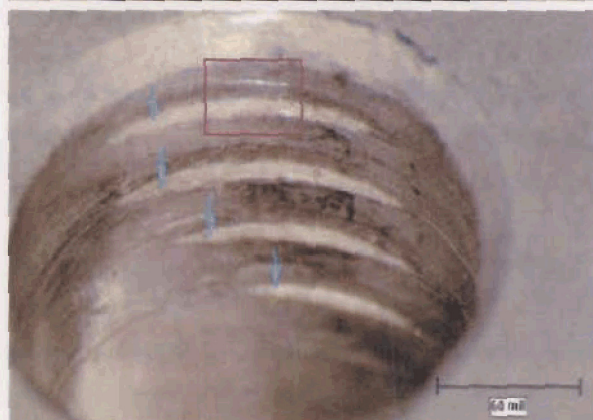
Figure 8

View of the damage in bolt hole No. 4 at higher magnification showing that from the flange side, there is evidence of raised material in the bolt hole (arrows) associated with each thread.

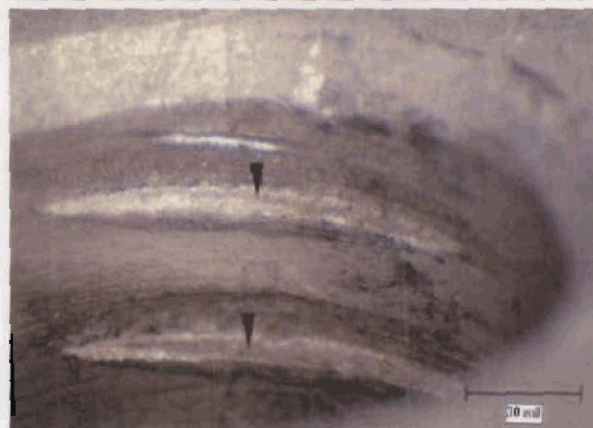
Figure 9

Aspect of the damage at higher magnification showing that in this area the threads of the bolt are grooved in the material of the drive body. The raised features are material from the drive body. Note that the surfaces of the raised features area that are facing the flange are smooth and flat (arrow heads).

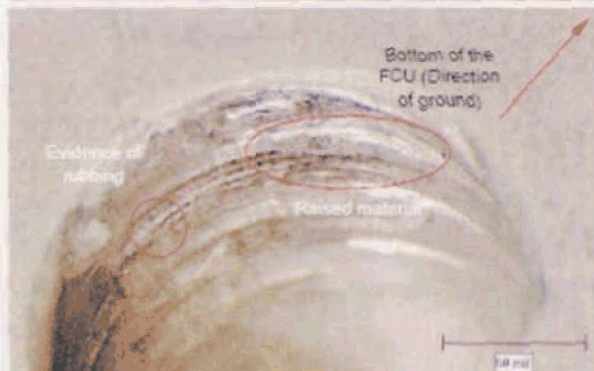
Figure 11

Damage in bolthole No. 3 on the drive body side, next to the flange. Evidence of raised material and of rubbing within the hole is also observed.

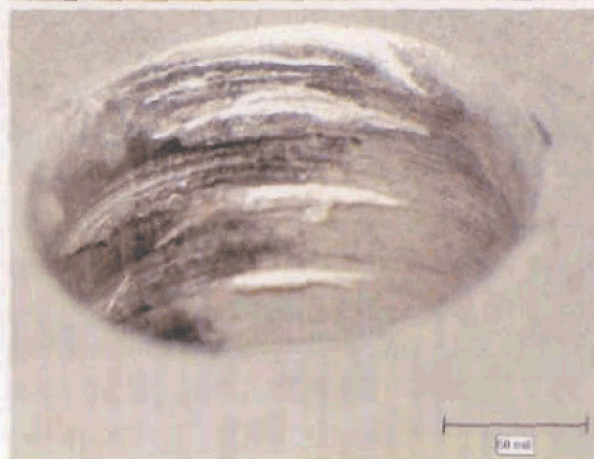
Figure 12

Evidence showing that the areas of raised material was most likely similar to what was observed in bolt hole No. 4. However these features appear to have been flattened while this was not observed in bolthole 4.

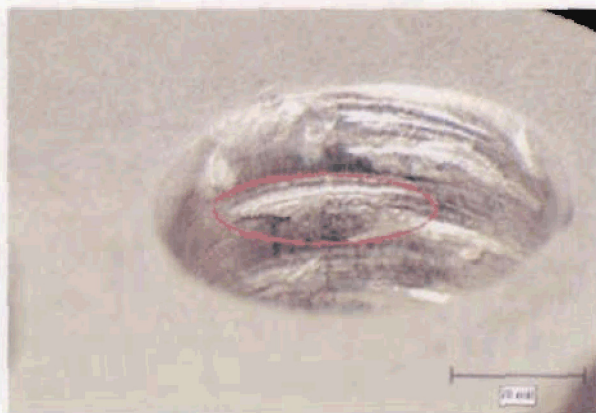
Figure 13

Presence of a tongue just beneath a thread mark along with lines indicating that the feature was rubbed. These features are consistent with a relative movement between the drive body and the bolt. This damage could have been done while the bolt is moving away from the flow body or while the drive body moves towards the flow body while the bolt remains stationary. The origin of the flatterer could not be determined.

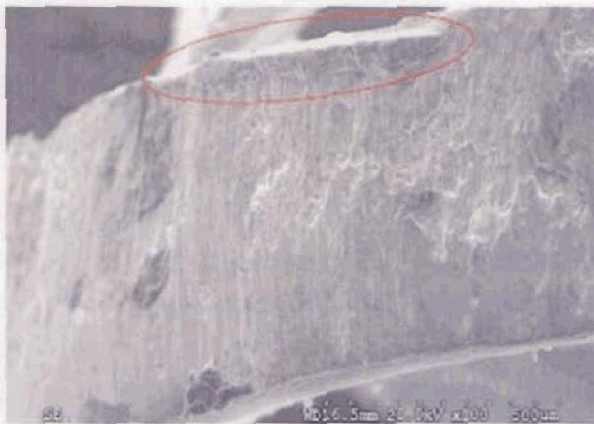
Figure 17

Aspect of the fracture surface of the stripped material at higher magnification showing the extent of the area exhibiting features A and B (black outlined area in Figure 15). An area of deformed material not consistent with the shear fracture is also visible along the root (circled area).

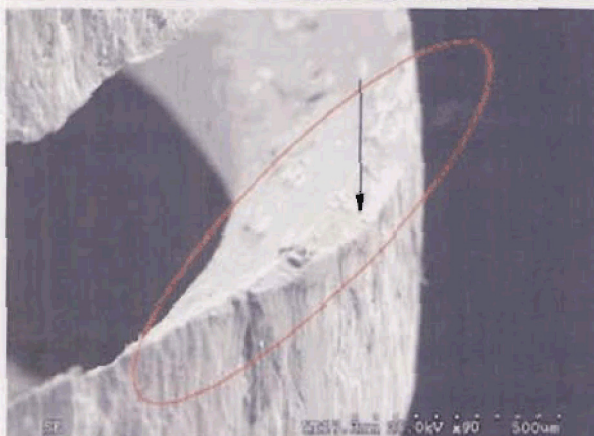
Figure 18

Additionally, the fractured threads revealed evidence of deformation not consistent with a shear fracture along the root of the fractured thread. This deformation and its orientation are consistent with a contact along this edge after the fracture. Furthermore, evidence of a partial shearing of the threads occurring during a prior event was also observed.

Same as Figure 17 showing the deformed area from the inwards portion of the thread. The deformation observed along the edge is consistent with the application of a force in the direction of the deformation, which is in agreement with a damage resulting from a contact at the location shown.

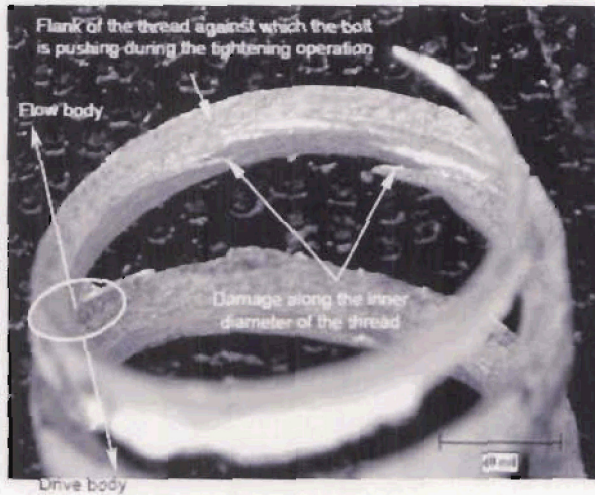
Figure 20

Damage along the inner surface of the thread fragment stripped from bolt hole No. 3 in the flow body. The damage is located along the flank of the thread facing into the tapped hole and consequently it is the surface on which the torquing load is applied. The damage visible on the right hand side corresponds to the feature seen in Figure 15 on the fracture surface.

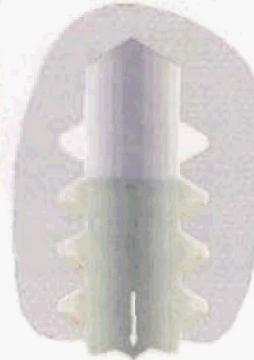
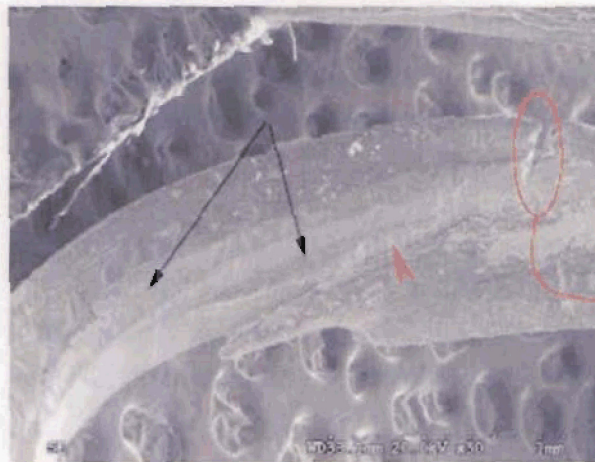
Figure 21

Damage to the inner surface of the stripped material shown in Figure 20 at higher magnification. This shows that the thread is partially sheared in this area (red arrow head). There is also evidence of rubbing on the thread indicating that the crest of the thread was damaged in this area (black arrows). Shearing was also observed from the fracture surface side (red arrow head in the inset).

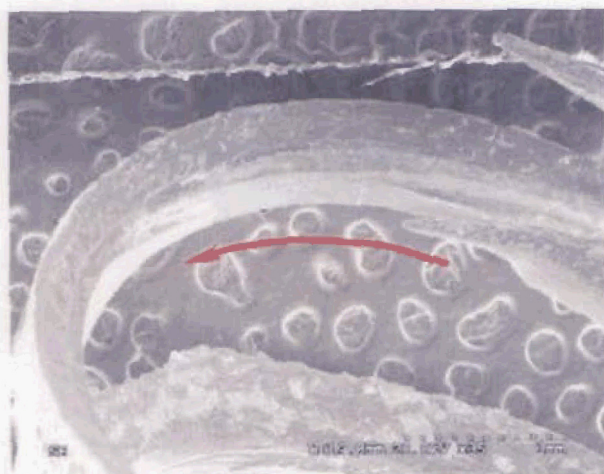
Figure 22

Damage to the inner surface of the stripped material shown in Figures 20 and 21. There is evidence of damage on the left hand side of the sheared area consistent with a damage that would be produced by the bolt that is being screwed in.

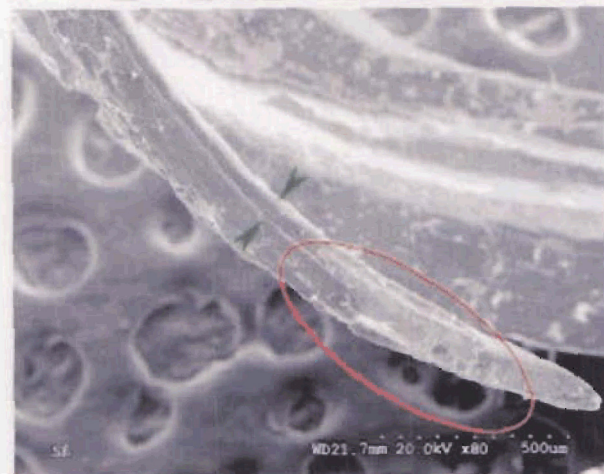
Figure 23

Damage similar to the one observed on the previous thread (Figure 22) are also visible along the crest of the last engaged thread (circled area). Grooving of the outer portion of the thread is also visible (arrow heads).

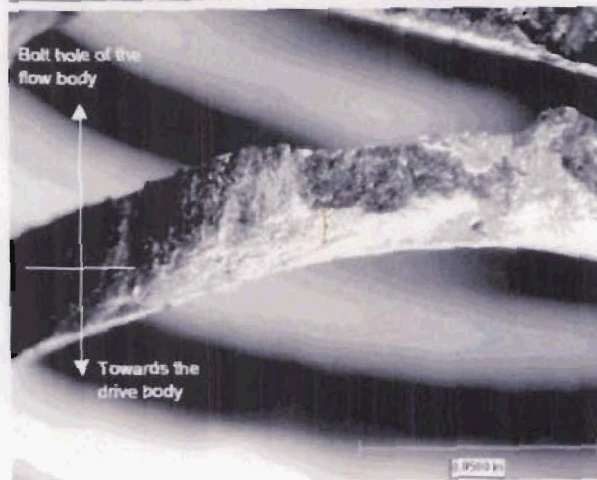
Figure 29

Area of the first thread of the fragment of stripped material exhibiting a different topography. Small parallel lines are visible (bracket). This feature is unique to the stripped material from the crash. A similar feature was not observed on the fragment produced in the overtorque or the pull tests performed by Honeywell. The fracture surface is approximately at a 45-degree angle to the axis of the bolt hole. This area is not associated with an area of partially sheared thread like the area shown in Figure 21.

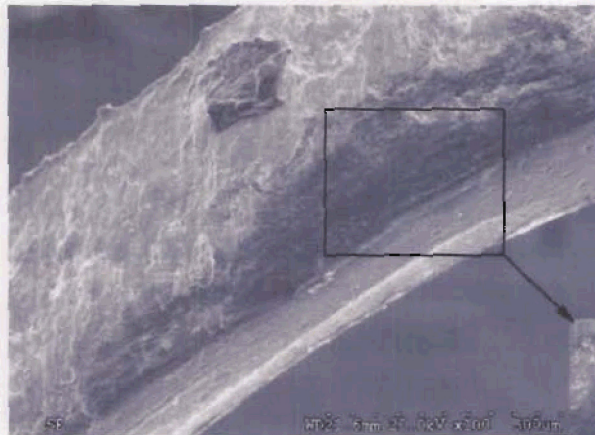
Figure 30

A third area exhibiting a different mode of fracture had contaminants on its fracture surface. The absence of such contaminants on the adjacent rubbed area is indicative that this portion of fracture surface was pre-existing. This contaminated surface exhibited a topography showing evidence of striations consistent with a fatigue mechanism. A portion of the shear overload fracture initiated from this portion of the fracture surface.

Area of the first thread of the fragment of stripped material exhibiting a different topography at higher magnification. The fracture surface exhibits a darker colour indicating that it is dirty. In addition, there are no evidence of rubbing damage nor shear overload features.

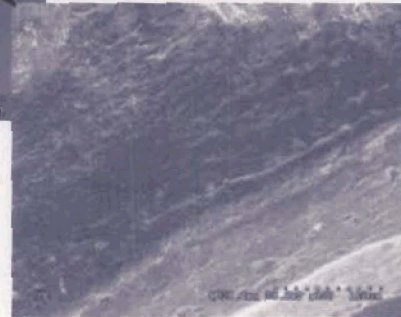
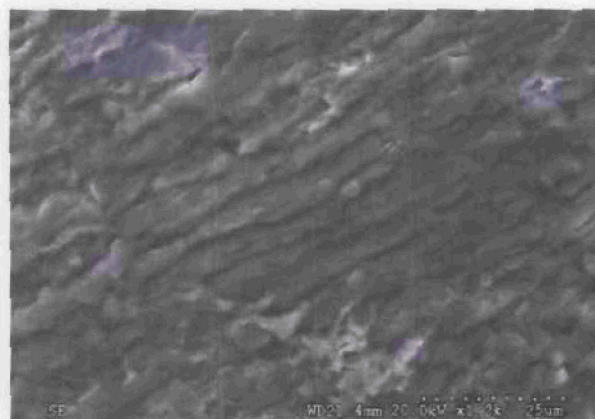
Figure 31

Evidence of large parallel striation-like features at higher magnification in the area of the fracture surface next to the root of the thread facing outwards. The presence of striation-like features is indicative of a fatigue crack propagation. However, the striations are not typical of a fatigue crack in Mode I (tensile) but are more consistent with a mixed Mode I-Mode II (tensile and shear).

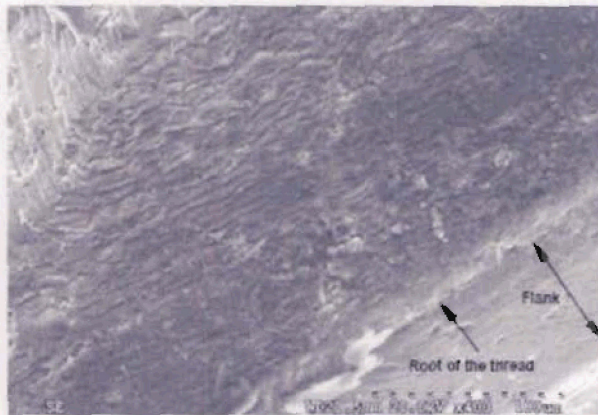
Figure 32

Area next to the root of the threads exhibiting striation-like features. The size and the spacing of these features are increasing from the root towards the sheared area. This is in agreement with a sub-critical crack growth under cyclic loading. Increasing striations spacing indicates that the fatigue crack was accelerating.

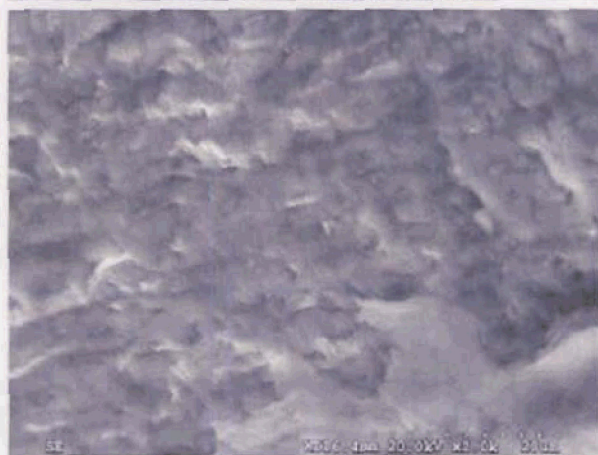
Figure 33

Aspect of the fracture surface next to the root of the thread (inset) at high magnification showing evidence of striations characteristic of fatigue crack propagation. The presence of these striations confirms a fatigue mechanism.

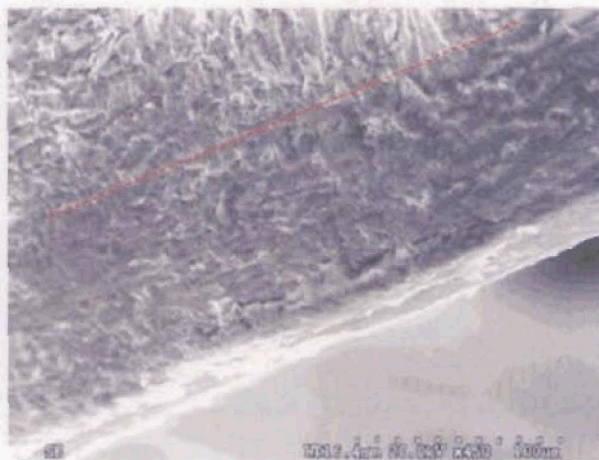
Figure 34

Transition between the fatigue crack and the overload shear fracture surface. There is no evidence of a sudden increase in the applied load that would have resulted in the shear overload fracture of the thread. The evidences show that the overload shear fracture initiated from the fatigue crack and consequently from a crack that existed prior to the final shear fracture.

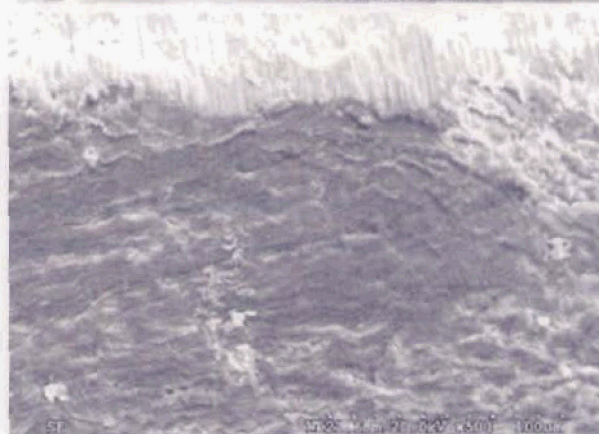
Figure 35

Other area showing the transition between the fatigue crack and the prior shear overload fracture subsequently damaged. Fatigue striations are visible on the fracture surface preceding the final overload fracture.

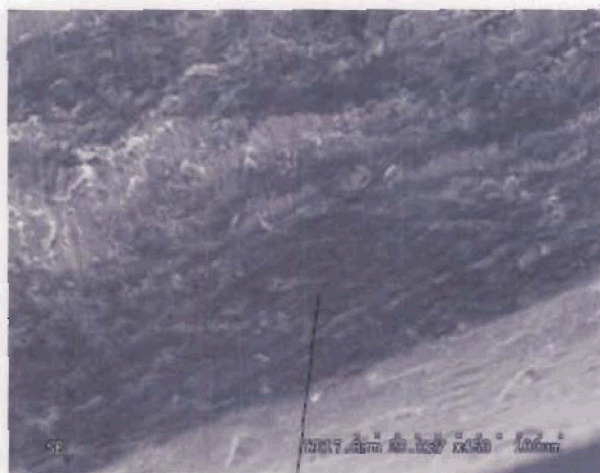
Figure 36

Chemical analysis of the greyish area exhibiting striation-like features on the fragment of stripped material. The Energy-Dispersive X-ray analysis showed the presence of elements such as cadmium indicating a contamination of the fracture surface. Cadmium is associated with the coating of the bolts used to fasten the drive body onto the flow body. Because the fracture surface shows evidence characteristic of fatigue crack propagation, the presence of chromium as well as mud cracks on the fracture surface cannot be attributed to the anodizing process since such a crack can only initiate during operation.

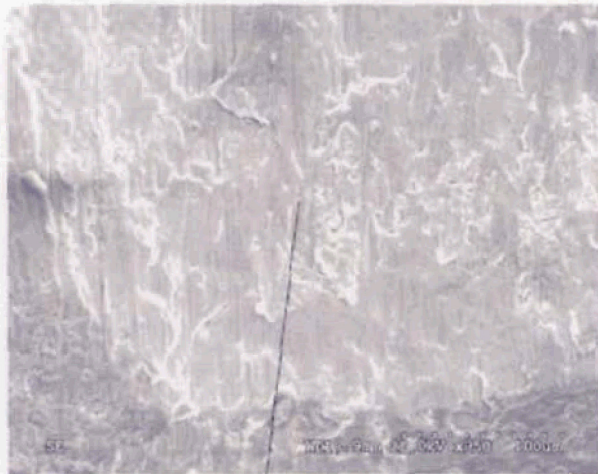
Figure 37

Chemical analysis performed on the sheared fracture surface on the fragment of stripped material. No evidence of cadmium was found indicating that the portion of the fracture surface next to the root of the thread where contaminants were found has most likely been present for some time and prior to the overload fracture.

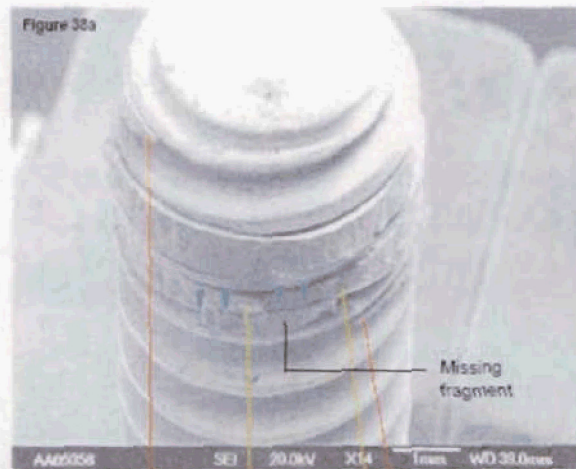
Figure 38

Figure 38a) Figure 9B from Honeywell's South Bend Materials Technology Center report No. AA05358 and titled "Investigation of B-37 fuel Control, S/N 69008", dated 11/11/05, showing the presence of a crack on the fragment of stripped material when it was still attached to bolt No. 3 (blue arrow heads)

Figure 38b) Area of the stripped material matching the area where evidence of fatigue crack propagation was observed on the as removed bolt No. 3. The details of the fracture surface are provided in photographs 29 to 37. This shows that there was a pre-existing crack at the time of the final fracture. The fragment containing the matching fracture surface was not submitted to the lab for examination.
