Piper Aircraft Corporation
Vero Beach, Florida, U.S.A.

SERVICE No. 921 BULLETIN

Aileron Inspection

PA-46-310P Malibu
PA-46-350P Malibu Mirage

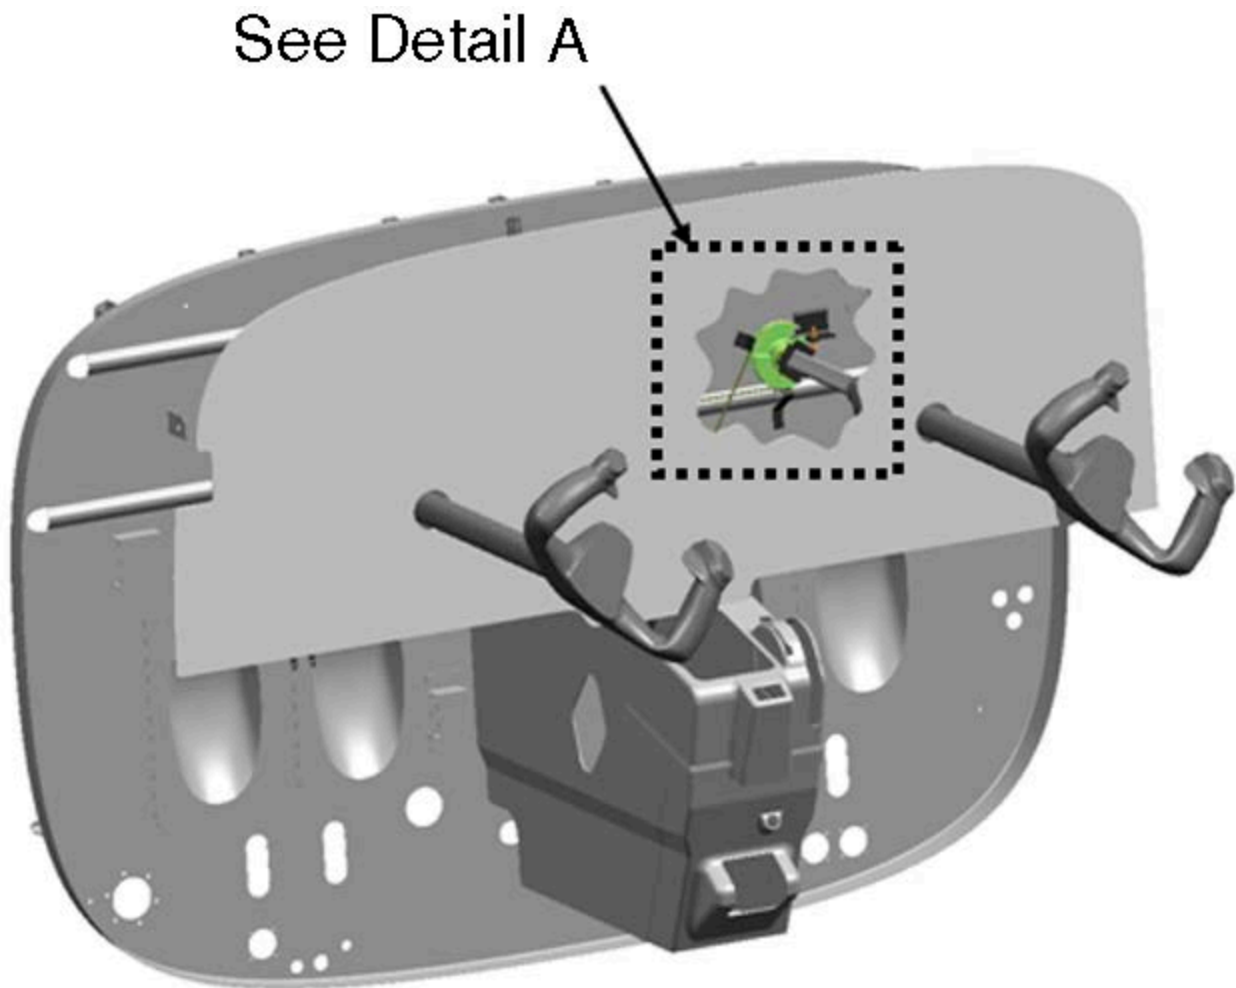
It has been discovered that the cable guards associated with the left and right Aileron Quadrants (located on the aft side of the forward pressure bulkhead) may not ensure positive retention of the aileron control cable for all situations. Left uncorrected, this condition could allow the aileron control cable to move to the opposite side of the cable guard, resulting in roughness and/or friction during roll-control inputs from the control wheel.

1. Locate the Aileron Quadrant Assembly, which is mounted on the aft face of the forward pressure bulkhead, coaxial with the control column tube, both left and right sides. Refer to Figure 1 for clarification (right side shown, left side opposite).
2. Verify that aileron cables are rigged properly, and are nested into the groove of the Aileron Quadrant Assembly (refer to Detail A), in accordance with the standard practices and procedures described in the "Flight Controls" chapter of the Maintenance Manual. Measure clearances between the 82858-002 Cable Guard and the following components: 82857-004 Angle (LH only), 82857-005 Angle (RH only), 85212-002 Aileron Quadrant Assembly (LH only), and 85213-002 (RH only), as shown in SECTION B-B. Rotation of the control wheel will be needed to align the 82857 Angle under the 82858 Cable Guard.

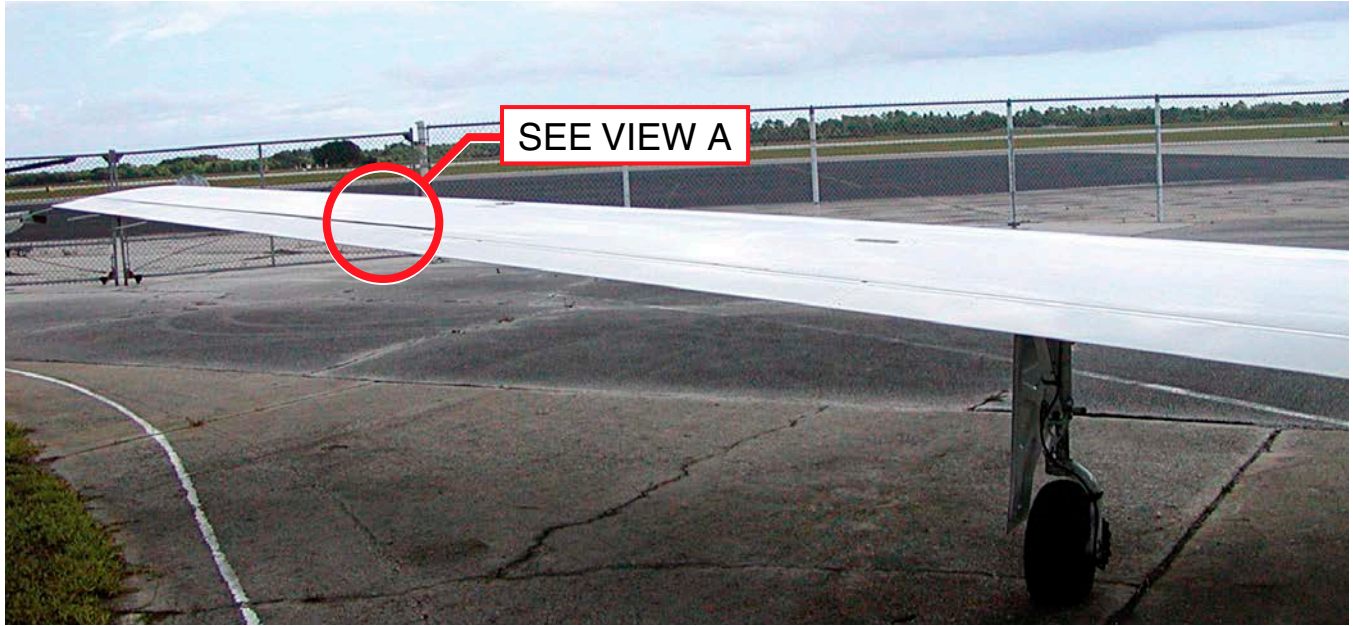
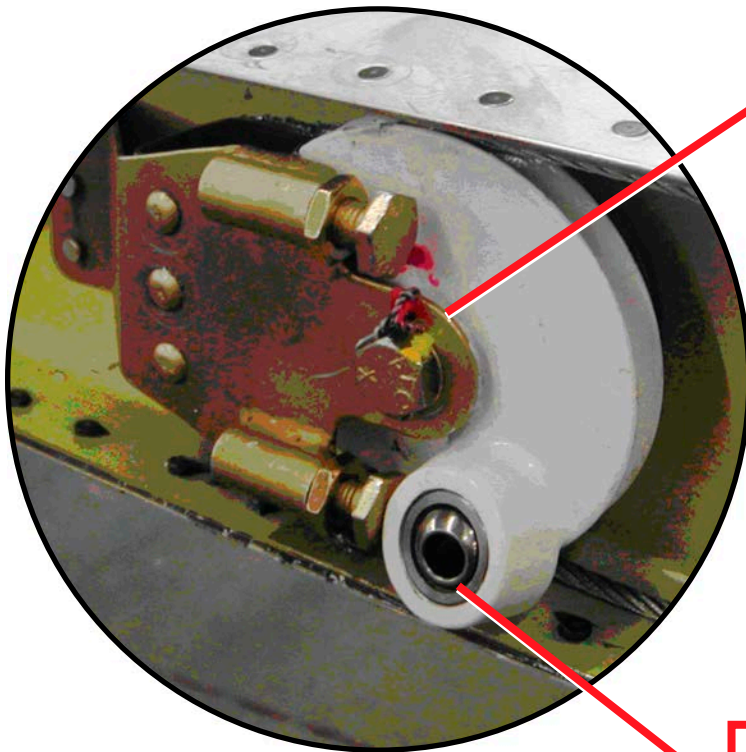
Figure 1
Aileron Sectors to be Lubricated

A field report was received of corrosion in an Aileron Sector needle bearing, leading to difficulty of operation during flight. Proper lubrication procedures are critical for prolonging the service life of all aircraft.

1. Clean exterior of Aileron Sector needle bearings with a quick-drying solvent, then apply "LUBRICATING OIL, GENERAL PURPOSE, LOW TEMPERATURE" conforming to MIL-PRF-7870C.
2. Wipe the Self Aligning Bearing area clean of old grease, oil, dirt, etc., then apply "DRY LUBRICANT conforming to MIL-L-60326.

NEEDLE BEARING
Apply Lubricating Oil,
General Purpose, Low
Temperature
conforming to
MIL-PRF-7870C

SELF ALIGNING BEARING
Apply Dry Lubricant
conforming to
MIL-L-60326
