**POST INSPECTION MEMORANDUM**

**Unit Inspected:** Anadarko Well-head **Unit ID:**  
**Unit Type:** Flowlines  
**Inspection Type:** M05 Special Assignment  
**Accident Location:** 6312 Twilight Ave.  
**Inspection Dates:** April 18-20, 2017  
**AFOD:** 3.0 (M05)  
**SMART Activity Number:** 156061  
**Incident Report number:** 1175960

**Project: Firestone, Home Explosion**

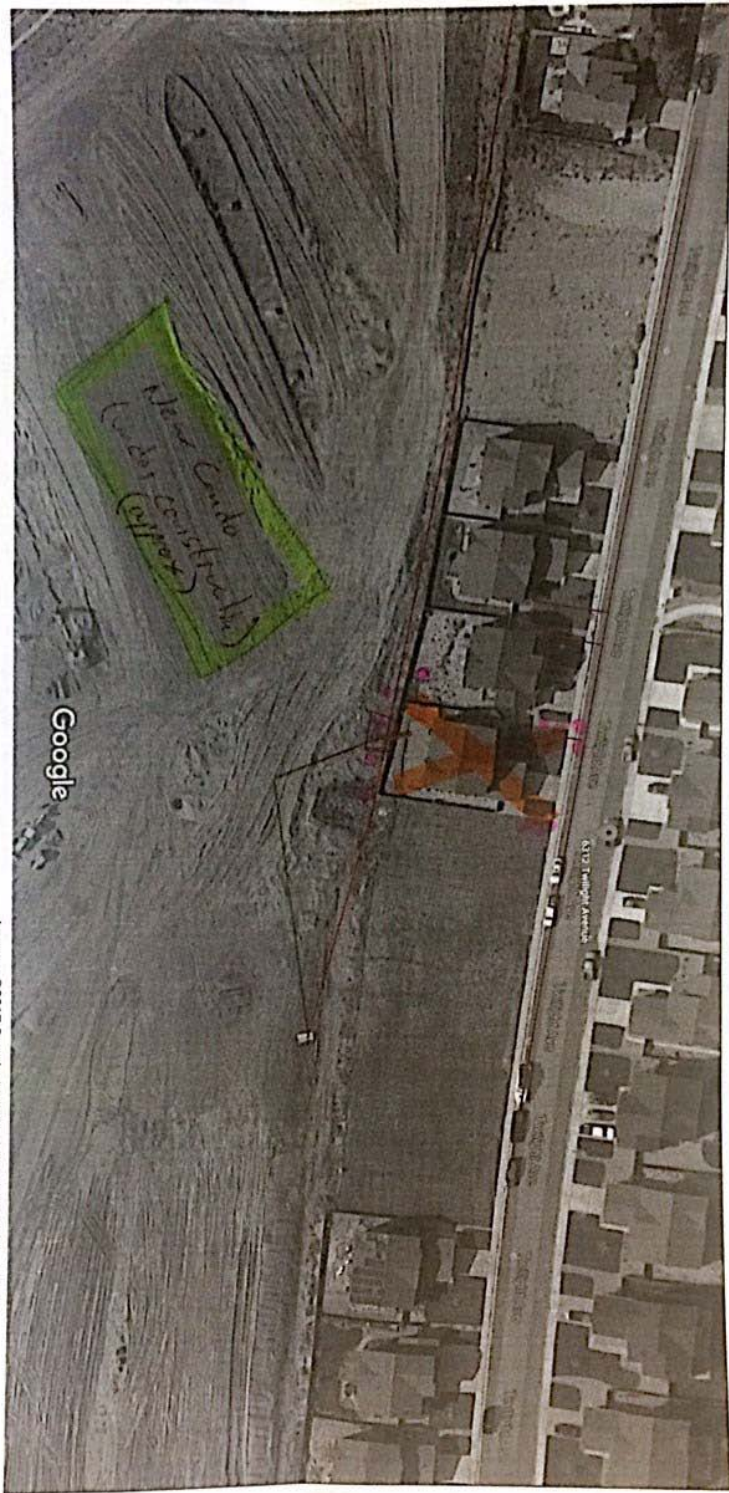
- There is also a 1" line that is connected to the wellhead whose termination point is unknown. During a line locate, the line locator lost the signal for the 1" line as it met with the 2" line (see figure 1). Per the Anadarko field personnel, the valve on this line had been shut in for 2 weeks.

Figure 1: Sketch of observations over Google satellite view.

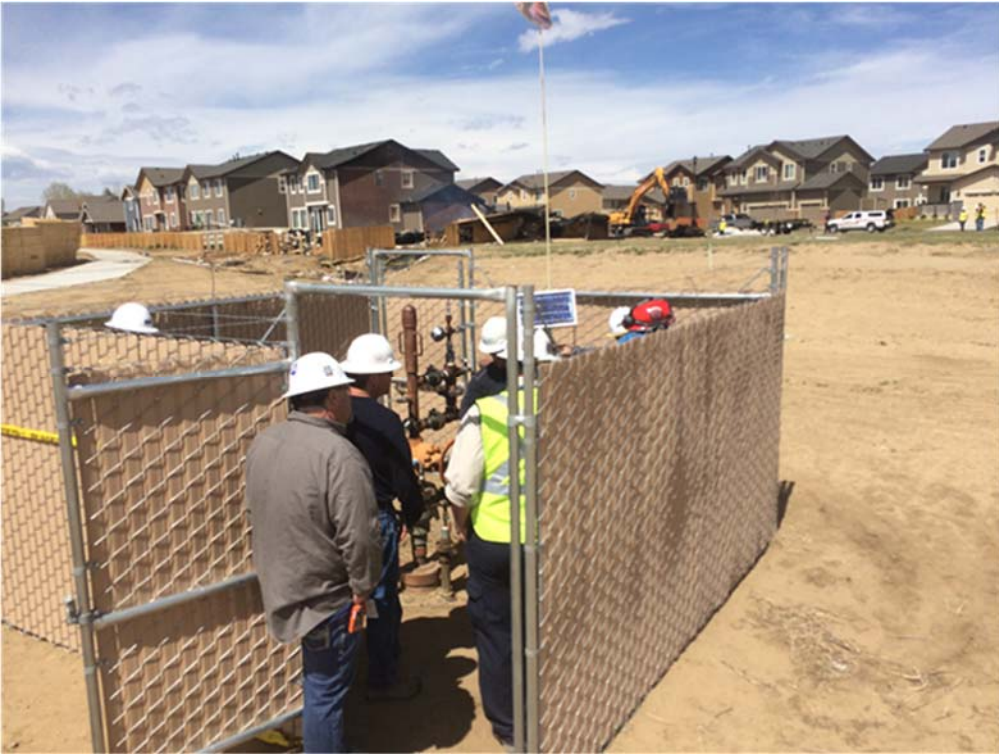
**Figure 2:** Wellhead in foreground, explosion site in background.

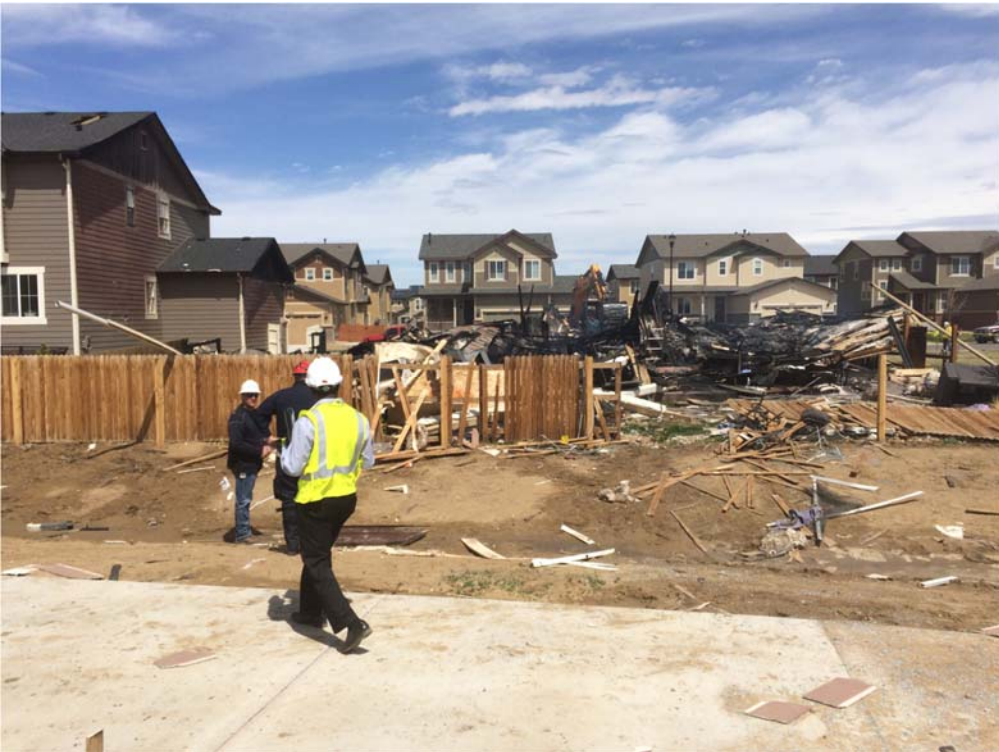
**Figure 3:** Explosion site from south side of property facing North.

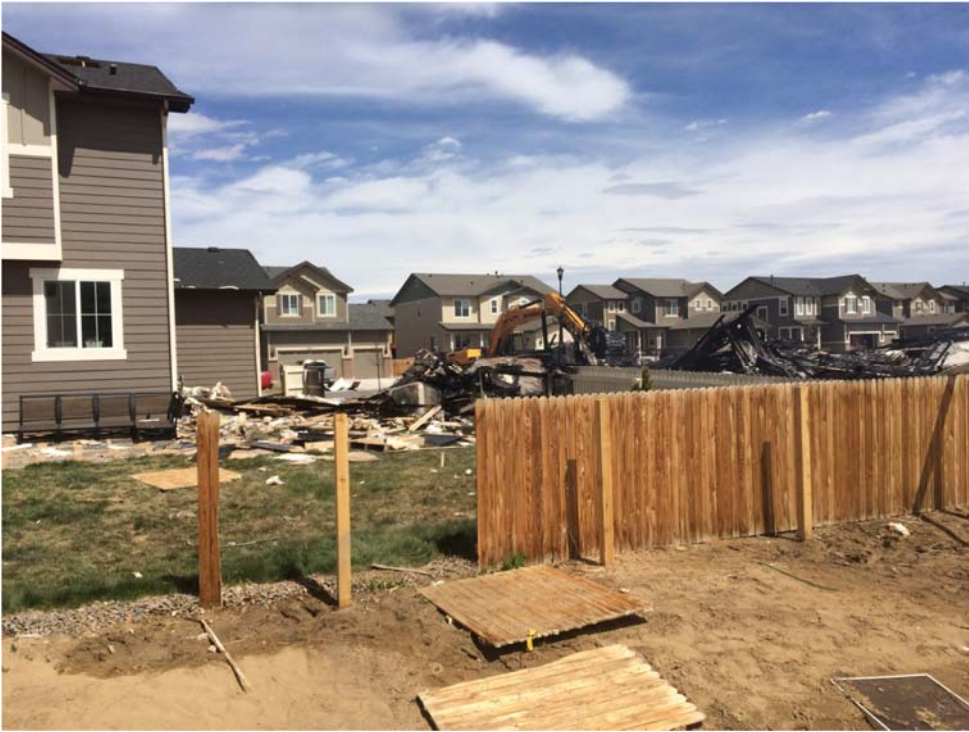
**Figure 4:** Explosion site, from Southwest side of property, facing Northeast.

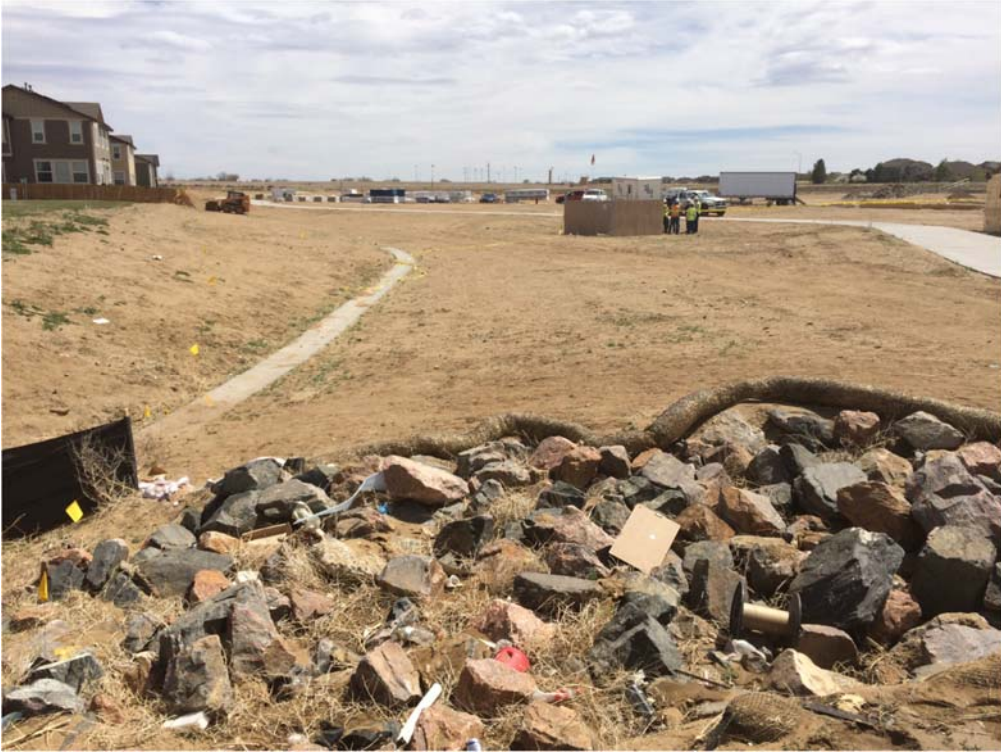
**Figure 5:** From Southeast corner of property looking toward the wellhead. Yellow flags indicate location of active 2" flowline.

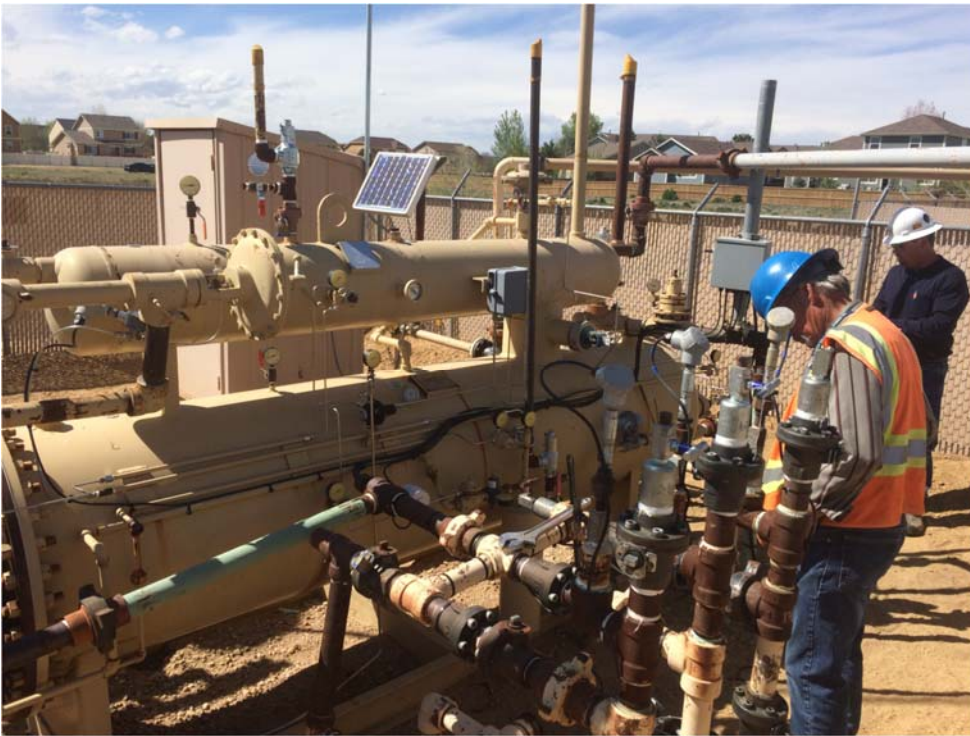
**Figure 6:** End of active 2" flowline at oil water separation unit.

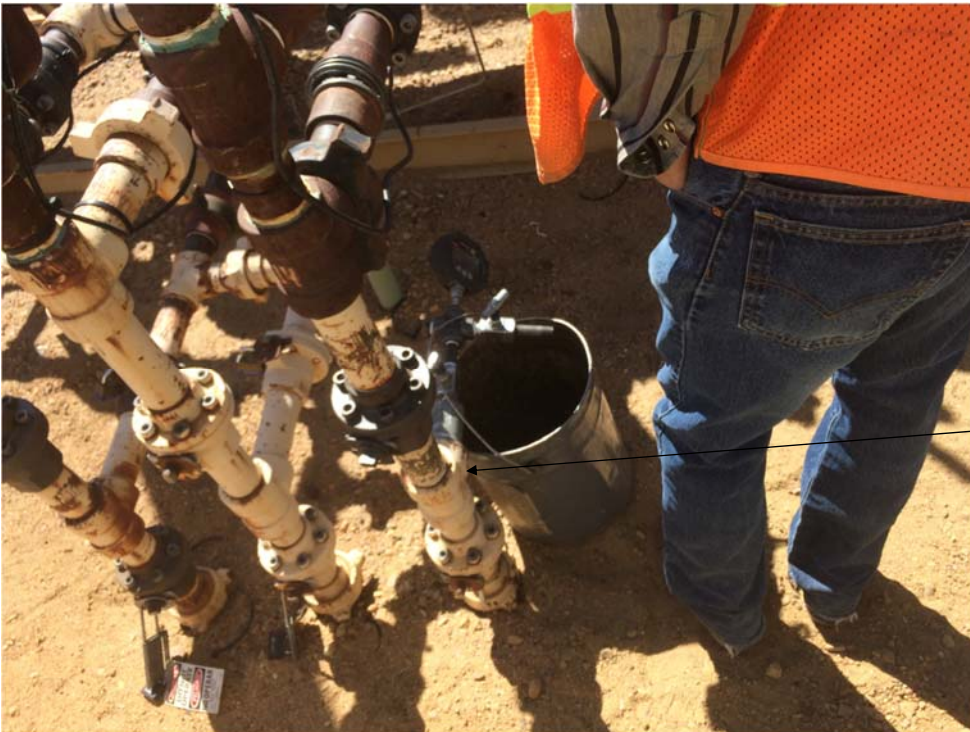
- Anadarko had performed a hydrostatic test on the production flow line (2") prior to my arrival and it held stable at 500 psi for 15 minutes. Joe MacLaren requested this test be performed again under the observation of the state and federal regulators and held for a longer period. Anadarko complied and the test held steady and stabilized for 1 hour at 500 psi.

**Figure 7:** End of 2" flow line a separator facility with pressure gauge installed for hydrotest

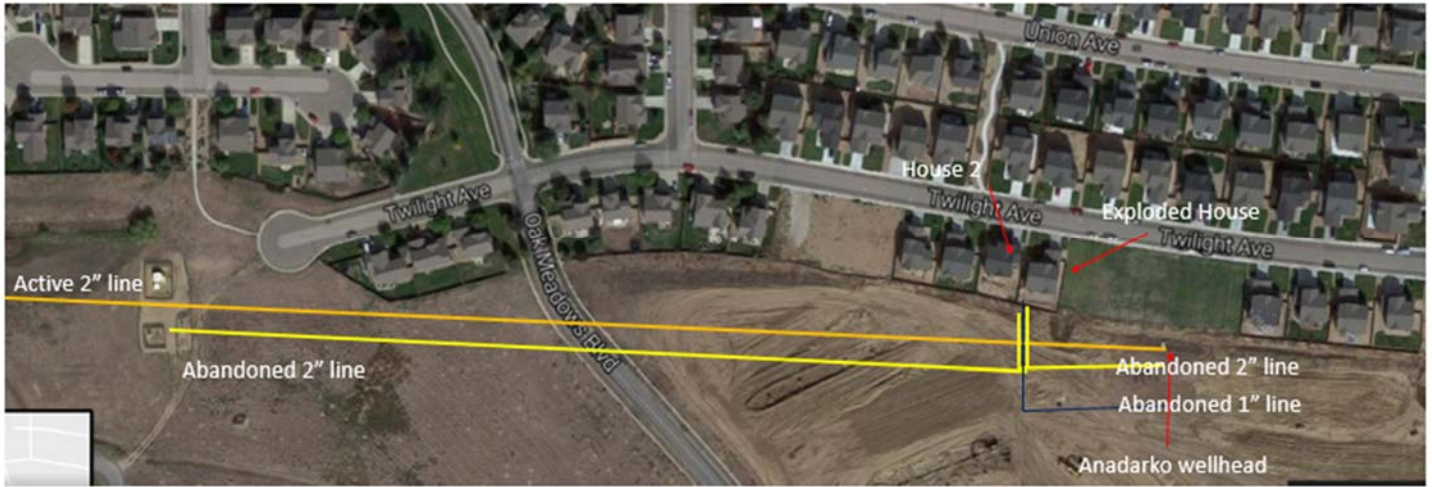
- Figure 8 is a Google map description and depiction of likely path of two 2" flow line and a 1" flow line going towards the basement of the exploded home. Figure 10 is the open trench behind the exploded house showing the three lines.

- House to the west of the exploded house (House 2) was vented overnight from 4/18 to 4/19. The LEL level was checked at approximately 0830, 30 min after the fan was off, the LEL reading was 0. Four hours later at approximately 1330 the LEL increased to 6%, as per test conducted by the Black Hills Technician. Figure 8 shows the position of house 2 on Google map.

**Figure 8:** Sketch of active and abandoned pipeline going to the back of the yard (Note, the map is not official, not drawn to scale, but a pictorial description based on the trenched line)

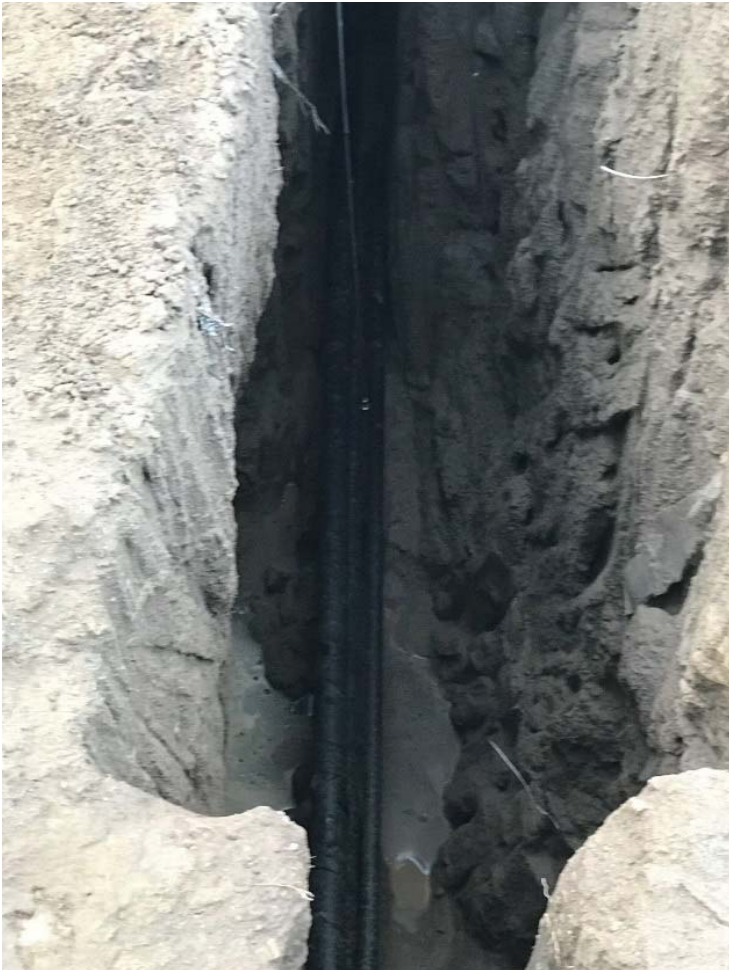
**Figure 9:** First open trench going towards the exploded house. Two 2" lines (steel) and a 1" line (plastic) are shown

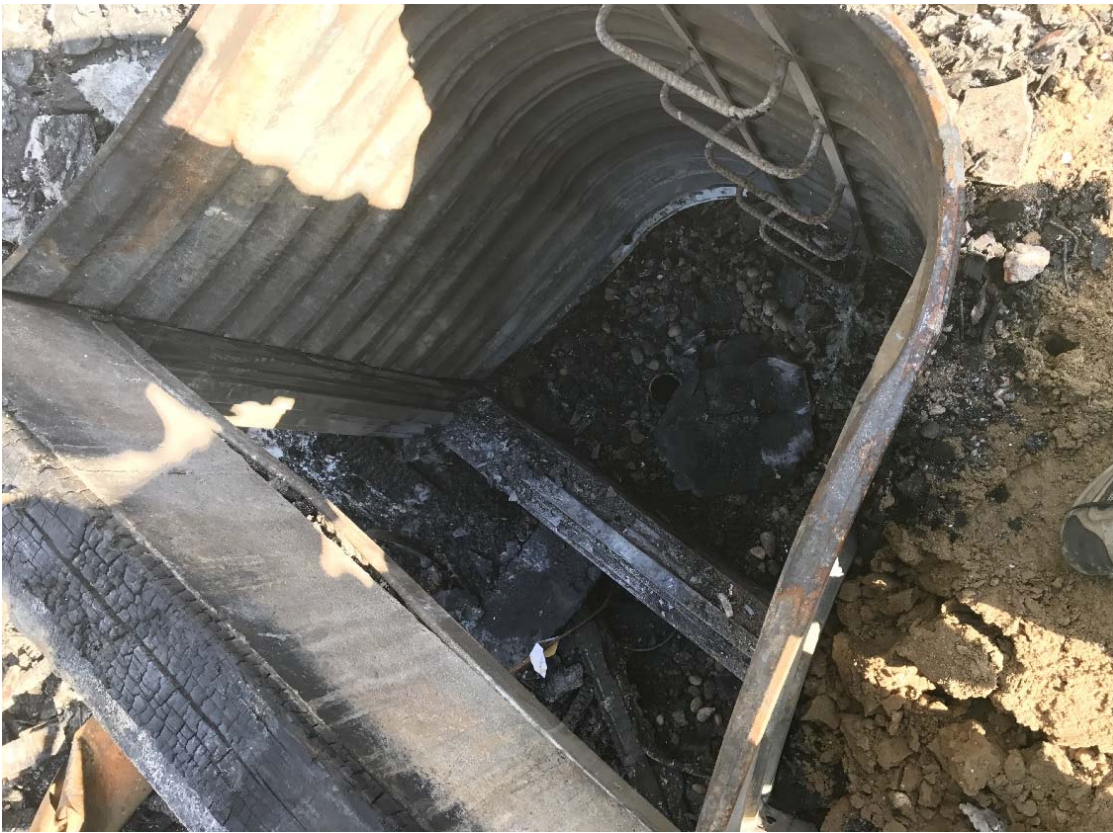
- Exploded house and House 2 each have separate drainage system that channel to the sump in the basement of each respective homes. The window water collection drainage system can be seen at the basement window of the house where there positive LEL level as shown in Figure 10 and 11.

**Figure 10:** Drainage system in the south window of the exploded house

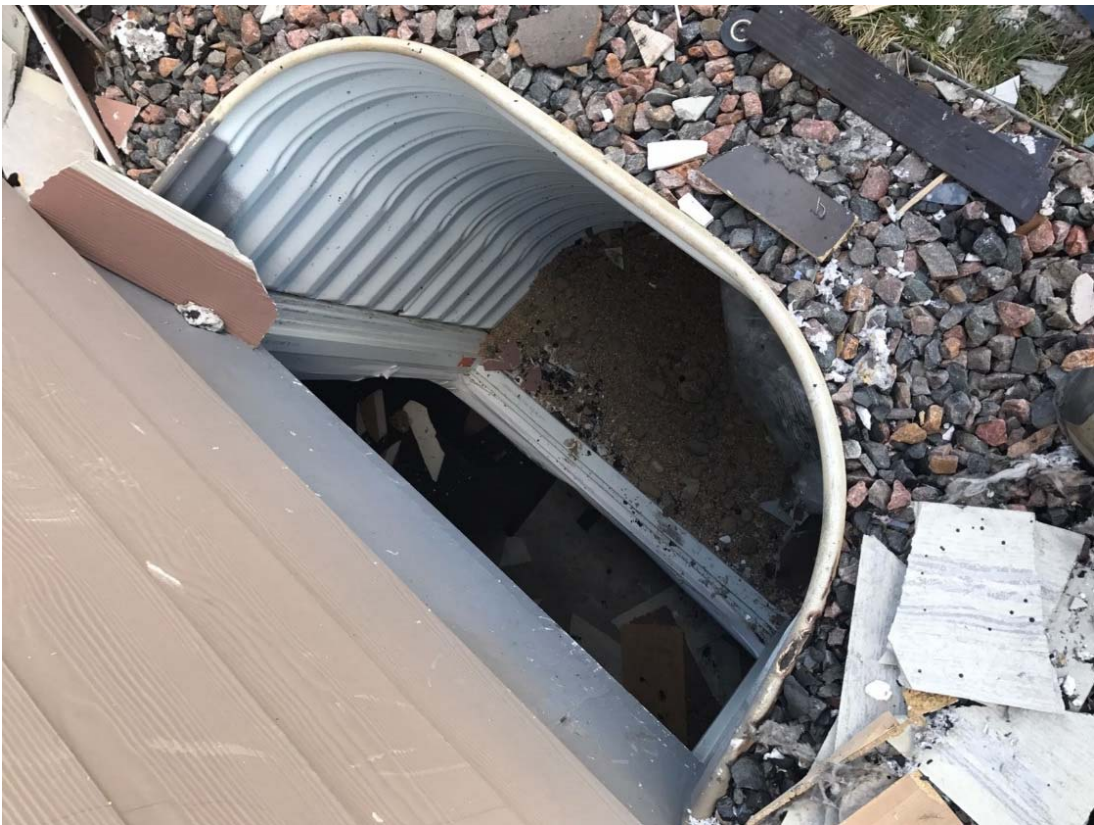
**Figure 11:** Drainage system in the east window of the unexploded House 2

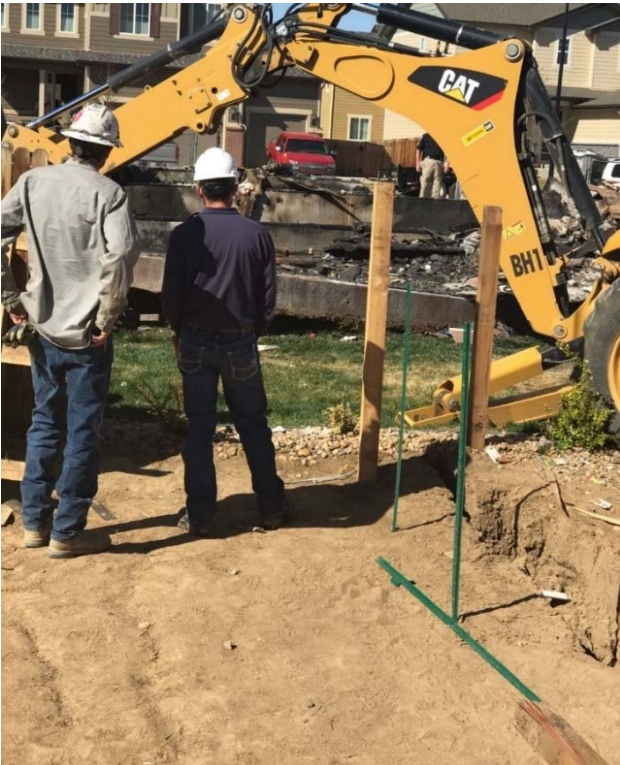
- The concrete slab at the back of the exploded house was lifted and a gas check was done, under the deck that showed a 10% LEL see Figure 12.
- Excavation of the section near the foundation occurred at approximate 1643 on the two 2" lines and 1" line, as shown in Figure 13. The trench was dug to expose the line in the yard of the exploded house close to the window, there was a strong smell of gas, like a petroleum product coming out of the open trench, the line sloughed afterwards.

**Figure 12:** Removal of the concrete slab at the back of the exploded house, relative to the position of the initially dug trench exposing the three flow lines.

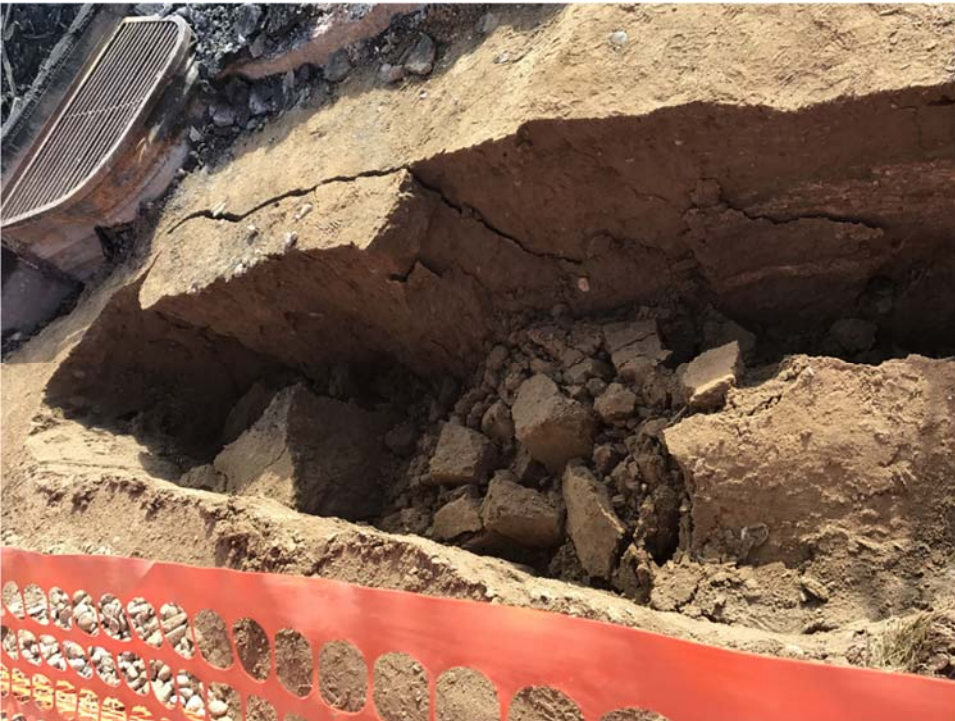
**Figure 13:** Sloughed trench close to the south window of the exploded house.

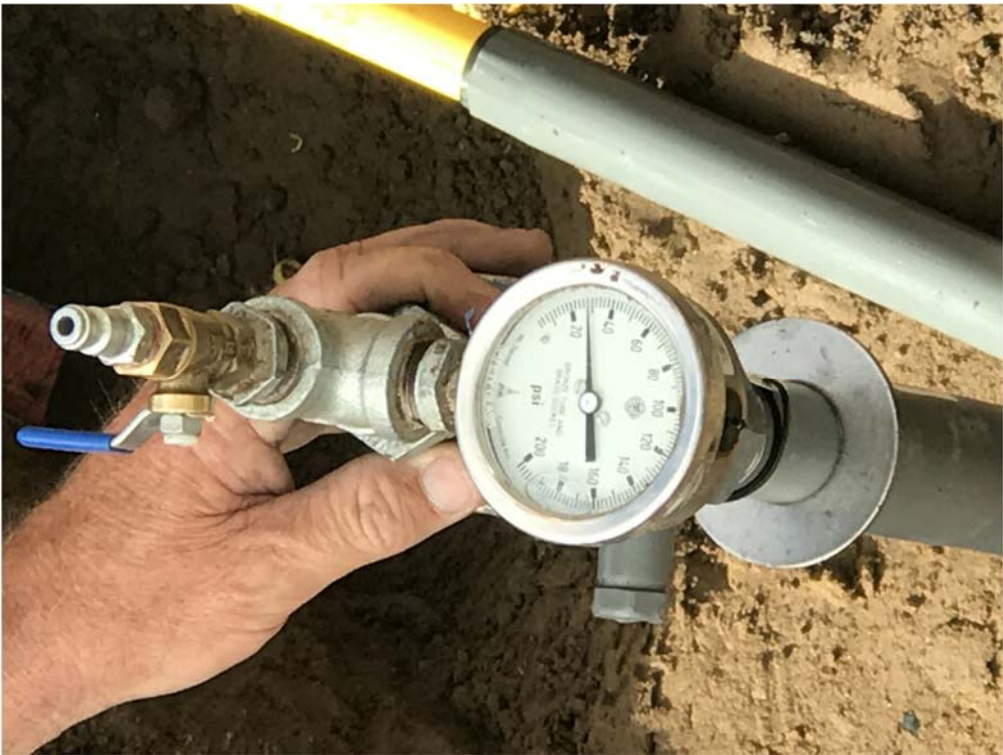
- The test started at 0938 and the pressure held at 30 psi for 10 min, test ended at 0950, pressure was constant for the duration see Figure 14.
- Routine test was conducted on the window of the unexploded house 2, test showed 50% by volume of LEL.

**Figure 14:** Black Hills Energy company service line pressure test pressure held for 10 min.

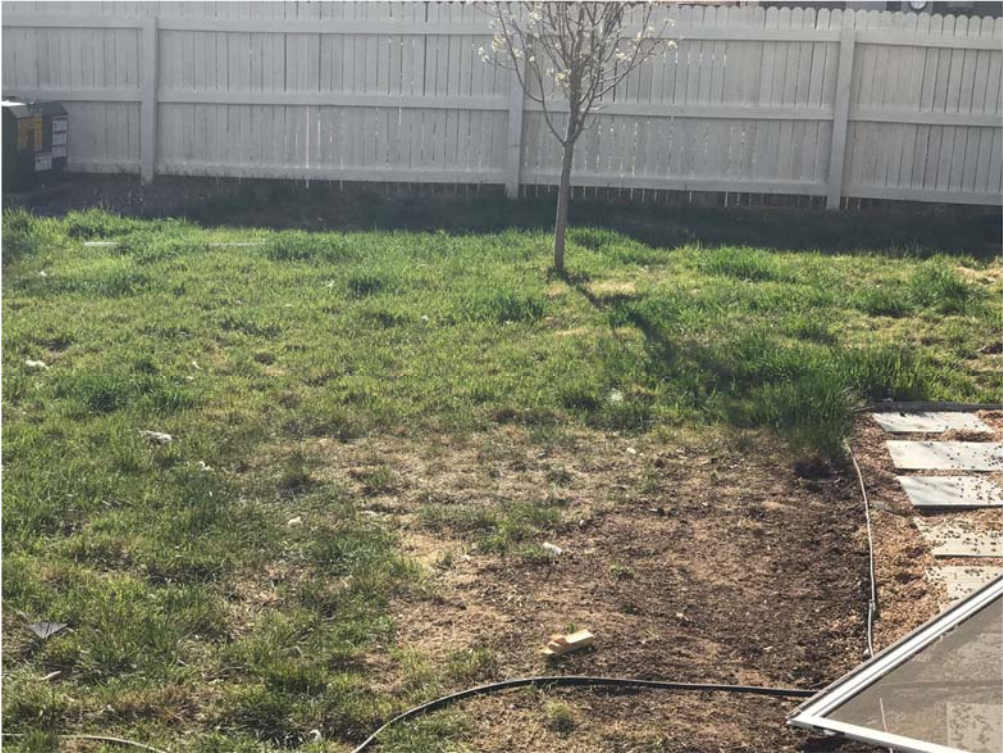
- Bar hole sample was taken at the back yard of House 2 to test for LEL, all bar hole locations tested positive for LEL see Figure 15.
- The sloughed trench at the exploded house was reopened at approximately 1330, once the three lines were exposed, there was strong odor of petroleum product again see Figure 16. All three lines appeared to be saw cut and not capped.

**Figure 15:** The backyard of the unexploded House 2 where a hole was dug and LEL tested.

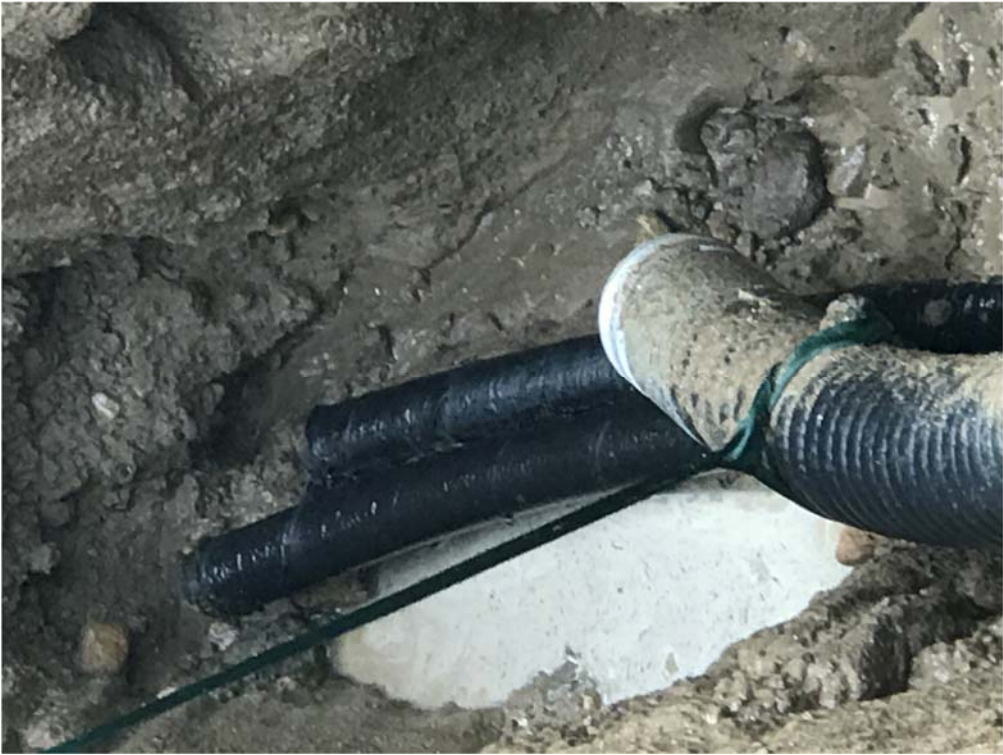
**Figure 16:** The exposed end of the three flow lines under the removed concrete slab. The 1” line is underneath the exposed two 2” line

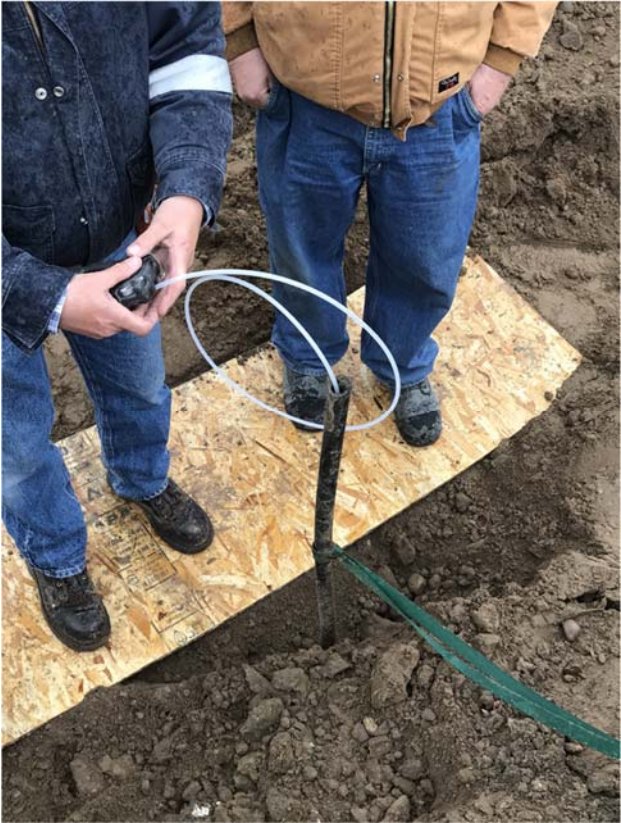
- The 1" line was brought to surface, and the hole was backfilled to allow for work to continue as shown in Figure 17. The exposed 1" line was tested for LEL, and the result was negative. Approximately 2 feet of the exposed 1" line was cut and removed for further analysis, see Figure 18.

**Figure 17:** End of 1” line brought to the surface.

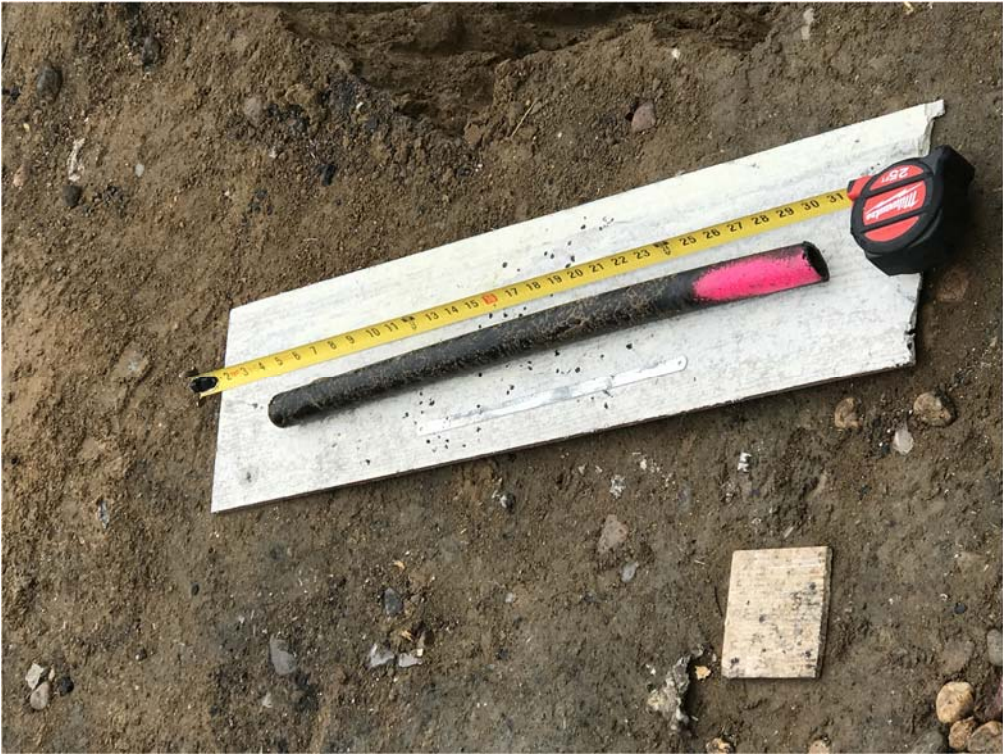
**Figure 18:** Approximately 2 feet of the exposed 1” line cut.

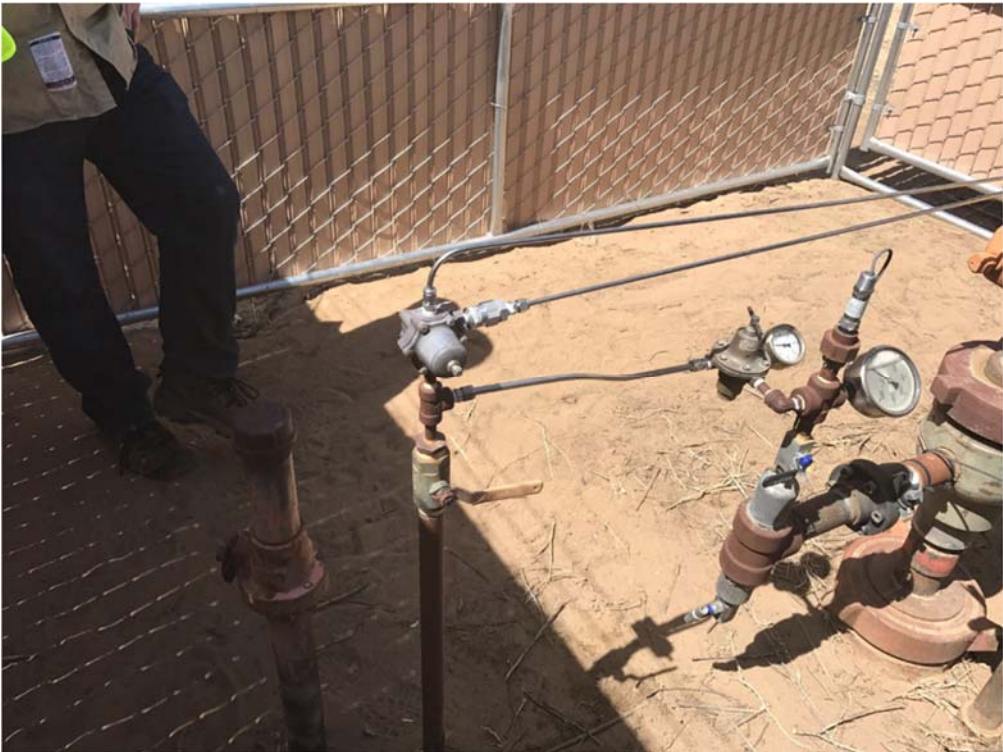
- Figure 19 was showing the wellhead after the explosion on April 18<sup>th</sup> showing a connection to the active wellhead.

**Figure 19:** The Anadarko wellhead East of the exploded property with the 1’ line still connected, photo taken 4/18/2017

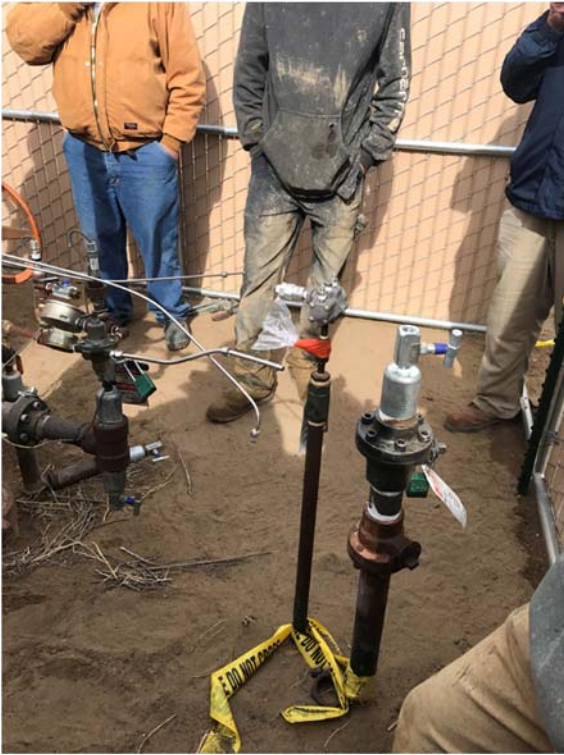
- The other end of the 1" line at the wellhead (Fig. 20) was tested for continuity by tapping a plastic bag to the inlet, and vacuum pressure from the vacuum-truck was applied on the exposed 1" line behind the exploded house (Fig 22). The test stopped when the plastic bag responded to the vacuum pressure, indicating continuity.

**Figure 20:** The 1” line at the wellhead with a plastic cover, ready for continuity test
