**NATIONAL TRANSPORTATION SAFETY BOARD**

**Office of Aviation Safety**

**ACCIDENT REPORT PHOTOGRAPHS**

**WPR11CA112**

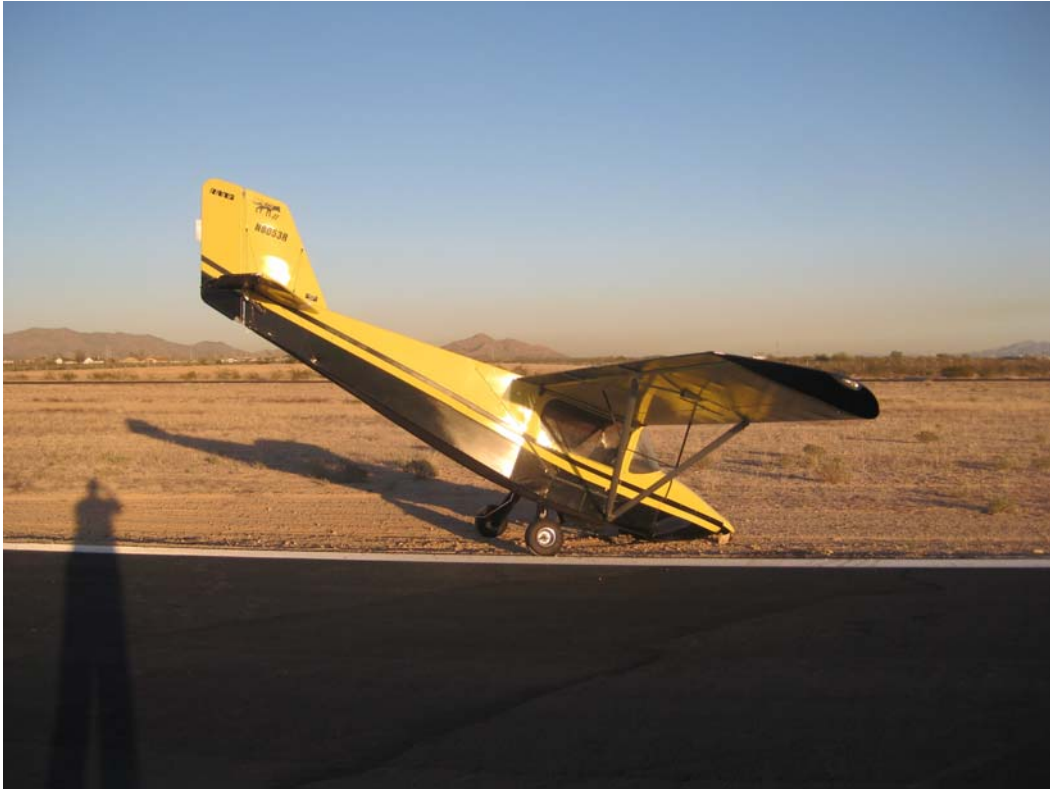
**Photo 1: Airplane on the right side of the runway.**

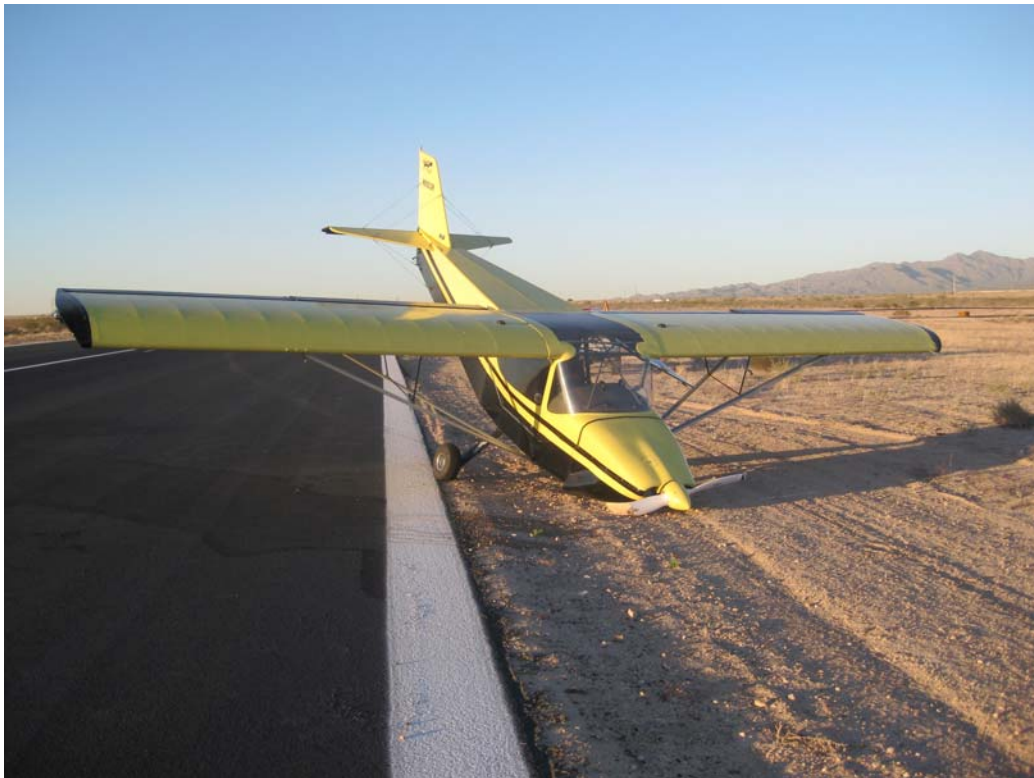
**Photo 2: Front view of airplane**

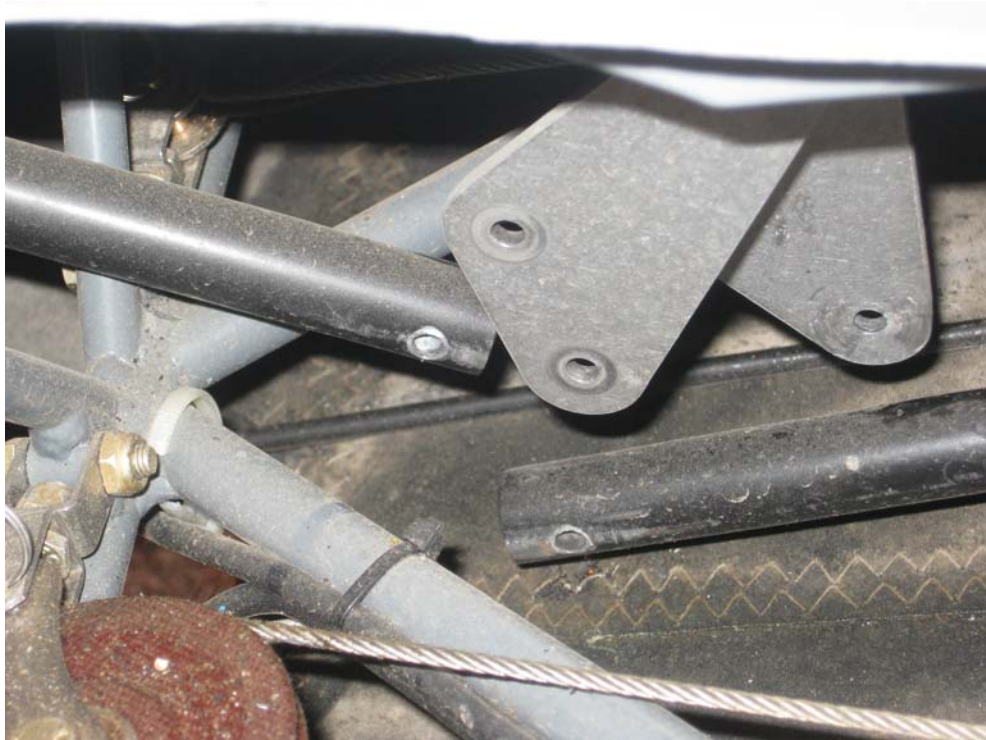
**Photo 3: the disconnected elevator control tube with the loose bolt removed.**

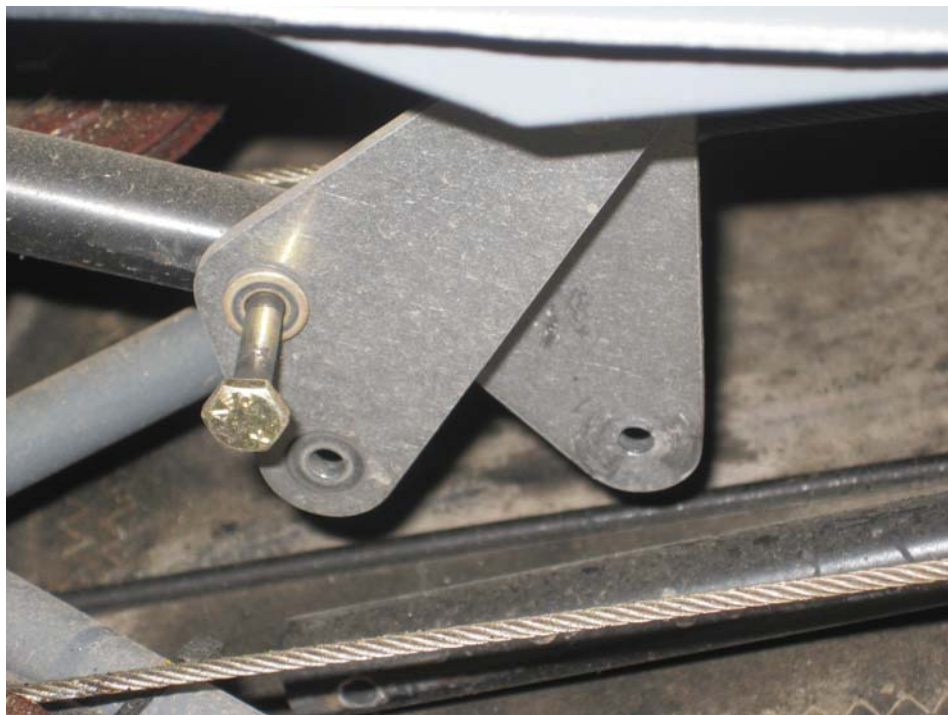
**Photo 4: the disconnected elevator control tube as found after the accident.**
