NTSB File No.: CEN14FA046

Aircraft: Mitsubishi MU-2B-25

PROPELLER TEARDOWN REPORT

Propeller Model: HC-B3TN-5M with 10178-11 blades.

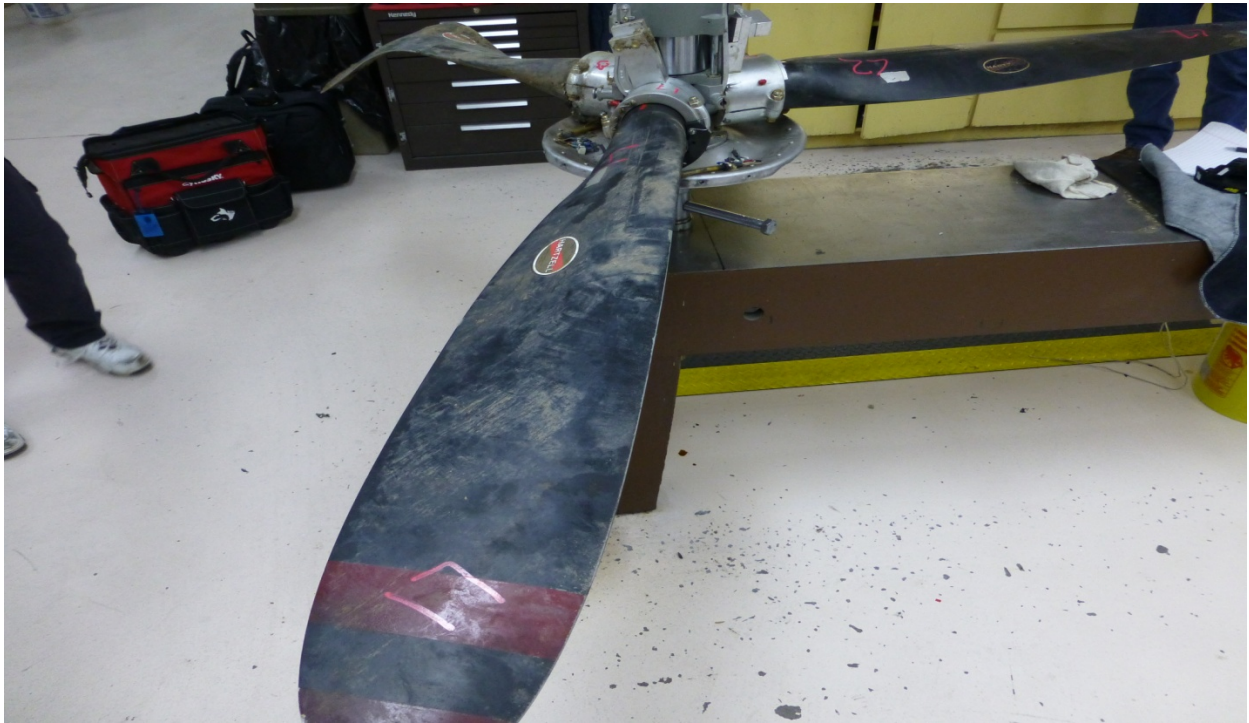
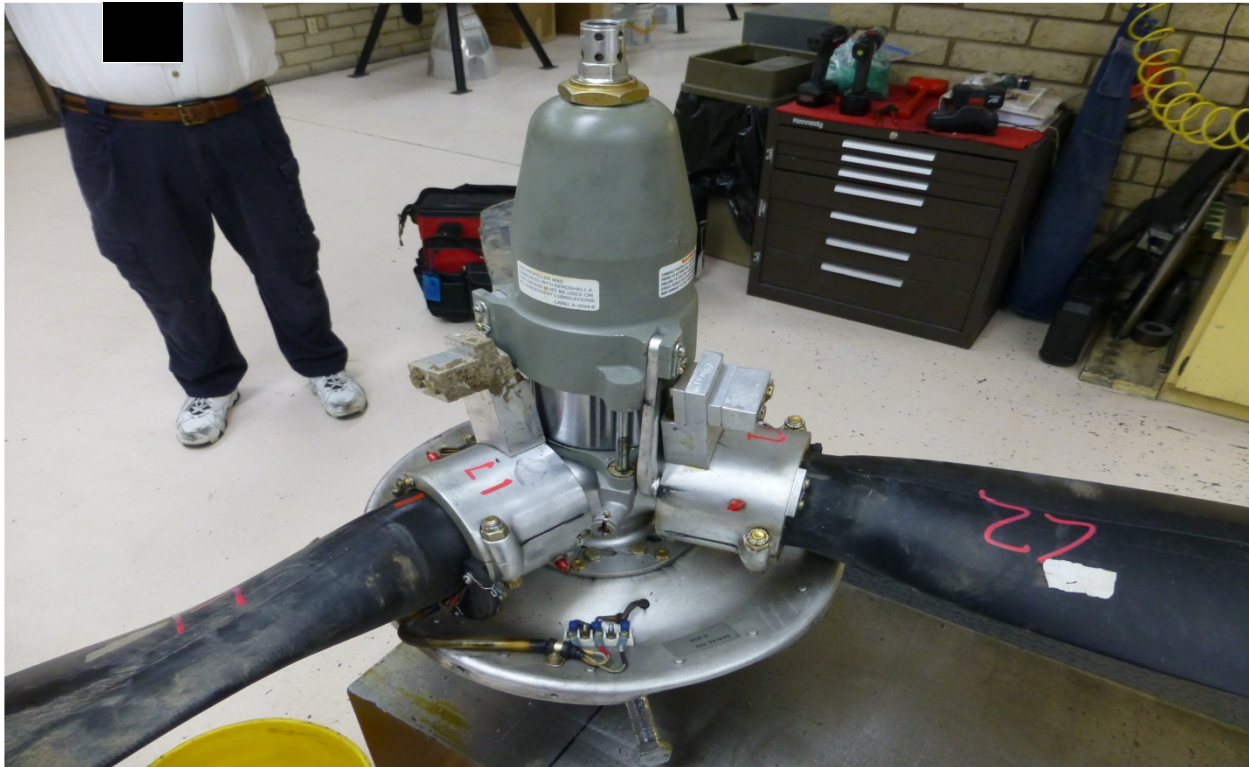
The propeller had mild damage, the L3 blade was slightly bent aft at midblade, otherwise, the propeller was intact and unremarkable. The spinner dome was missing. The propeller was in the feather position when received.

Photo #1, propeller as received.

Photo #2, propeller as received.

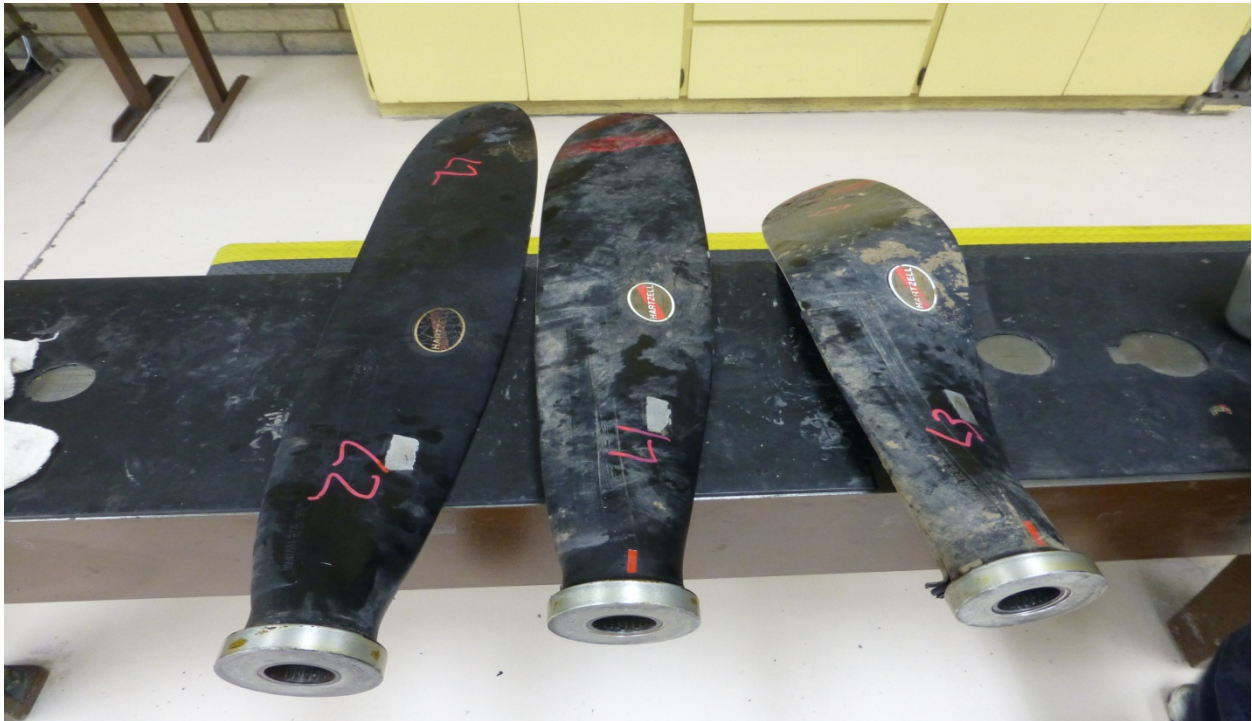
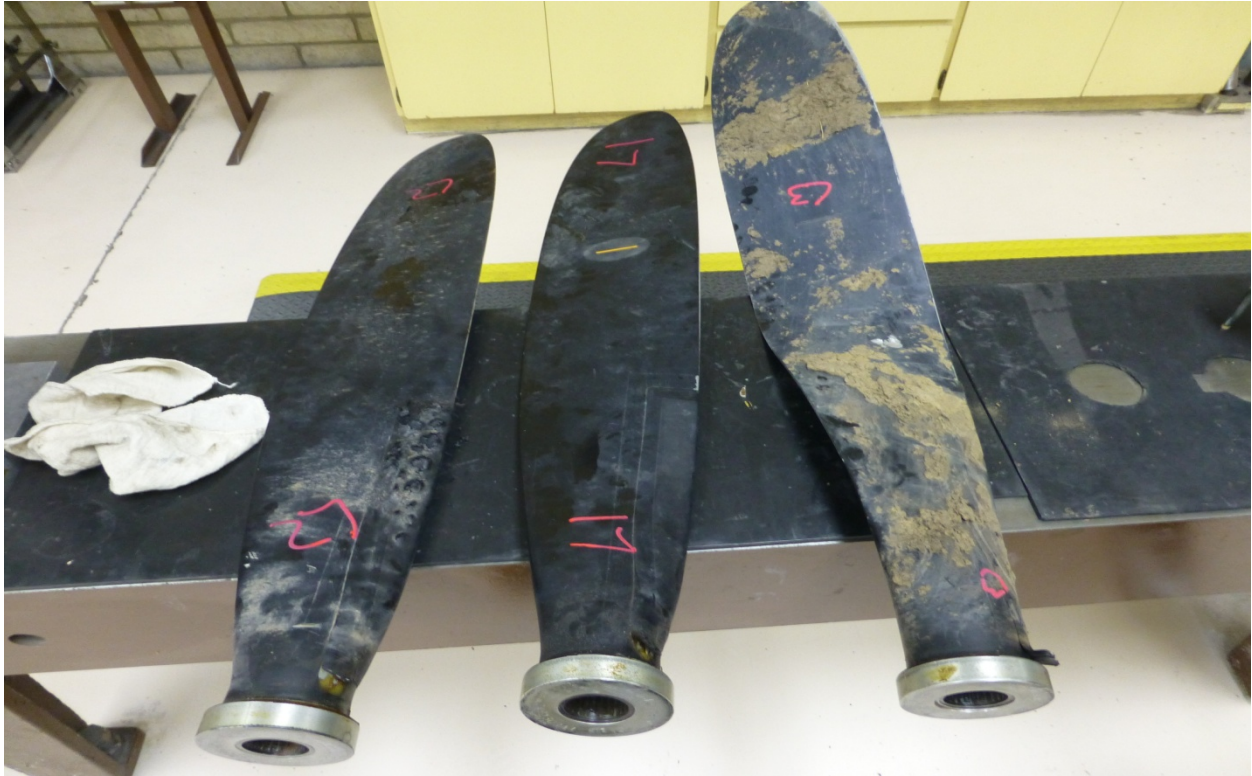
paint, camber side - intact with some small knicks and scratches.
paint, flat side - intact with some small knicks and scratches.
bend - bent aft at midblade.
twist - none.
lead edge damage - none.
trail edge damage - none.
butt impression - none.

Photo #3, left propeller blades

Photo #4, left propeller blades.

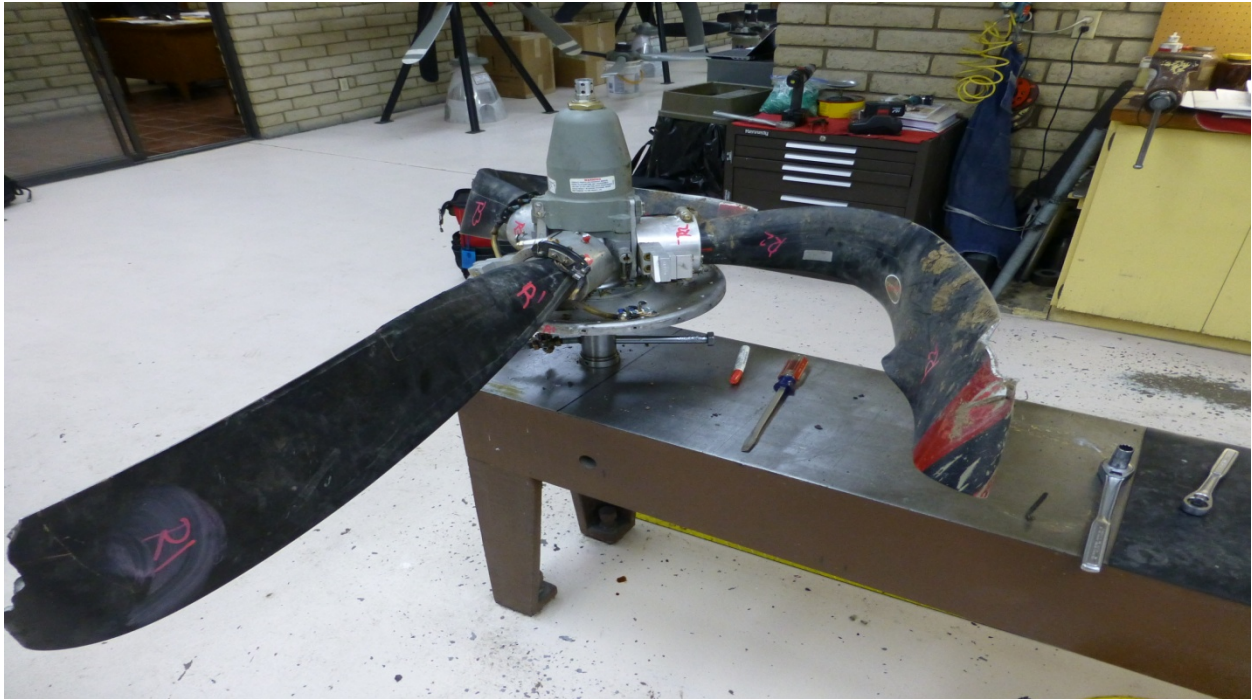
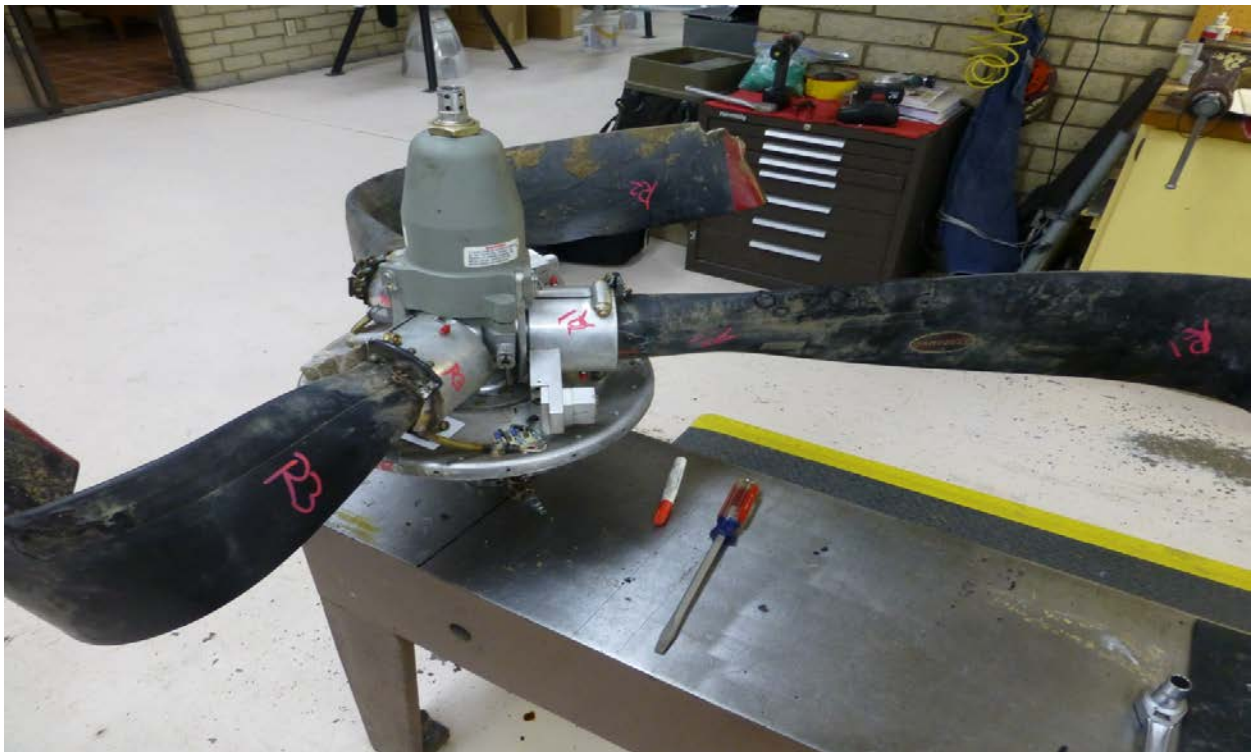
The R1 and R3 blade tips were torn off. The R2 blade had gouges missing and the tip was curled under. The R2 and R3 blades were bent over 100° forward. The

spinner dome was missing. All three link arms were disconnected from the blades clamps.

Photo #5, propeller as received.

Photo #6, propeller as received.

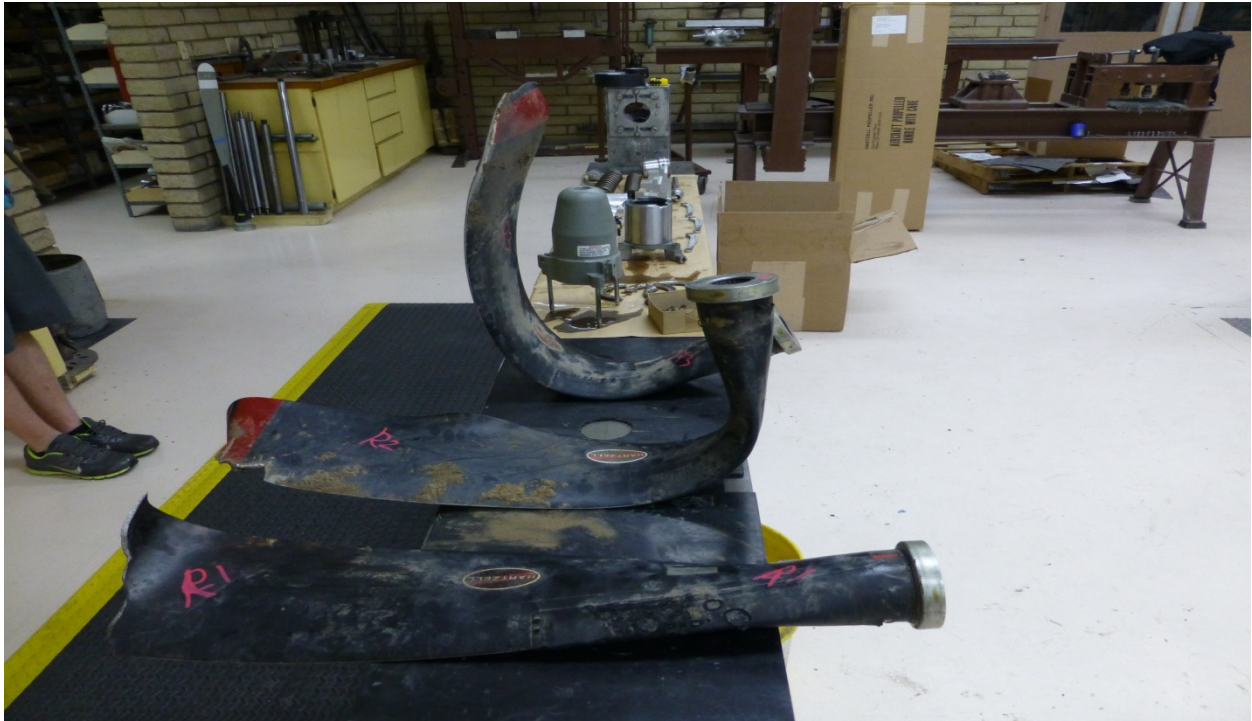
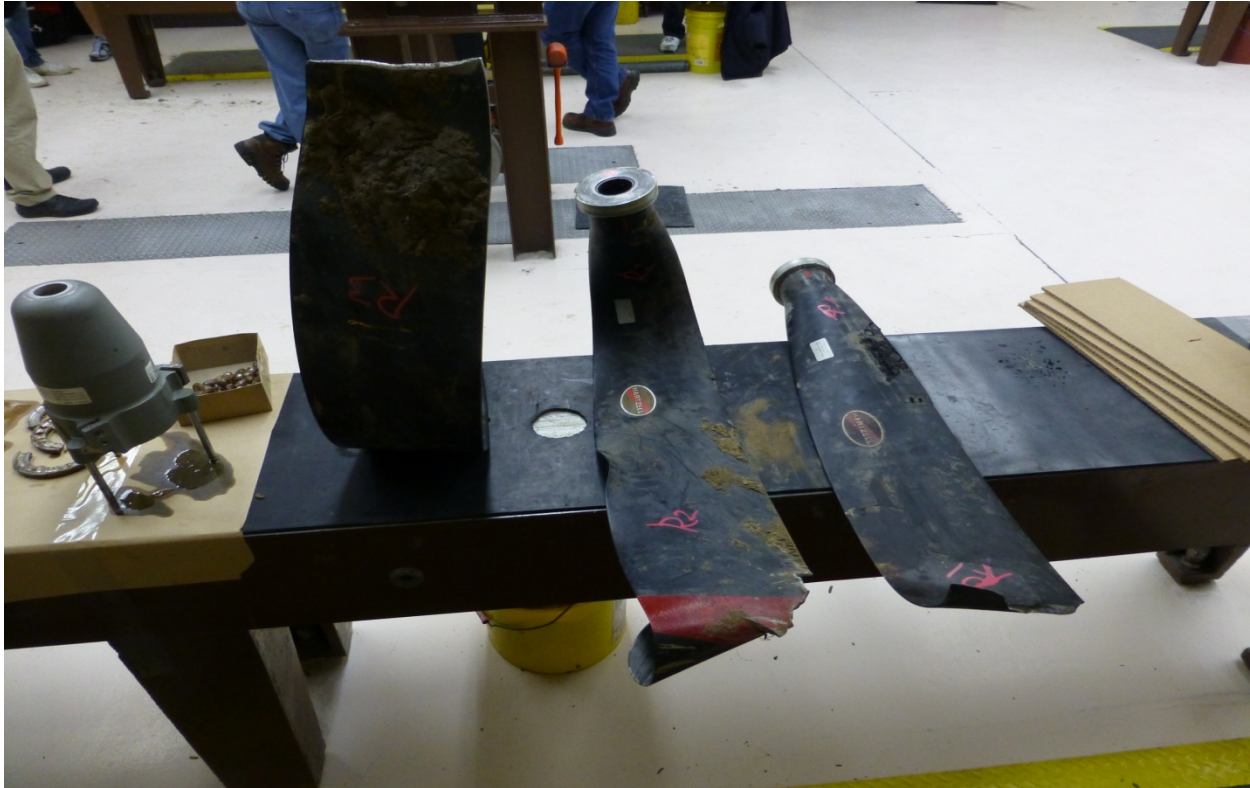
- paint, camber side - intact and unremarkable.
- paint, flat side - intact and unremarkable.
- bend - tip missing, bend forward towards tip.
- twist - none, tip missing.
- lead edge damage - some thermal damage.
- trail edge damage - none.
- butt impression - impression from raised surface of hub at 9 o'clock.

- paint, camber side - intact and unremarkable.
- paint, flat side - intact and unremarkable.
- bend - bent forward 90° at midblade, tip curled under.

twist - none
lead edge damage - tip torn and gouges, curled under.
trail edge damage - bends and tip curled under.
butt impression - impression from raised surface 360°.

paint, camber side - intact and unremarkable.
paint, flat side - intact and unremarkable.
bend - bent forward 90° at midblade.
twist - none.
lead edge damage - none, tip missing.
trail edge damage - none, tip missing.
butt impression - impression at the 3 o'clock.

Photo #7, right propeller blades.

Photo #8, right propeller blades.
