**M&P LAB REPORT  
LR # 233269**

**DIVISION: CSD  
PART NUMBER: 308570-1007, S/N 0464B, J/N R742179  
PROGRAM: EMB 145  
REPORT DATE: 4/27/11**

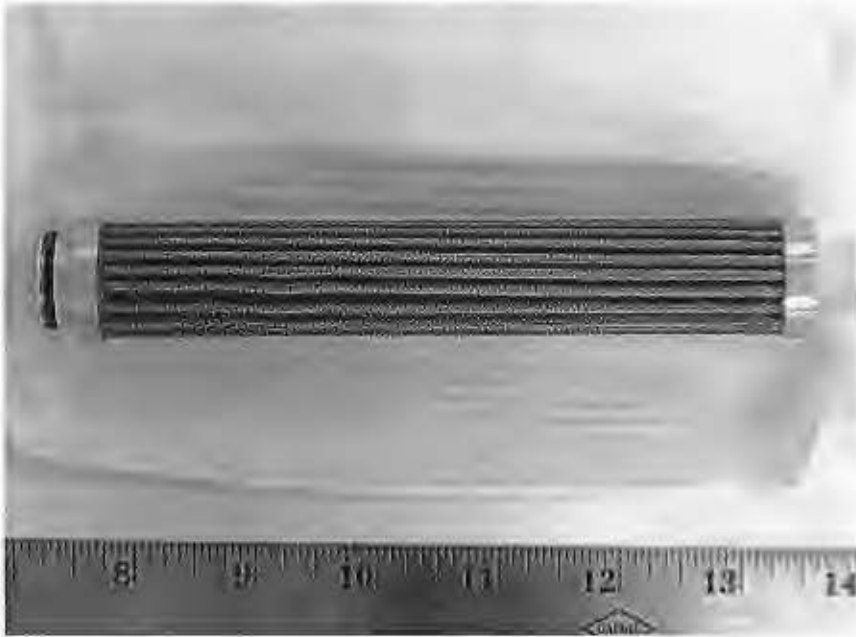
**Figure 1: This photograph shows the Pressure Filter.**

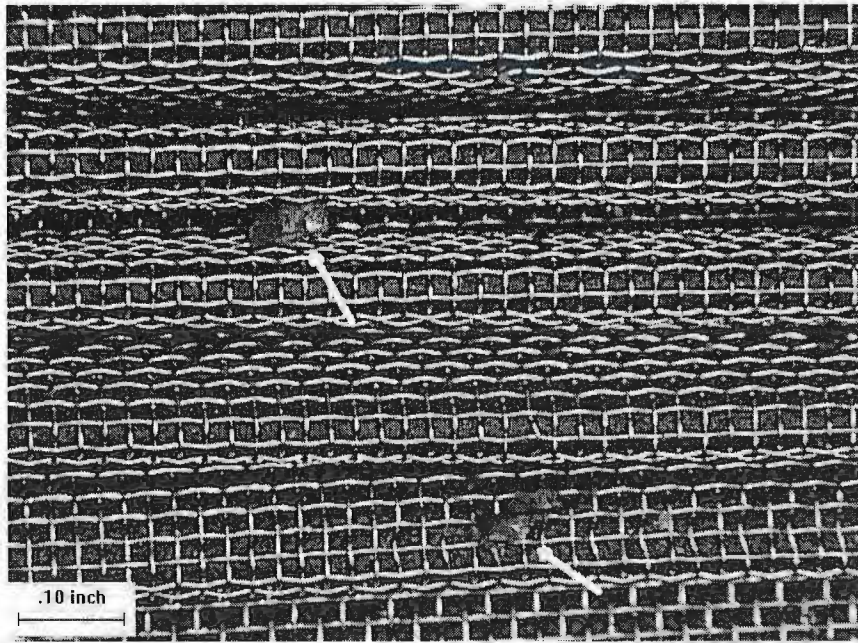
**Figure 2: Arrows point to 2 particles in the Pressure filter.  
Magnification: Approx. 7.5x**

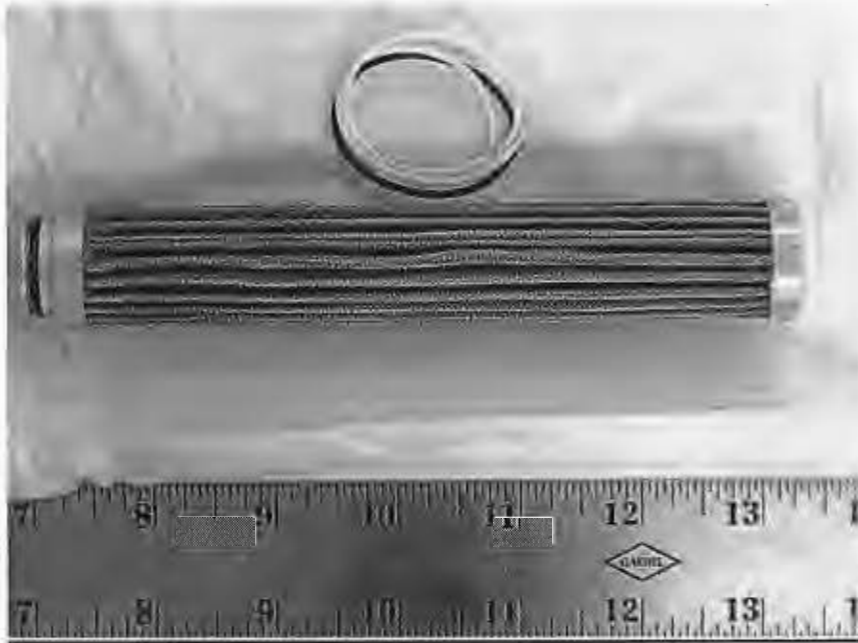
**Figure 3:** This photograph shows the filter and seals from Return.

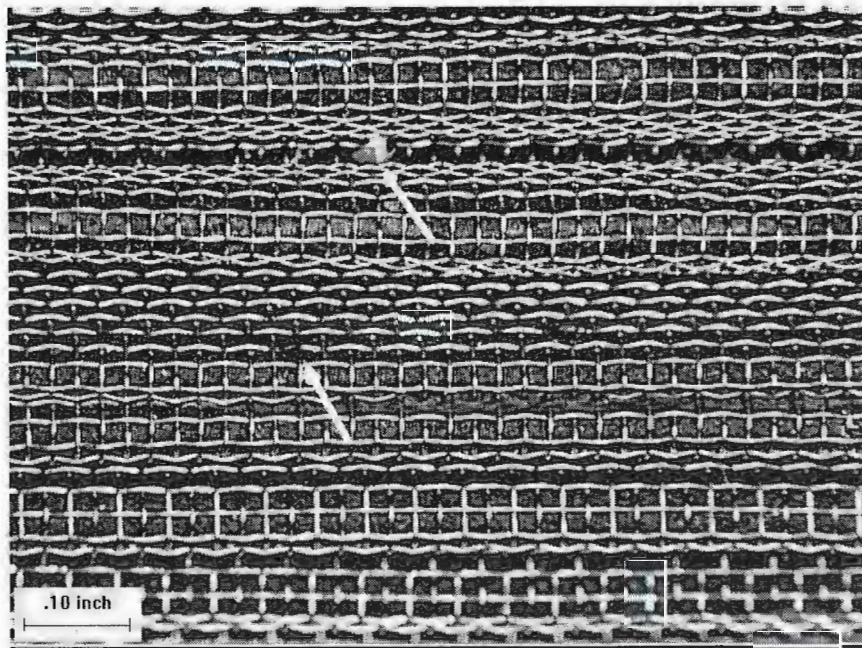
**Figure 4:** Arrows point to 2 particles in the Return filter.  
Magnification: Approx. 7.5x

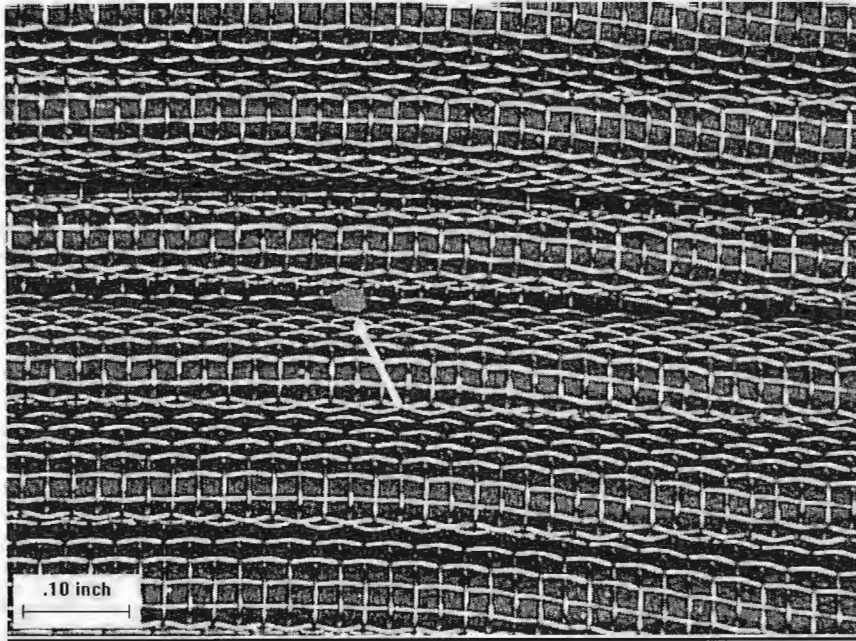
**Figure 5:** This photograph shows close up of Case Drain Filter (arrow points to a particle). Magnification: Approx. 7.5x

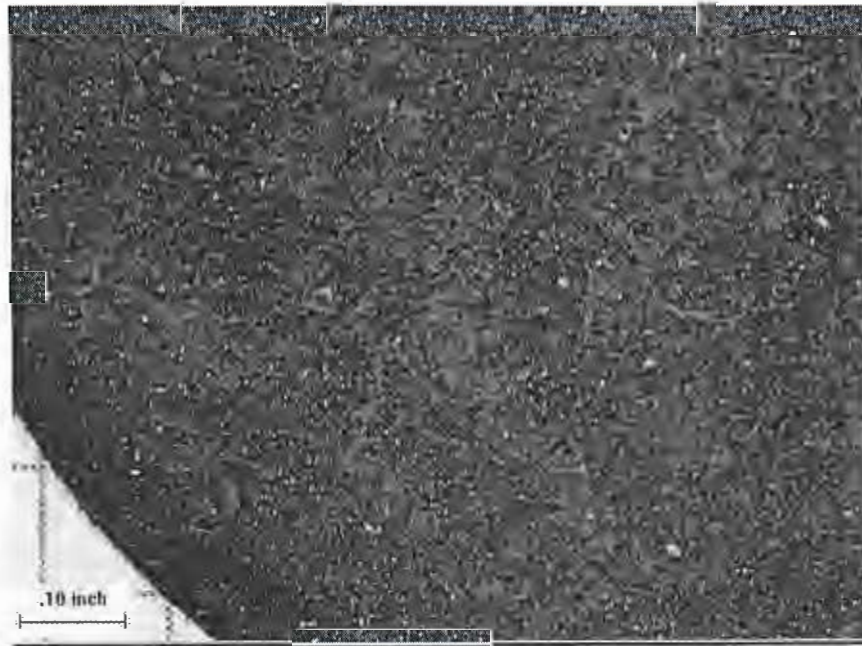
**Pressure Filter:** The patch from pressure filter was contaminated with dark Teflon material, fibers, metal particles, some white Teflon grease, white aluminum corrosion and green paint particles.

EDS analysis run on nine metal particles showed four aluminum particles (2000 & 7000 series, up to 550 microns in length and 350 microns in width), three stainless steel particles (300 series, largest one measured 625x350 microns in length and width), one tin bronze particle (copper/tin, 500x40 microns) and one low alloy steel particle (iron, 410x200 microns).

**Figure 6:** This photograph shows part of the patch from Pressure filter. Magnification: Approx. 7.5x

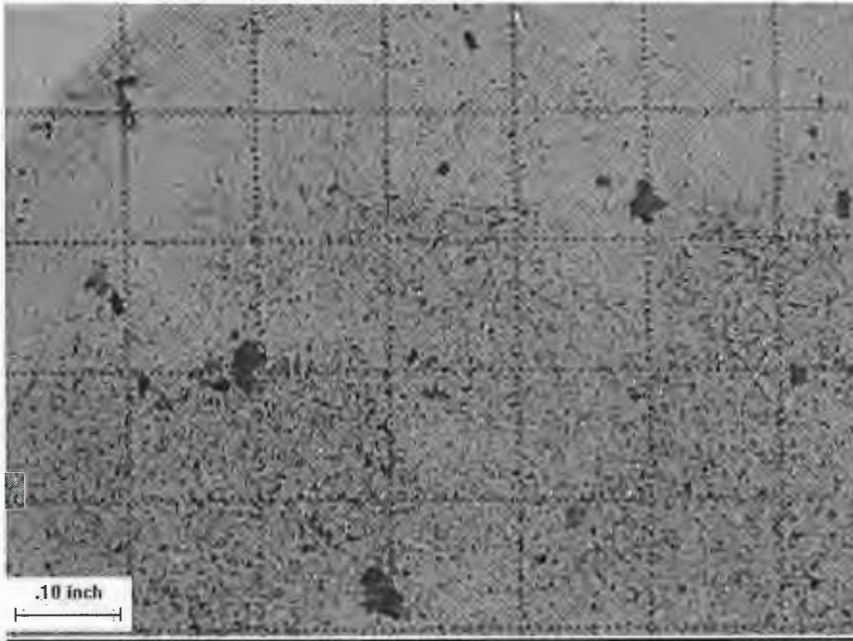
**Pressure Fluid sample:** The patch from pressure fluid was contaminated with dark Teflon material, metal particles, fibers and some white Teflon grease.

EDS analysis run on seven metal particles showed five aluminum particles (2000 series, up to 560 microns in length and 150 microns in width) and two tin bronze particles (larger one measured 500x35 microns in length and width).

**Figure 7: This photograph shows part of the patch from the fluid sample from Pressure. Magnification: Approx. 7.5x**

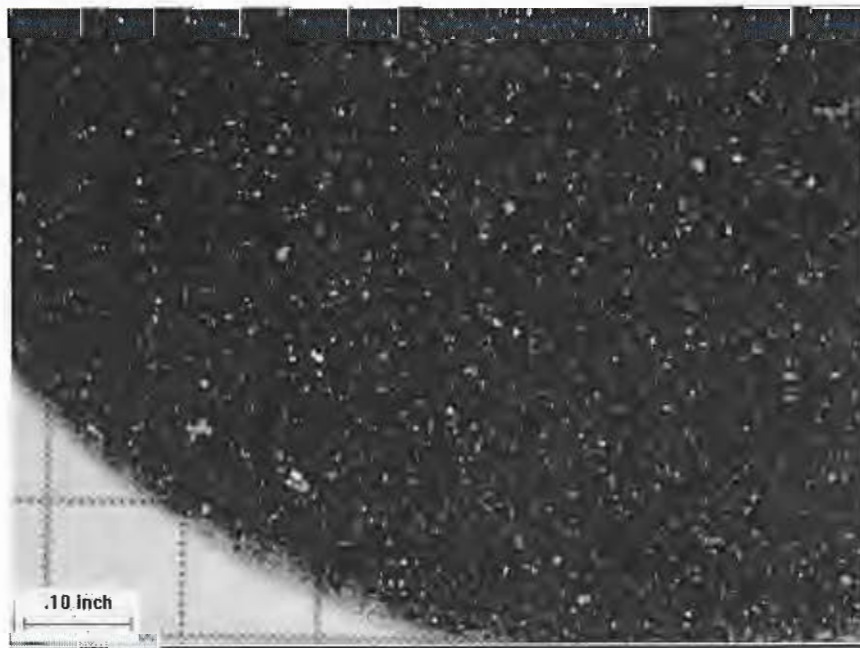
**Return Filter:** The patch from return filter was contaminated with dark Teflon material, Teflon grease, fibers, metal particles, white aluminum corrosion, o-ring material and some paint particles (red & green).

EDS analysis run on six metal particles showed they were aluminum particles (2000 series, largest one measured 1250x375 microns in length and width).

**Figure 8: This photograph shows part of the patch from Return filter. Magnification: Approx. 7.5x**

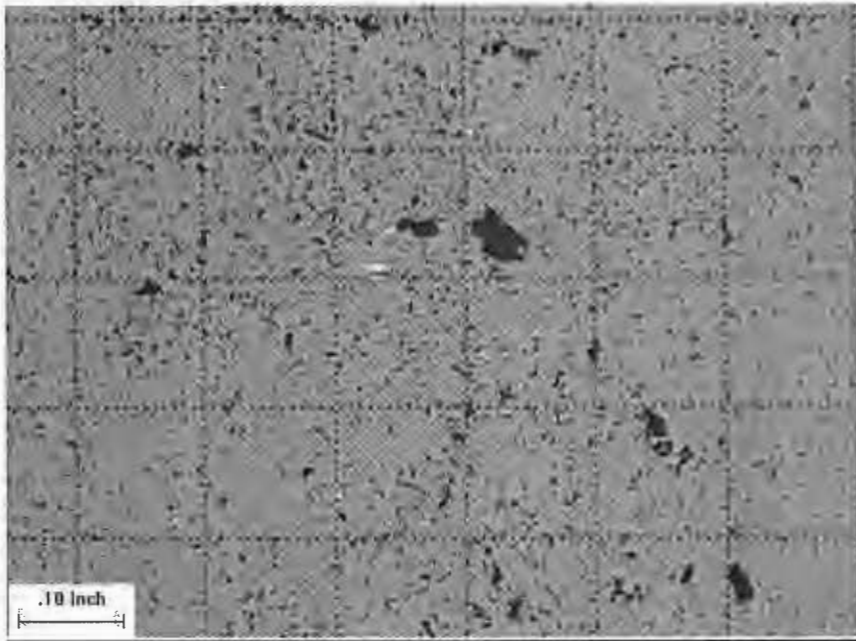
**Return Fluid Sample:** The patch from return fluid was contaminated with Teflon material, metal particles, fibers, some Teflon grease, few particles from adhesive and paint.

EDS analysis run on eleven metal particles showed seven aluminum particles (six 2000 series & one 7000 series, up to 1160 microns in length and 440 microns in width), one 300 series stainless steel particle (690x130 microns), one PH stainless steel particle (380x70 microns), one low alloy steel particle (590x570 microns) and one zinc particle (185x90 microns).

**Figure 9: This photograph shows part of the patch from the fluid sample from Return. Magnification: Approx. 7.5x**

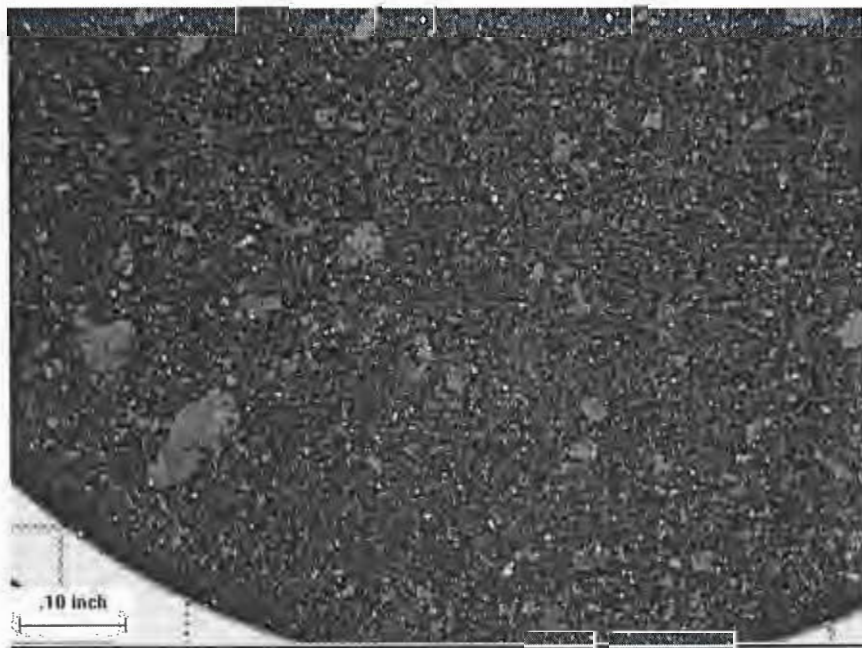
**Case Drain Filter:** The patch from case drain filter was contaminated with Teflon material, fibers, white aluminum corrosion and metal particles.

EDS analysis run on thirteen metal particles showed six low alloy steel particles (largest one measured 2785x350 microns in length and width), three aluminum particles (largest one measured 385x200 microns in length and width), three tin bronze particles (up to 500 microns in length and 80 microns in width) and one 300 series stainless steel particle (285x115 microns).

**Figure 10: This photograph shows part of the patch from Case Drain filter. Magnification: Approx. 7.5x**

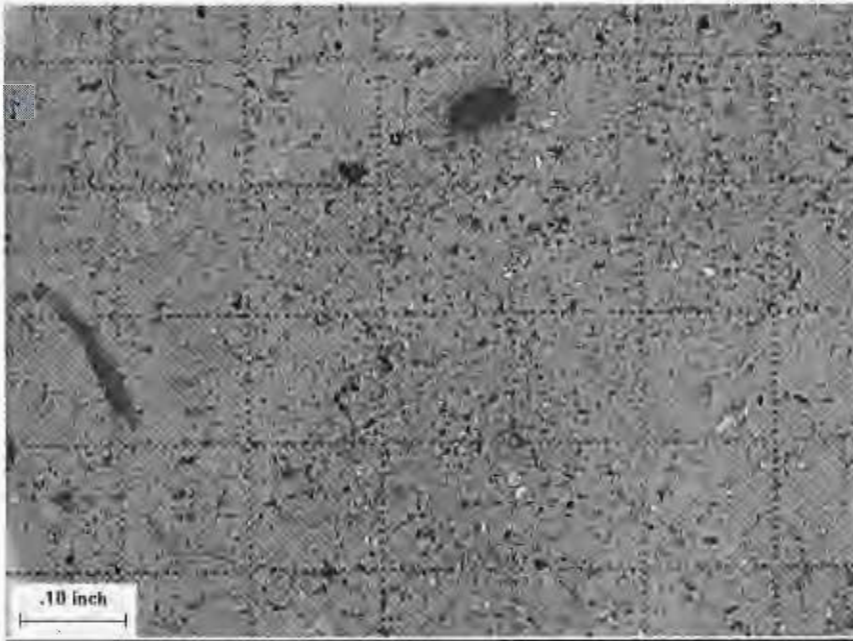
**Case Drain Fluid Sample:** The patch from case drain fluid was contaminated with Teflon material, fibers, white aluminum corrosion and metal particles.

EDS analysis run on fifteen metal particles showed six low alloy steel particles (largest one measured 1040x450 microns), five aluminum particles (up to 760 microns in length and 240 microns in width), two tin bronze particles (larger one measured 290x200 microns), one stainless steel particle (750x400 microns) and one brass particle (copper/zinc, 280x210 microns).

**Figure 11: This photograph shows part of the patch from the fluid sample from Case Drain. Magnification: Approx. 7.5x**

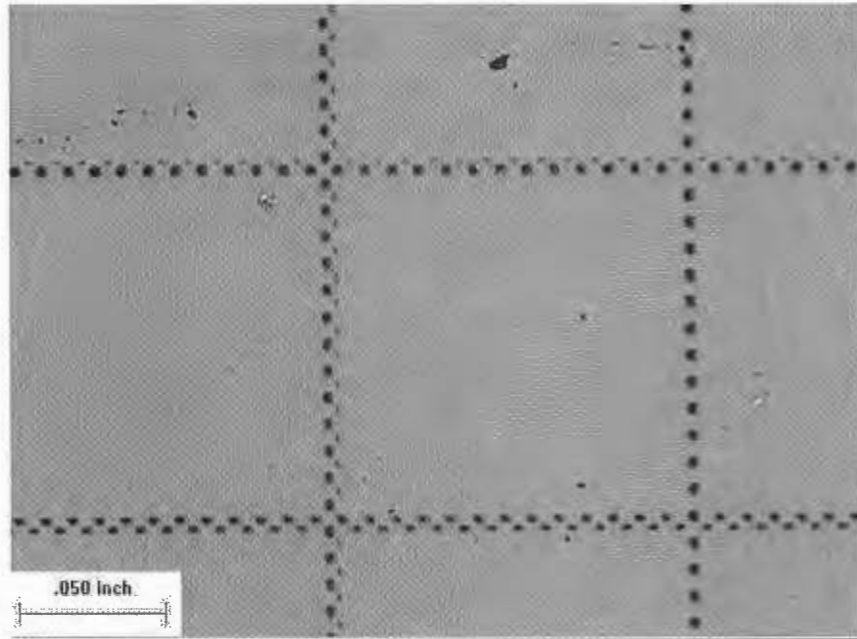
**Skydrol Fluid Sample:** The patch was contaminated with dark Teflon material and metal particles.

EDS analysis run on ten metal particles showed nine aluminum particles (7000 series, up to 510 microns in length and 160 microns in width) and one low alloy steel particle (350x120 microns).

**Figure 12:** This photograph shows a small area of the patch from the fluid sample of Skydrol. Magnification: Approx. 20x

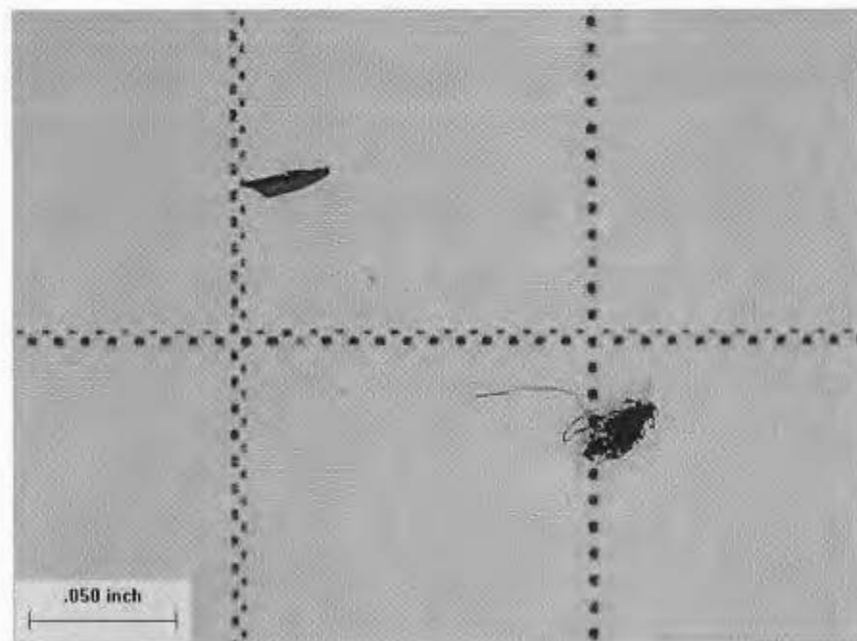
**Two particles in alcohol:** One particle was red in color and it was epoxy material (775x200 microns). The other particle was mass of fibers (800x300 microns).

**Figure 13:** This photograph shows the 2 particles from the alcohol sample. Magnification: Approx. 20x
