Customer:	Evaluation Date:
FAA	15 July, 2014
Sales Order:	Repair Order#:
981753	K166776
Part Number:	Model Number:
2751550	
Serial Number:	
0056	Complaint Verified: Yes No

Reason for Return: Investigation

On July 5, 2013, about 1845 Pacific daylight time, a Rockwell International Corporation NA-265-65, Mexican registered XB-RSC, sustained substantial damage following a reported loss of control while taxiing at the McCarran International Airport (LAS) Las Vegas, Nevada. The airplane was registered to and operated by Eseasa Contrucciones, S. A. de C. V., under the provisions of Title 14 Code of Federal Regulations Part 91. The captain, first officer and four passengers were not injured. Visual meteorological conditions prevailed and instrument flight rules (IFR) flight plan was filed for the personal flight which originated from Brownsville, Texas at about 1755, central daylight time.

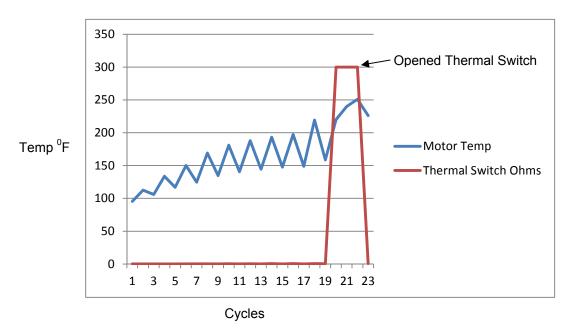
Table 2

- 2 cycles of 3 minutes on; 3 minutes off while monitoring the thermal switch continuity and external motor temperature.
 - Results are in Table 1 and Table 2.

- Thermal switch opened when outside motor temperature reached 220°F.
 - o Thermal Switch closed when outside motor temperature reached 226°F.
 - The maximum outside motor temperature achieved was 251°F.

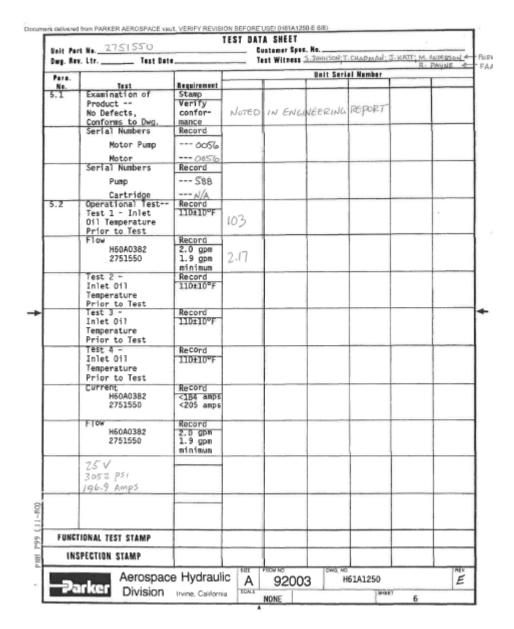
Appendix 1
Test Results

- o 2.17 gpm
- o 25V
- o 3052 psi
- o 196.9 amps
- See Appendix 1 for Test Results
- The unit was run for 1 minute in an attempt to see if the thermal switch opens

This pump motor package operated normally and satisfied acceptance testing per H61A1250 flow and current requirements.
