**NATIONAL TRANSPORTATION SAFETY BOARD**  
Office of Aviation Safety  
Washington, D.C. 20594

**Computed Tomography Specialist's Factual Report**

WPR-13-FA-430

Operator: CREX-MML LLC  
Location: Santa Monica Municipal Airport, Santa Monica, CA  
Date: September 29, 2013  
Time: 1820 pacific daylight time  
Airplane: Cessna 525A Citation, N194SJ

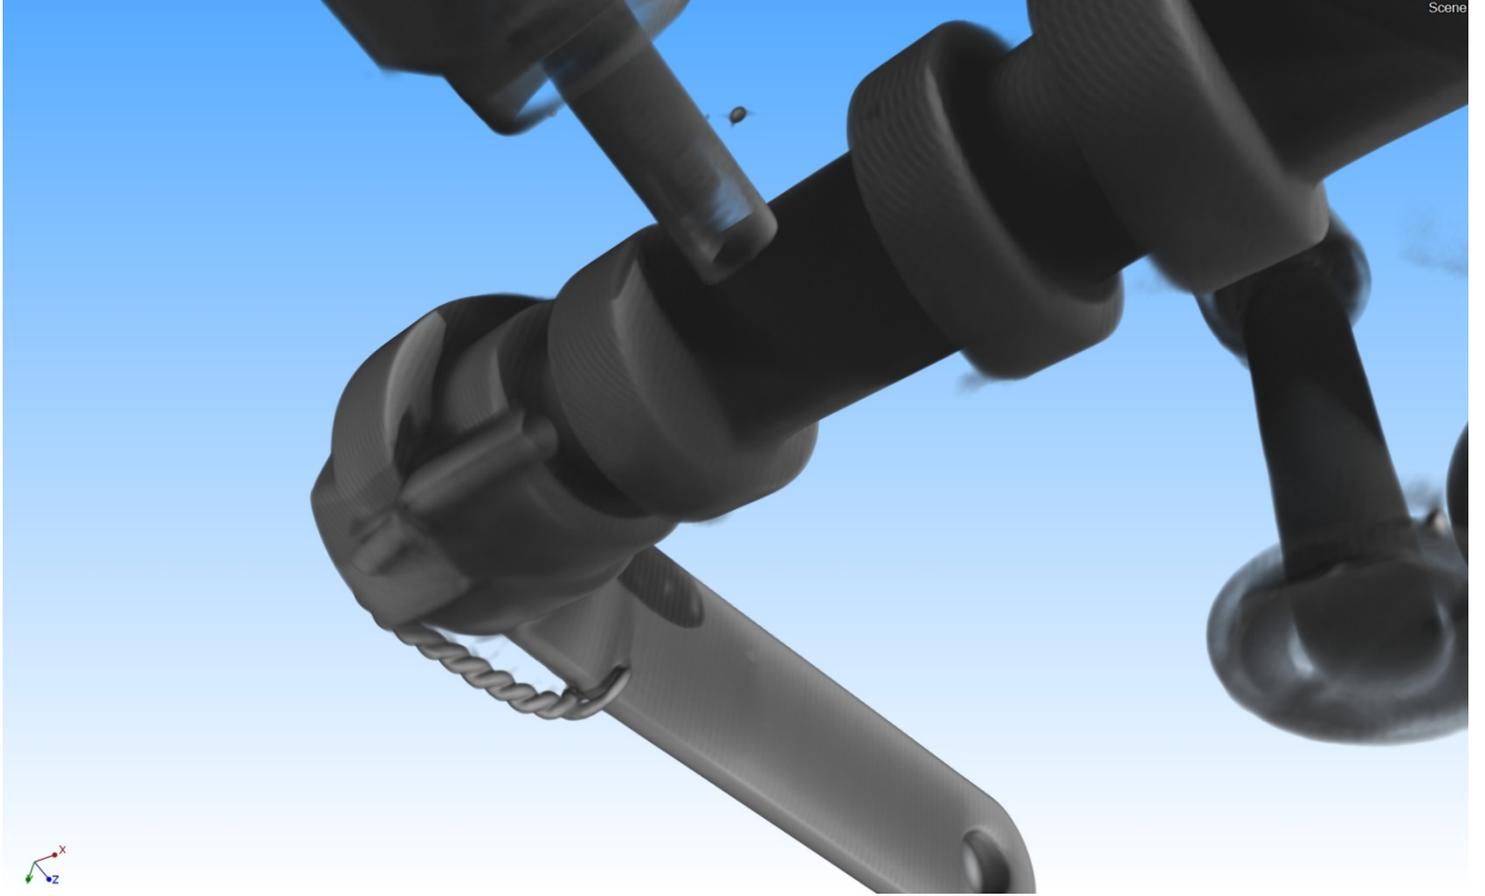
Figure 8  
Parking brake valve – 3D view of roll pin

The computed tomography (CT) results for the parking brake valve are shown in figures 1 through 11. Review of the images showed that the valve cam (spool) was overdriven past the closed position roll pin stop. The roll pin that created the stop was noted to be fractured. The thermal relief valves appeared to be seated against their respective stops.
